# EARTHQUAKE RECOVERY (EQR) DOCUMENTATION

# EQR Property Overview Report

| EQC Property ID | Property Address | Vulnerable? | Property F Status | Property Finalisation Indicator | | |
|---|---|---|---|---|---|---|
| 2010027427 | 5 DUDLEY STREET, RICHMOND | | F3 - Complete & Finalised | Some Finalisation has taken place | | |

### 5 Dudley Street, Richmond

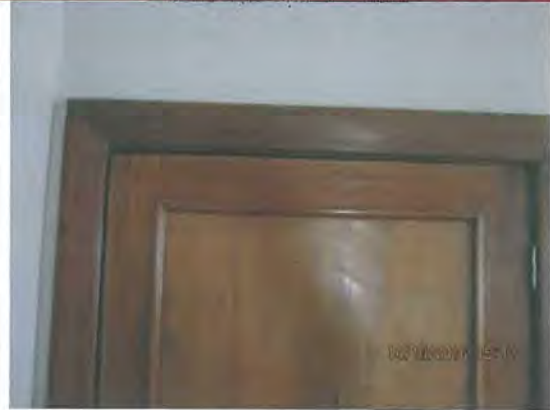
Photo 1:

Photo showing the rotated living room door.

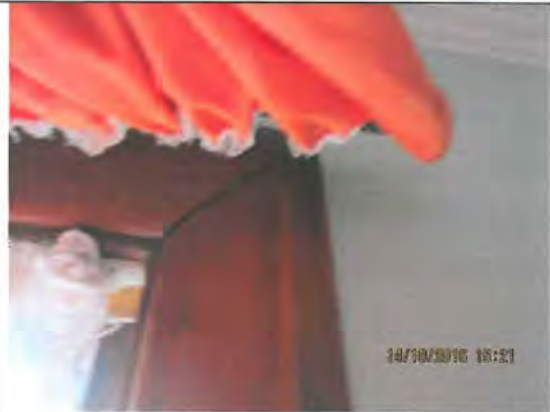
Photo 2:

Photo showing the typical openings at the frame corners.

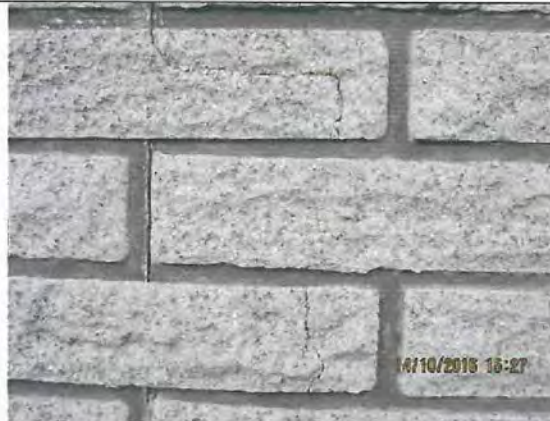
Photo 3:

Photo showing the typical step cracking through the existing "brickolite" cladding.

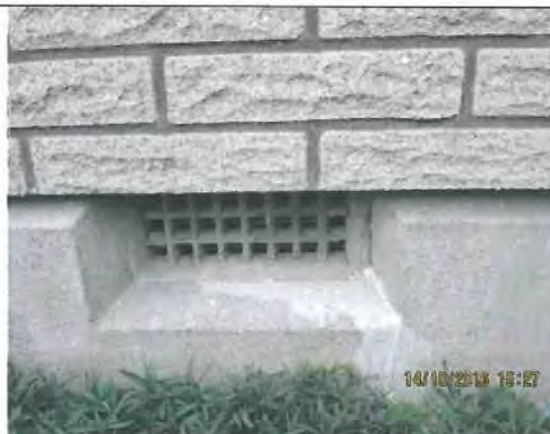
Photo 4:

Photo showing the typical perimeter foundation repairs.

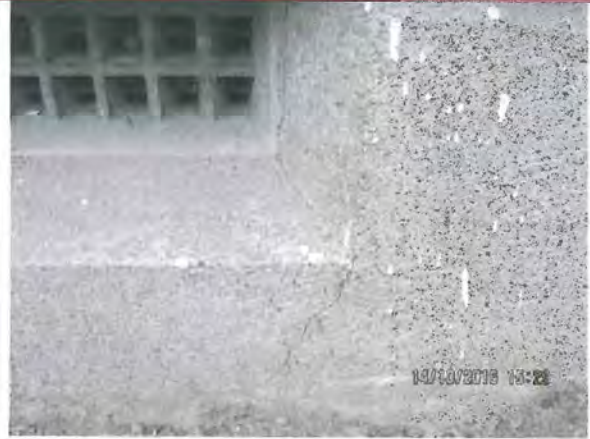
Photo showing the minor cracking at the subfloor vents on the western elevation.

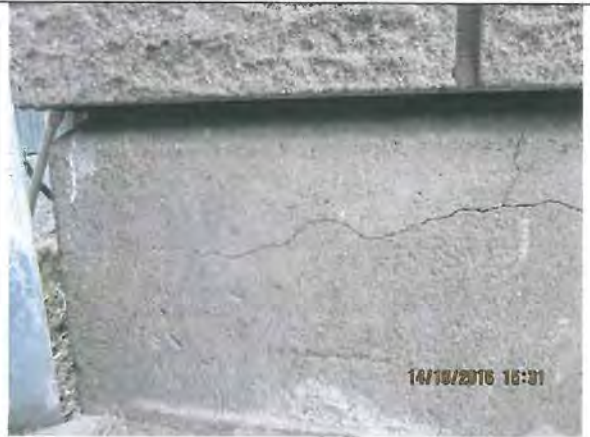
**Photo 6:**

Photo showing the minor horizontal cracking on the western elevation at the north corner.

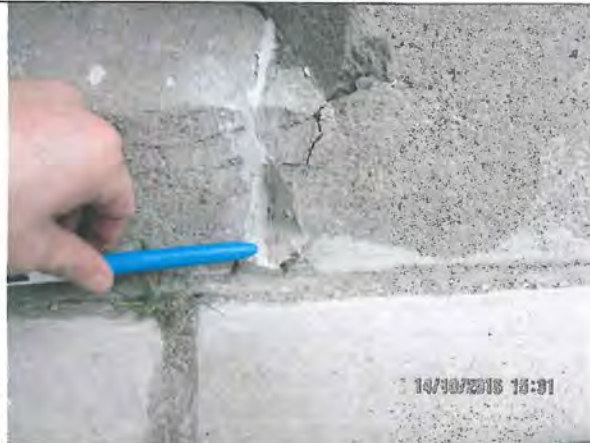
**Photo 7:**

Photo showing the large crack repair on the northern elevation.

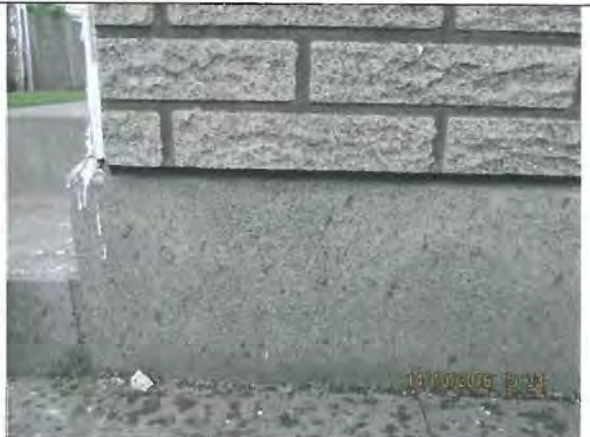
**Photo 8:**

Photo showing the minor cracking on the eastern elevation at the northern corner.

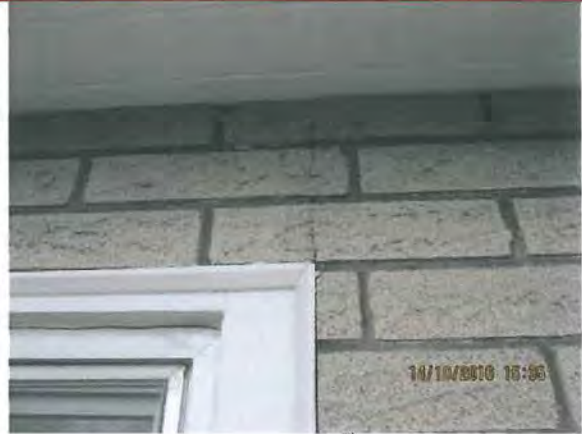
Photo 9:

Photo showing the typical cracking at the ends of openings.

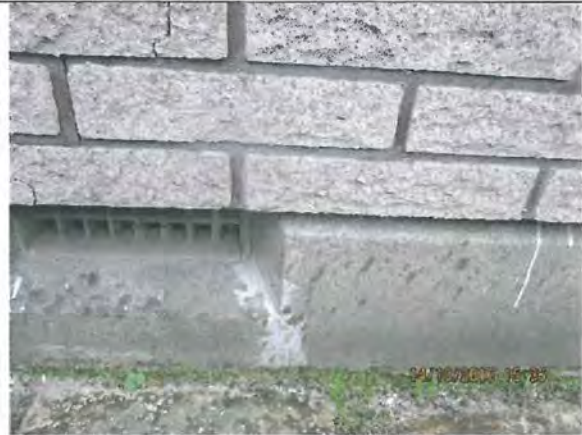
Photo 10:

Photo showing the typical repair to the perimeter foundation.

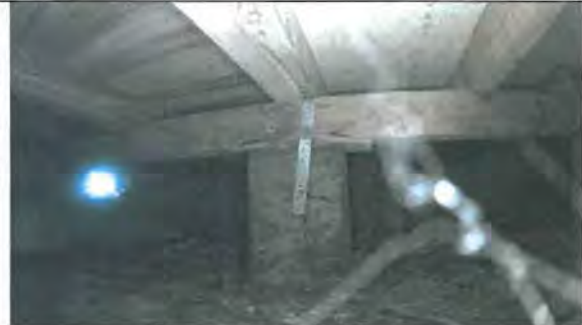
Photo 11:

Photo showing the galvanised strap connecting the concrete pile to bearer.

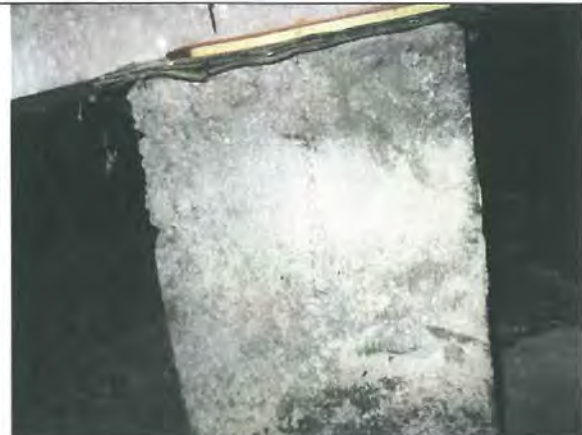
Photo 12:

Photo showing the plastic shim packing that has been used.

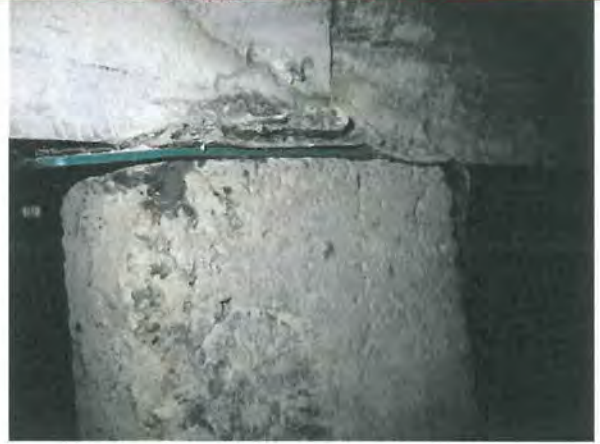
Photo 13:

Photo showing the plastic shim packers.

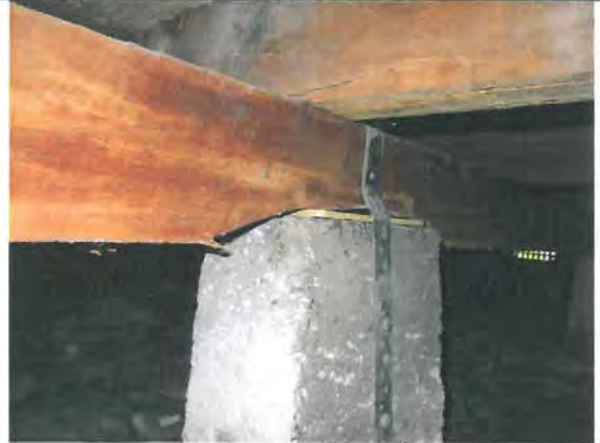
Photo 14:

Photo showing the notching of bearers and also the packing with plastic shims.

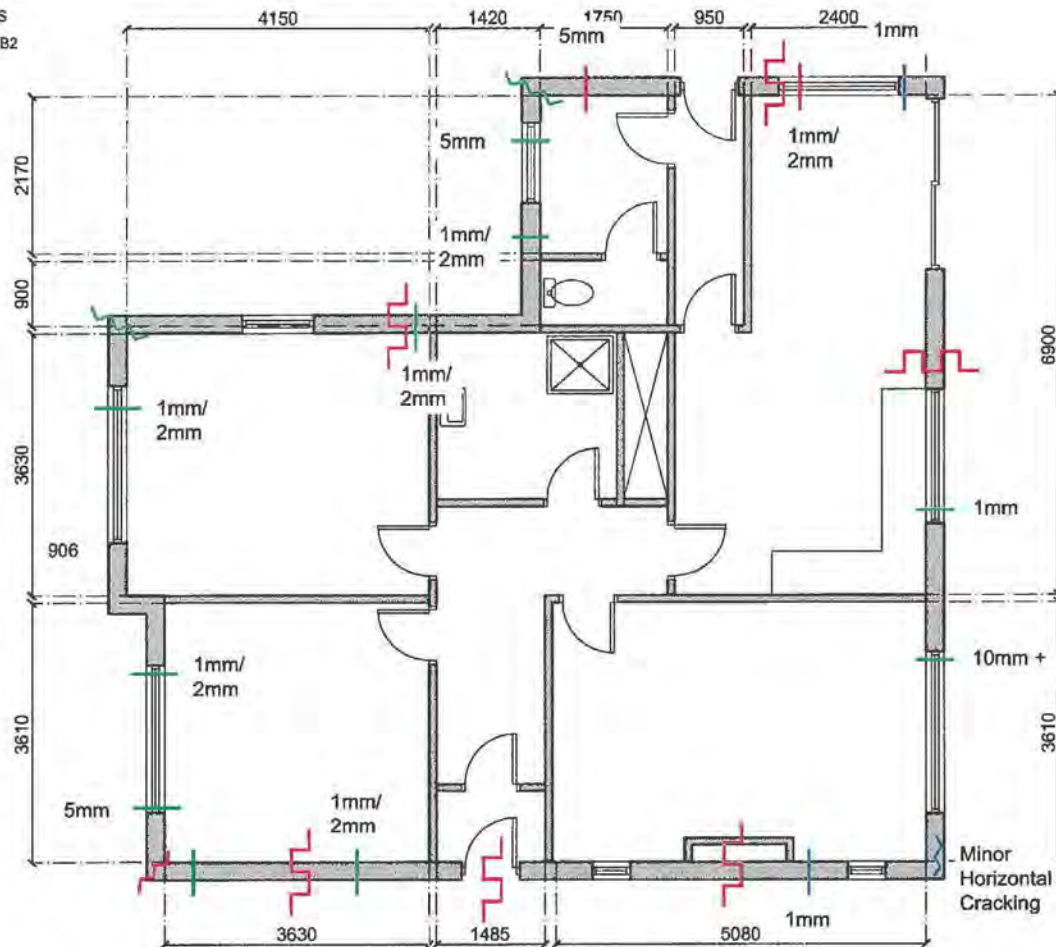
Exterior Damage Plan

- Step Cracking In Cladding
- Cracking Repair
- Cracking To Perimeter

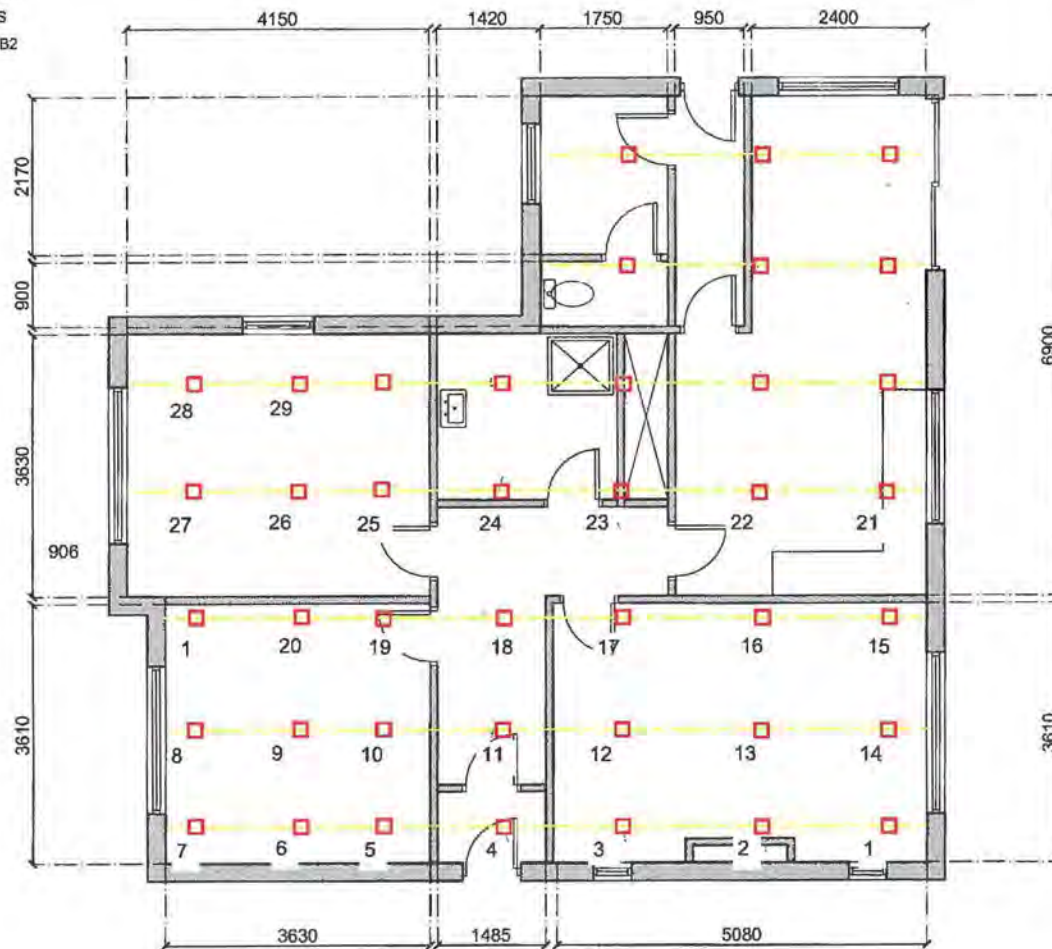
**LEVEL SURVEY - GROUND FLOOR**

- Pile 1 - Pile cracked replacement, glavanized fixing.  
 Pile 2 - Galvanized fixing.  
 Pile 3 - Notching, packing and fixing to be redone.  
 Cracked pile, new timber pile installed.  
 Pile 4 - No repair work carried out.  
 Pile 5 - No repair work carried out.  
 Pile 6 - No repair work carried out.  
 Pile 7 - No repair work carried out.  
 Pile 8 - No repair work carried out.  
 Pile 9 - No repair work carried out.  
 Pile 10 - No repair work carried out.  
 Pile 11 - No repair work carried out.  
 Pile 12 - Galvanized connection.  
 Pile 13 - Galvanized connection.  
 Pile 14 - Galvanized connection  
 Pile 15 - No repair work carried out.  
 Pile 16 - No repair work carried out.  
 Pile 17 - No repair work carried out.  
 Pile 18 - No repair work carried out.  
 Pile 19 - No repair work carried out.  
 Pile 20 - No repair work carried out.  
 Pile 21 - No repair work carried out.  
 Pile 22 - No repair work carried out.

Pile 23 - No repair work carried out.  
 Pile 24 - Packing, DPC and fixing to be redone.  
 Pile 25 - Packing, DPC and fixing to be redone.  
 Pile 26 - Notching greater than 20mm, packing, DPC and connection to be redone.  
 Pile 27 - Notching greater than 20mm, DPC and connection to be redone.  
 Pile 28 - Notching greater than 20mm, packing, DPC and connection to be redone.  
 Pile 29 - Notching greater than 20mm, packing, DPC and connection to be redone.

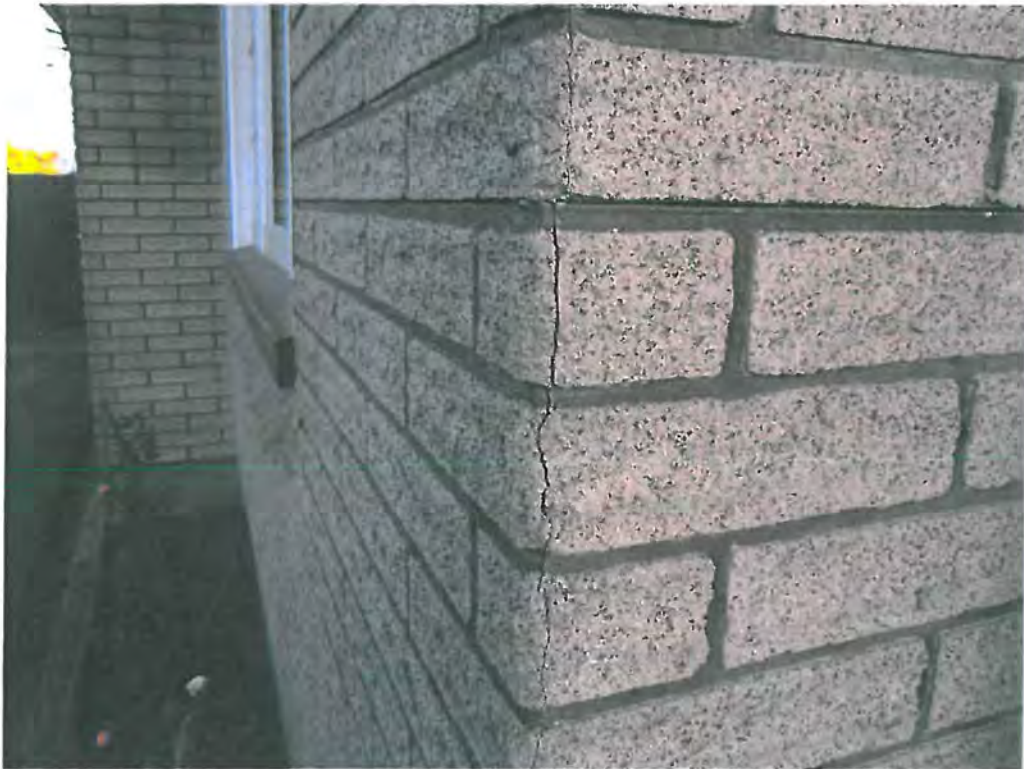
Externally there is frequent cracking throughout the brickolite veneer.

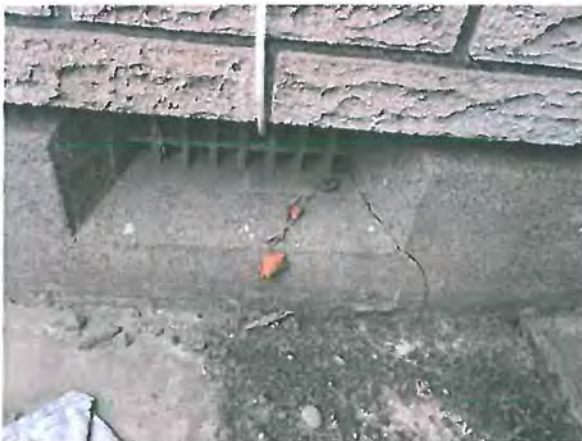
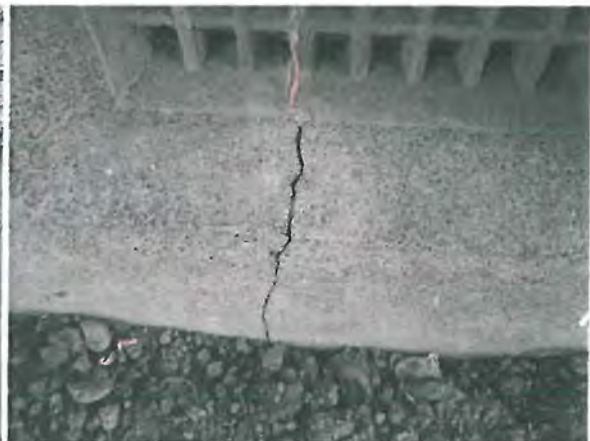
There are numerous cracks in the foundation ring beam ranging in size up to a maximum of 7mm wide.
