# EARTHQUAKE RECOVERY (EQR) DOCUMENTATION

# EQR Property Overview Report

| EQC Property ID | Property Address | Vulnerable? | Property F Status | Property Finalisation Indicator | | |
|---|---|---|---|---|---|---|
| 2010127541 | 57 COLOMBO STREET, CASHMERE | | F3 - Complete & Finalised | Some Finalisation has taken place | | |

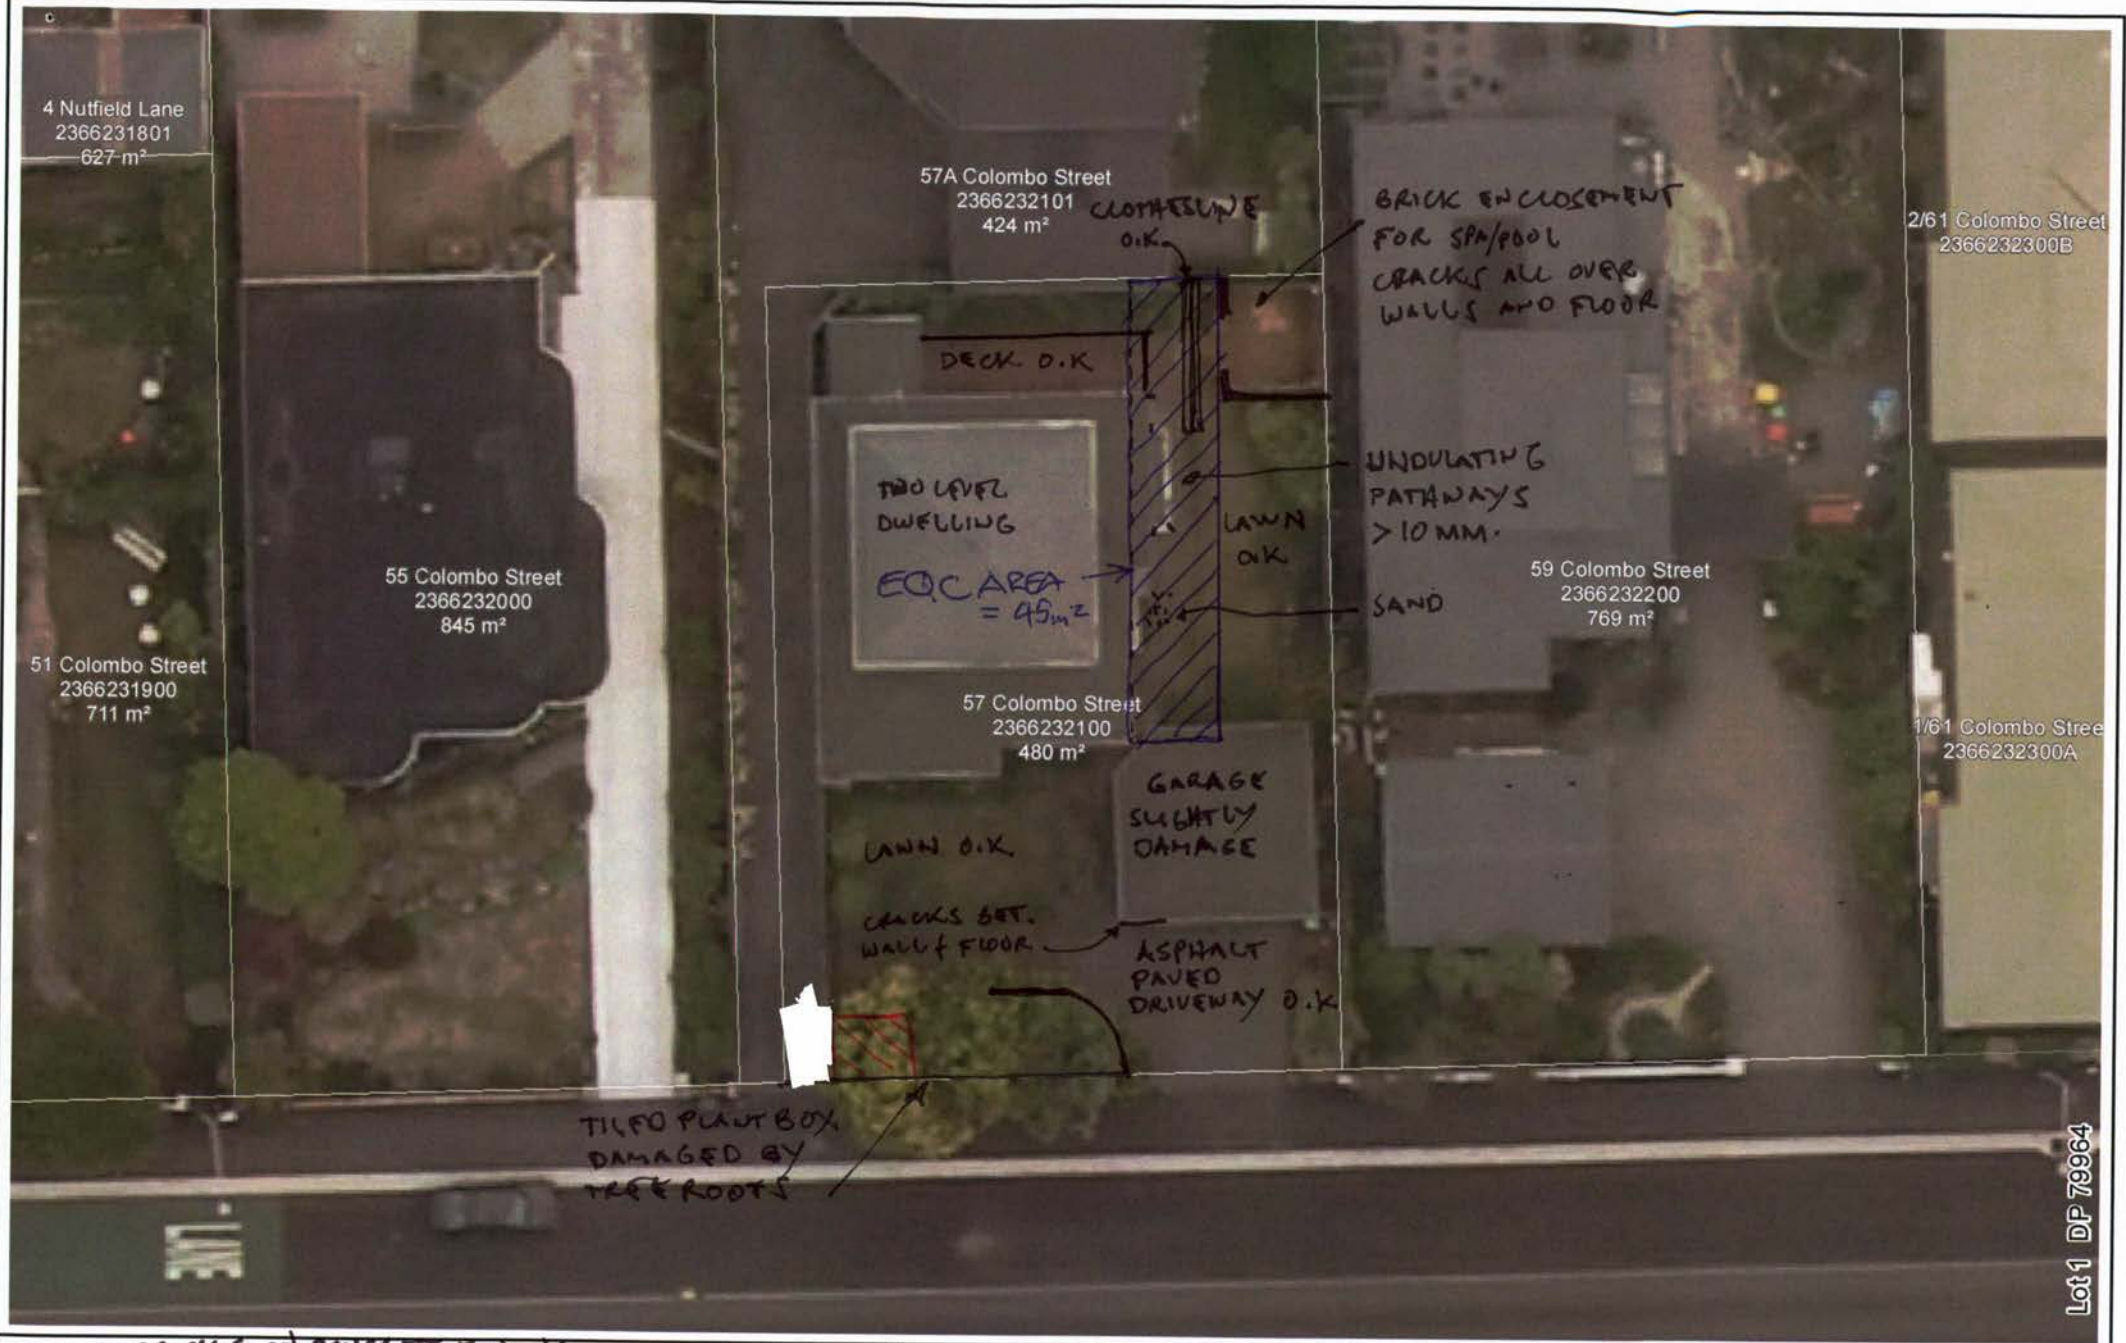
1 CRACKS on CONCRETE FOOTING
