# EQC Documents

Scope of Works

Completed by: Chris Armiga 0823  
 Date: 9 Apr 2013  
 Claim number: CLM/2012/194695

Assessment of Property at: 46 BAINE STREET, BURWOOD, CHRISTCHURCH 8083

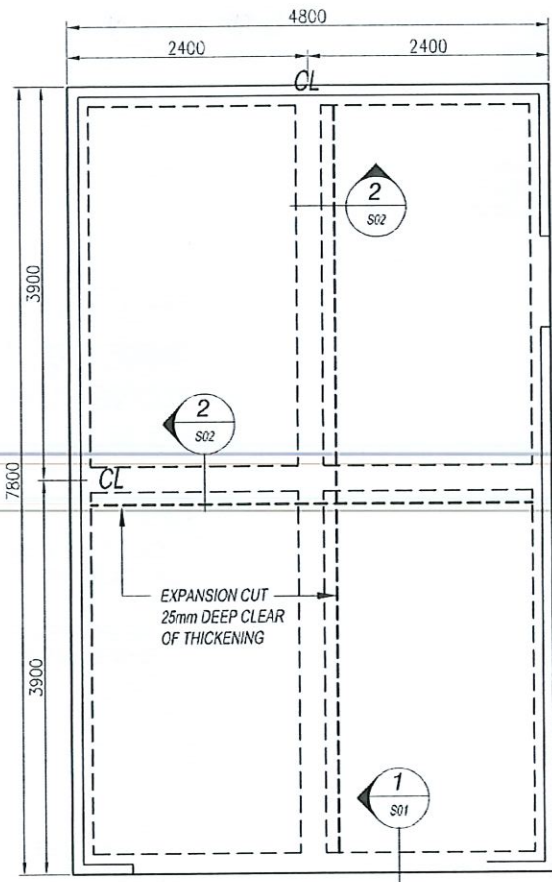
**FOUNDATION PLAN**  
SCALE 1:50

Further to inspection of your information and carrying out site soil tests ( see attached results) please find attached foundation information as required for the proposed garage. Note the property is in the Green Zone, Technical Category 3, Blue and the site appears stable with minimal lateral spread and no liquefaction.

As the ground is between 40 to 65 kPa allowable bearing at 200mm depth, it is satisfactory for standard foundations for the lightweight garage proposed however because it is in TC3 zone enhanced foundations are required with floor thickenings as shown on the plan. Also we recommend the foundation depth to be 300mm below ground level to encounter firm bearing. The ground had encountered firm bearing of 55kPa at 1000mm deep.

- 1) Inspections by Council Building Inspector
- 2) Engineer to inspect pre concrete pour of Foundations.
