Far North Inspections LTD

Inspection Report

14 Nimmo Street , Northland, Rawene

Date of Inspection: 6/8/2019

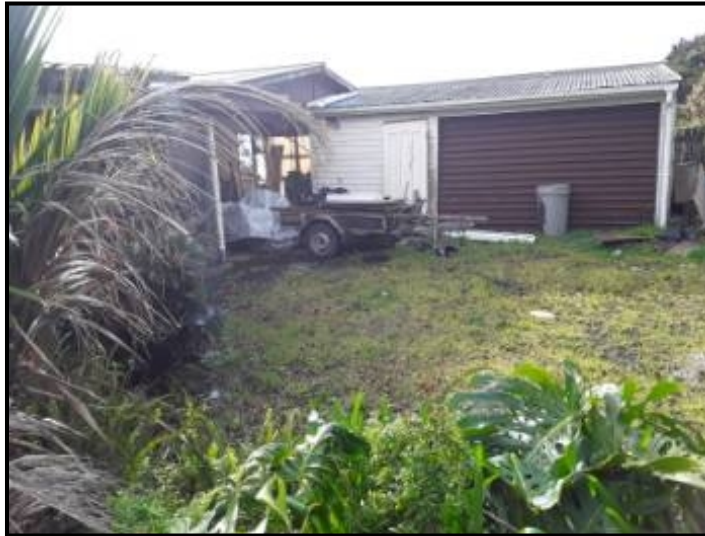
- The gravel driveway should be weed sprayed to eliminate moisture and dirt being tracked into house.

This area needs to be weed sprayed or similar.

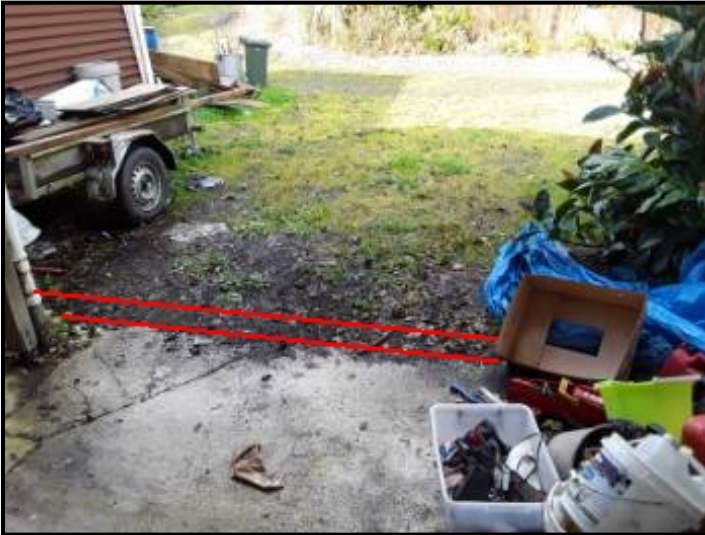
- Too much debris sitting up against exterior walls.
- There needs to be a drain/grate system installed in front of concrete porch to divert ground water away from house.
- **Improper slope towards foundation**

Possible drainage solution shown.

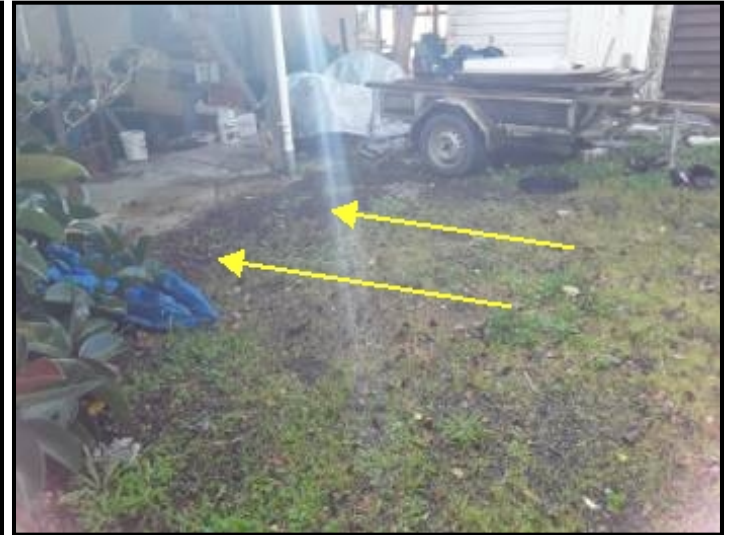
Ground slopes toward house.

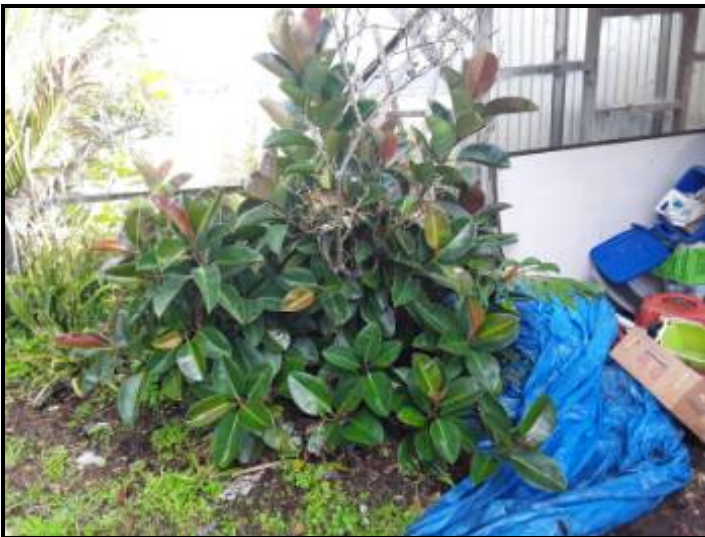
- There is major vegetation areas that should be cut back to allow the structure and cladding to dry out and ventilate.

Vegetation too close to house area.

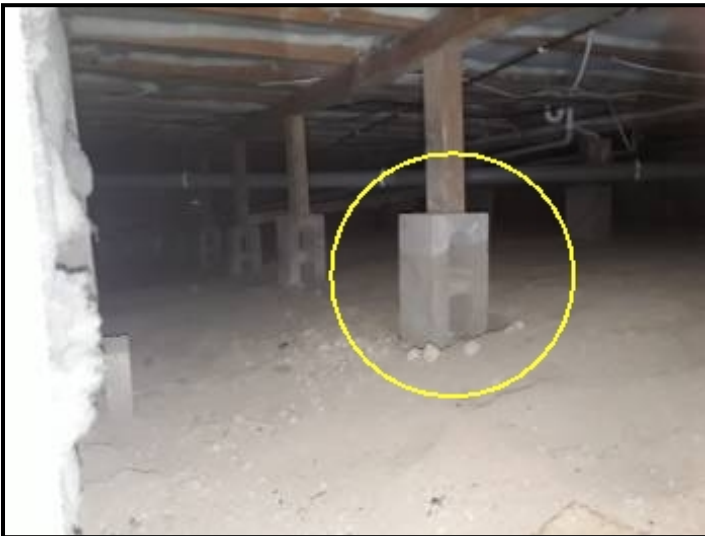
- Recommend review by a qualified professional for repair or replacement as necessary.
- Foundation supports for most of the house do not comply with regulations. Consider consulting a contractor or structural engineer.

Posts incorrectly supported.

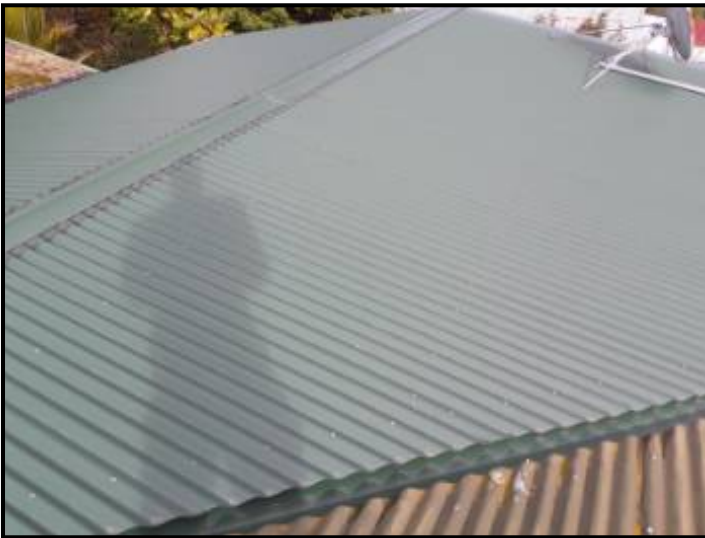
Living room roof acceptable.

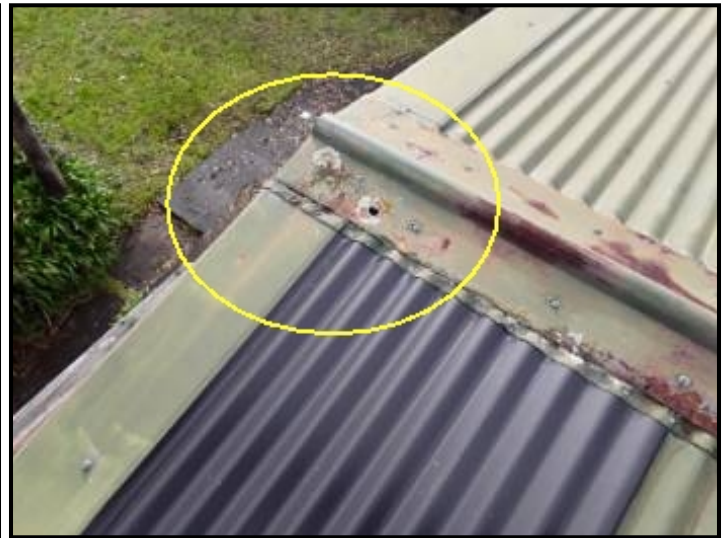
- The roof area over the main living area is in fairly good condition. Valleys are clean from debris. Roofing is well screwed down.
- The older part of the roof area more than likely lets water enter. The ridge cap joins are open to the weather. The lap in the corrugate near the ridge is inefficient as a lap on this roof slope should be at least 300mm. Wind driven rain will drive up and into this lap. There is holes in the flashings also that will let water into the roof structure.

Ridge flashing holes

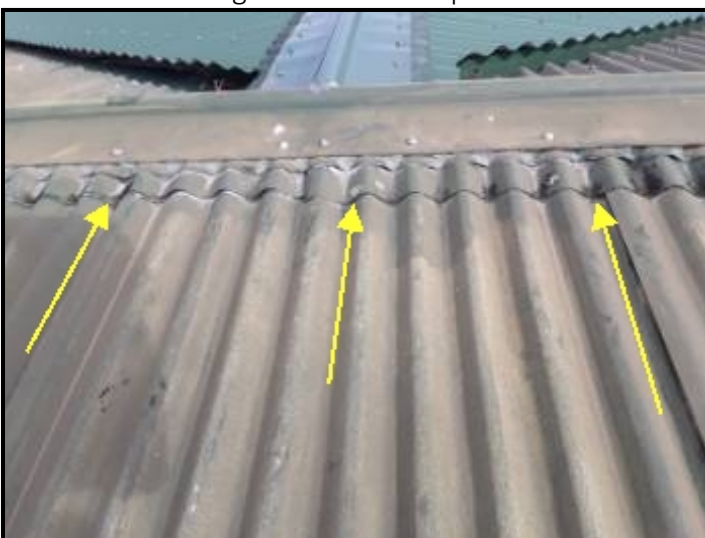
Water can drive under lap here.

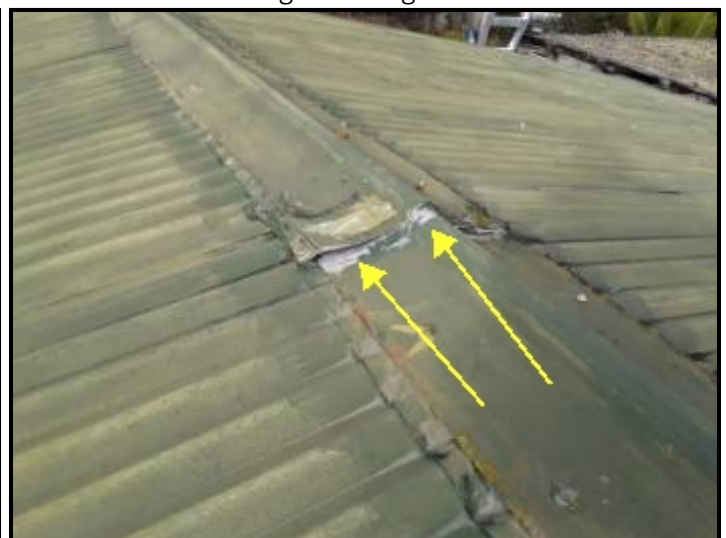
No seal to ridge cap joins.

- The ridge capping laps require attention.

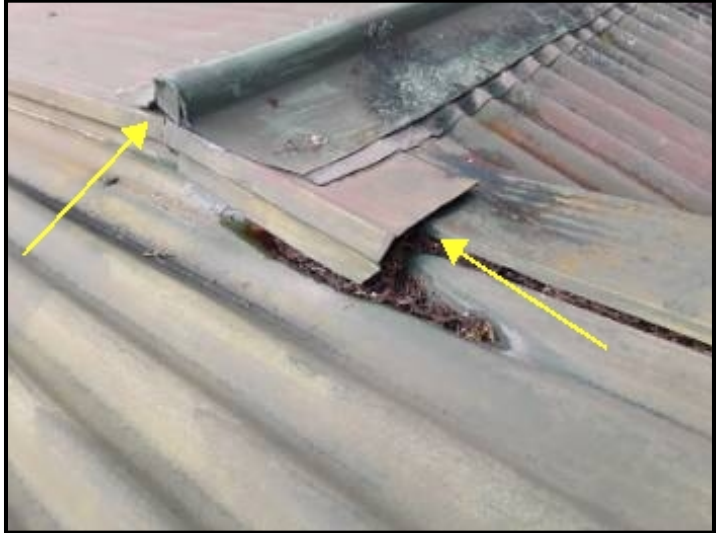
Water can drive in here.

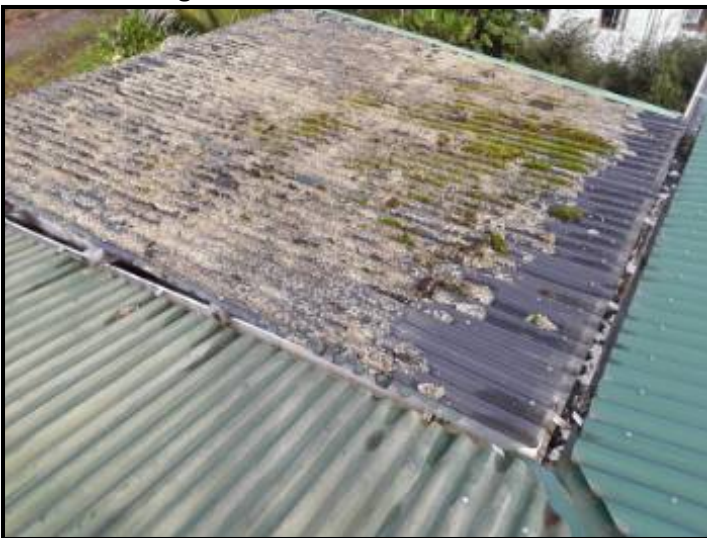
Clearlight roof needs attention.

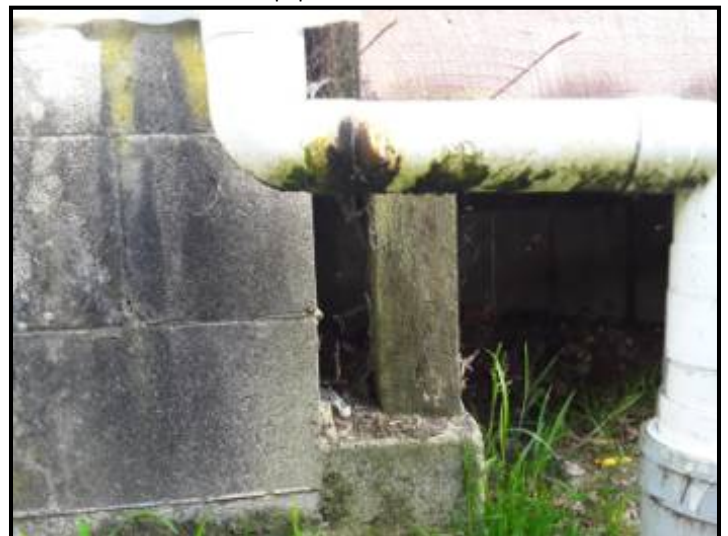
- Gutters are PVC type.
- Downpipes should be flushed to clear debris that may be accumulating due to dirty gutters
- The gutters are mostly free from debris.
- The downpipes appear to be full of water due to a blockage in the pipes somewhere. They need to be disconnected and flushed clear after determining where the blockage is.

Downpipe holding water.

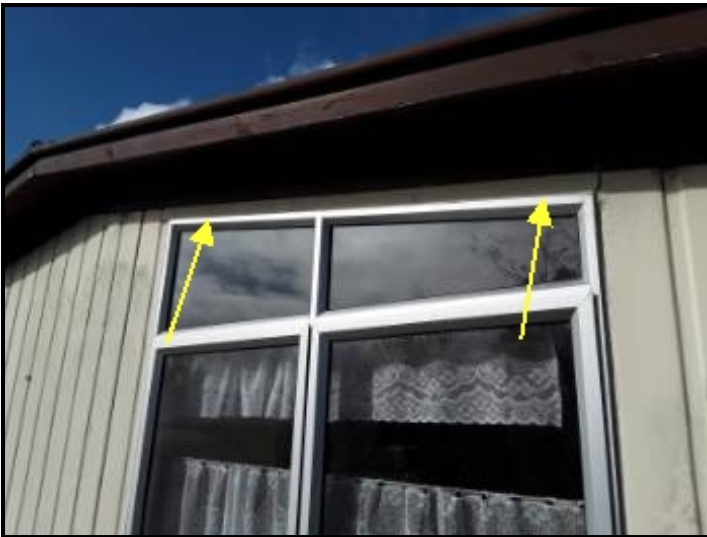
- Head flashings are broken or non existing.

This has the potential to let water enter the framing and create a damp living environment.

No head flashing to this window.

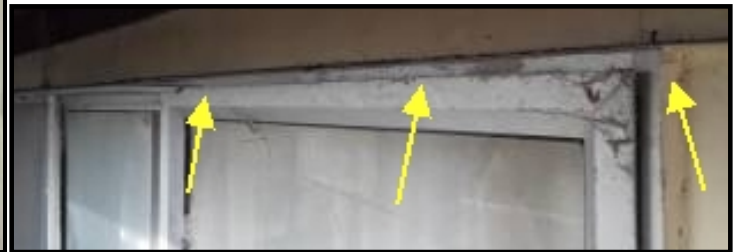
Head flashing broken.

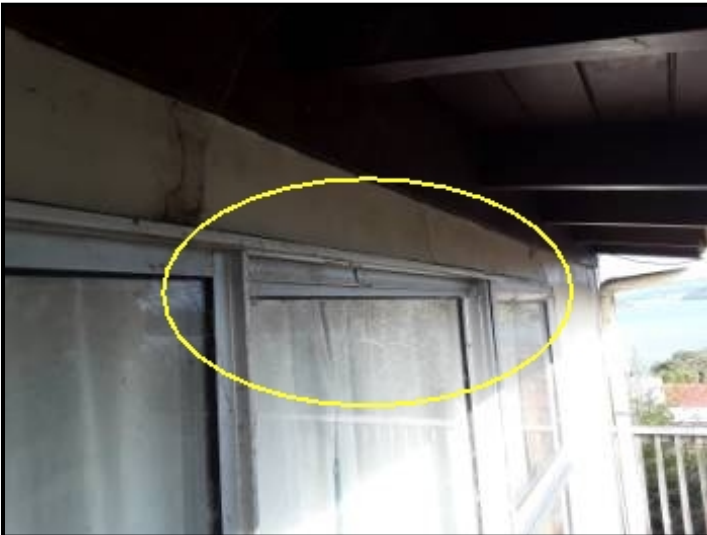
Head flashing broken.

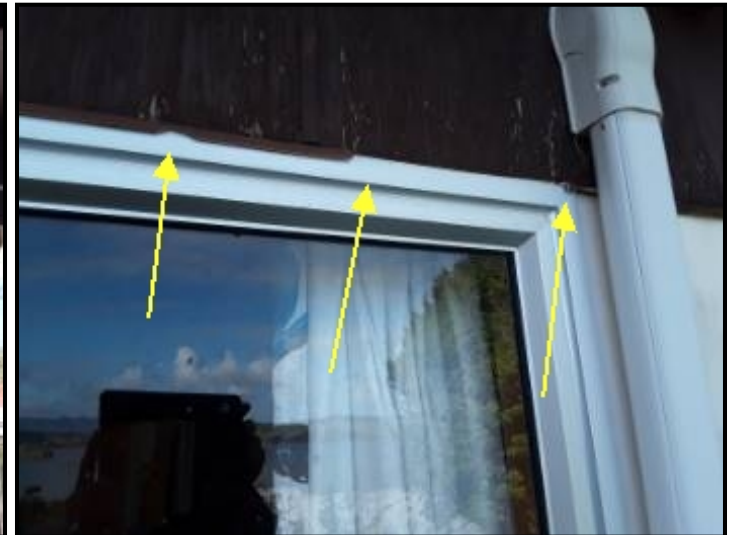
Broken head flashing.

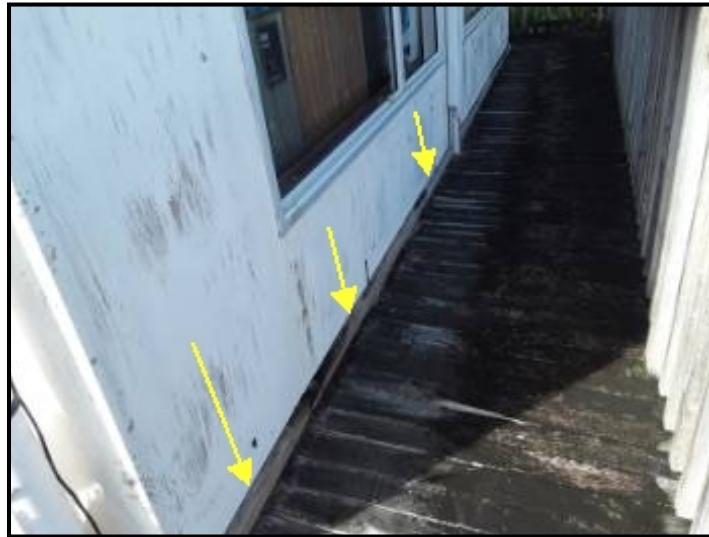
- Ply cladding is in need of maintenance.
- Corner weather flashings damaged
- Base board around cladding should be removed to assess the rot damage to the plywood.

Cladding needs resealing. Ply will rot under this board.

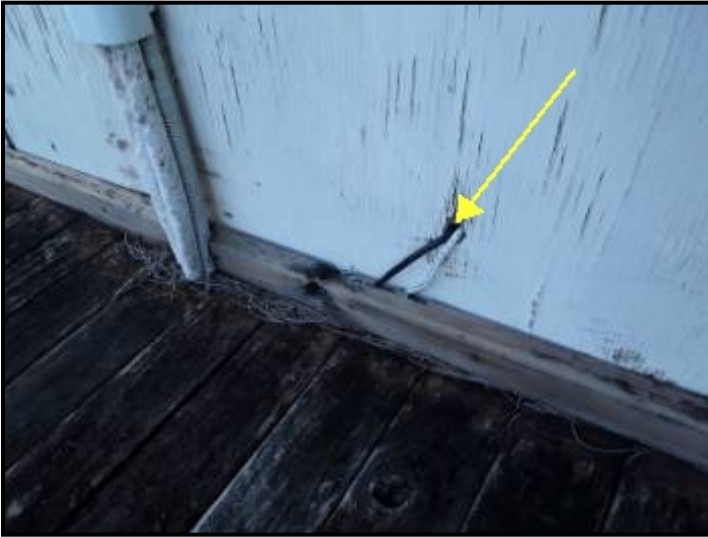
No sealant here.

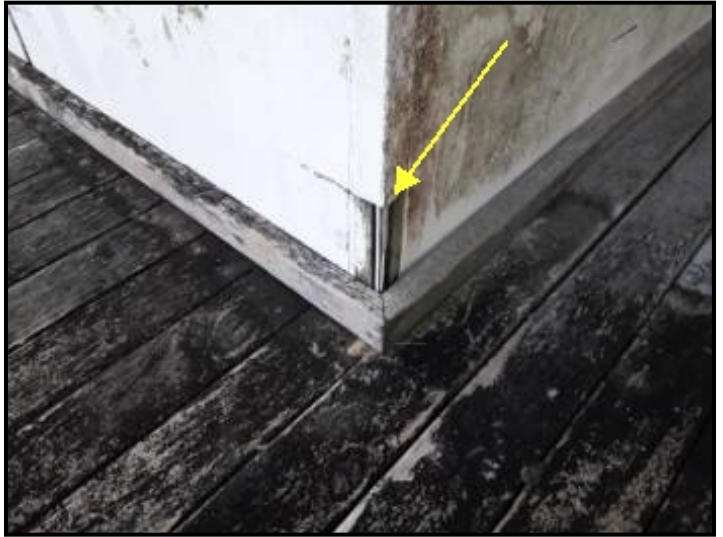
Corner flashing broken.

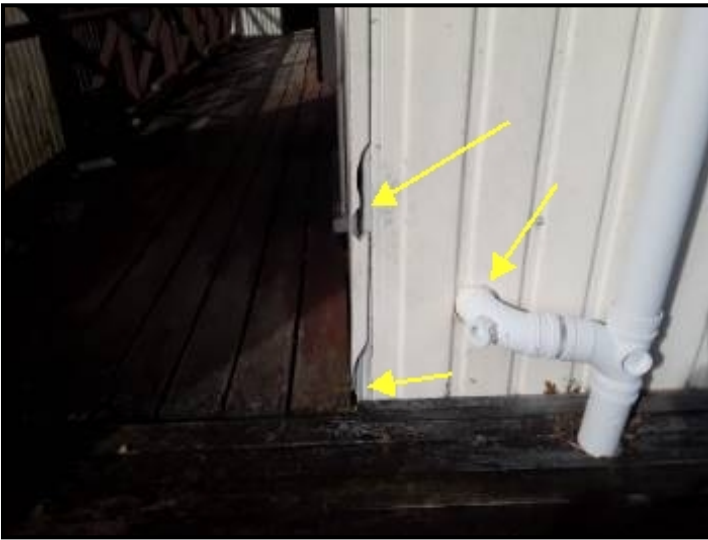
Water can seep in here.

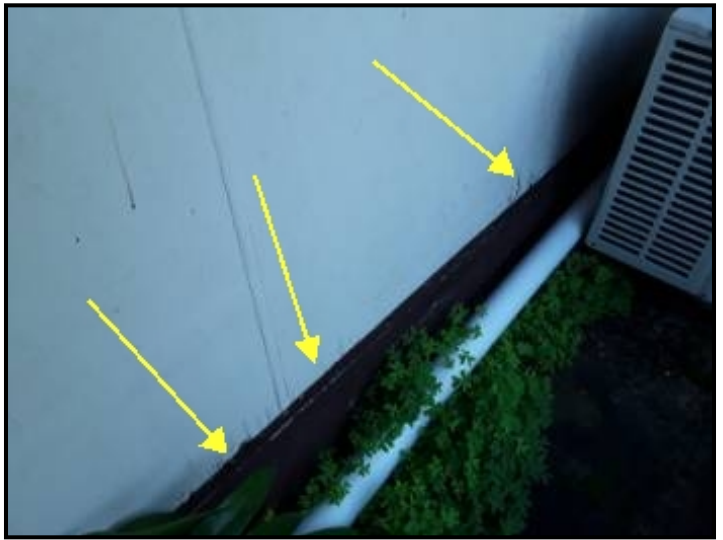
Ply rotting creating damp interior.

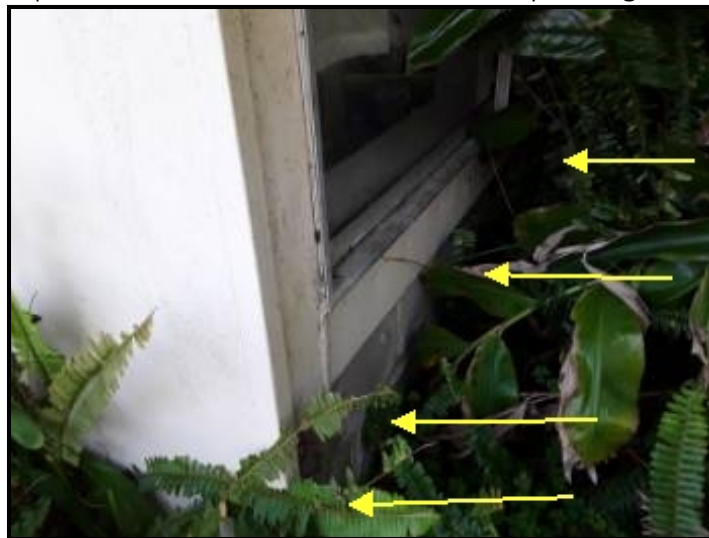
Water penetrates through the block work.

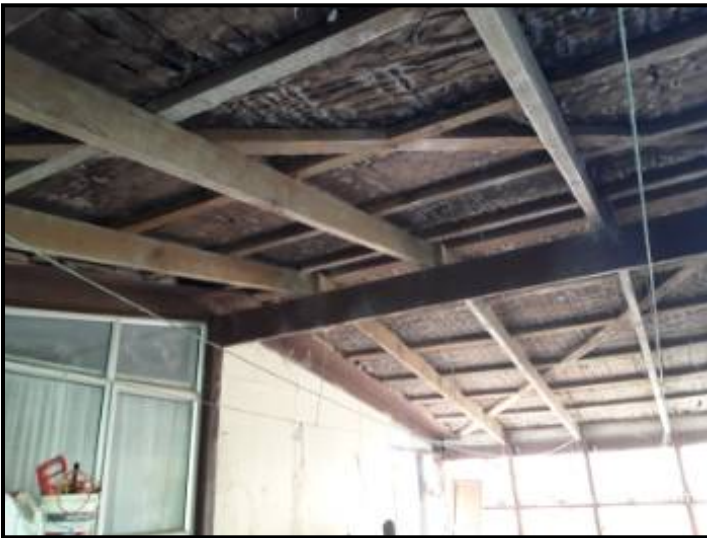
- Soffits are generally in an acceptable condition.
- The soffit area around the front has gaps that have the potential to let vermin and birds to nest.

Bird nesting areas.

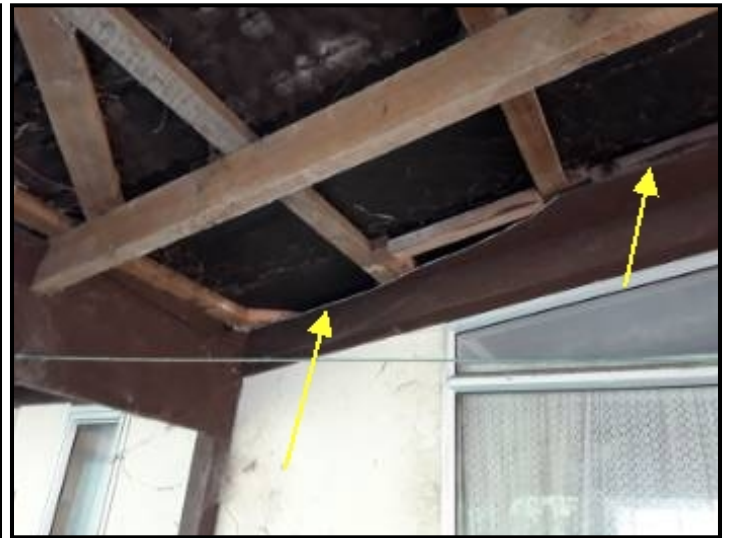
Holes for possible vermin/birds.

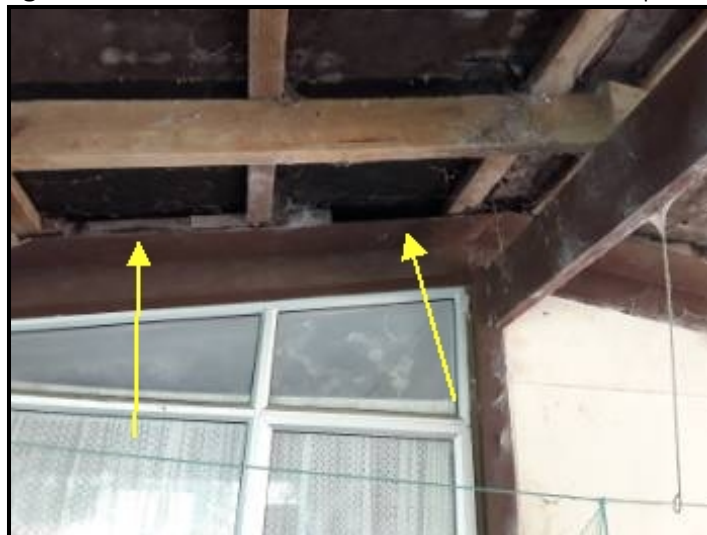
Vermin / bird nesting holes.

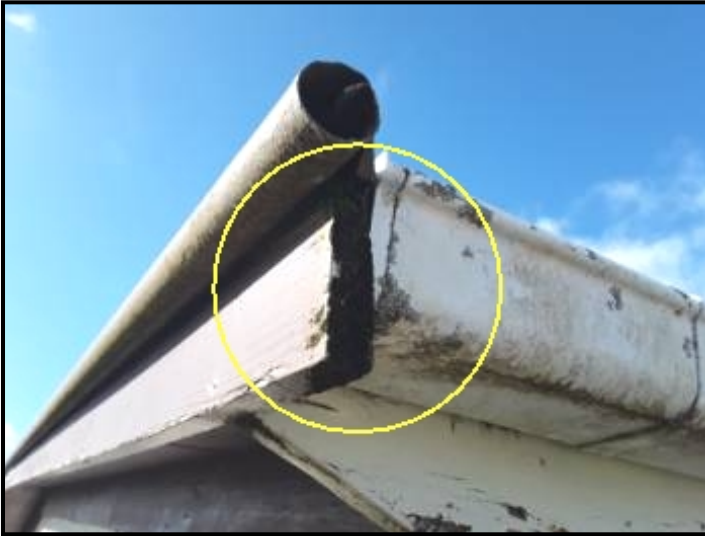
- All barges were in need of maintenance at time of inspection.
- Barges show signs of deterioration at ends.
- Fascias require a waterblast to remove mold growth.
- All timber exposed to the weather should be regularly maintained to keep timber from deteriorating.

Barge board deteriorating.

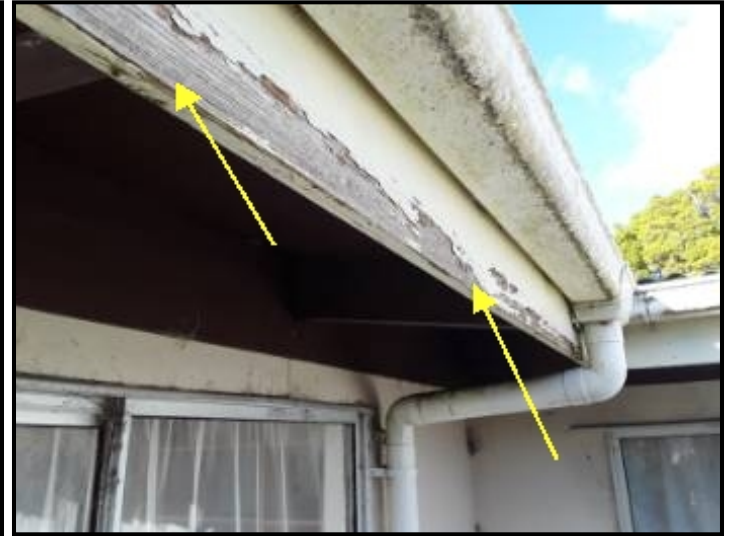
Fascias need resealing.

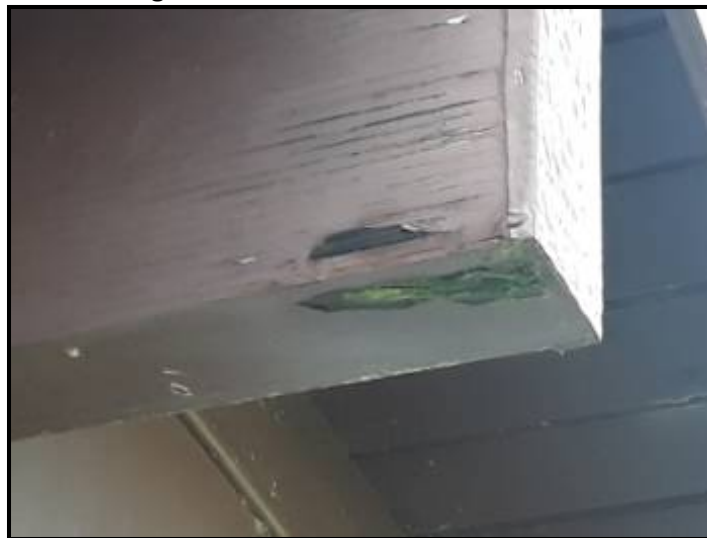
Ridge beam rotting.

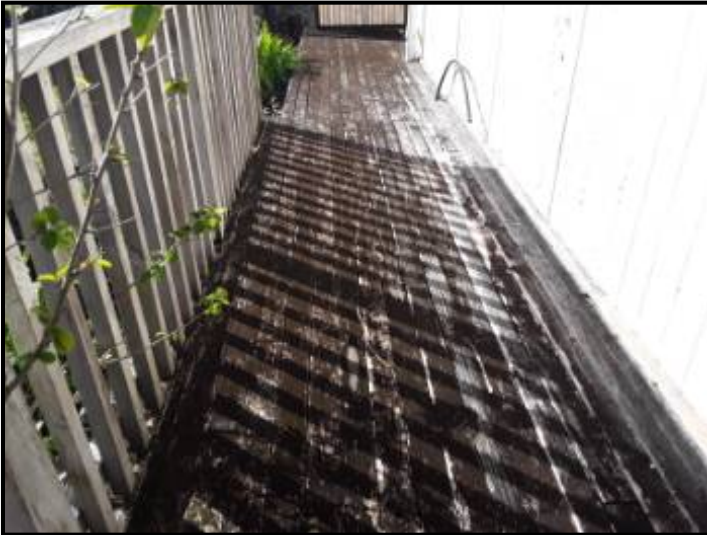
- All deck areas require a waterblast to help remove algae and mould growth.
- The west deck is severely sloping and should be raised level.

Decks need water-blast.

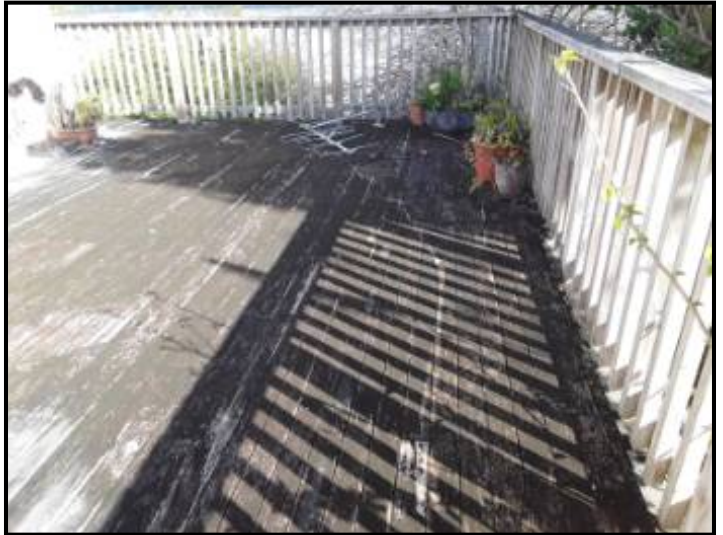
Decks need a water-blast.

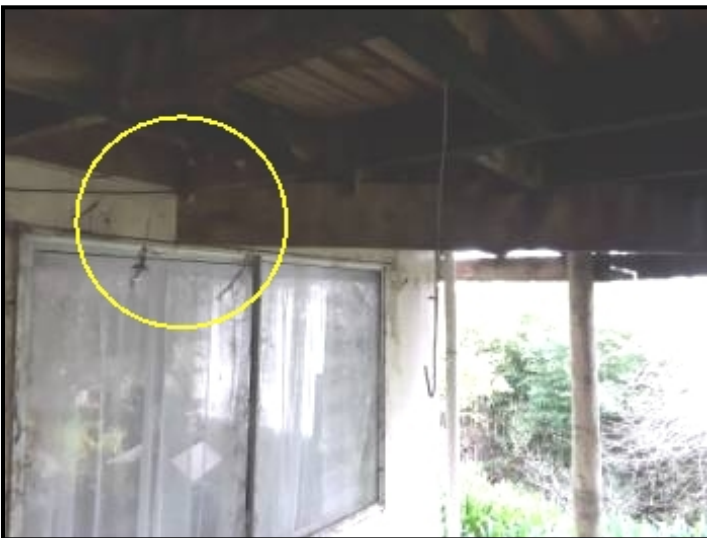
Unprofessional connection here.

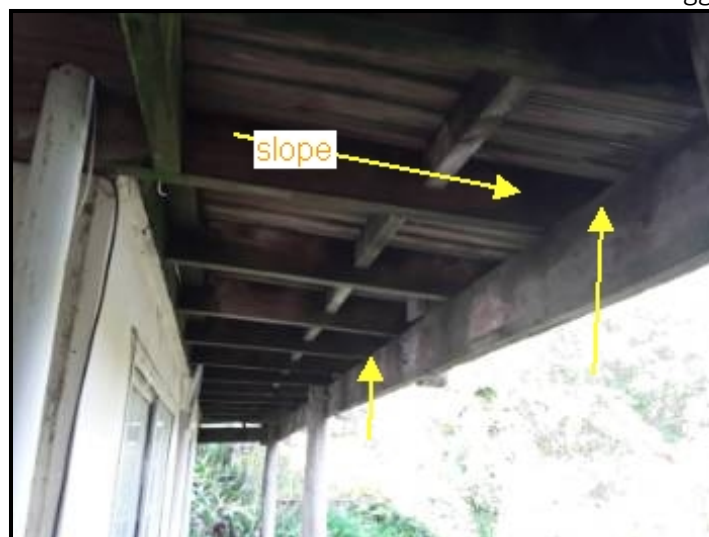
Deck joists all sloping. Suggest packing above beam.

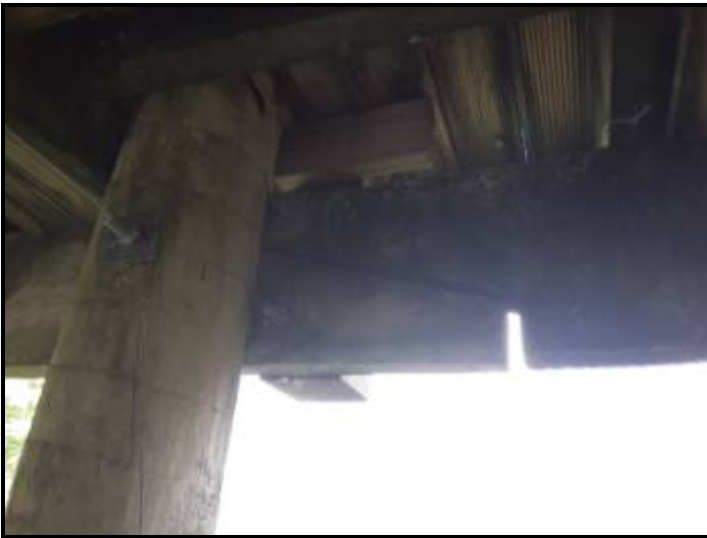
Unprofessional join to beam

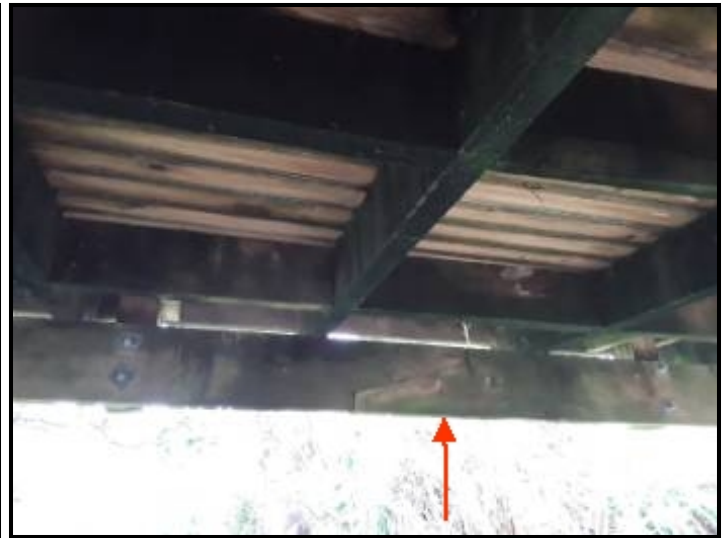
Post required under this join.

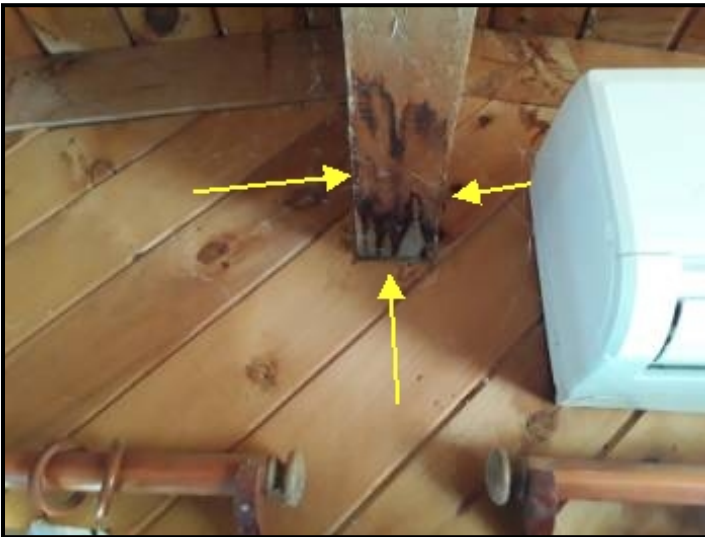
- Some areas not accessible due to stored personal items.
- There is evidence of moisture entering structure.
- The walls to lounge areas around the windows showed high moisture levels.

Water entering around ridge beam.

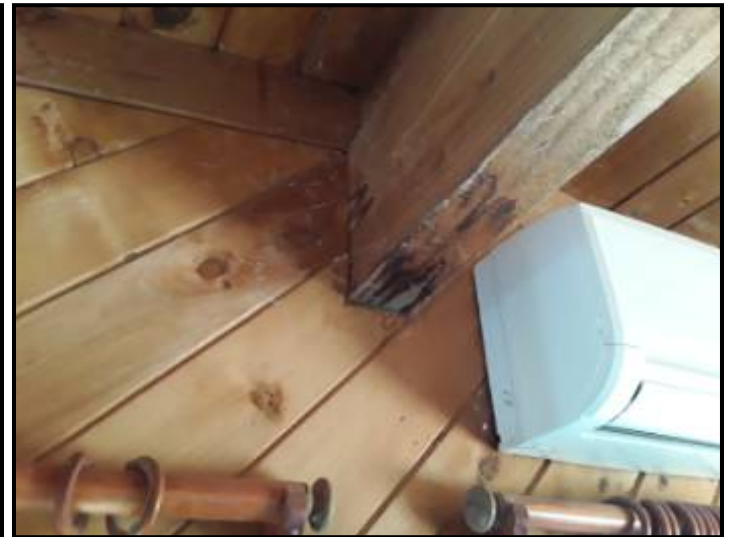
There is signs of water ingress to ridge beam.

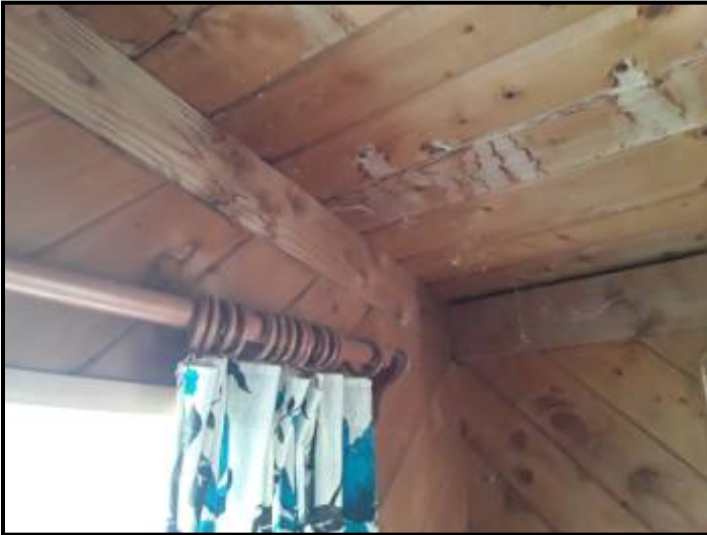
Old water stains. Tested dry here.

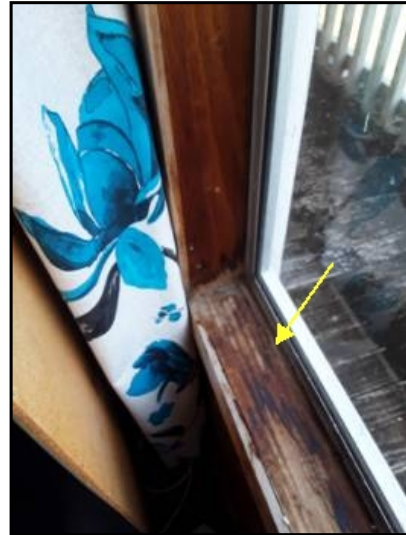
Water staining from dampness.

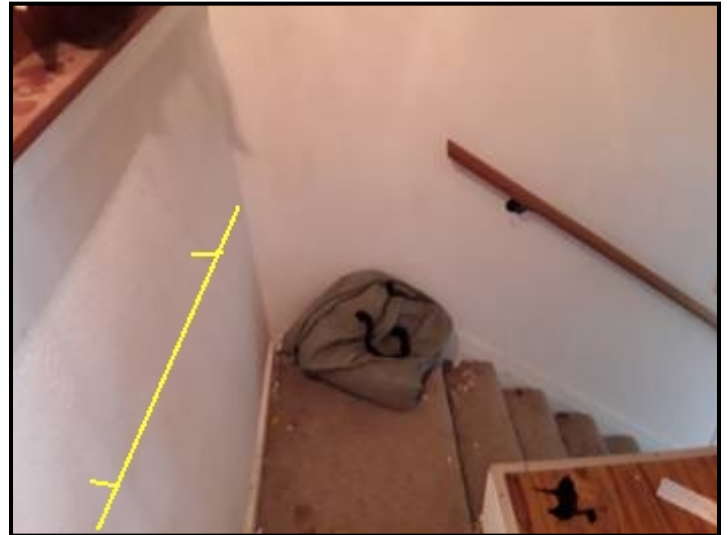
- Stairs are functional. A handrail is recommend in the middle stairway part.

Handrail required here.

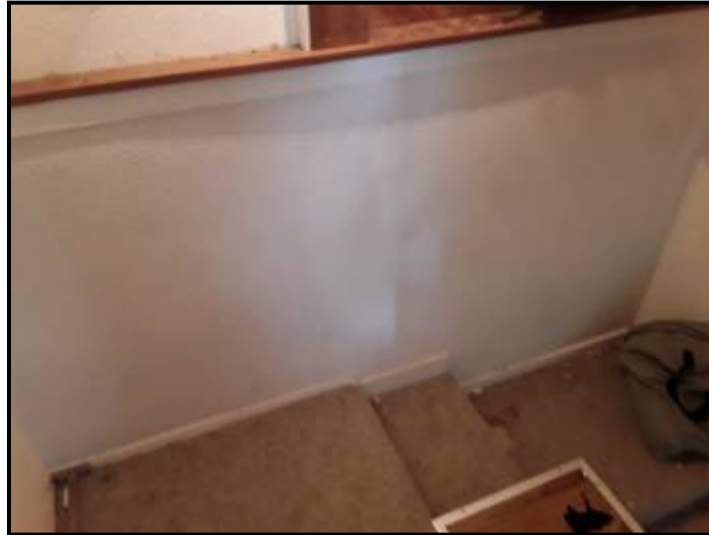
Missing handrail.

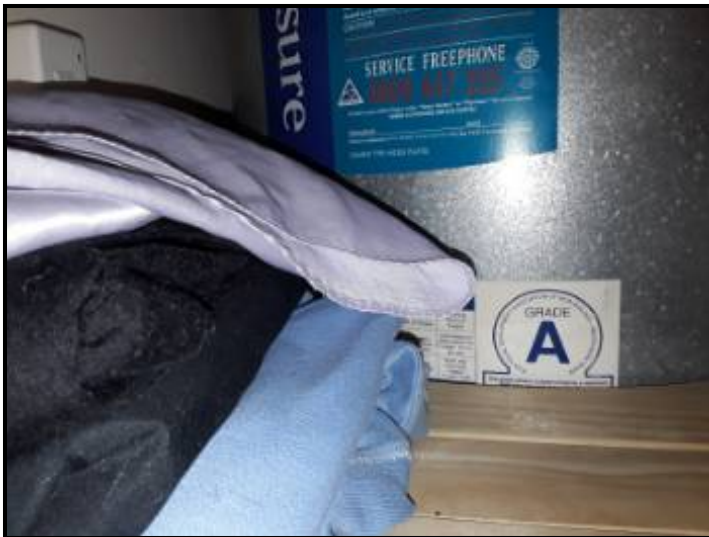
- There is no seismic straps fitted.
- Appeard functional at the time of inspection.
- There were personal items in cupboard and cylinder could not be fully inspected.

No seismic straps fitted.

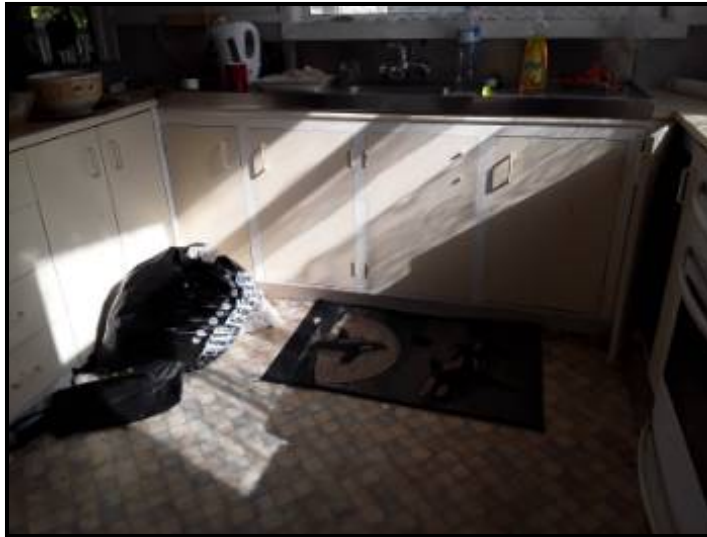
- Cabinets doors and drawers are in adequate condition for age.
- Appeared functional, at time of inspection.
- Some cabinet drawers need hardware repair/adjustment (to stay shut). Repair as needed.

Cabinets need attention.

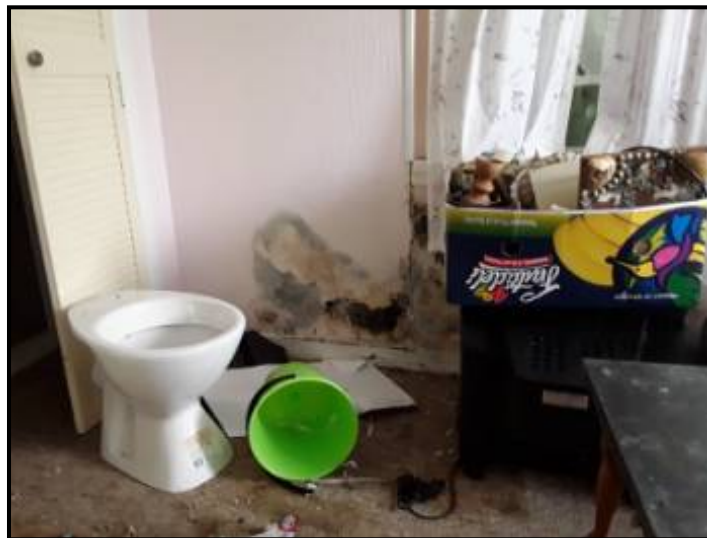
- Some areas not accessible due to stored personal items.
- There is high moisture levels in the bedroom closest to the road. Most likely moisture is coming through the block work. The vegetation to the outside should be stripped right back as well.

Water ingress has destroyed wall lining.

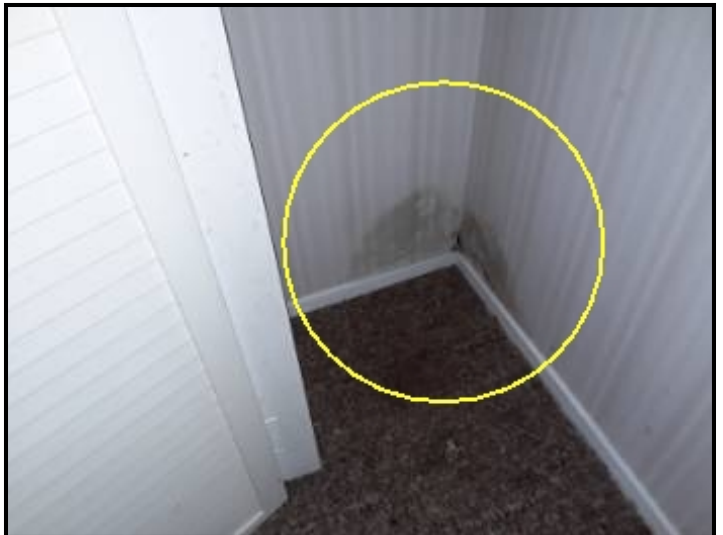
Water damage here.

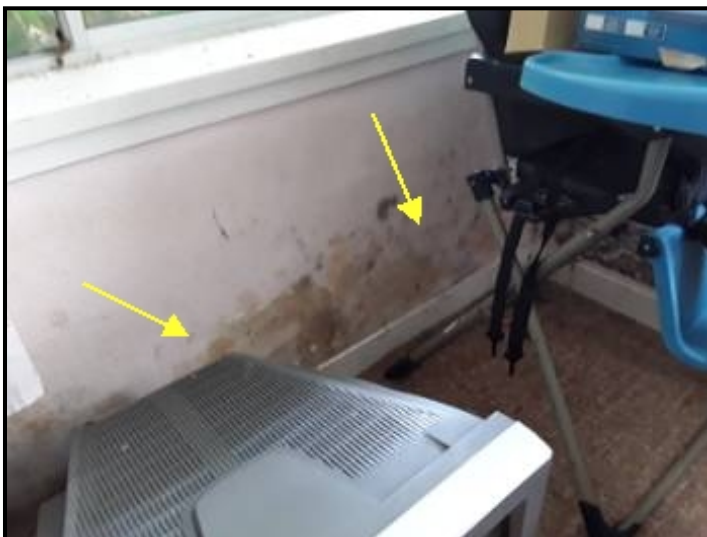
- Both bedrooms require major attention to get them up to a healthy living standard.

Water issues here.

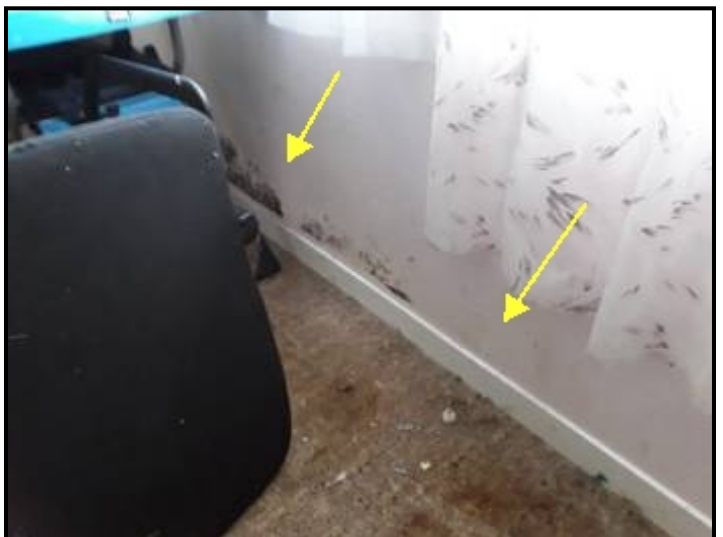
High moisture readings.

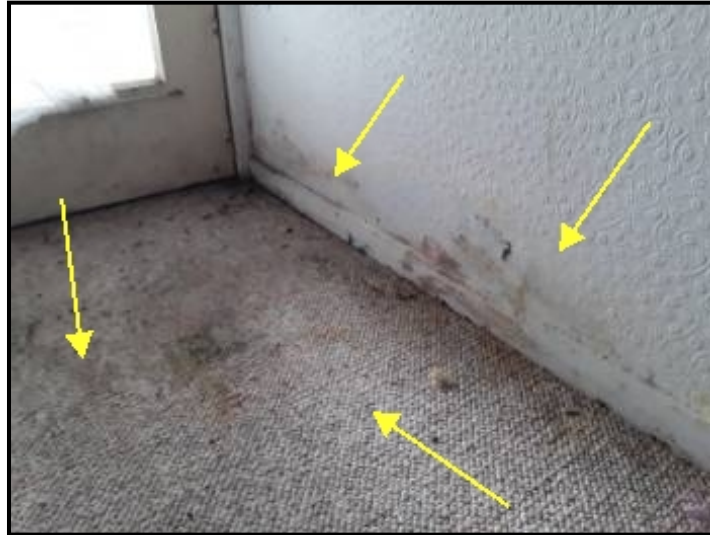
High moisture readings.

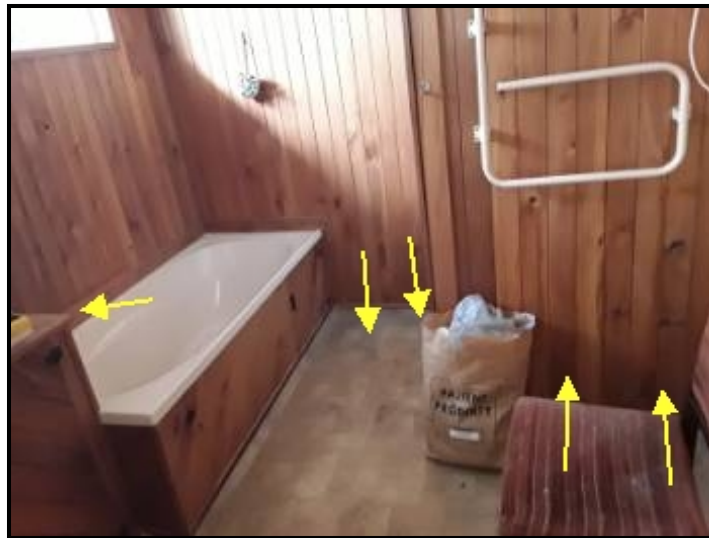
High moisture readings here.

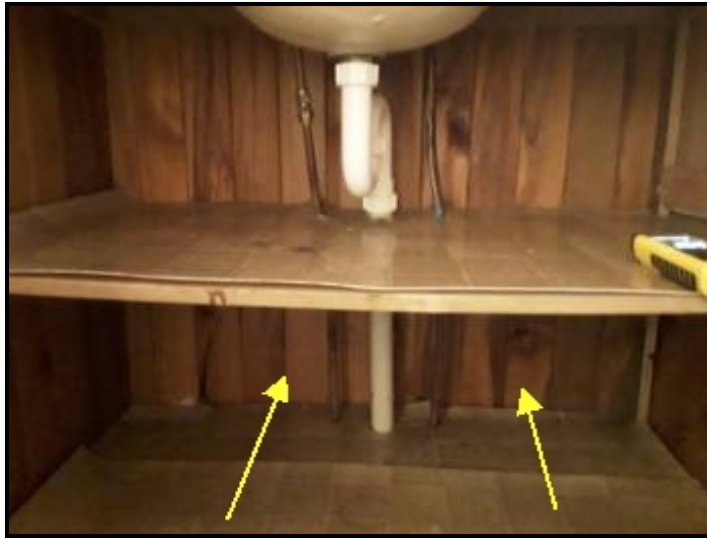
- Appeared functional and in satisfactory condition, at time of inspection.
- Moisture levels were high under the vanity cabinet at the back wall.

High moisture readings here.

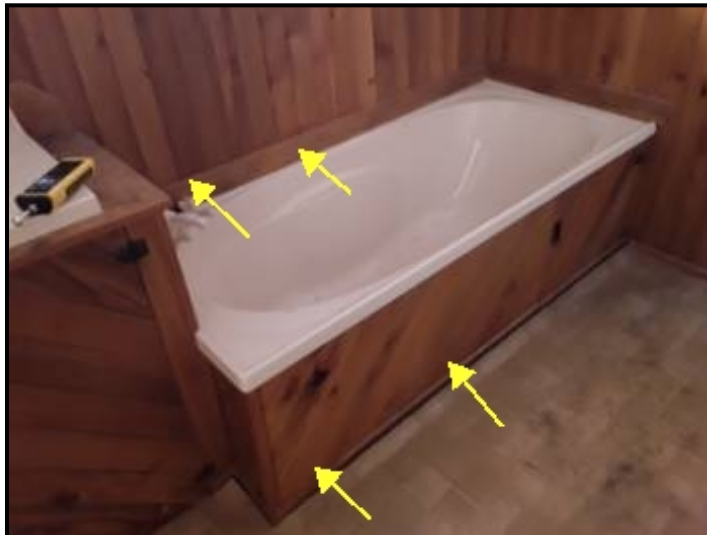
High moisture readings here.

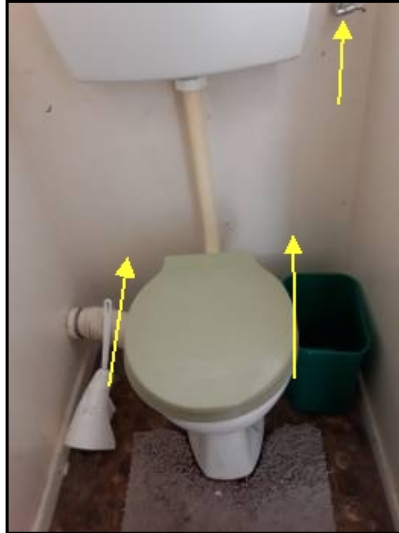
- Observed as functional and in good visual condition.
- Operated when tested. No deficiencies noted.
- Toilet loose and may need re-anchoring.
- High moisture levels were noted behind toilet bowl.

High moisture readings here.

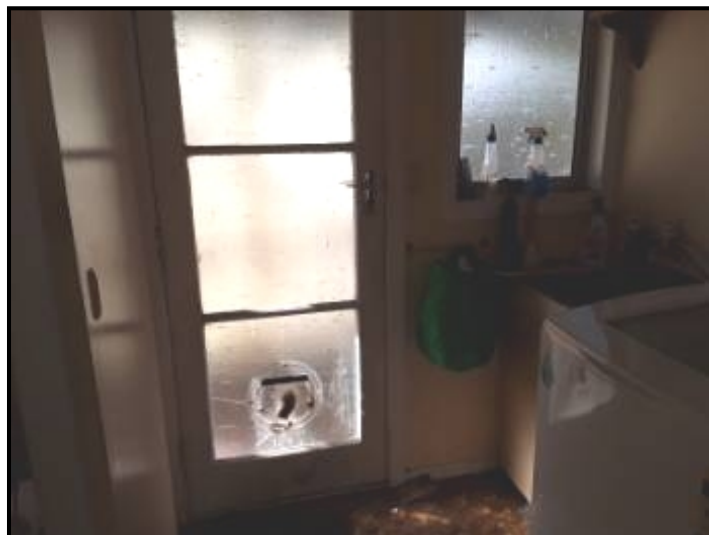
Cracked glass.

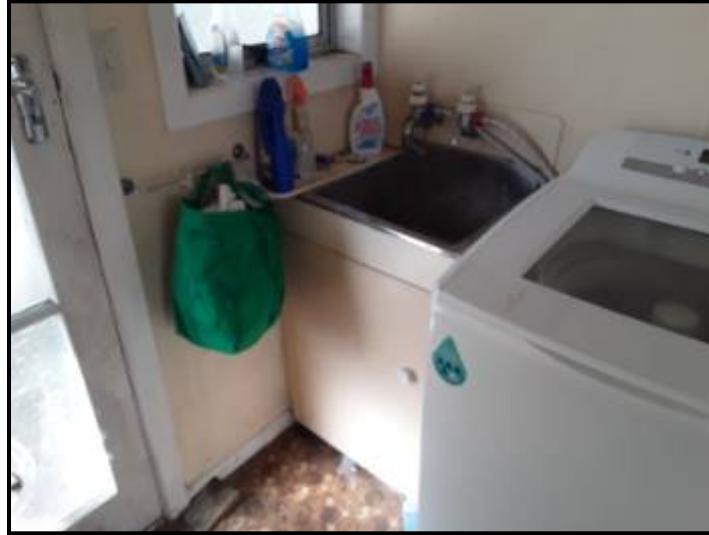
- Floor by tub showed high moisture levels.

High moisture readings behind tub.
