Weir Property Inspections - Building Survey Report

Client name:	EllenWilliamson
Date of inspection:	26/03/2026
Inspection address:	31 TODD AVENUE
Scope of inspection:	The inspection is conducted strictly in accordance with our Terms and Conditions and is limited to a visual Pre-Purchase or Pre-Sale assessment, following the guidelines of NZ4306:2005.
Report number:	2026/0003-32

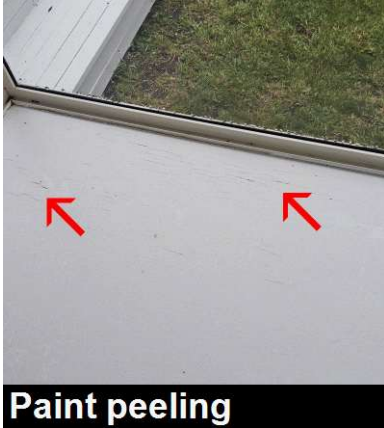
Paint is peeling on the windows. To protect the timber from moisture they can be sanded back and re-painted.

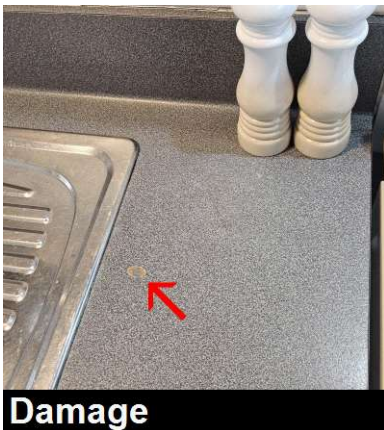
There is some damage to the bench top that can be repaired.

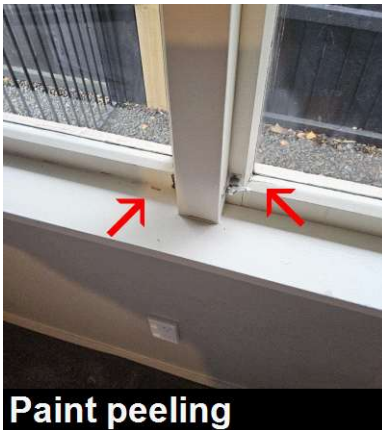
Paint is peeling on the windows. To protect the timber from moisture they can be sanded back and re-painted.

Paint peeling

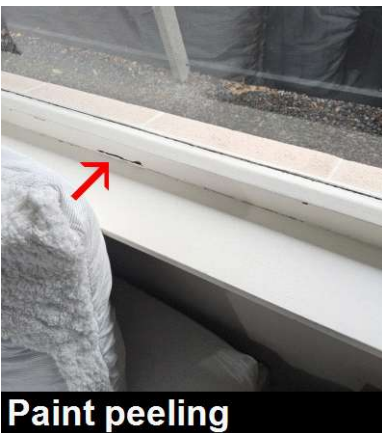
Paint is peeling on the windows. To protect the timber from moisture they can be sanded back and re-painted.

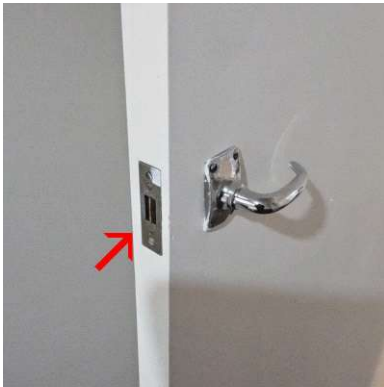
The door hardware is damaged and can be replaced.

Damaged

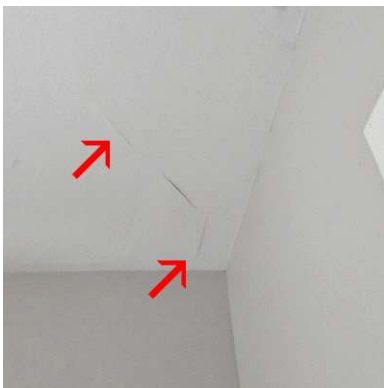
Ceilings:
Plaster board.
The lining paper was noted to be peeling in places, but it tested dry at the time of this inspection.

Peeling

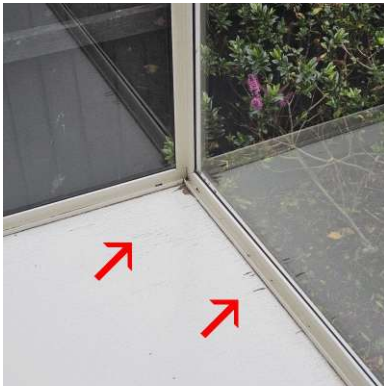
Paint is peeling on the windows. To protect the timber from moisture they can be sanded back and re-painted.

Paint peeling

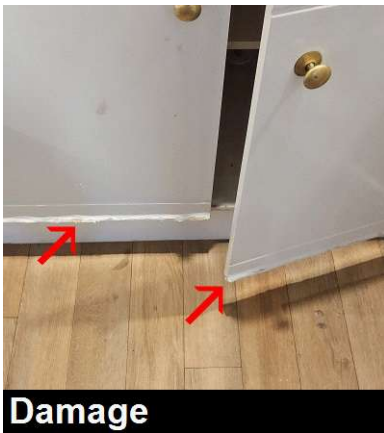
The vanity has some moisture damage, but is still usable. It can be repaired or replaced.

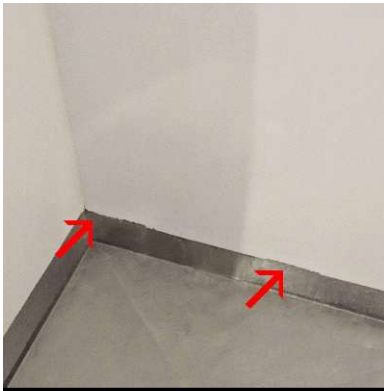
The shower linings are showing signs of deterioration in places. They will need replacing to prevent moisture damage. The state of the internal structural framing is unknown.

Deteriorating

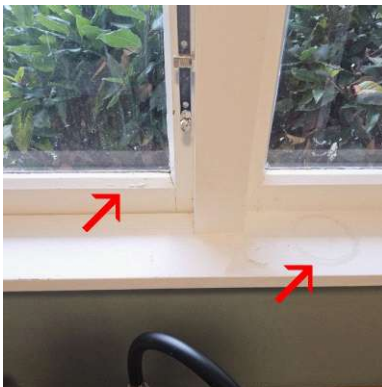
Paint is peeling on the windows. To protect the timber from moisture they can be sanded back and re-painted.

Paint peeling

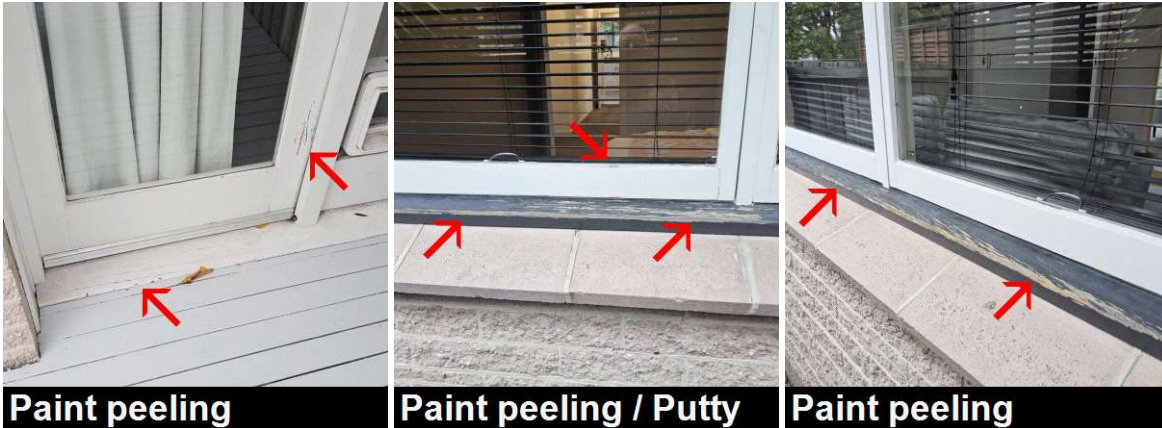
There is cracked and missing putty that needs to be replaced.

Paint is peeling in some areas, which can be prepared and re-painted.

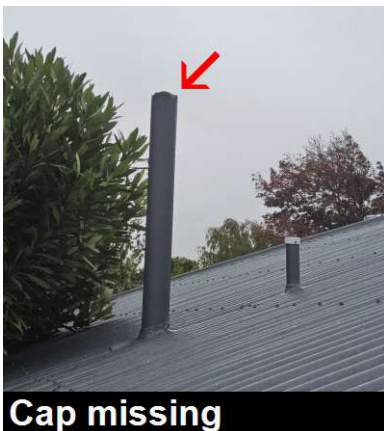
The vent pipe cap is missing and should have one fitted. These prevent birds or vermin getting in.

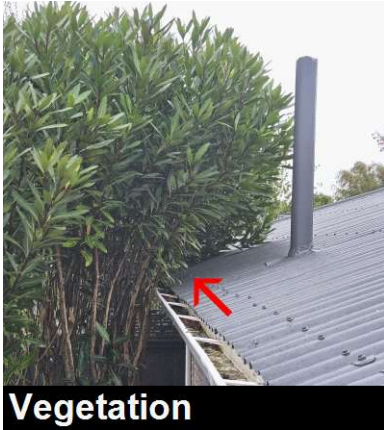
To avoid dampness and damage, we recommend clearing vegetation away from the roof.

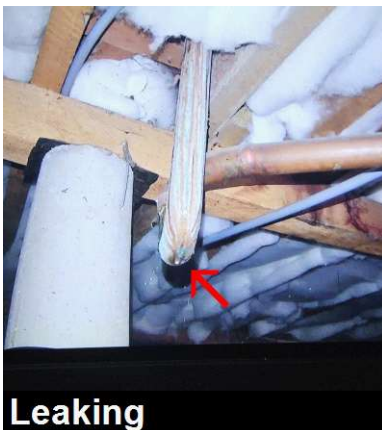
There is evidence of leaking wastes, which a registered plumber should investigate and repair as necessary.
