Weir Property Inspections - Building Survey Report

Client name:	EllenWilliamson
Date of inspection:	26/03/2026
Inspection address:	31 TODD AVENUE
Scope of inspection:	The inspection is conducted strictly in accordance with our Terms and Conditions and is limited to a visual Pre-Purchase or Pre-Sale assessment, following the guidelines of NZ4306:2005.
Report number:	2026/0003-33

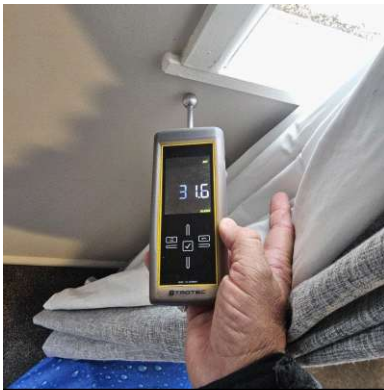
Normal moisture

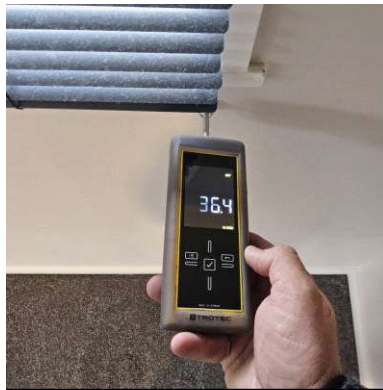
Normal moisture

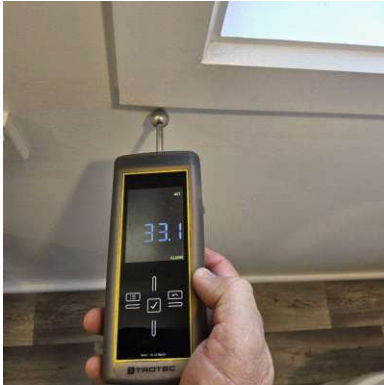
Normal moisture

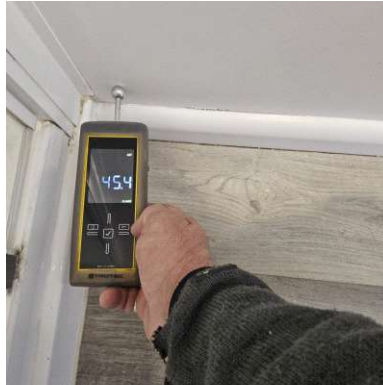
Normal moisture

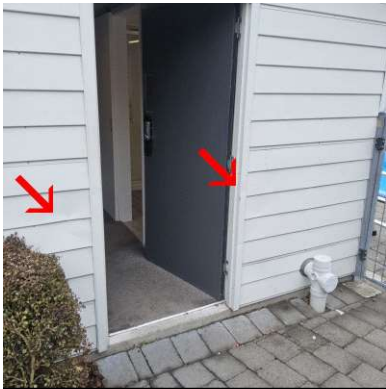
Some of the cladding has dents. But are not causing any issues or problems.

Dents

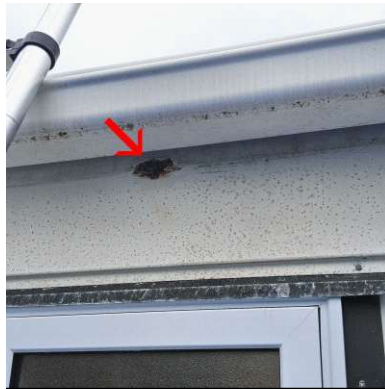
The cladding has surface rust, that needs to be sanded back, primed and painted to prevent any further damage.

Rust

If any holes are found, the cladding should be replaced.

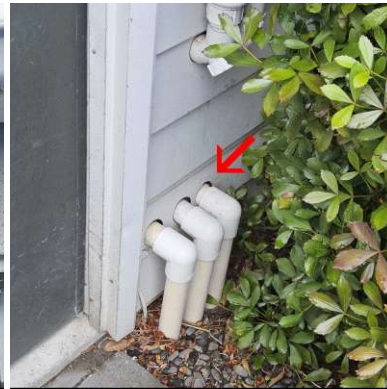
Where any cables or pipes penetrate the exterior cladding, they need to be sealed with sealant or escutcheon to stop driving rain and moisture getting in.

Penetrations

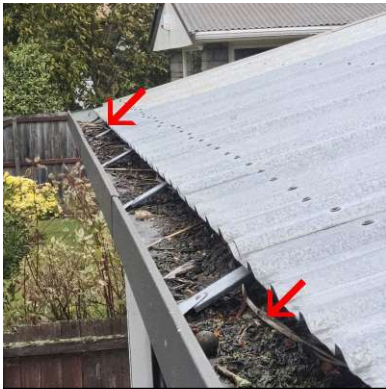
The guttering has some debris that needs to be removed to allow water to flow to the down pipes.

Debris

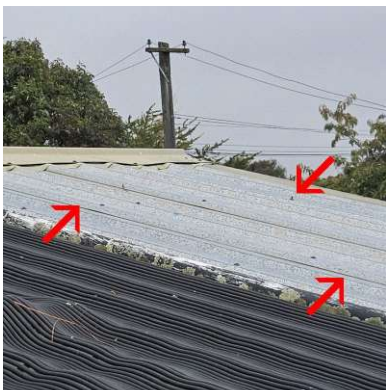
Paint is peeling in some areas, which can be prepared and re-painted.

Some of the roof fixings are loose or damaged and require removing and replacing.

Paint peeling / Loose fixings

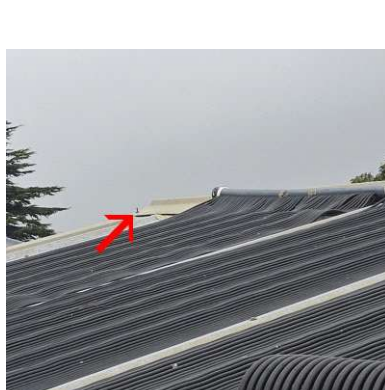
Loos fixings

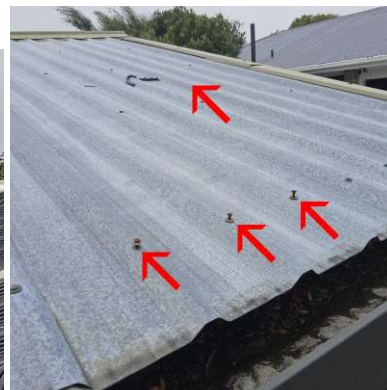
Paint peeling / Loose fixings

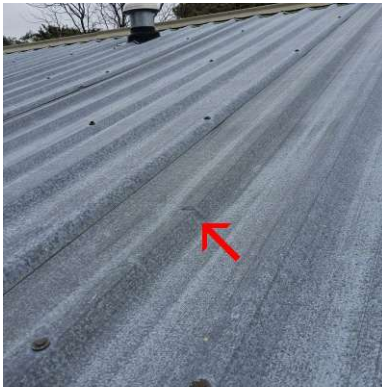
Some of the roofing has dents. But are not causing any issues or problems.

Dent
