EQC
Files

CASH SETTLED CLAIM(S)

Claim Number: 132431

Address	7 PALMSIDE STREET, SOMERFIELD, CHRISTCHURCH, 8024	EQC Claim Number	CLM/2011/110584
Hazards	No hazards	EQC Assessor (L,F)	Judson, Andrew
Inspection Date	14-Oct-2011	Placard	No Sticker
		EQC Estimator (L,F)	Thomas, Charles

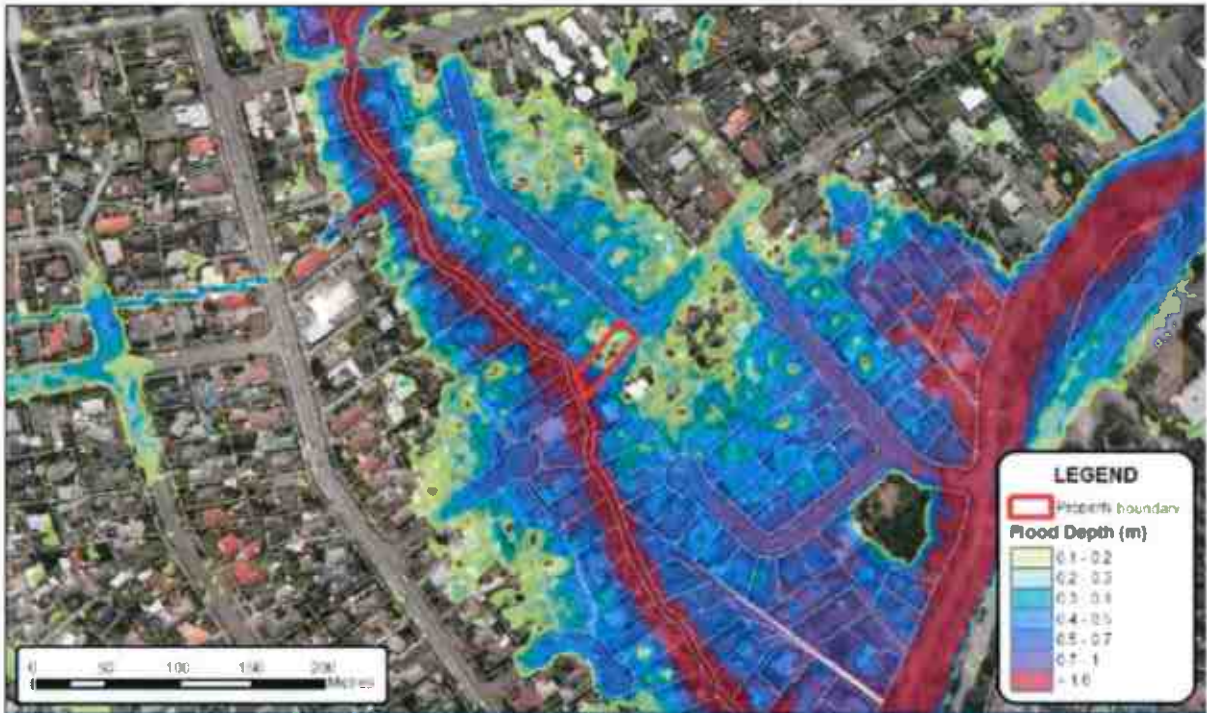
Map 2: Modelled flood depths for a 1 in 100 year flood event before Canterbury earthquake sequence

Map 2 shows flooding for the 1 in 100 year flood event before the Canterbury earthquake sequence.

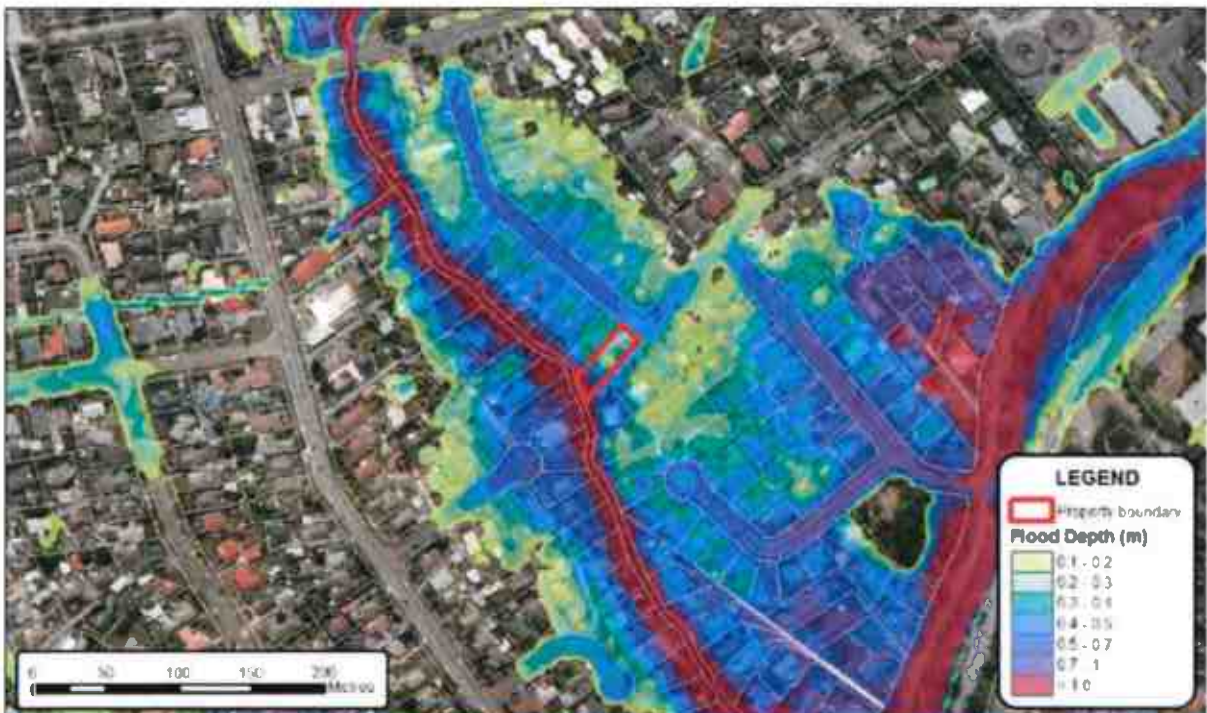
Map 3: Modelled flood depths for a 1 in 100 year flood event after the Canterbury earthquake sequence

Map 3 shows flooding for the 1 in 100 year flood event after the Canterbury earthquake sequence. EQC's flood model maps are available to technical professionals on the Canterbury Geotechnical Database.

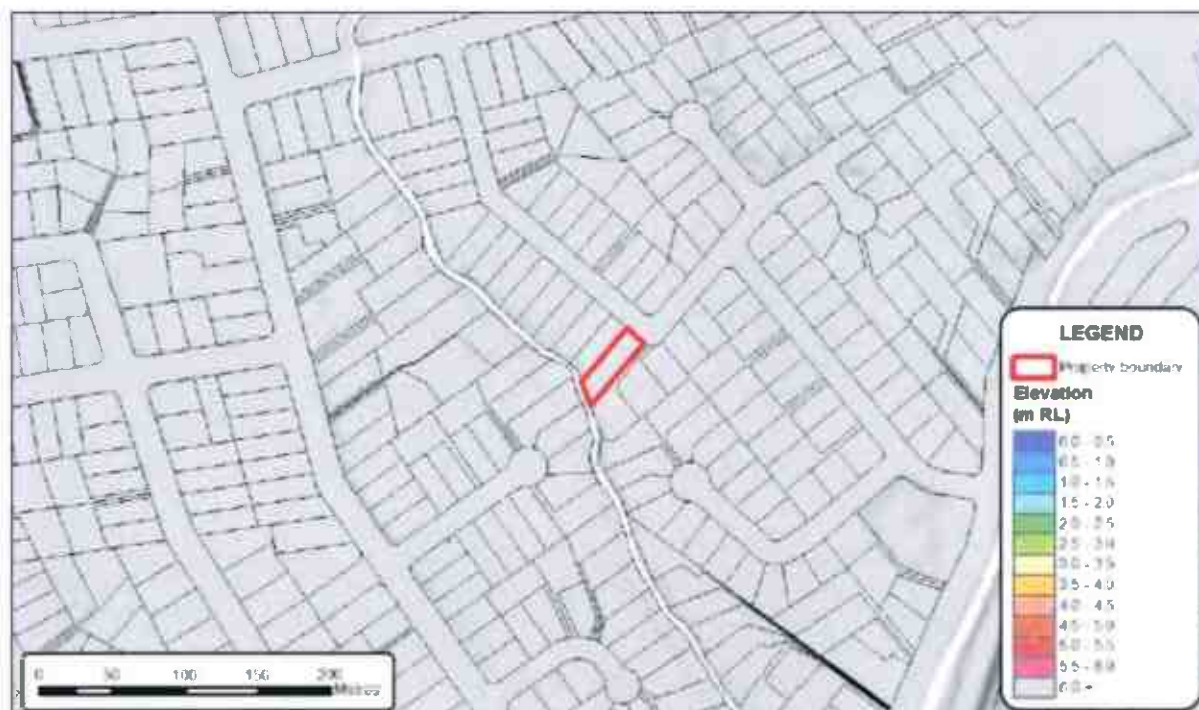
Map 4: Ground surface elevation post December 2011

Map 4 shows the ground elevation (i.e. the height of the land) following the Canterbury earthquake sequence. The ground surface elevation was measured using an aerial LIDAR survey (which involved scanning the ground surface

from an aircraft). This post-earthquake ground elevation survey is a key input into the modelling of the post-earthquake flood depth. Similar surveys were used as an input into the modelling of pre-earthquake flood depths.
