## RESIDENTIAL HOUSE INSPECTION

11 Zinnia Way  
Christchurch, Canterbury 8025

25/10/2024

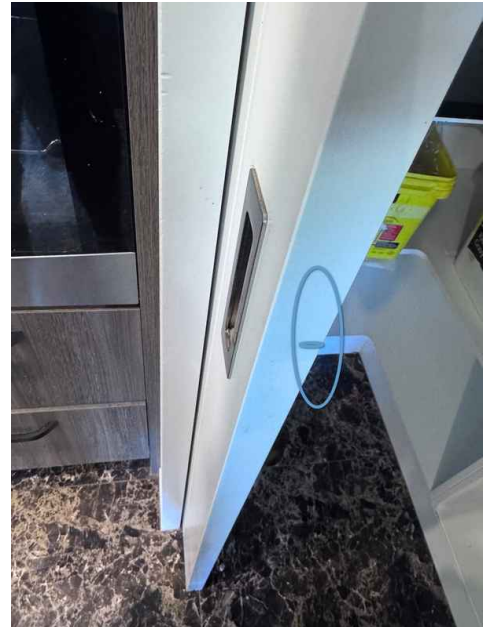
## 14.1.1 Walls and Ceiling

**DOOR MISSING PULL HANDLE**

Maintenance Item
