RED LBP MAINTENANCE REPORT

MAINTENANCE REPORT

Property Address	392G Hukanui Road Rototuna, Hamilton 3210		
Client	Tony Cawte		
Date of Inspection	9th December 2024	Time	12:45 pm
Inspector	Pita King Carpentry & Joinery Cert III (AUS), LBPno.135726, Diploma of Project Management.		
LBP Number	135726		
Additional Information			
People Present	Owner, Inspector		
House Occupied	Yes

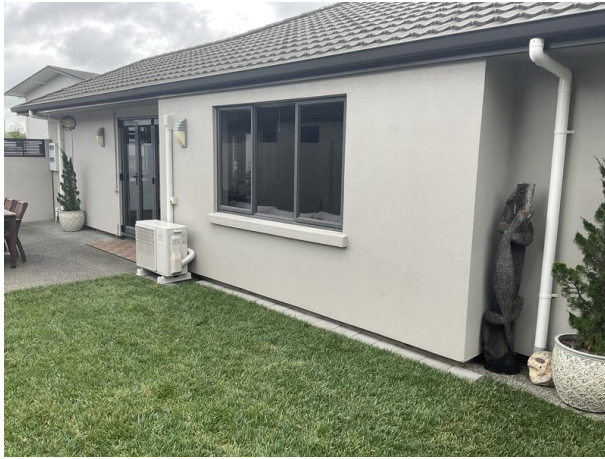
Photo 3

External cladding on the western side of the property. No visible horizontal or vertical cracking. No cracking around joinery.

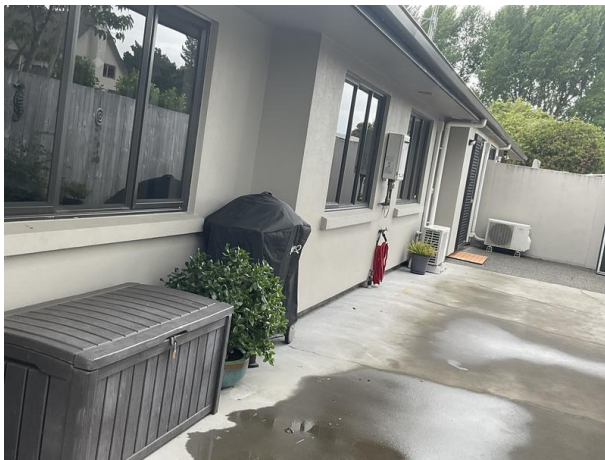
Photo 4

External cladding on the southern side of the property. No visible horizontal or vertical cracking. No cracking around joinery.

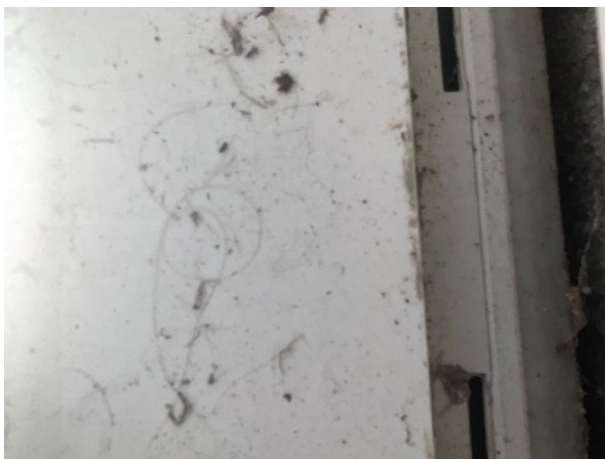
Photo 5

External plastered cladding over an unknown substrate installed on a cavity system. Cavity closers visible.

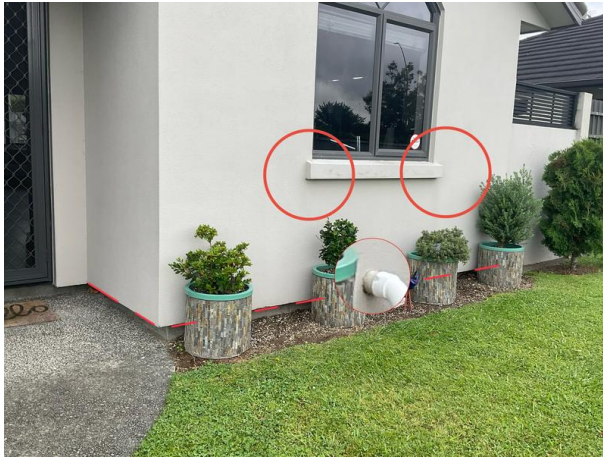
Photo 6

Sufficient ground clearances visible. Sealed penetrations. No visible cracking around joinery.

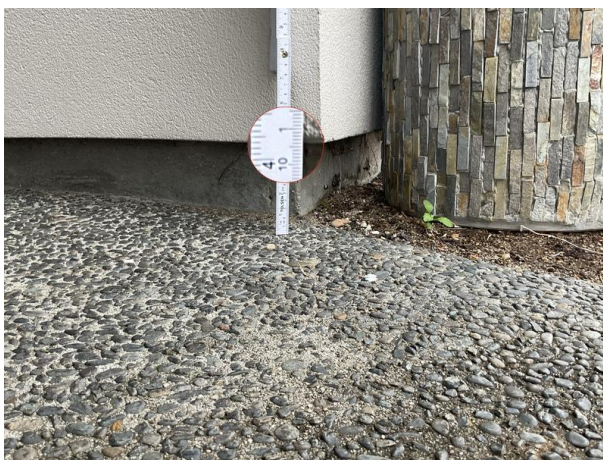
Photo 7

Sufficient ground clearances.

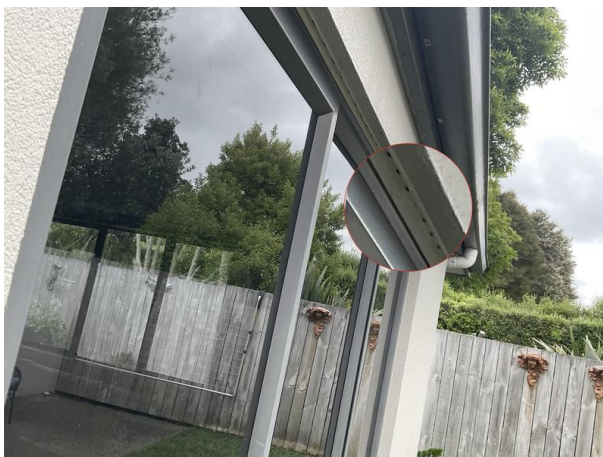
Photo 8

Cavity closers visible above joinery.

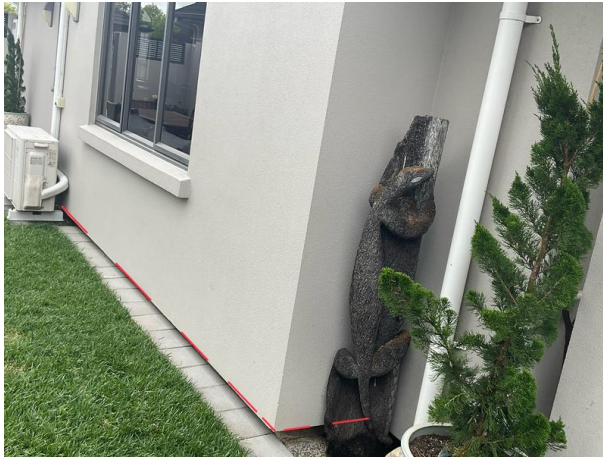
Photo 9

Cladding on the western side of the property. No visible horizontal or vertical cracking. No cracking around joinery. Sufficient ground clearances.

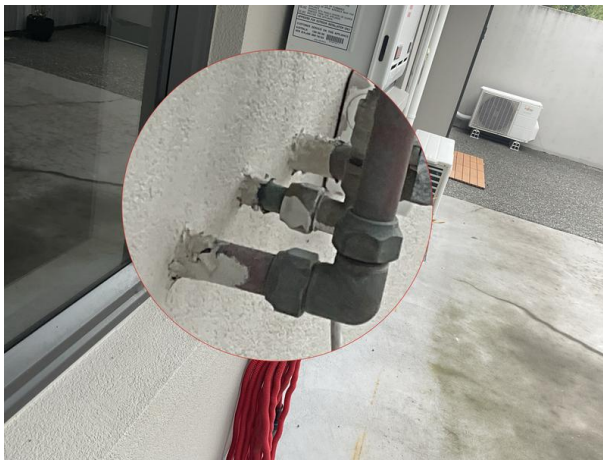
Photo 10

Sealed penetrations on the southern side of the property.

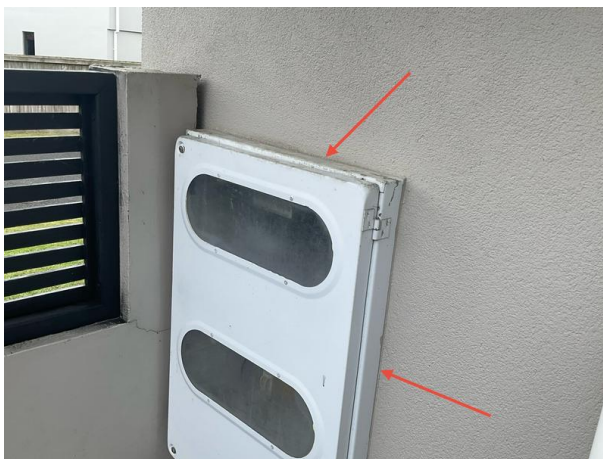
Photo 11

Sealed penetrations on the western side of the property.

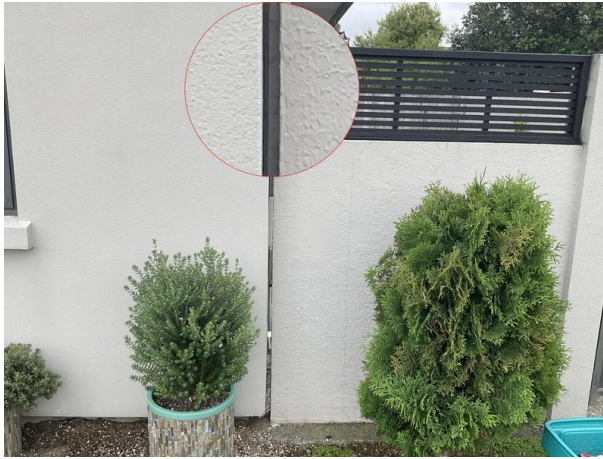
Photo 12

Fence on the western side of the property. Photo shows no penetration through external cladding.

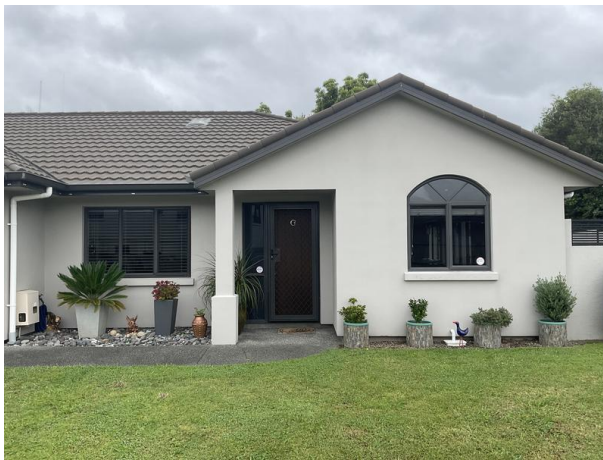
Photo 13

External cladding on the northern side of the property. No visible horizontal or vertical cracking. No cracking around joinery.
