# CASH SETTLED CLAIM(S)

## Scope of Works

## Assessment of Property at 2 CHILCOMBE STREET, ILAM, CHRISTCHURCH 8041 on 25/01/2012

## EQC Full Assessment Report

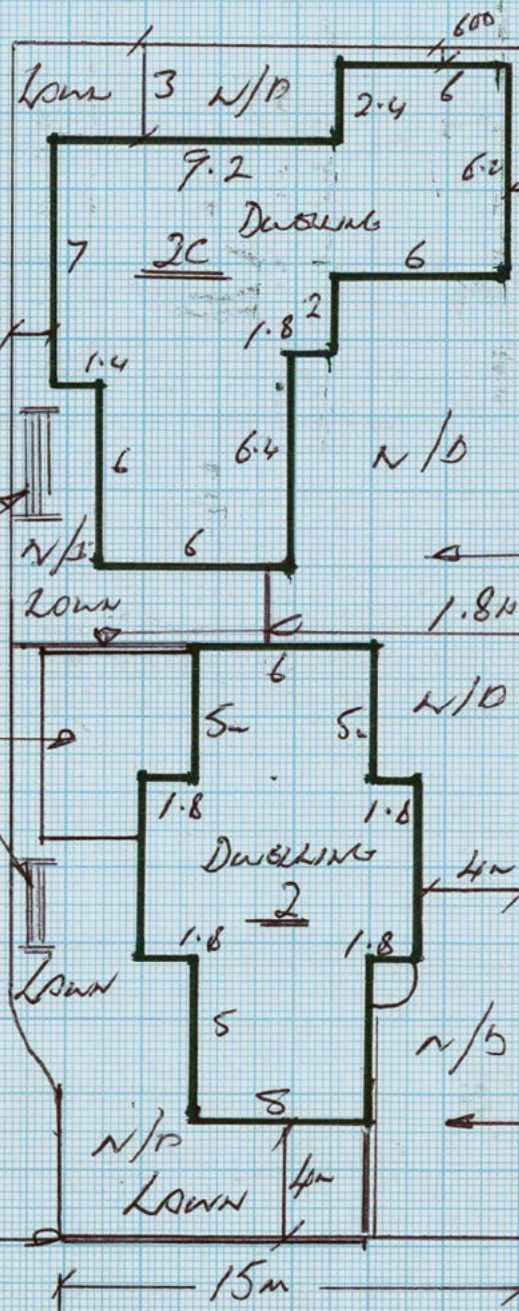
ALL WITHIN 261 LEVEL

NO DAMAGES

CHECKED
