# CASH SETTLED CLAIM(S)

CLM 2010/012667  
Claimant Name: P. Pen. 5h  
157 Church Rd  
Waipara.

This document provides a summary of the earthquake damage identified by the EQC assessment team. Land, building and room by room damage is listed along with an indication of how this damage is to be repaired. A glossary of terms describing the type of damage that may be listed on your Scope of Works is provided at the end of this document.

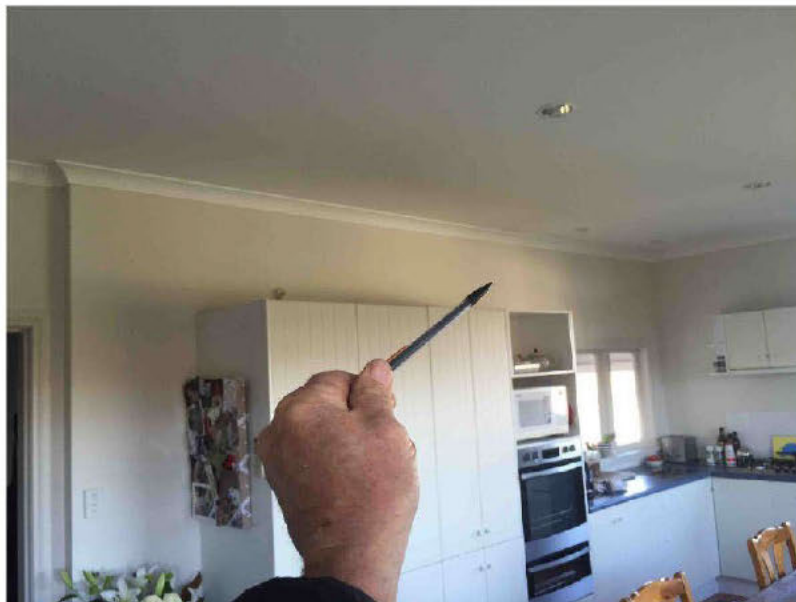
Figure 3 : Pointing to wall sheet join cracking in the kitchen

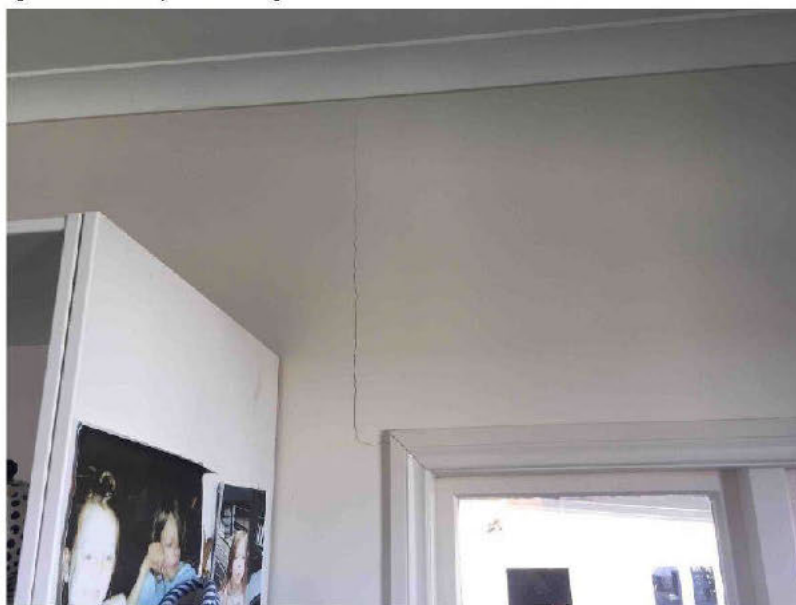
Figure 4 : wall sheet join cracking in the kitchen

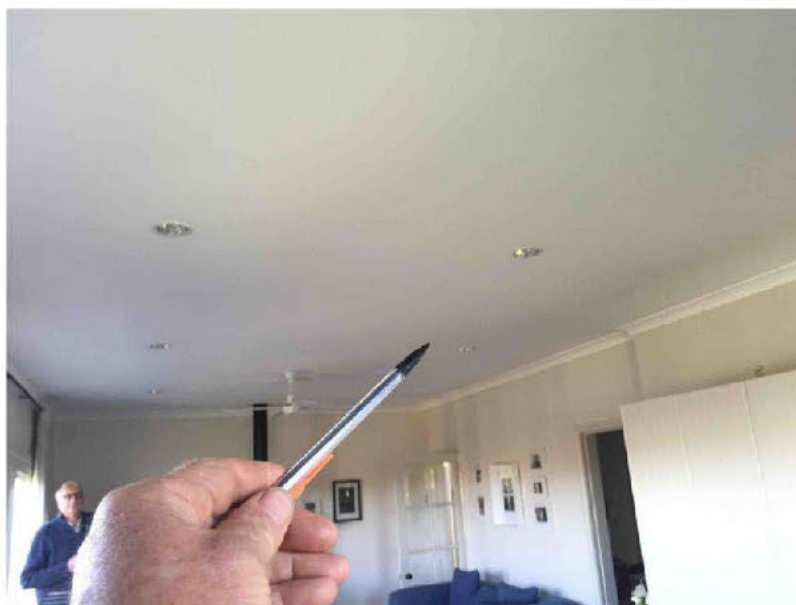
Figure 5 : Ceiling sheet join cracking in the kitchen

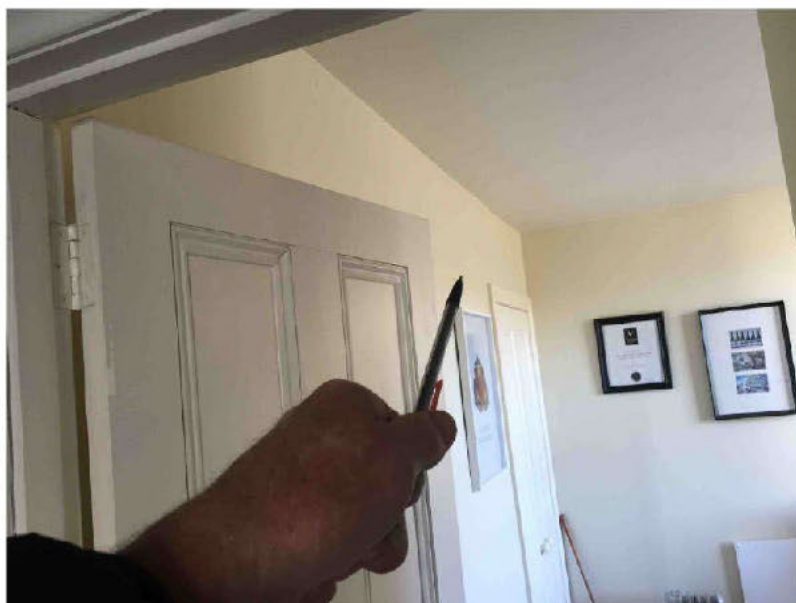
Figure 9 : Pointing to the cracking on office wall

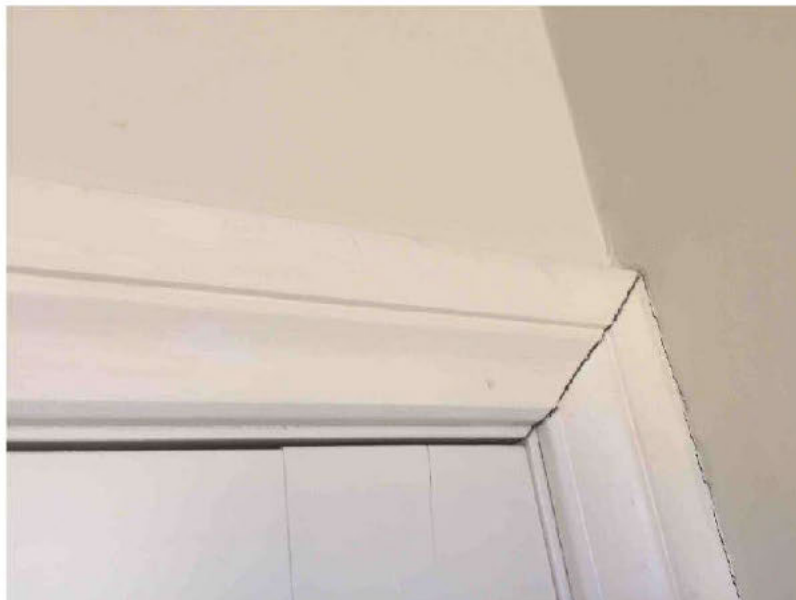
Figure 11 : Mitre opening

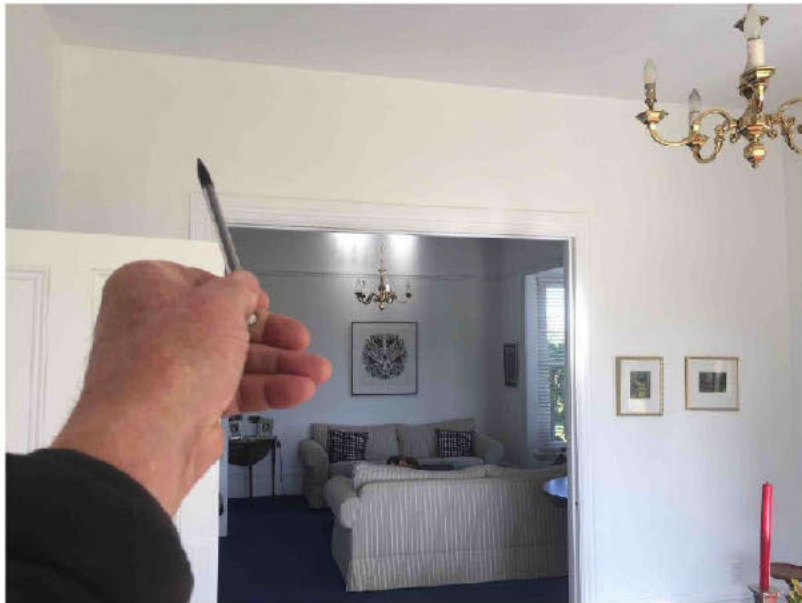
Figure 13 : Pointing to the wall crack above the opening

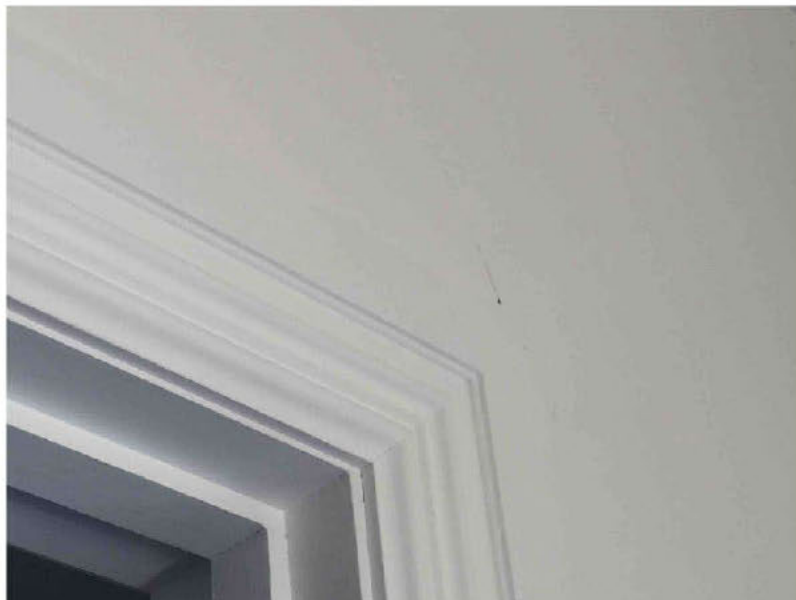
Figure 15 : Other side the same

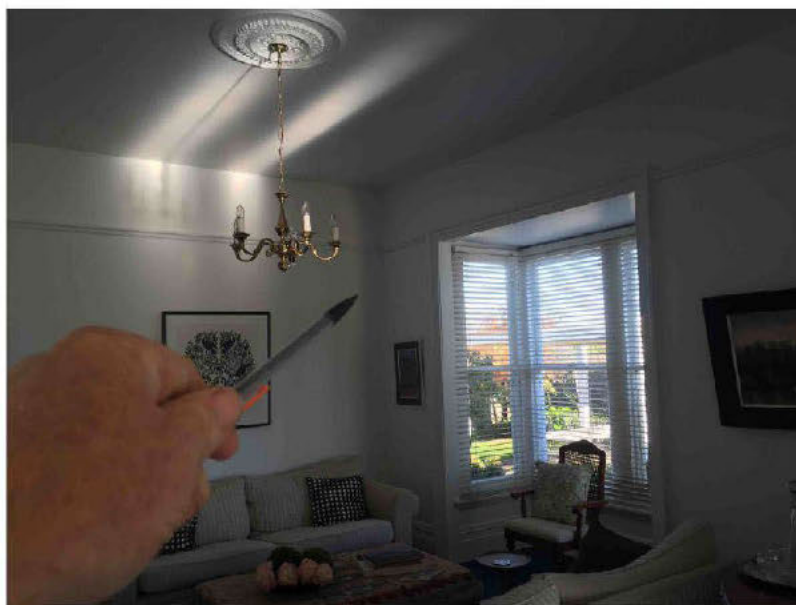
Figure 16 : Pointing to cracking at the wall junction

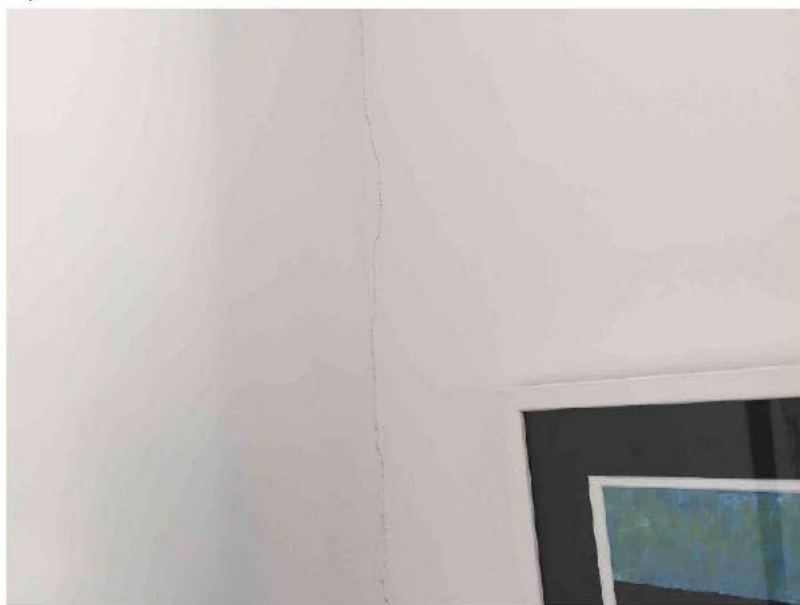
Figure 18 : Same as above
