NZ Residential Property Inspection Report

Inspection Date: Wed, 26 Feb 2025

Property Address: 7 Rollesby Street, Hoon Hay, Christchurch
8025, New Zealand

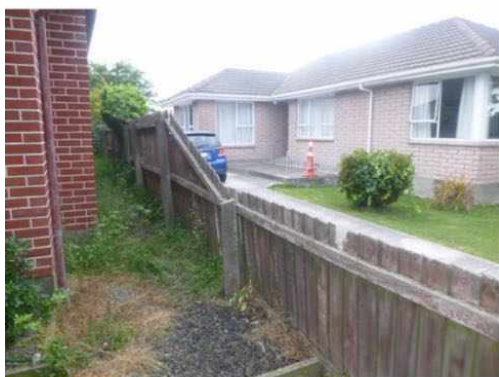
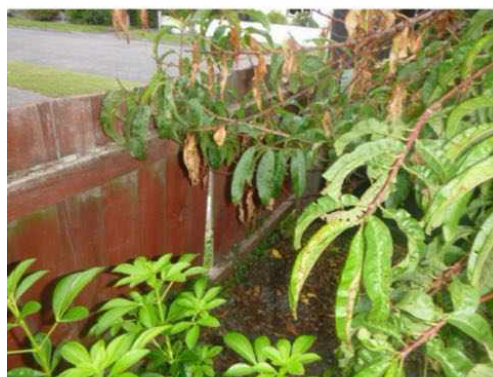
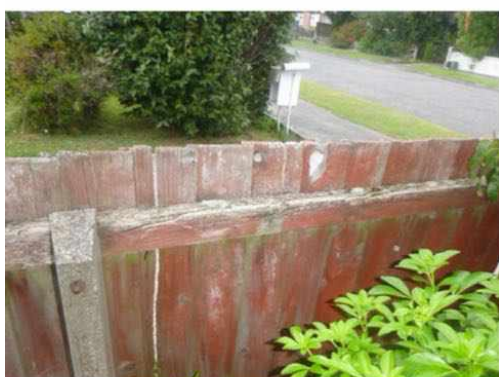
Defects 3.02

Building: Main Building
 Location: All Areas > All Areas
 Finding: Fence - Palling
 Information: The majority of the fencing is in good condition. A number of palling are damaged or missing and will need repair/replacing to prevent any further deterioration of the fence .

This canbe carried out by a qualified builder at the clients discretion.

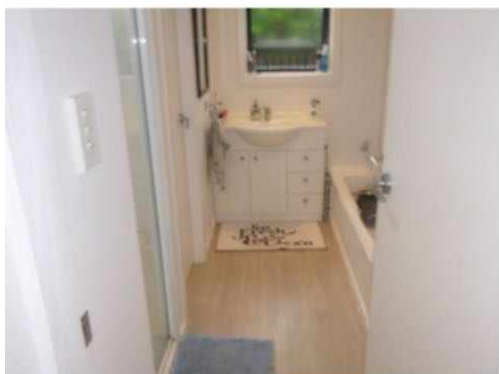
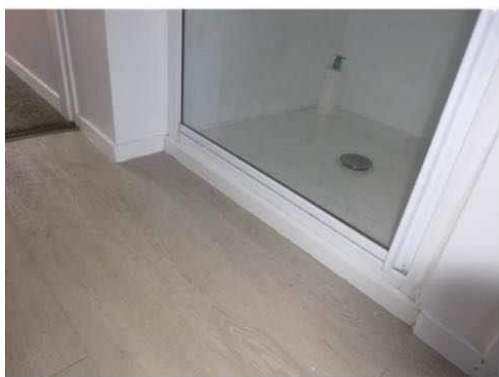
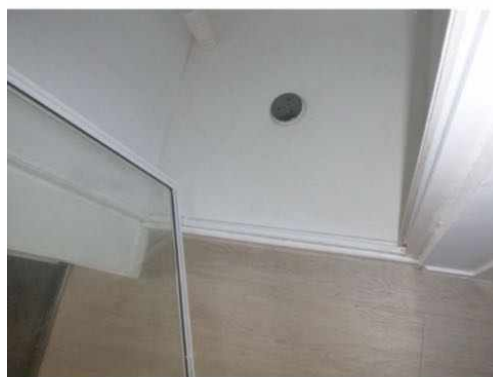
Defects 3.03

Building: Main Building
 Location: Bathroom > Centre
 Finding: Door - Seals - Showers
 Information: A new door seal should be fitted to the bottom of the door to prevent moisture getting under the door when the shower is operational.

Moisture was detected in the skirting at the time of the inspection. Once a seal is installed the moisture should dissipate over time.

This can be carried out by a general handy person.

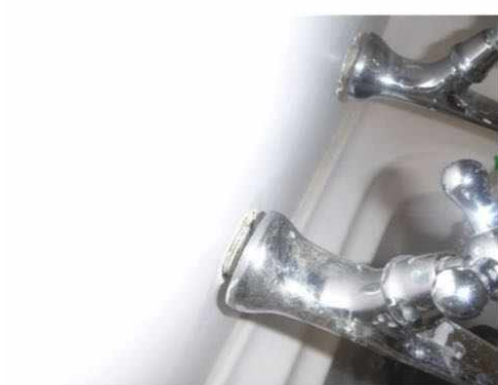
Defects 3.04

Building: Main Building
 Location: Bathroom > Centre
 Finding: Tap - Gap
 Information: The tap in this area have a gap .This tap having a gap creates potential for water leaks and subsequent water damage to the surrounding area.

A qualified plumber should be appointed to re-fix the plumbing fitting.

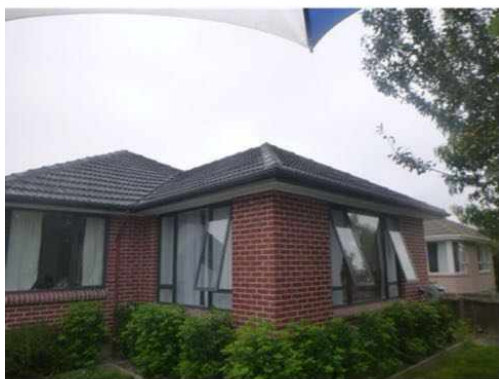
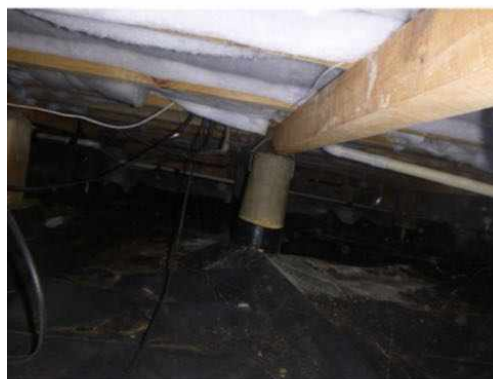
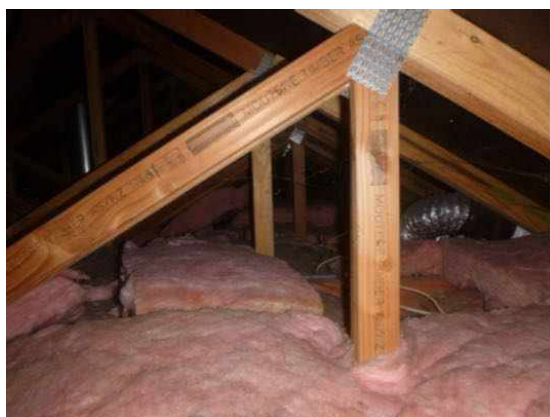
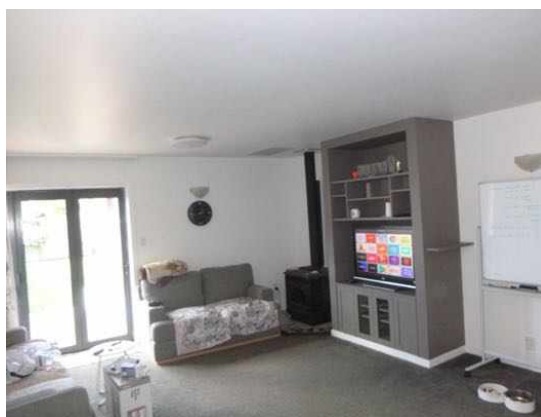
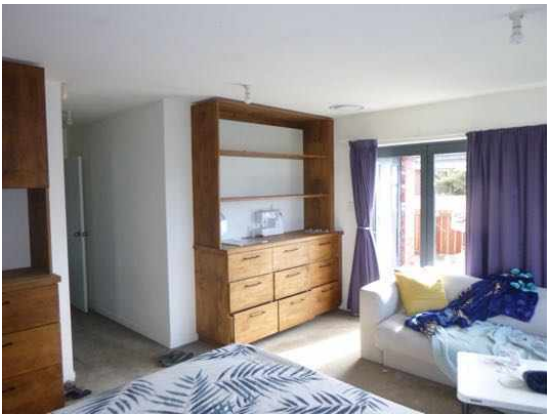
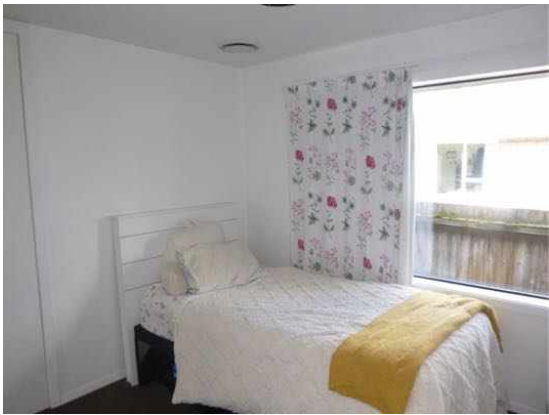
Building: Main Building
Location: NZ Only > All Areas
Finding: Additional Photos - Obstructions and Limitations
Information: These photographs are an indication of the obstructions and limitations which impeded full inspection of the property at the time of inspection. These obstructions can hide an array of defects and should be removed to allow full inspection to be carried out. A re-inspection is recommended once the areas are made accessible.

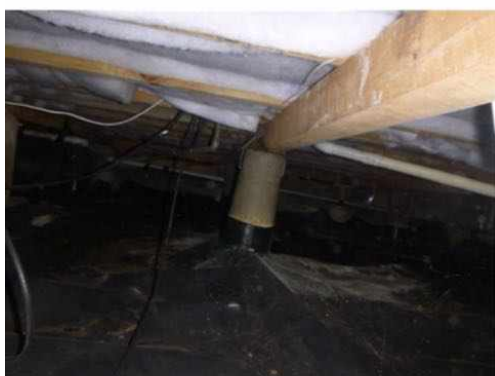
Building: Main Building
 Location: NZ Only > All Areas
 Finding: Subfloor
 Information: At the time of inspection the concrete piles appeared to be in good condition and visually plumb. It does appear that the piles observed were fixed to the structure.

The subfloor structure consisting of a ring foundation and concrete piles generally appeared to be in good condition with viewing from the manholes only.

The subfloor has insulation fitted to a good standard and a PVC vapour barrier fitted to the ground to a good standard.

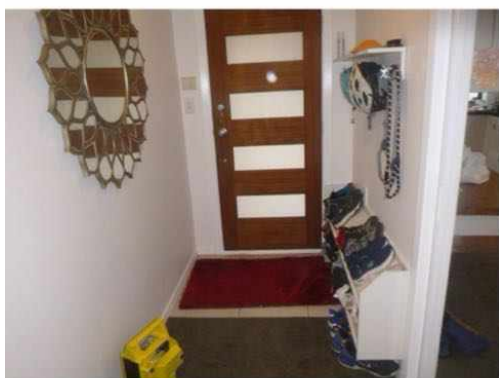
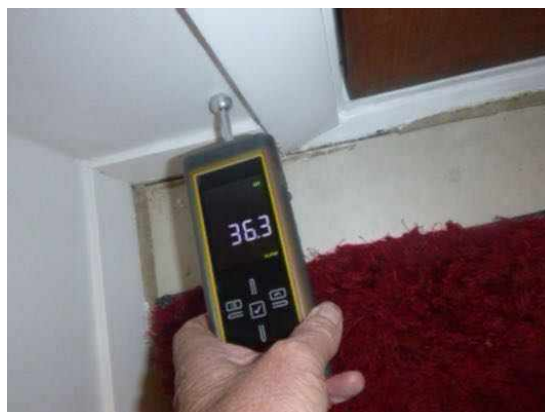
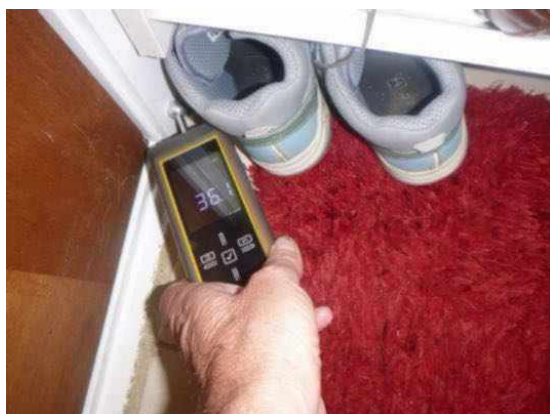
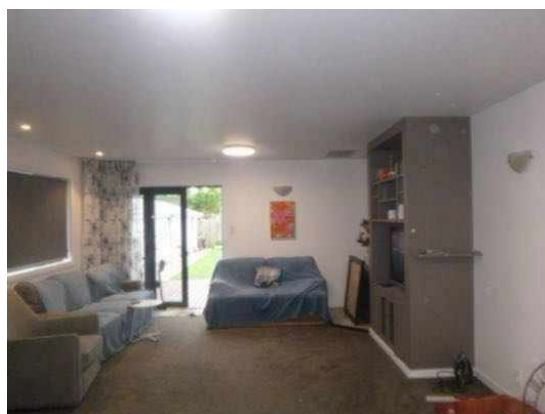
Building: Main Building
Location: All Areas > All Areas
Finding: Moisture - Testing
Information: TROTEC T660 Non-Invasive Moisture Meters

Moisture Test Result. Base reading is taken on an area which is known to be dry, from here all readings are relative to these base readings.

All reading were in the normal range with no concerns with the results.

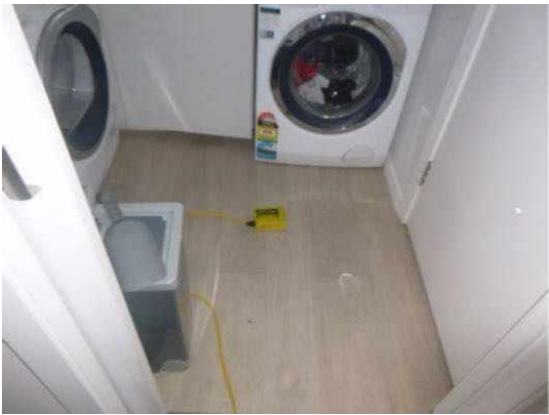
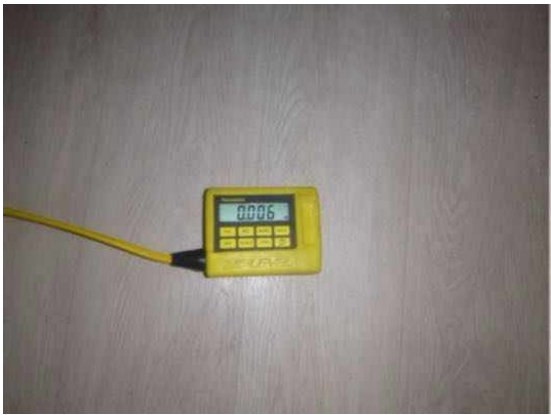
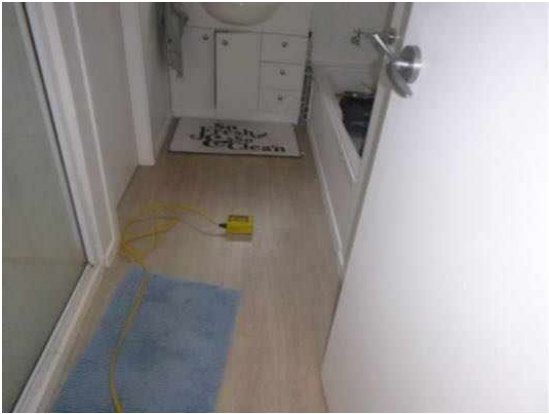
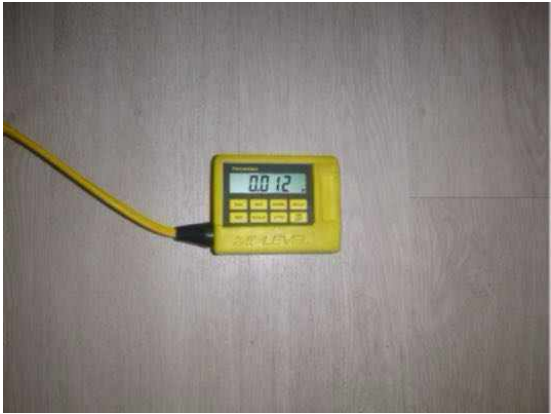
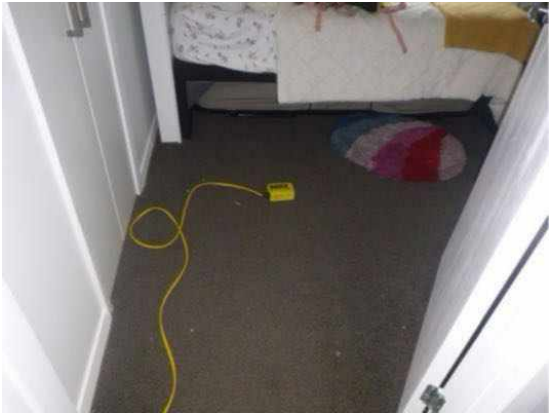
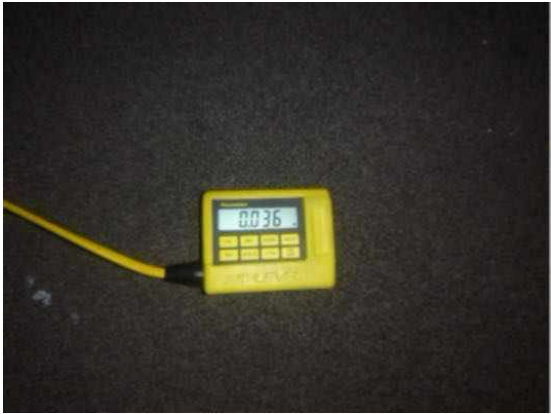
Building: Main Building
 Location: All Areas > All Areas
 Finding: Floor - Levels
 Information: Floor levels were randomly checked with a zip level in various locations throughout the dwelling, the dwelling is within the Ministry of Business, Innovation (MBIE) guidelines and tolerances, for variation in level less than 50mm over the overall floor plan.

Please note this is not a floor level survey, tolerances in measuring devices and benchmarks may occur.

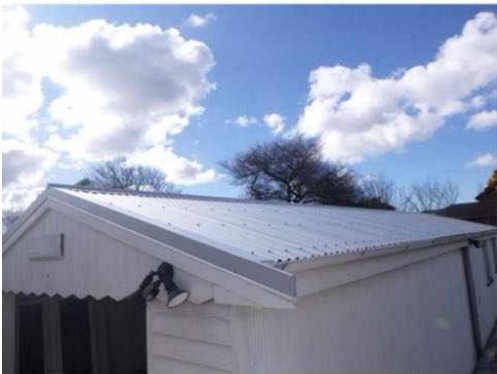
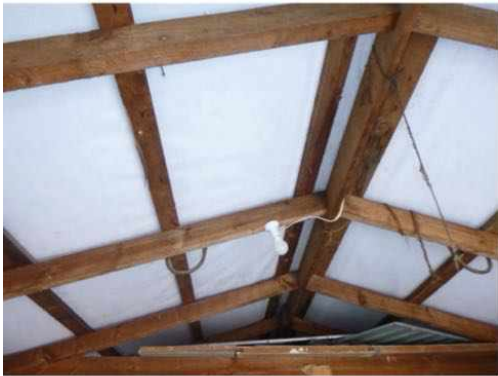
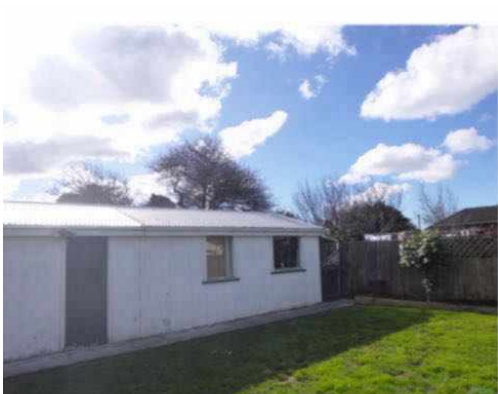
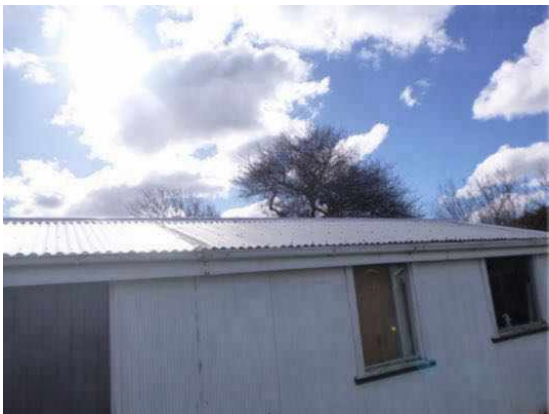
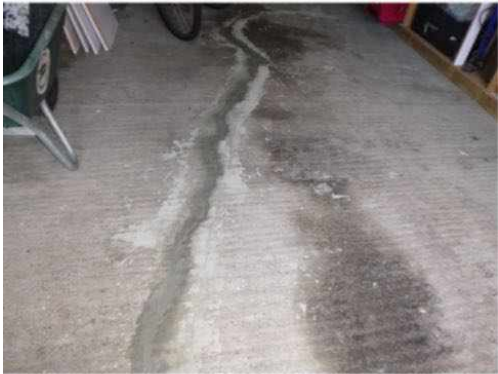
Building: Main Building
Location: Garage >
Finding: Garage
Information: The overall condition of the garage is fair/good with notable defects found that will need repair/replacement.

A section of the roof iron has been replaced ,the cladding at the rear of the garage has deteriorated and will need repairs.

The concrete slab has had a repair.

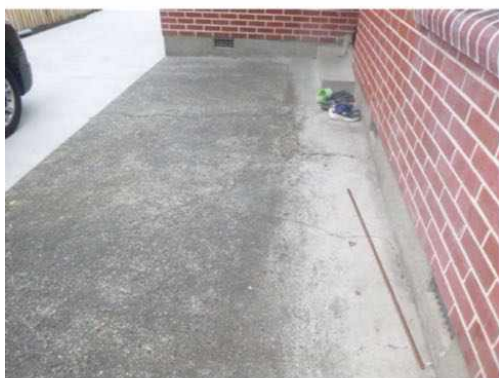
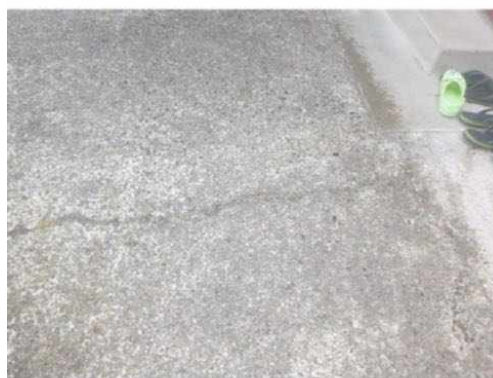
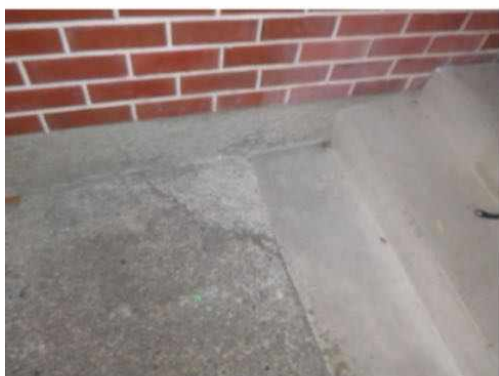
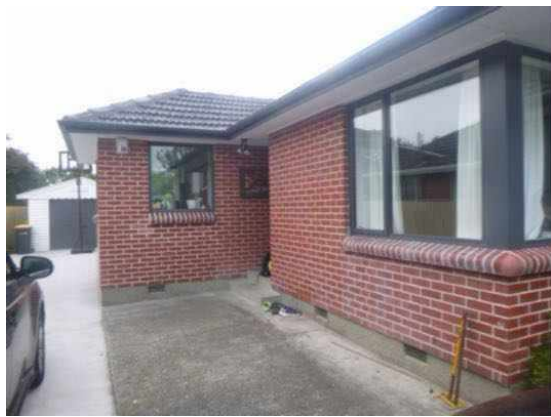
| Information: | Fine cracks were identified in external concrete . Although fine cracks are quite noticeable, they are often only considered to be an appearance defect, and usually do not indicate any structural damage. |

General age and expected deterioration of the concreted areas is a common cause of this type of cracking. However, expansion and contraction of the slab may also have occurred due to environmental factors. Such factors include variable moisture and weather conditions, the presence of trees and their roots having a settling or lifting affect on the soil, or the effect of load bearing, e.g. heavy vehicles over a sustained period of time.
