## BUILDING CONDITION ASSESSMENT REPORT

Date of Assessment: 07 November 2024

Subject property: 18A Tekoah Place, Judea

Lot 2 DP 389316

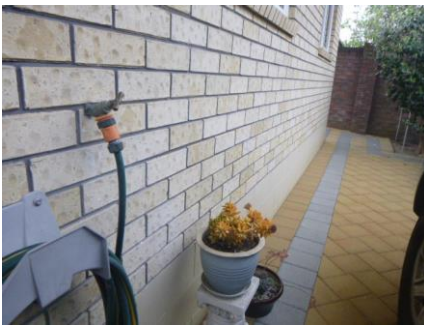
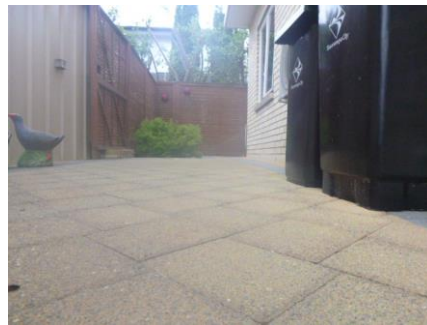
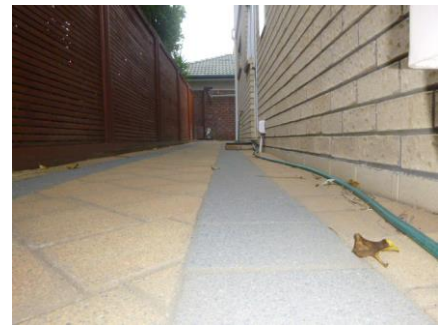
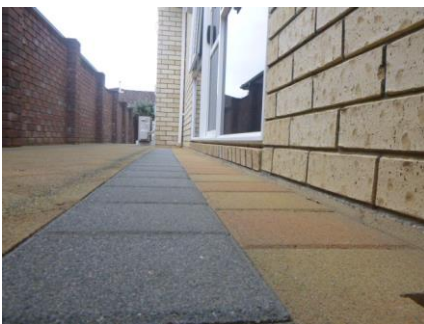
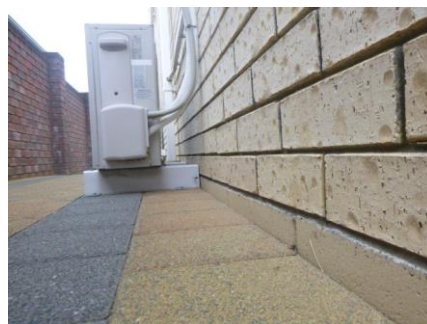
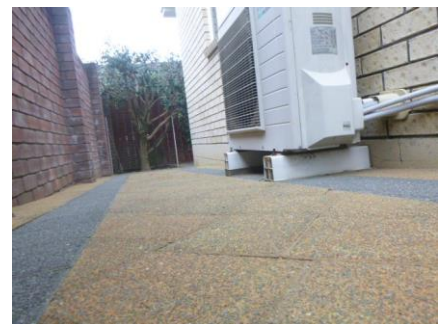
*The clearance between the interior floor level and ground is generally good*

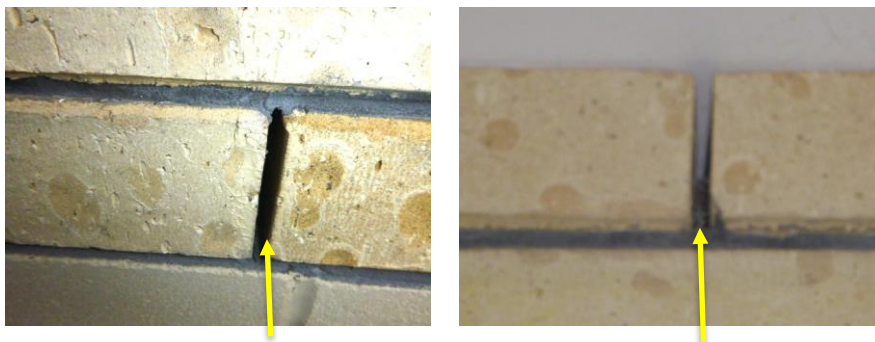
*Note the open vertical perpendicular joints to the bricks that assist the cavity system to drain and ventilate as required*

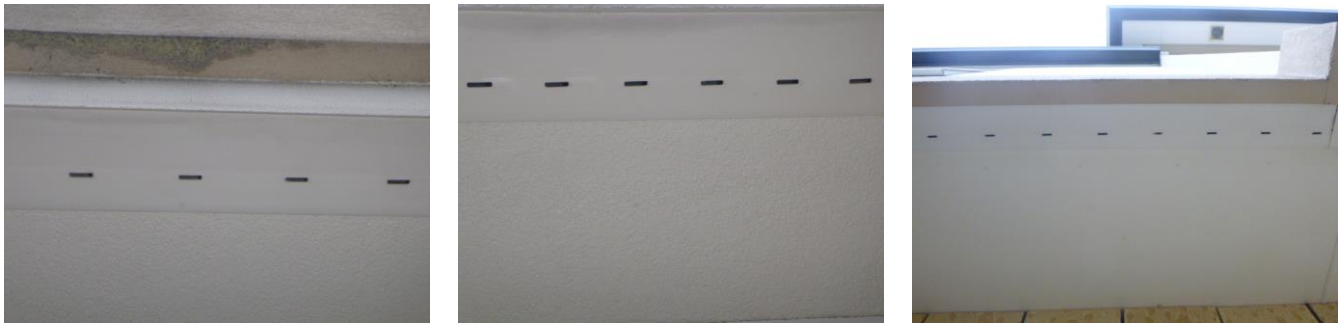
*Note the cavity closure strips to the cladding that allows the cavity to drain and ventilate as required*

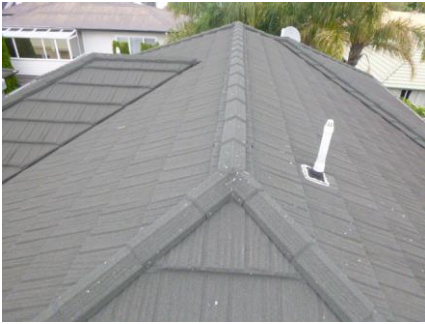
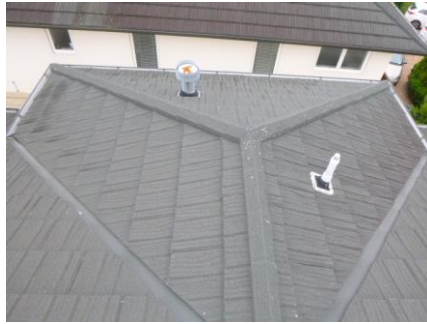
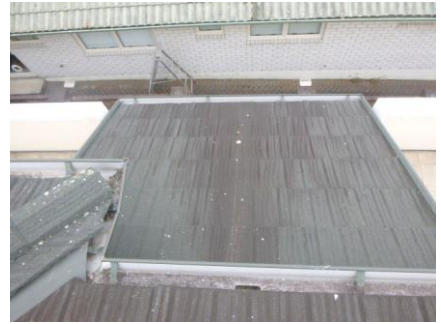
*The roof installed to this dwelling is generally in good visual condition for its age*

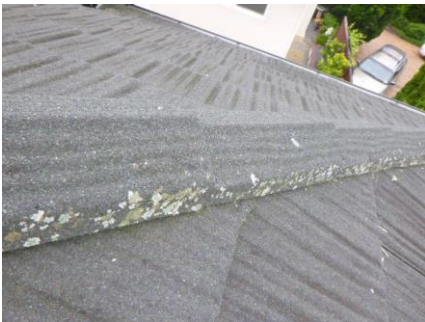
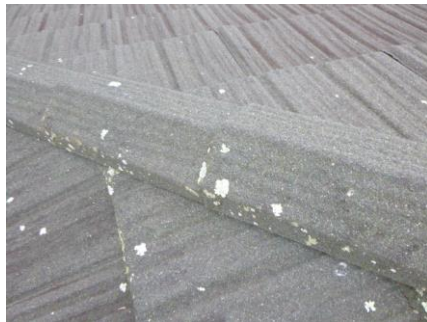
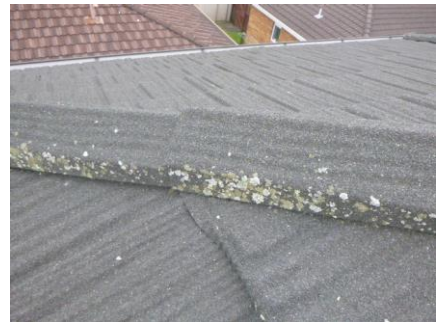
*Removing any lichen is advisable*

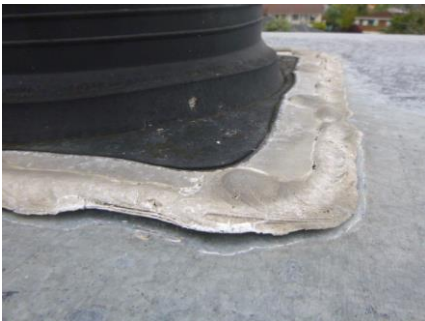
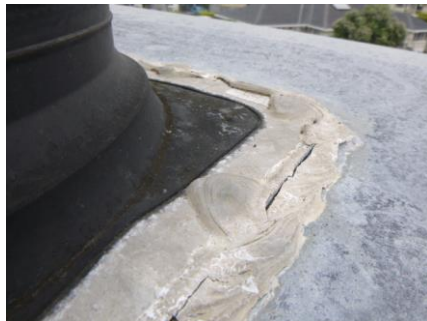
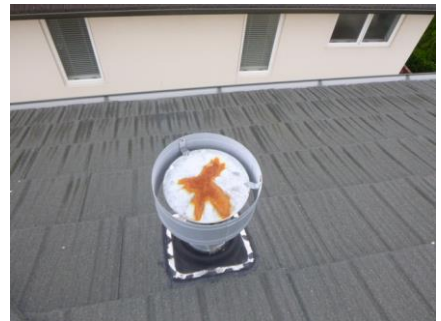
*Some deterioration was noted to the silicone around the fire flue seen in the left-hand and middle photos. In the right-hand photo some corrosion was noted to the range hood flue pipe.*

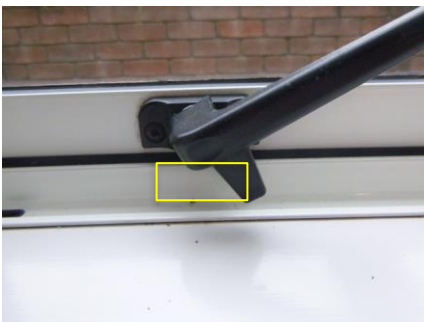
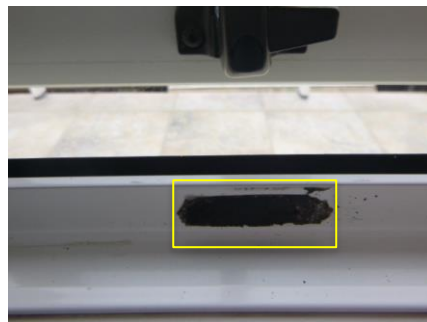
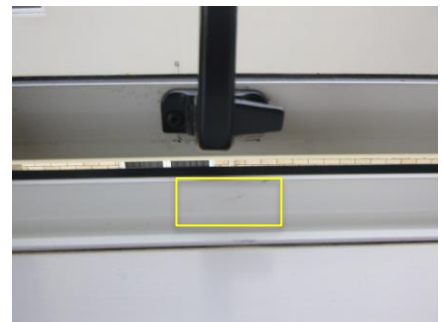
*Note these photo examples of the missing window latch receivers*

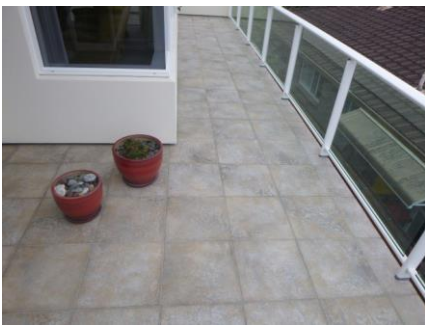
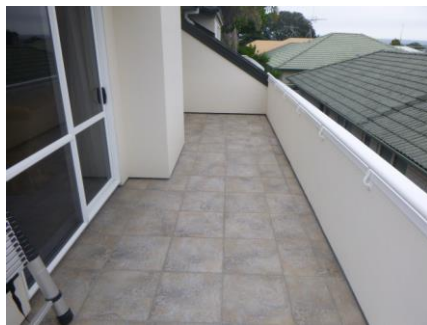
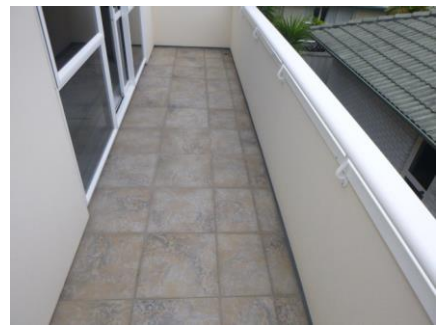
*The decks were in good visual condition*

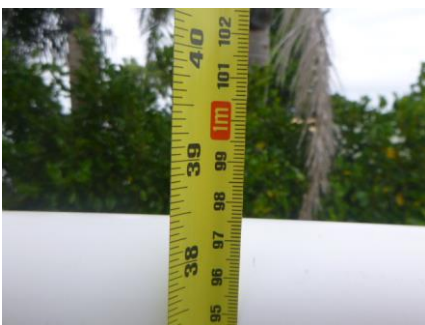
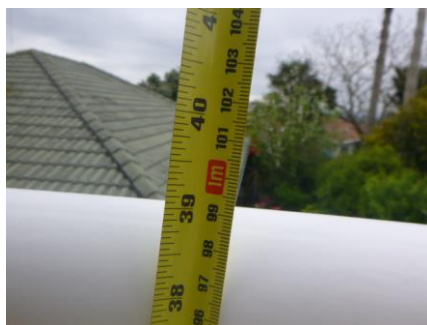
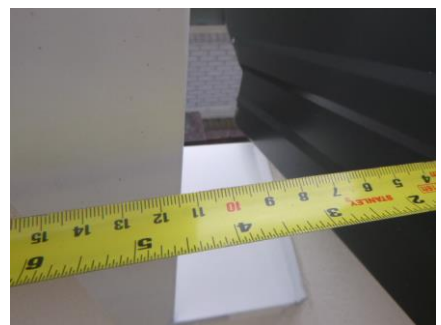
*Note that the western handrails are not currently in compliance*

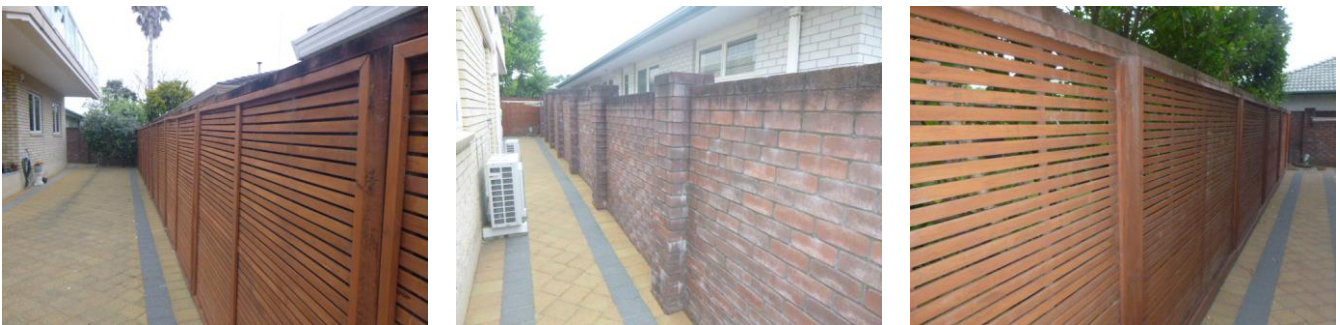
*On the day of our inspection there were no signs of any excessive movement to these fences*

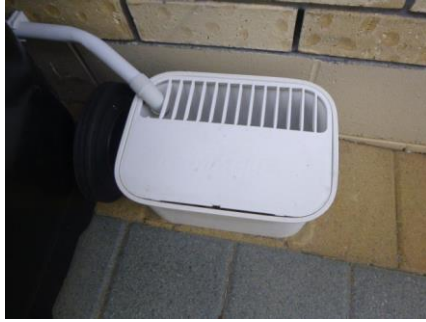
*The gully trap has been installed at the correct height above the ground to prevent surface water entry*

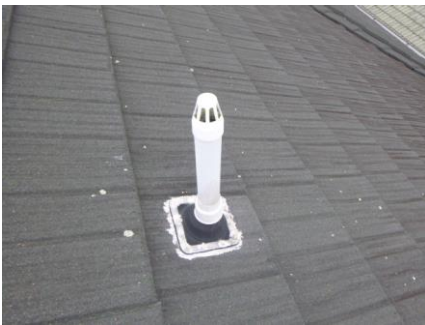
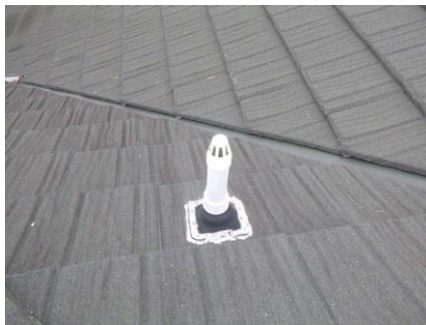
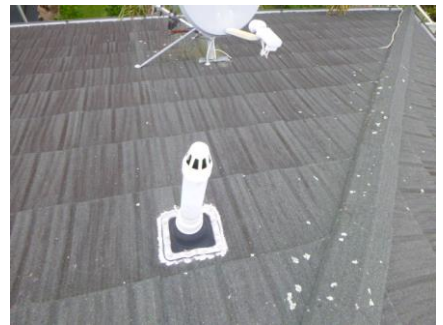
*The terminal vent pipes are bird proofed as required*

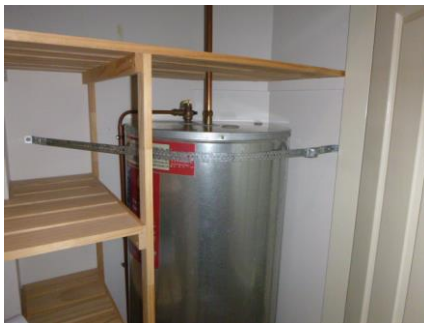
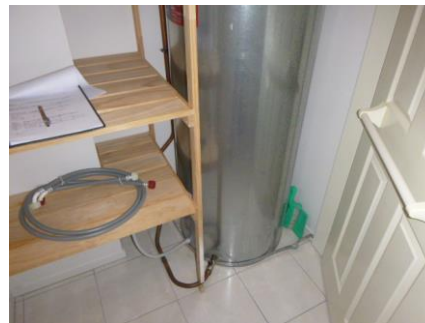
<b>Type</b>	January 2007 (see comments) electric indoor hot water mains pressure cylinder visually in good condition at the time of our inspection however it is <b>not strictly</b> seismically restrained as required. Installing one more seismic restraint to the middle of the hot water cylinder is required for earthquake reasons and this was a Building Code requirement at the time that this dwelling was constructed.
<b>Location</b>	Laundry cupboard
<b>Capacity</b>	250 litres

*On the day of our inspection there were no leaks evident to this hot water cylinder and note that it is not strictly seismically restrained as required*

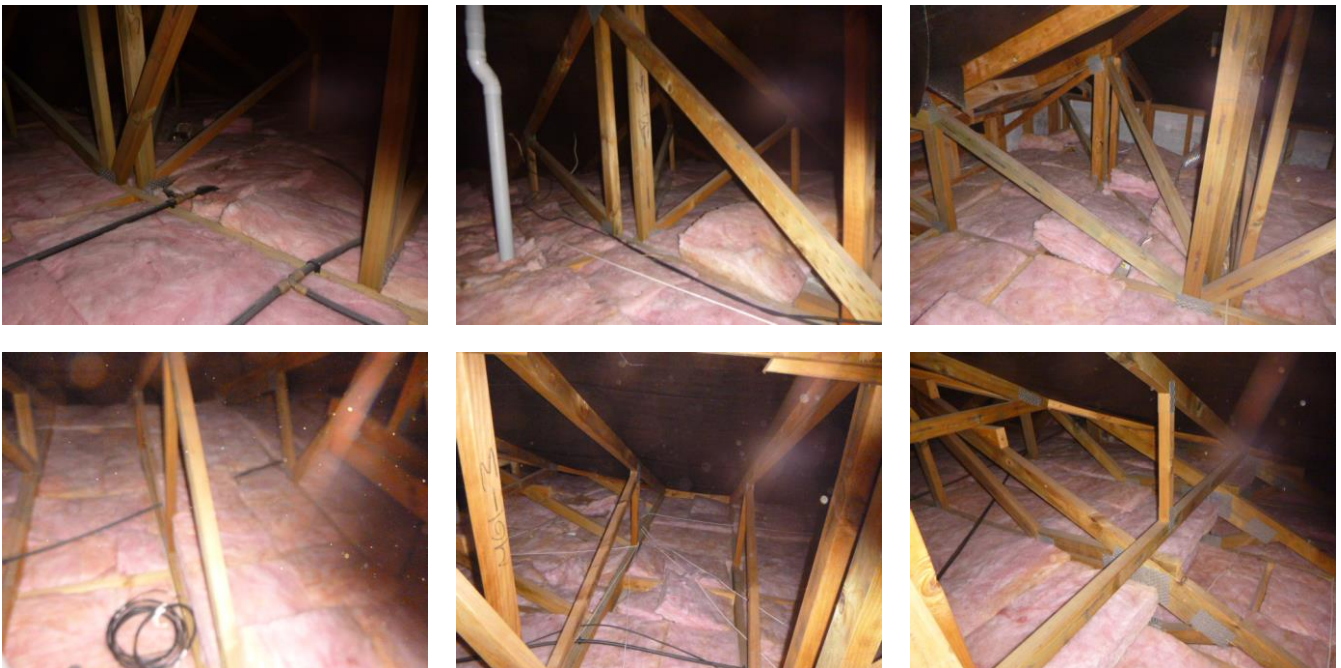
*The roof cavity was dry and insulated on the day of our inspection*

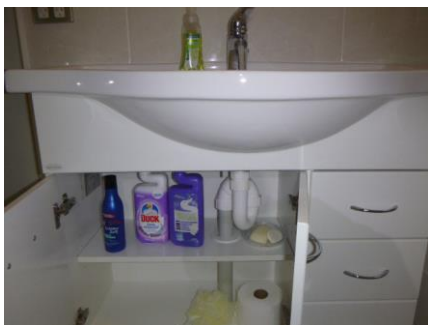
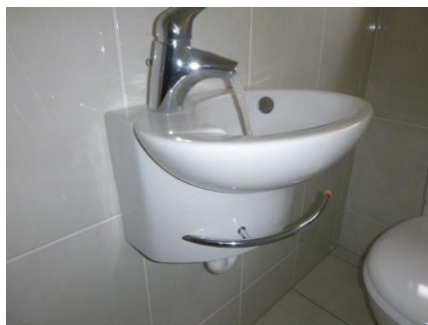
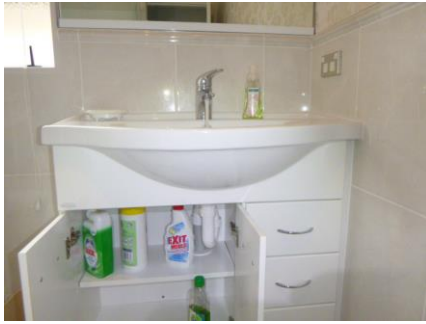
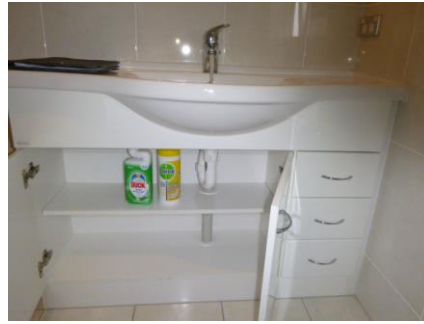
*On the day of our inspection there were no current leaks evident to these vanity units*

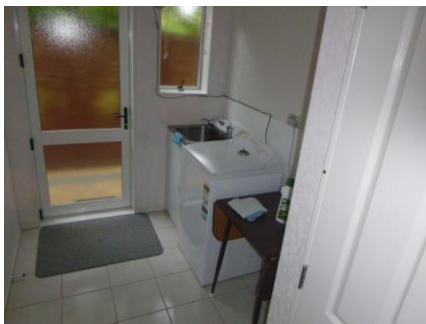
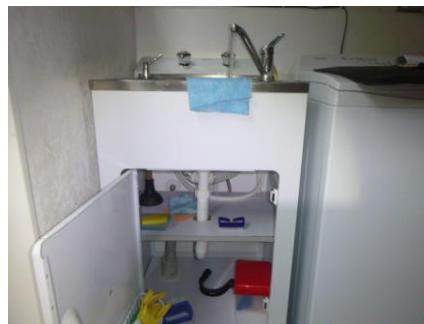
*On the day of our inspection there were no current leaks evident to the laundry tub*

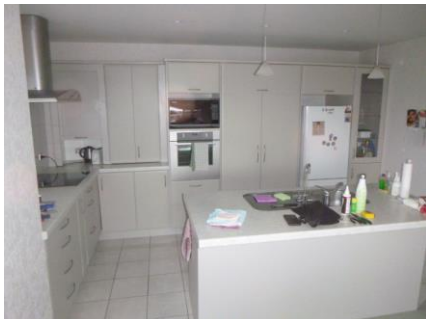
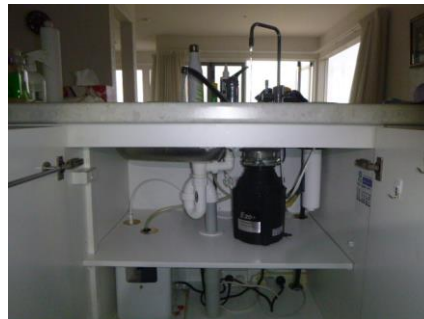
*On the day of our inspection there were no current leaks evident to the kitchen sink insert*

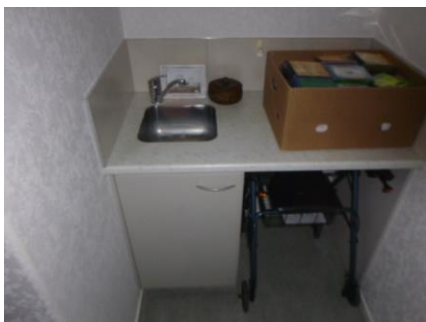
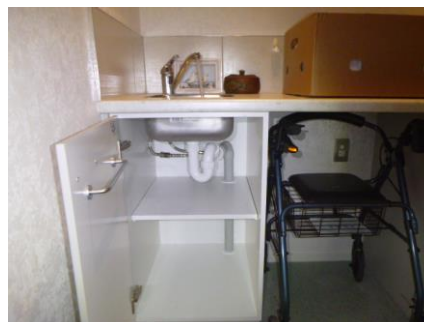
*There were no leaks to the entertainment room sink insert*
