## EQC Full Assessment Report

**Claim Number:** CLM/2011/102777  
**Claimant:** JASON SAIL  
**Property Address:** 26 HEMINGWAY PLACE  
 SPENCERVILLE  
 CHRISTCHURCH 8083

Our Ref: 170050

## **RESIDENTIAL ENGINEERING EVALUATION REPORT AND REPAIR METHODOLOGY FOR 26 HEMINGWAY PLACE, BROOKLANDS**

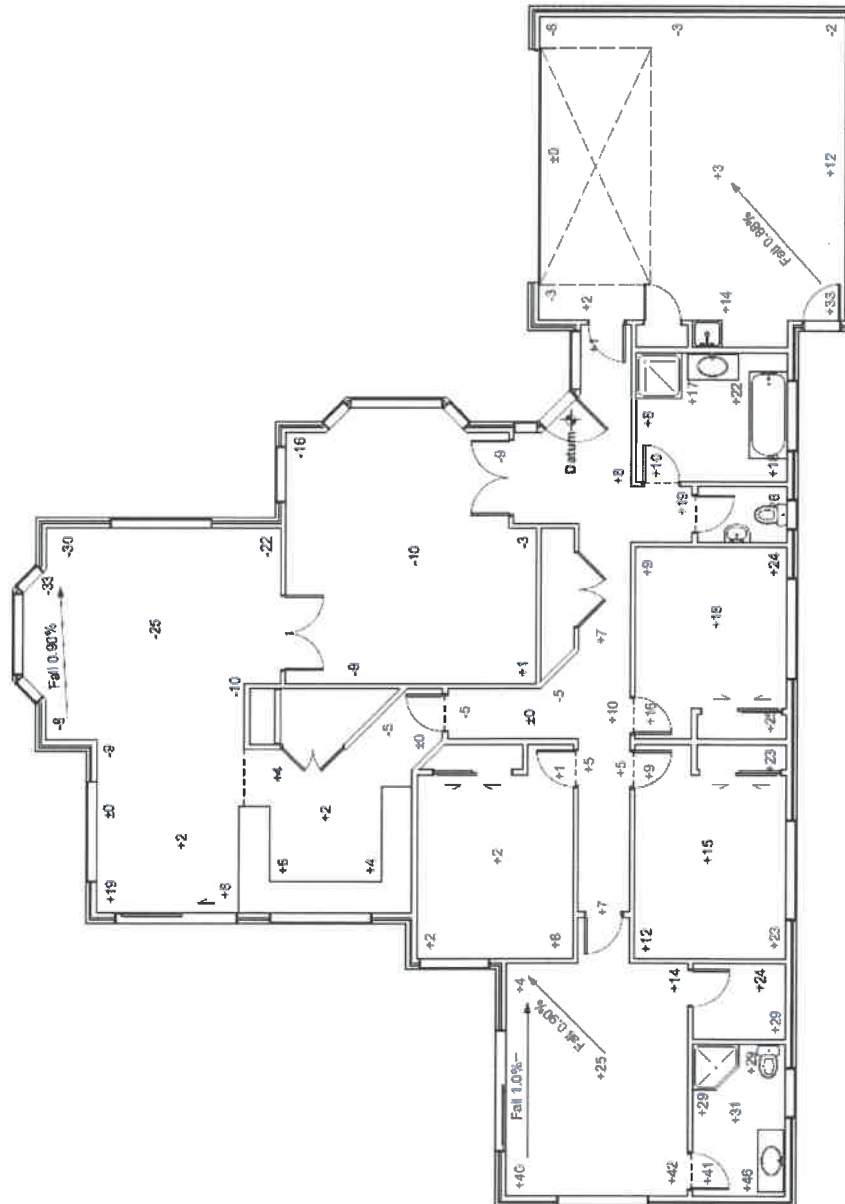
Figure 1: Floor Level Survey

The MBIE has guidance around floor levels which takes into consideration non-earthquake related settlement, construction tolerances and serviceability requirements. The guidance recommends that where total differential settlement over the floor plan is between 50 mm and 100 mm, re-levelling is required.

Considering the recorded floor levels and observed damage at the Concrete Floor Slab and Concrete Perimeter Foundation Beam, it is Frontier Engineers opinion that the Residential Building may be re-levelled in order to achieve acceptable floor slopes as required by the current New Zealand Building Code and the MBIE Guidance for Residential Buildings damaged by the Canterbury Earthquake Sequence.

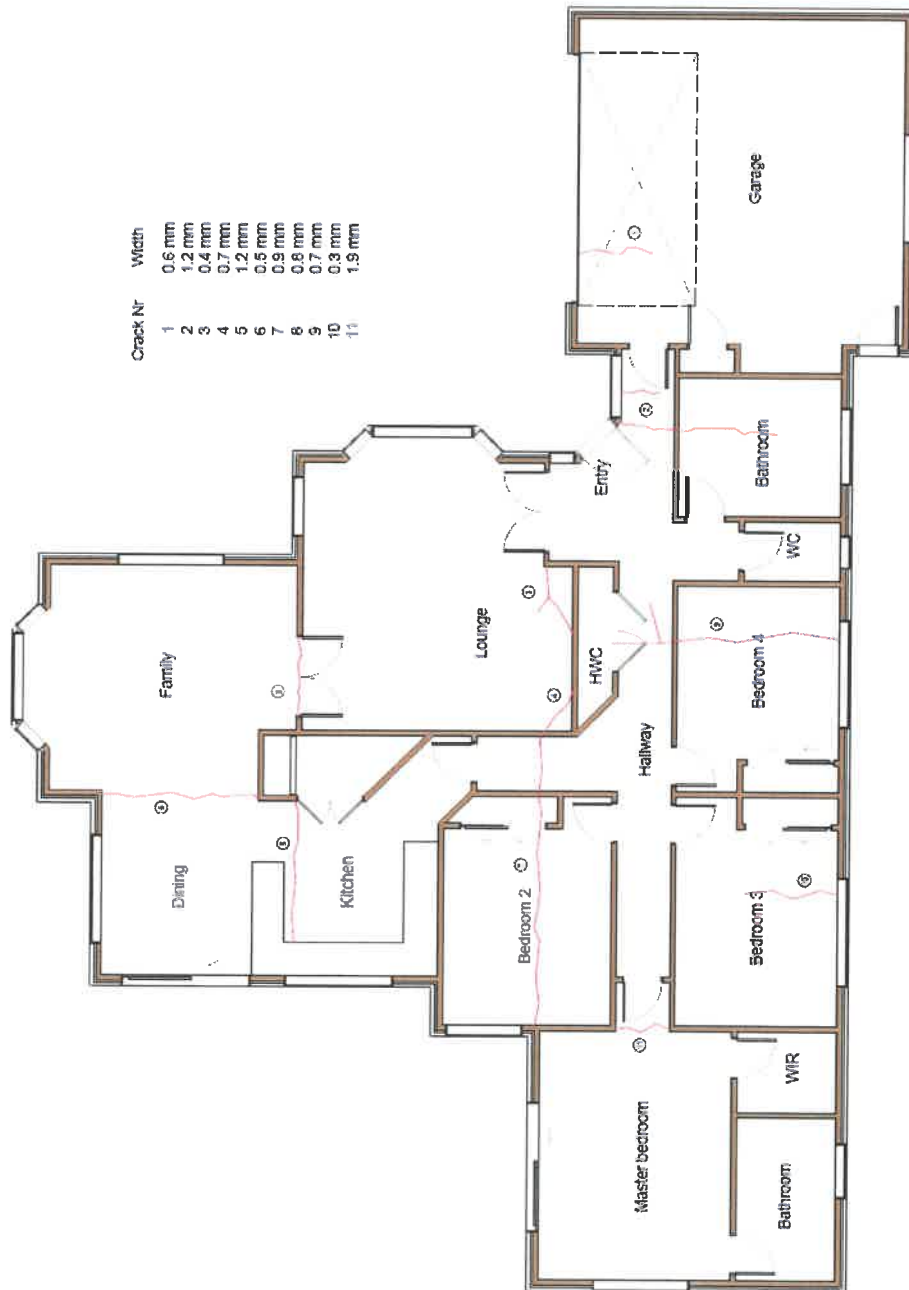
Figure 2: Crack Map

Cracks were recorded during the site inspection, most cracks were between 0.4 mm and 0.8 mm wide and typically originate from re-entrant corners. The maximum crack width recorded is 1.9 mm at the master bedroom. A floor plan indicating the recorded cracks is shown in Appendix 2. Due to the absence of adequate control joints, the extent and width of the cracks observed, it is Frontier Engineers opinion that the cracks are predominantly due to drying shrinkage of the irregularly shaped floor slab. It is likely that the cracks may have been exacerbated by the Canterbury Earthquake Sequence, but the crack widths and lack of super-structure damage indicates that exacerbation and widening of the cracks was minimal.

The maximum cumulative crack width recorded in any direction is 5.10 mm which is below the threshold of 20 mm as indicated by the MBIE Guidance for lateral stretch of a Concrete Foundation. Furthermore, the lateral stretch criteria is typically applied to the Concrete Perimeter Foundation Beam which, when observed from the exterior around the perimeter of the Residential Building, did not contain any noticeable cracks.

The perimeter Concrete foundation beam and floor slab are not damaged to an extent that could limit re-levelling

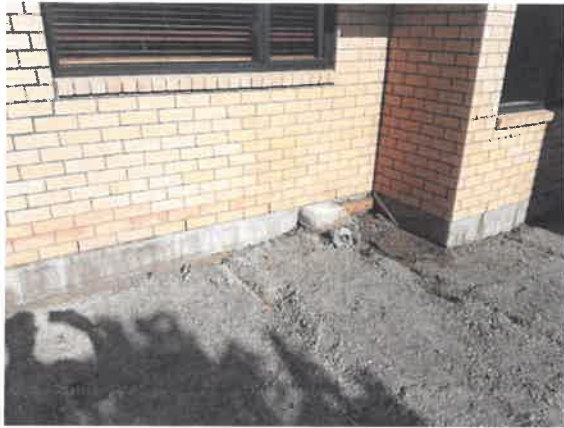
**Photo 1: Typical Concrete Perimeter**

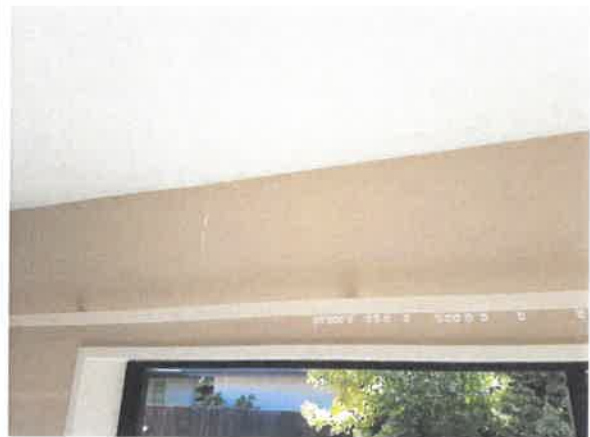
The verticality of walls were recorded and found to be within construction tolerance except for one garage wall at the Northern elevation and the dining room wall at the western elevation. The recorded verticality of 8 mm/m and 7 mm/m is not a structural concern and does not indicate that the lateral bracing capacity of the Residential Building is compromised. No pattern of racking or creasing in the corners of joining walls and ceilings was noted that would indicate that the ability of the Residential Building to withstand a future seismic event is reduced.

**Photo 2: Typical damage at internal lining damage**

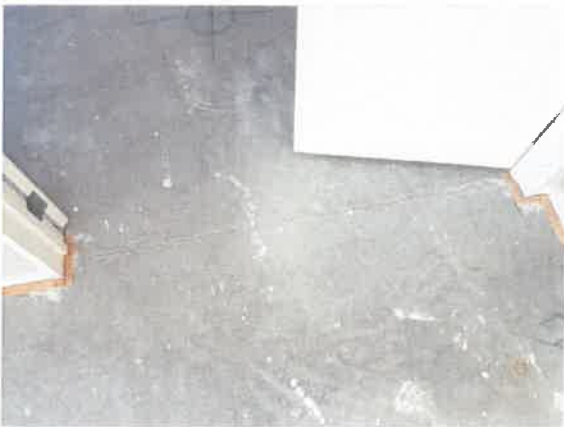
**Photo 3: Typical crack originating at re-entrant corners**

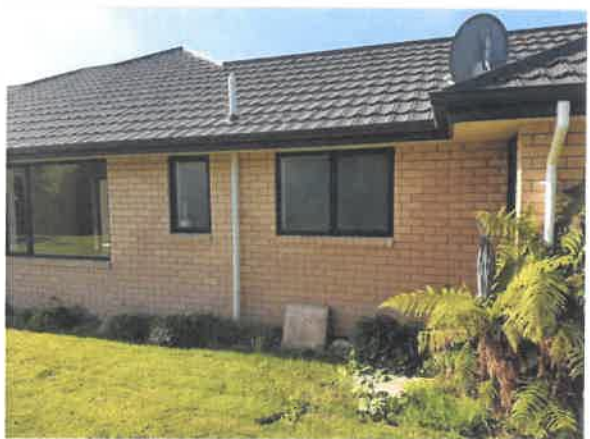
The roof is in a good structural condition as no deflection of the ridgeline or variable slopes in the gutter and valleys was noted. The roof cladding was not loose and downpipes appeared in working order.

**Photo 4: Roof in good condition**
