Weir Property Inspections Building Survey Report

Client Name:	Regan Alexander-Stevens.
Client Address:	7 Adam's Place Chch
Client Phone Number:	0223970784
Date of inspection:	June 10, 2021
Inspection address:	311 Main South Rd Chch.
Scope of inspection:	Pre-purchase inspection.
Report number:	2021/0009-06.

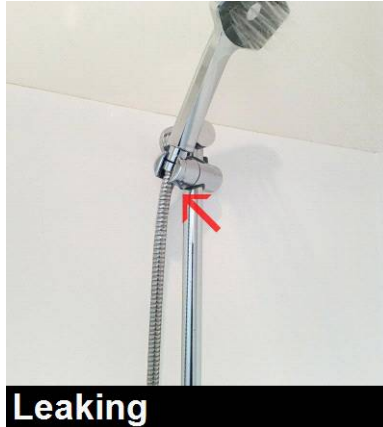
<i>Doors (Internal):</i>	Hollow core. Frames, material type. Painted. Material type unknown.
<i>Vanity:</i>	Melamine.
<i>Basin:</i>	Vanity mounted. Porcelain. Wall junction seal present. Yes.
<i>Basin Tap/Faucet:</i>	Working. No signs of any current leaking.
<i>Toilet:</i>	Toilet type. Floor mounted. "P" trap. Capacity. 4.5 litres. Dual flush. This toilet was flushed twice and was operating.
<i>Shower Flow. (This is the opinion of the Inspector only)</i>	Good flow rate.
<i>Shower Taps/Mixer and Rose:</i>	The rose hose is leaking and requires repair or replacement. This can be further assessed by a plumber.

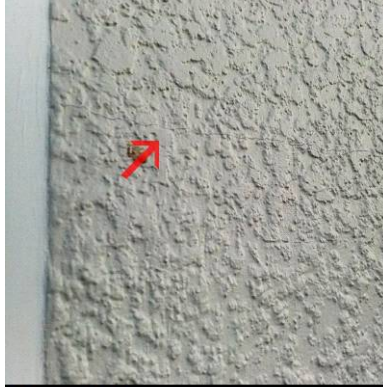
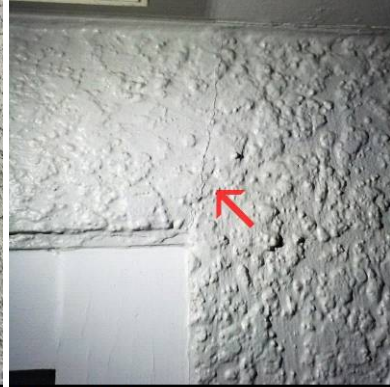
Solid plaster. There are cracks in the exterior cladding, which need to be professionally repaired, as any cracks can allow moisture in behind the cladding and into the internal framing.

Cracking

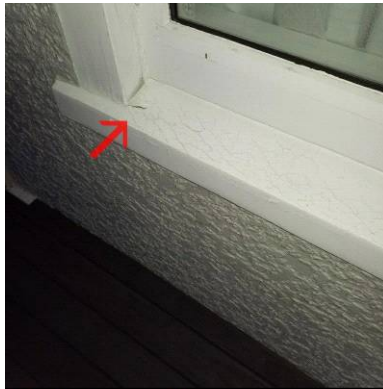
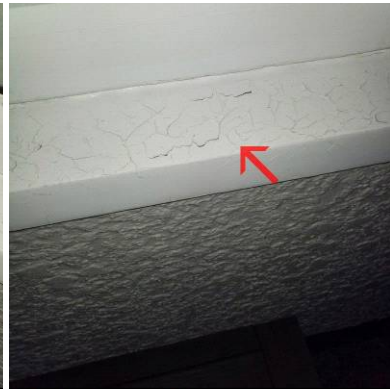
Timber and glass. Paint is peeling in places, and the joinery can be sanded back and re-painted.

Paint peeling

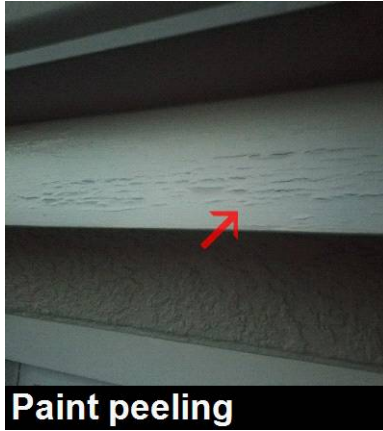
Timber. Paint is peeling and the fascia can be sanded back and re-painted.

Paint peeling

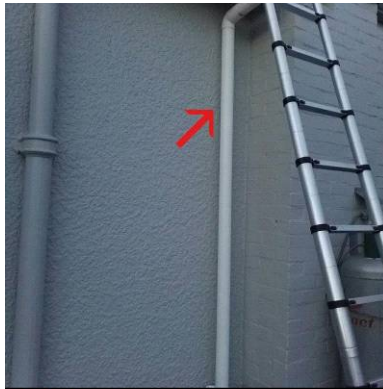
The spouting is full of debris and requires clearing to allow water to drain freely. Some downpipe brackets need to be re-fixed and the holes sealed.

Fit brackets

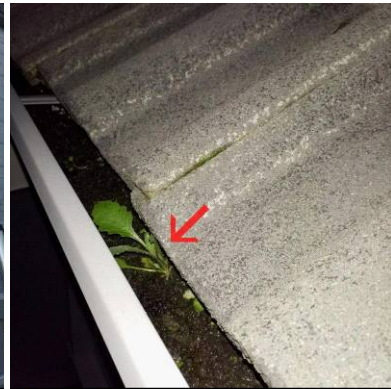
Debris

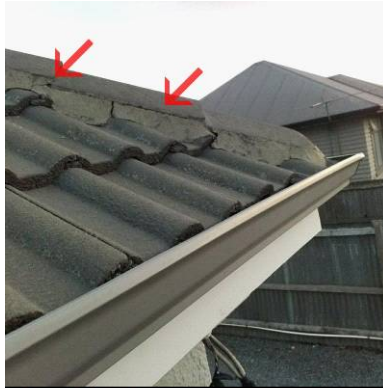
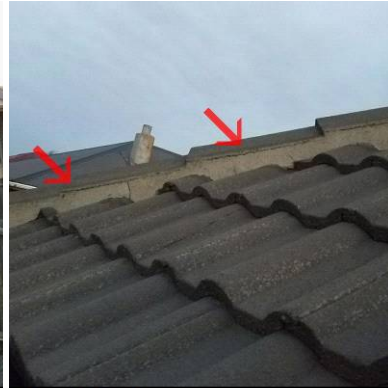
Seal ridge

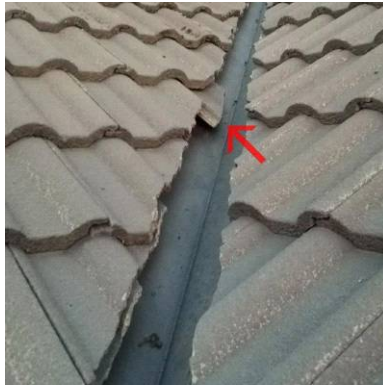
The roof tiles are beginning to slip in some areas and require re-positioning. The ridge capping on the roof should be kept well sealed.

Tiles slipping

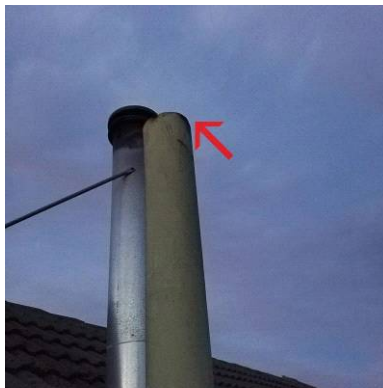
Metal. The cap is missing off the top, and one can be re-fitted to prevent moisture or pests getting in.

Cap missing

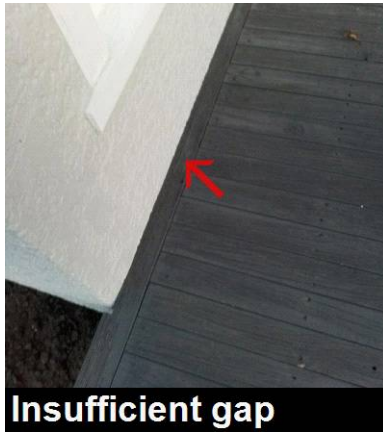
<i>Location:</i>	Front right.
<i>Framing:</i>	Timber.
<i>Decking:</i>	Timber. This is an older Deck and while there was no evident rot damage at the time of the inspection, some deterioration would be expected due to its age. This may become apparent with time. As the decking is painted, the detection of defects can be more difficult.
<i>Steps:</i>	Timber.
<i>Fixings:</i>	The fixings appear to be sufficient for the age of the Deck.
<i>Threshold Step:</i>	It is our opinion that it is satisfactory for the construction type and age of this Deck.
<i>Cladding Clearance:</i>	There is insufficient gap between the cladding and decking, which is not recommended, as it can cause damage to the cladding and allow water to become trapped at this junction. We recommend the decking be trimmed back to create the recommended gap.

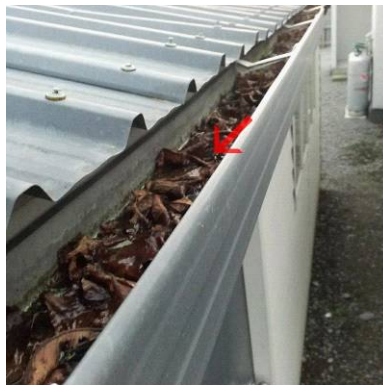
PVC. Colour steel. The spouting is full of debris and requires clearing to allow water to drain freely.

Debris

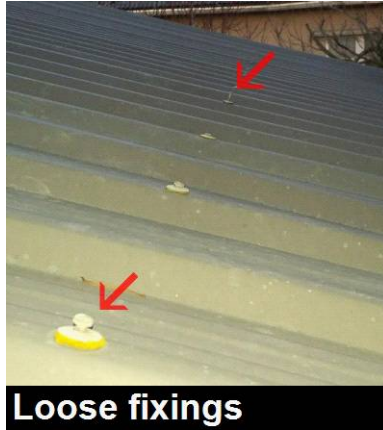
Profiled Pre-finished paint coated steel. Pitch of roof. 10 degrees. There are some loose or damaged fixings that should be pulled and replaced.

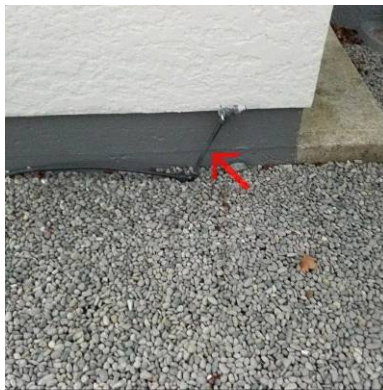
<i>Contour:</i>	Flat site.
<i>Site and Vegetation:</i>	Established.
<i>Paths and Patios:</i>	Paver/tile. Gravel.
<i>Exterior Steps and Hand Rails:</i>	Concrete. Timber.
<i>Driveway:</i>	Gravel. The drive is a shared drive and any repairing liability should be established.
<i>Fencing:</i>	Timber. Metal. Approximately. 1.8m.
<i>Surface Water Control:</i>	No indication of site drainage issues.
<i>Letterbox</i>	Metal.
<i>Gully Traps</i>	Location. Back of home. The drains appear to be old earthenware pipes and the only way to assess their condition is with the use of a CCTV camera.
<i>Taps</i>	Two. Exposed plastic plumbing should be protected from UV light.

Exposed pipe

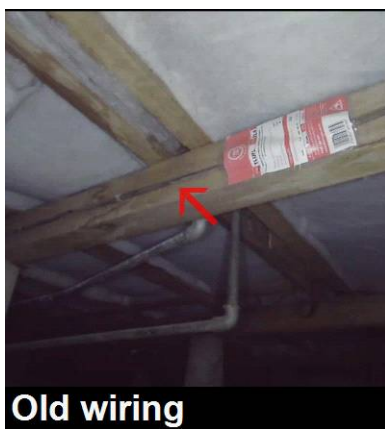
Older wiring. We recommend a registered Electrician inspect this wiring to determine its use and condition.

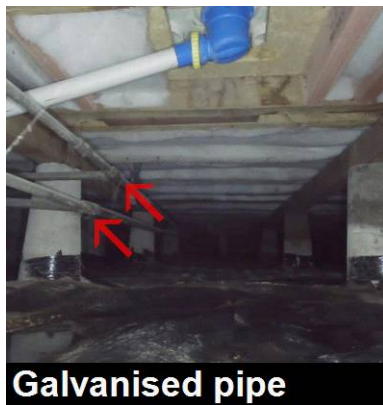
PVC. Galvanised plumbing has been identified within the foundations space. This type of plumbing is quite old and corrodes internally, which can be difficult to detect and consideration should be given to replacing it.

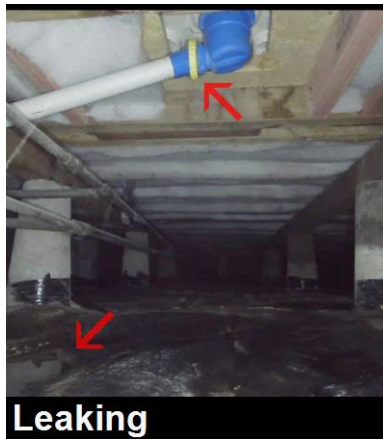
There is evidence of leaking wastes that should be inspected and repaired as necessary by a registered Plumber.
