Geotechnical Investigation for Proposed Subdivision

550 Birchs Road
Lincoln 7672

16.03.2015
11896.000.000/01

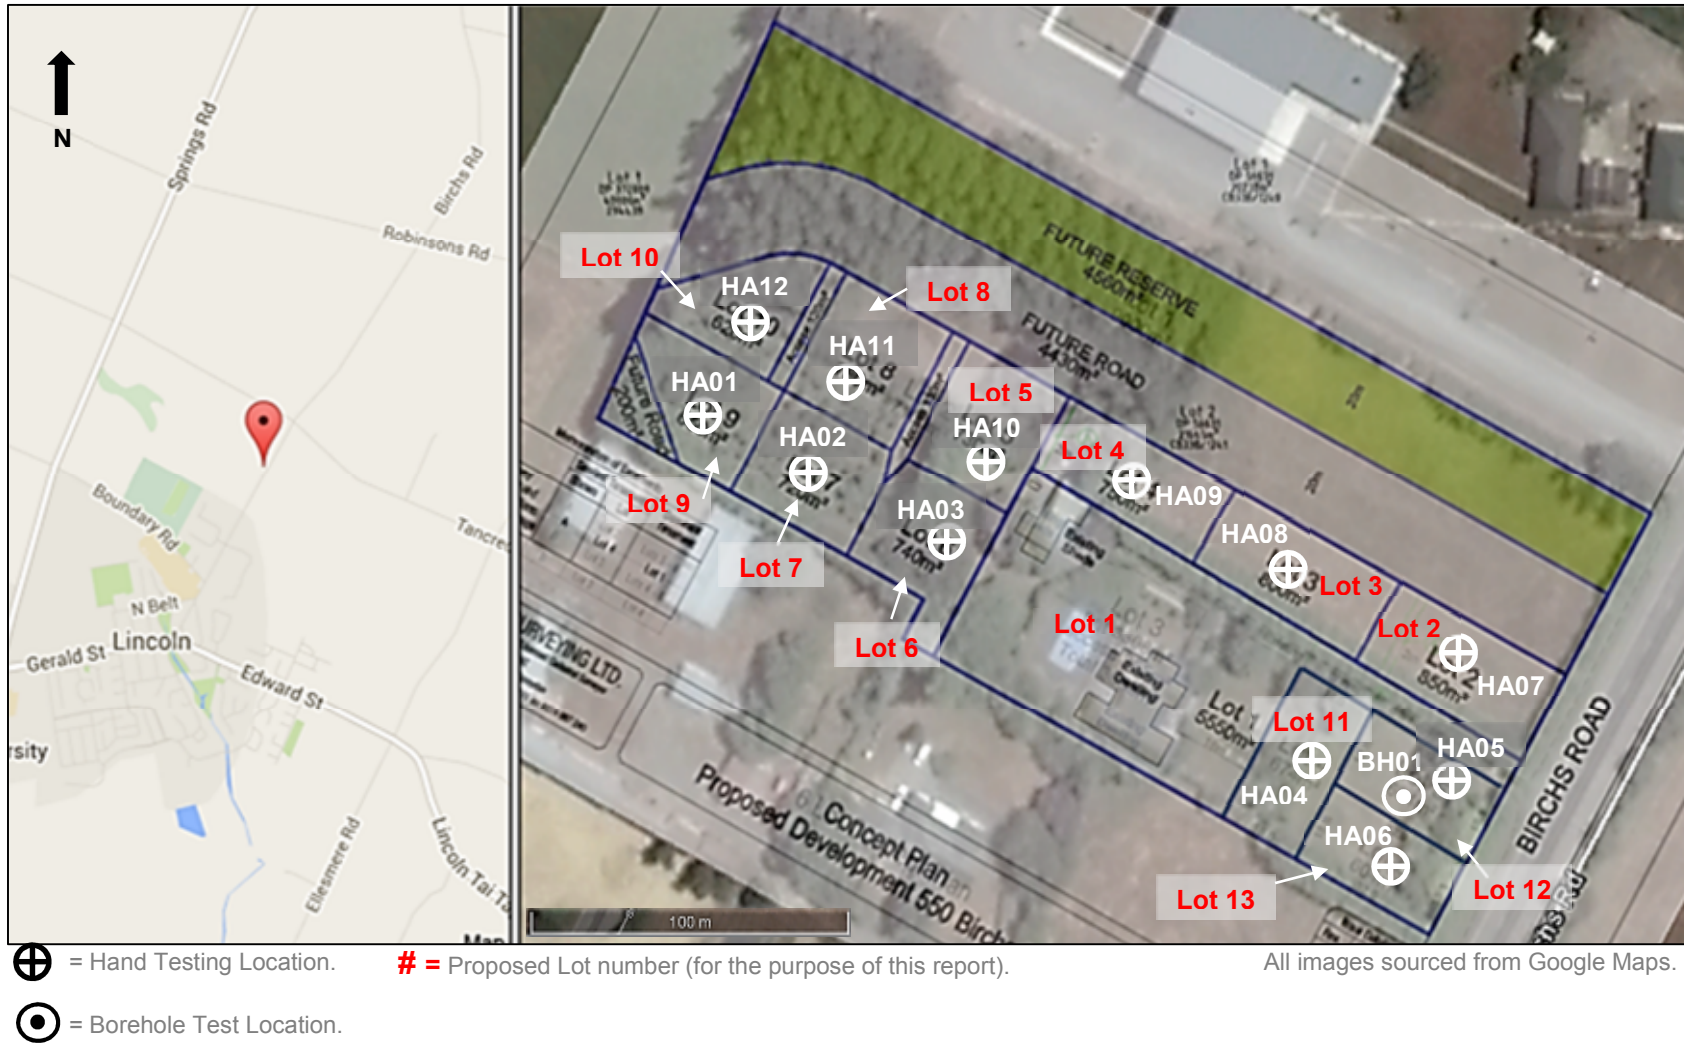
Figure 1: Site Location Plan and Investigation Locations

The site is located in Lincoln, on a relatively flat section of 21,645 m² (Figure 1). The north-western and western parts of the site are predominantly vegetated land with a walnut orchid in the western corner and an area of Eucalyptus trees in the northwest, the eastern part of the site is predominantly grassed paddock land, and the south-eastern and central part of the site is a predominantly residential area containing a dwelling, swimming pool, grassed tennis court and garage. It is bound to the southeast by Birchs Road, to the southwest by a rural residential lot, to the northwest by a rural lot and to the northeast by the Lincoln Baptist Church site.

Your Structural Engineer may have alternative options capable of tolerating the settlements anticipated for this site. Specific lot and test locations are shown in Figure 1, lot locations in figure 1 are purely for the purpose of this report.

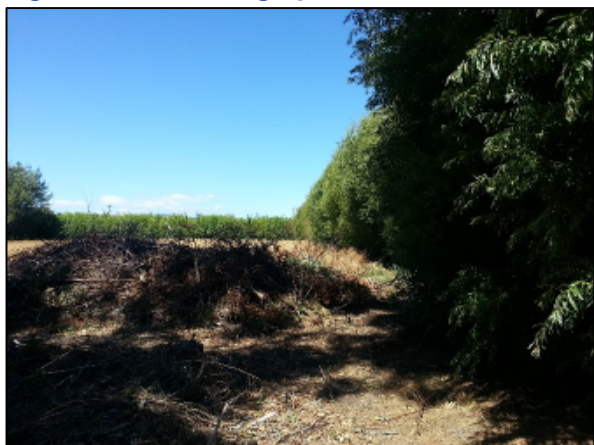
Photo 1: View towards the southeast of proposed Lots 2, 3 & 4.

We recommend a NZS 3604:2011 concrete slab foundation designed to bear on “good ground” below topsoil (0.3 m depth in hand auger borehole HA07).

We recommend a NZS 3604:2011 concrete slab foundation designed to bear on “good ground” below topsoil (0.4 m depth in hand auger borehole HA08).

We recommend that a NZS 3604:2011 concrete slab foundation designed to bear on “good ground” below topsoil (0.3 m depth in hand auger borehole HA09).

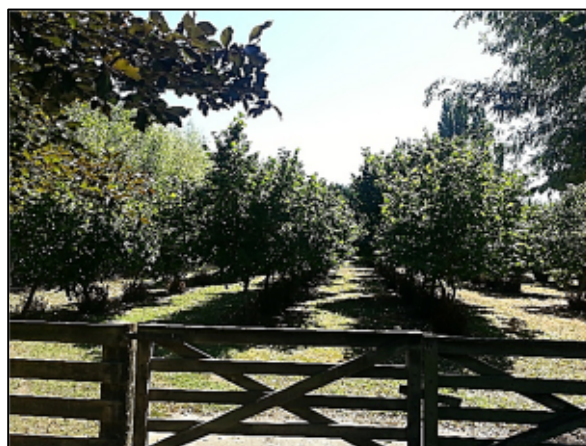
Photo 2: View towards the northwest of the current walnut orchard and proposed Lots 7, 8, 9 & 10.

We recommend a NZS 3604:2011 concrete slab foundation specifically designed to bear on natural ground below topsoil (0.3 m depth in hand auger borehole HA02) assuming a geotechnical Ultimate Bearing Capacity of 300 kPa.

We recommend that a NZS 3604:2011 concrete slab foundation designed to bear on “good ground” below topsoil (0.4 m depth in hand auger borehole HA11).

We recommend that a NZS 3604:2011 concrete slab foundation designed to bear on “good ground” below topsoil (0.4 m depth in hand auger borehole HA01).

We recommend that a NZS 3604:2011 concrete slab foundation designed to bear on “good ground” below topsoil (0.3 m depth in hand auger borehole HA12).

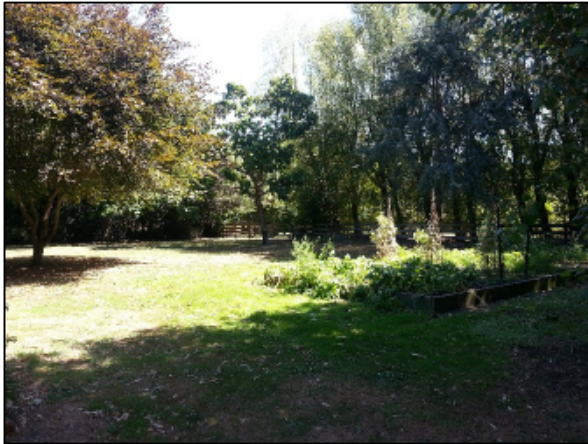
Photo 3: View towards the southwest of proposed Lots 5 & 6.

We recommend a NZS 3604:2011 concrete slab foundation designed to bear on “good ground” below topsoil (0.4 m depth in hand auger borehole HA10).

We recommend a NZS 3604:2011 concrete slab foundation designed to bear on “good ground” below topsoil (0.5 m depth in hand auger borehole HA03).

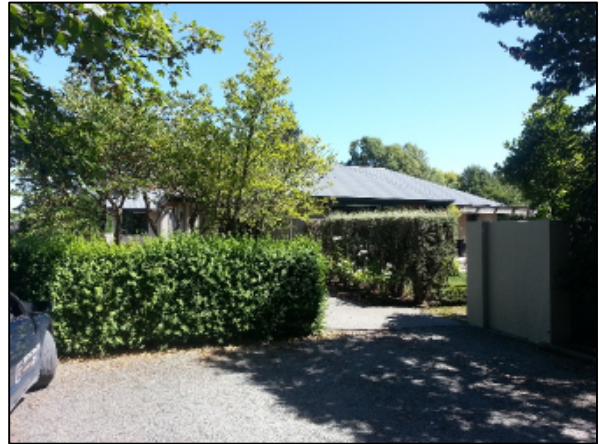
Photo 4: View towards the southwest of the current dwelling located in the central southern part of the site.
