# Property Inspection Report

**- Habit Christchurch Limited -**

***6 Woodleigh Lane, Prebbleton***

***Prepared for: Wayne and Jacinta Gardner.***

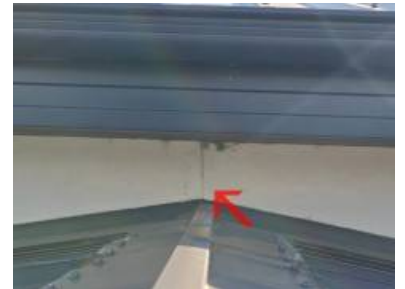
Plaster above roof has been damaged, probably done during construction, suggest repair here.

This fault does not affect weathertightness as eaves is covering over the area, cosmetic only.

This is how it is supposed to look like, on the opposite side of the house.

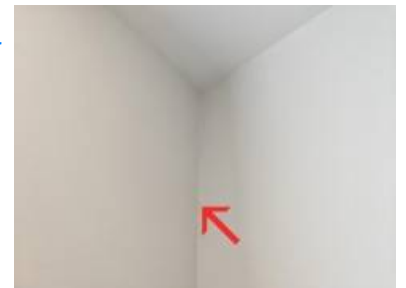
*Internal Ceiling & Wall Linings:* Base linings intact, good condition. Hairline crack to wall lining joint, can gap fill and paint, or leave it alone as it's cosmetic.

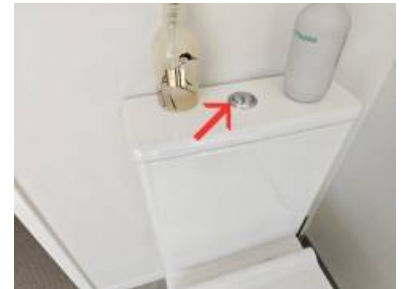
The toilet is consistently running when it's nearly filled up for around 20 seconds, this suggest a faulty flapper that doesn't seal, suggest plumber to repair.

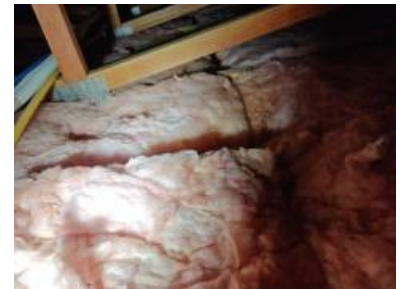
Fibreglass or wool batts. Insulation in reasonable condition and thickness (Over 120mm), has reduced in thickness over time. Still in place, reasonably tidy.
