# BUILDING INSPECTION REPORT

11 Jun 2026 / 4 Wherstead Rd

## Pre-Purchase/Sale Visual Non-Invasive Property Inspection

Eye Spy Property Inspections  
Pre sale building report  
4 Wherstead Rd, Cashmere

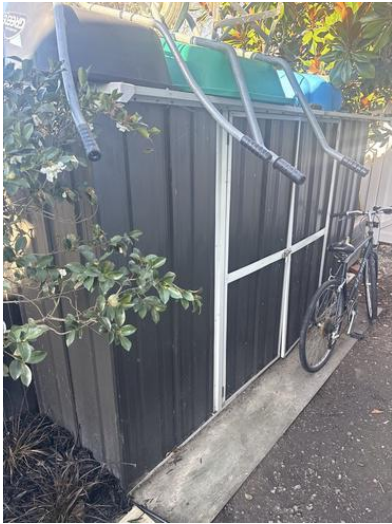
Photo 14

Detached steel garden shed

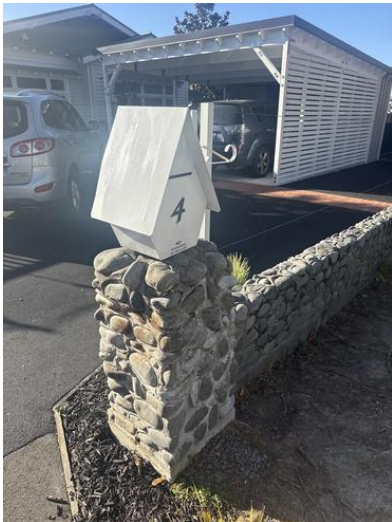
Photo 15

Appears in sound usable condition

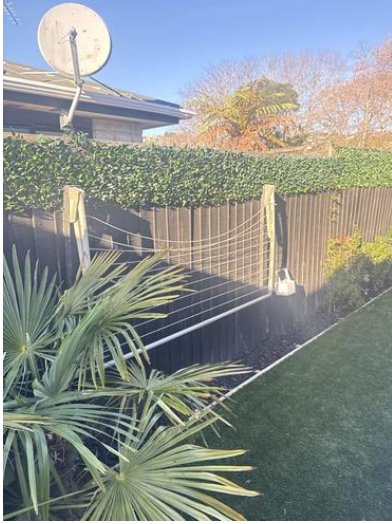
Photo 16

Appears in sound usable condition

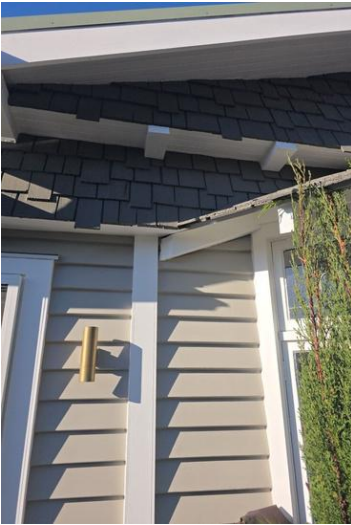
Photo 33

The painted timber weatherboard appears to be in generally sound condition, which is typical for its age.  
1: The pipe penetration requires sealing.  
2: Several borer holes necessitate treatment and filling, in addition to some paint finishing.

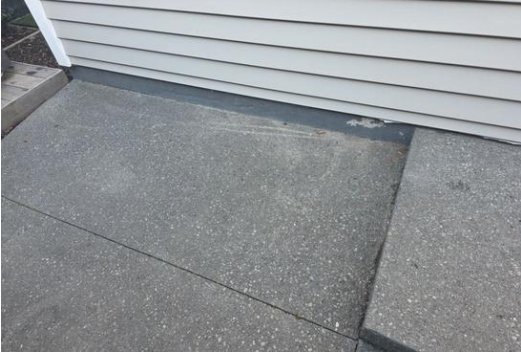
Photo 42

Concrete ring foundation. Visible sections appear generally sound, with no significant visible cracking or movement. Some minor cracking typical for age

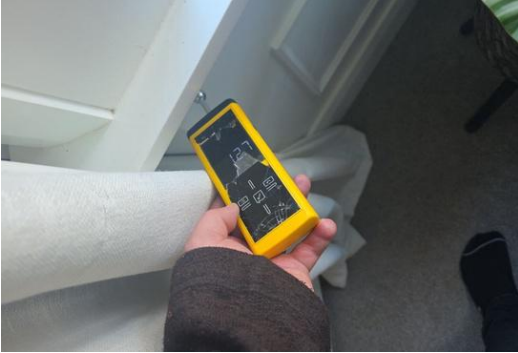
Photo 81

Tested low at the time of the inspection

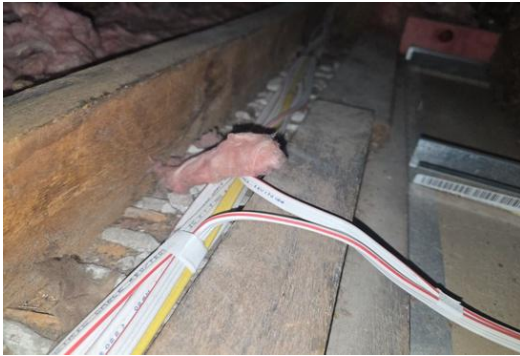
Photo 111

This is a pitched roof with timber rafters and joists

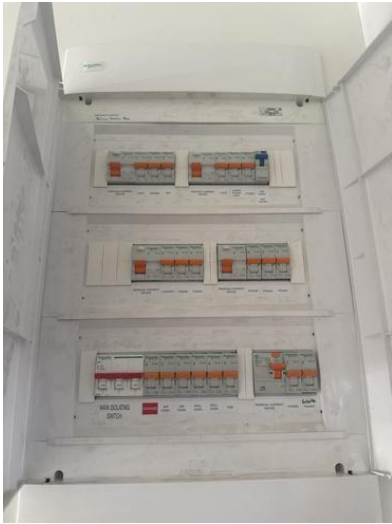
Photo 115

Switchboard in hallway has mini circuit breakers. Power was on at the time of the inspection

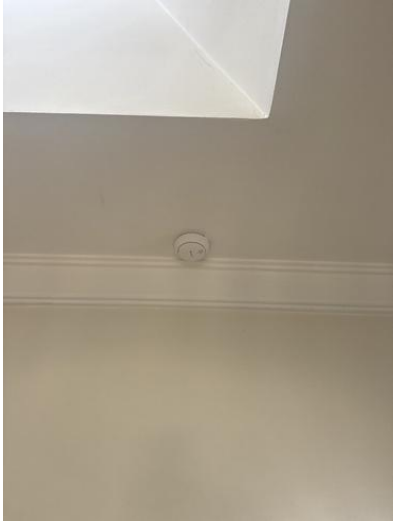
Photo 116

Battery powered  
 Not tested  
 Within 3m of bedrooms
