# Property Inspection Report

**- Habit Christchurch Limited -**

***24 Edward Law Boulevard, Prebbleton***

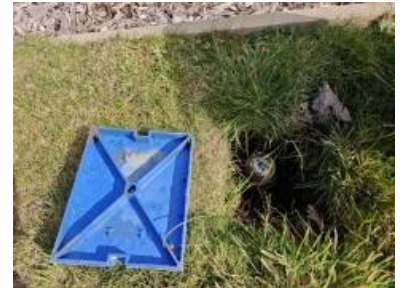
*Main Water Supply, On/Off Control:*

Road side area, no leaks evident.

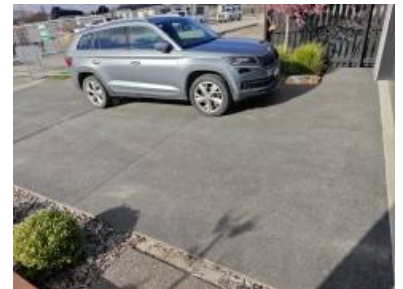
*Driveway:*

Exposed aggregate concrete, Driveway in good condition. Drainage installed in the driveway. Good fall on the surface for drainage.

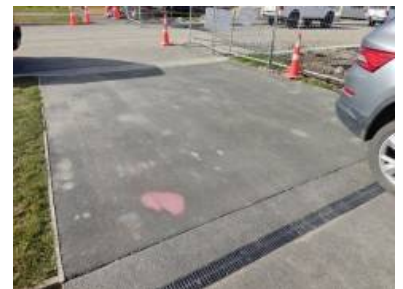
*Driveway 2:*

Asphalt, Driveway in reasonable condition. Good fall on the surface for drainage. Council property.

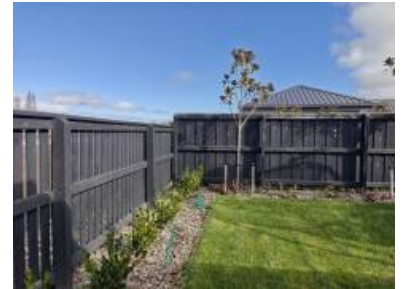
*Fencing General:*

Timber, Fence material in good condition.  
Fence height: Up to 1.8 Metre

Suggest make fence paling 1.8m height by  
clothesline area.

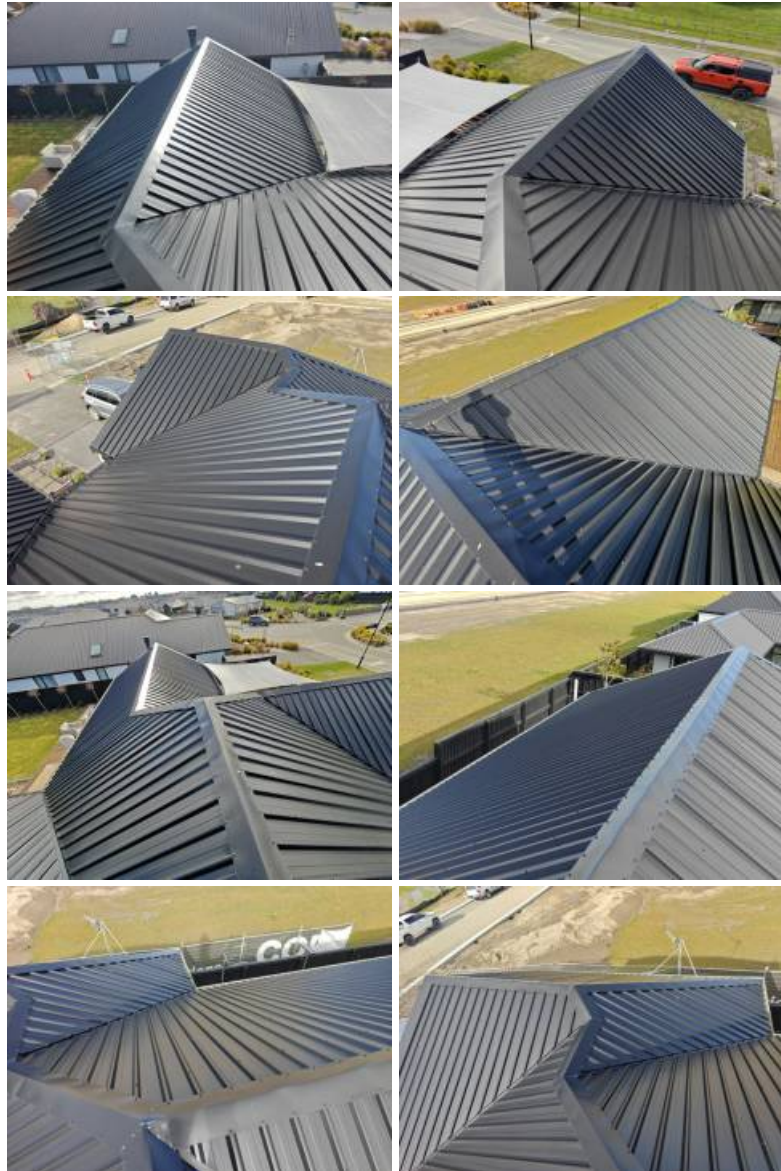
*Main Roof Cladding:*

Colour steel long run iron, Surface finish: Good condition.

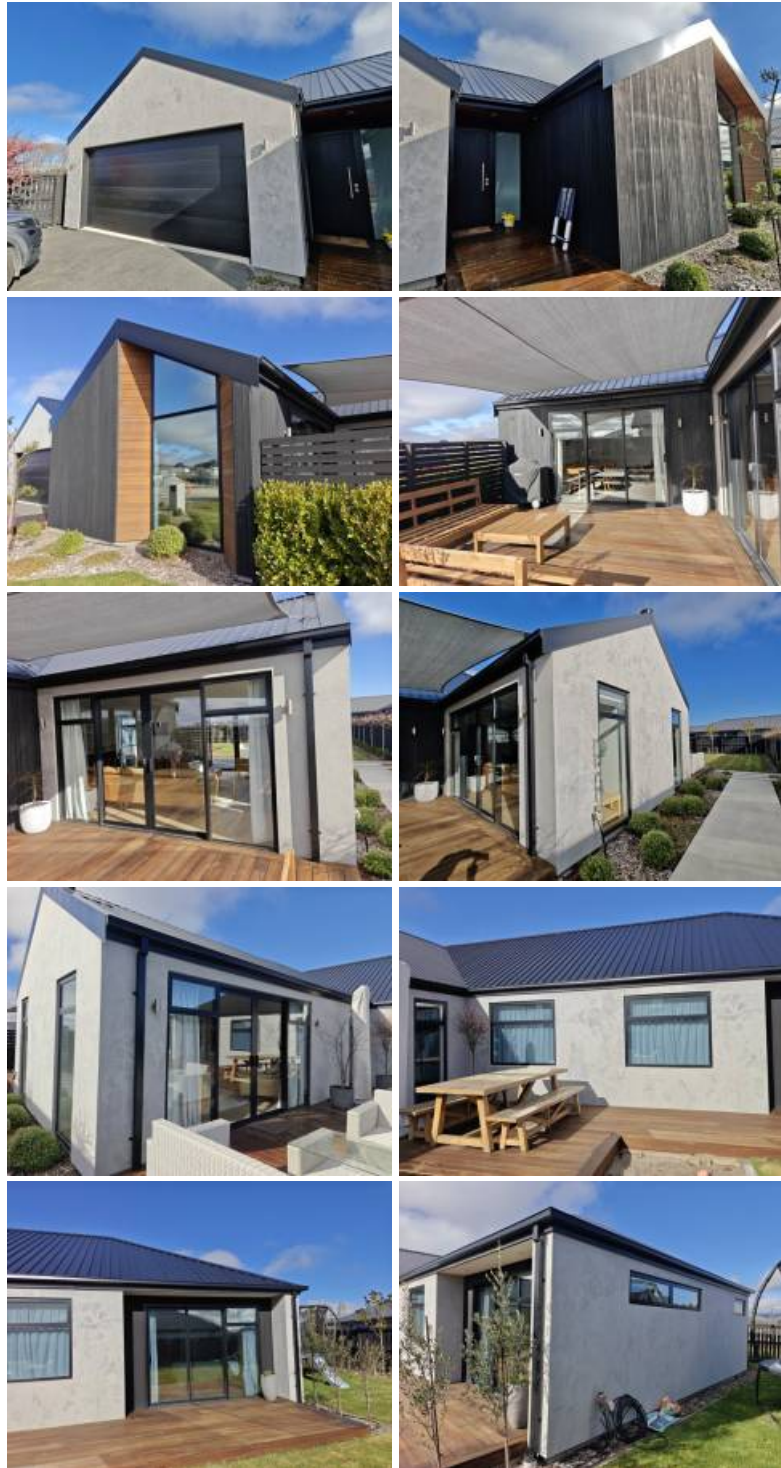
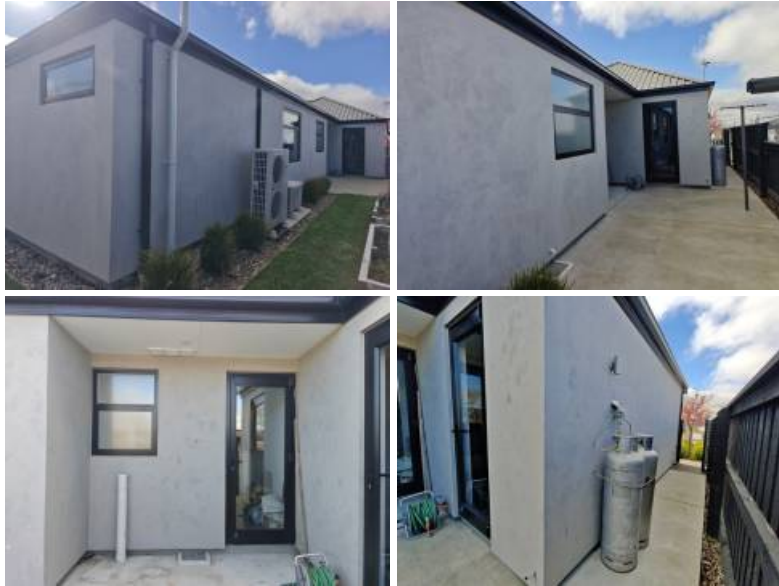
*External Wall Cladding:*

Architectural concrete-finish plaster system over AAC panel. Surface finish in good condition.

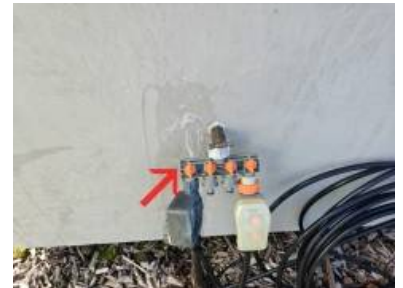
*Exterior Taps:*

Tested, working, 4 way tap is faulty, suggest replacement.

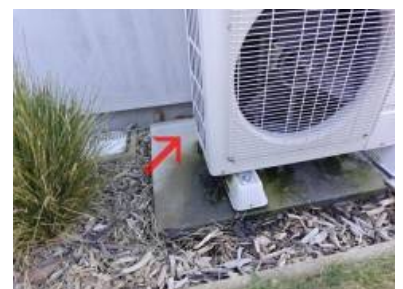
*Heat Pump:*

Securely installed.

Suggest install a condensation pipe and feed it to the waste trap nearby.

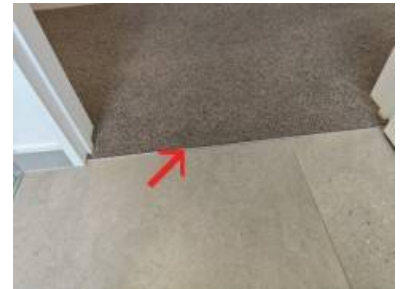
*Floor Covering:*

Tiled, Good condition.

Maintenance task: Toes can easily get hurt while walking onto tiles, suggest carpet to be ramped up to match level of tiles, a carpet layer can install this. Applies to all tiled areas with carpet transition.

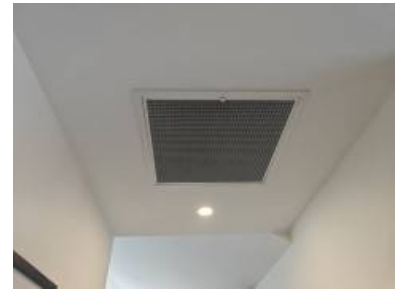
*Heating:*

Central heating system installed, Central heating return vent installed, suggest clean filter annually.

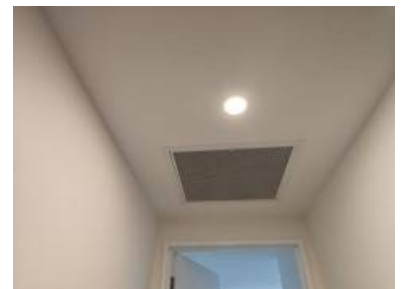
Central heating system installed, Central heating return vent installed, suggest clean filter annually.

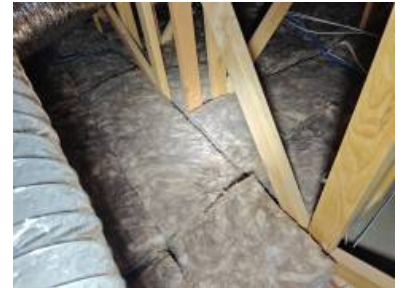
*Insulation:*

Fibreglass or wool batts. Insulation in reasonable condition and thickness (Over 120mm), has reduced in thickness over time. Still in place, reasonably tidy.

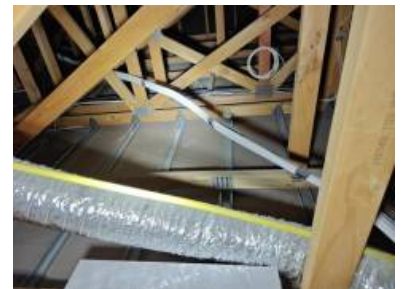
No insulation installed over garage area, this is not a current building code requirement.

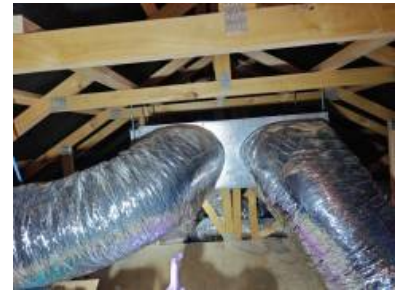
Central heating installed, reasonable condition.
