Information request – CLM/2011/147051 - 7 Rollesby Street, Hoon Hay, Christchurch 8025

Subject: 7 Rollesby Street, Hoon Hay, Christchurch 8025
Project Number: 160520

ENGINEERING DESIGN 7 ROLLESBY STREET, HOON HAY, CHRISTCHURCH 8025

Increased Liquefaction Vulnerability (ILV) Engineering Assessment

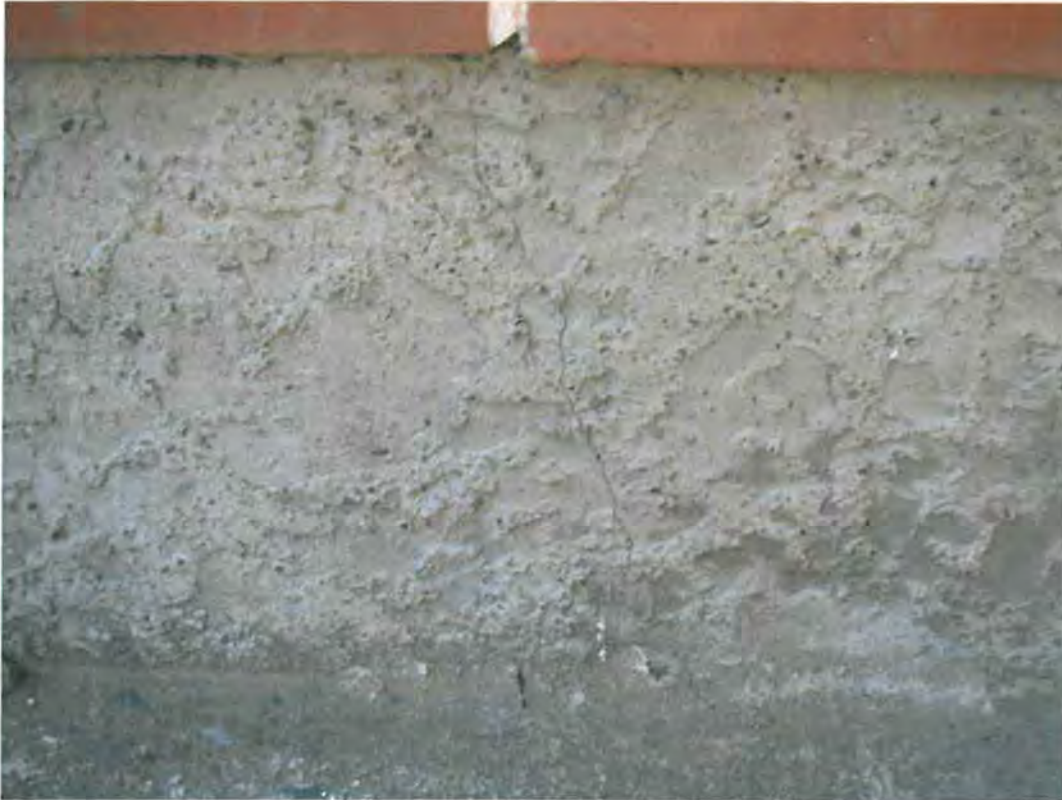
Photo 1: Crack on concrete perimeter foundation wall

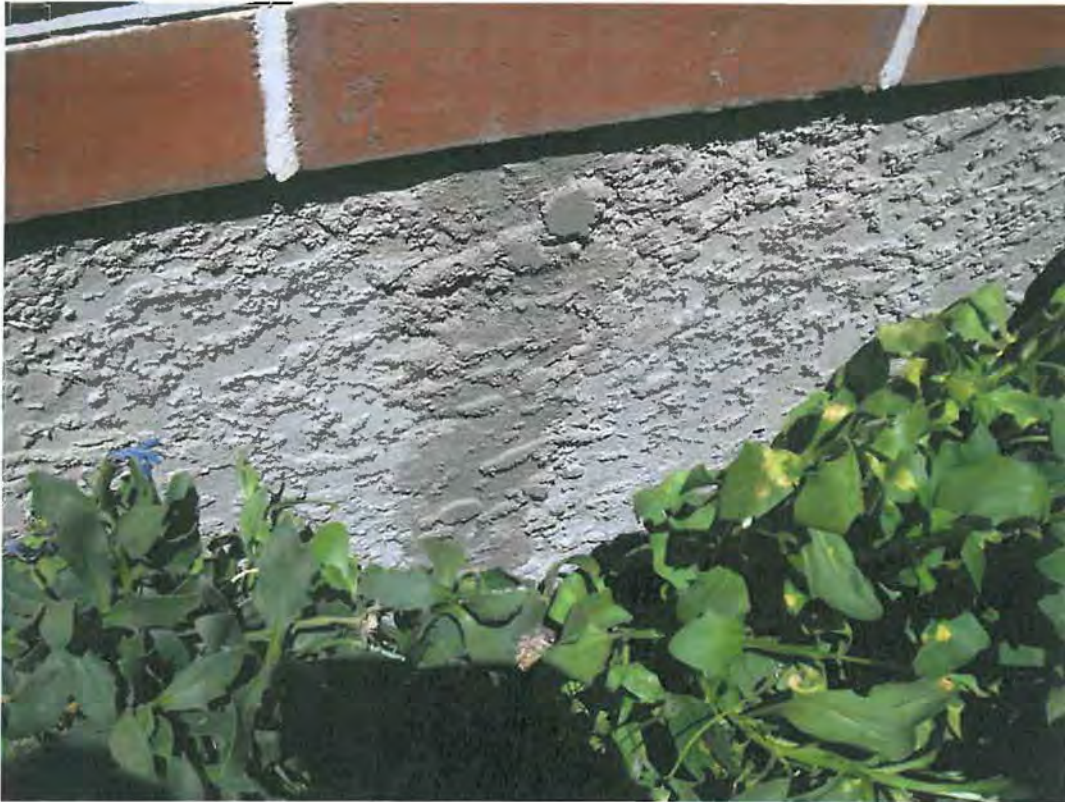
Photo 2: Plaster over repaired crack

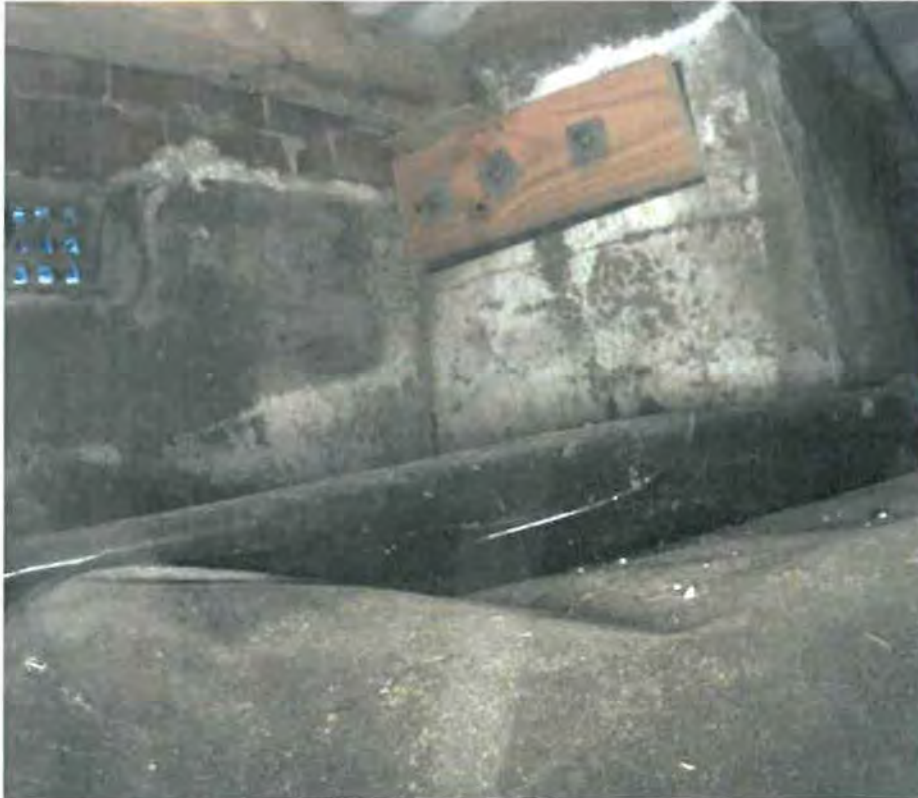
Photo 4: Packer not fixed to bearer and bearer supported by wall plate

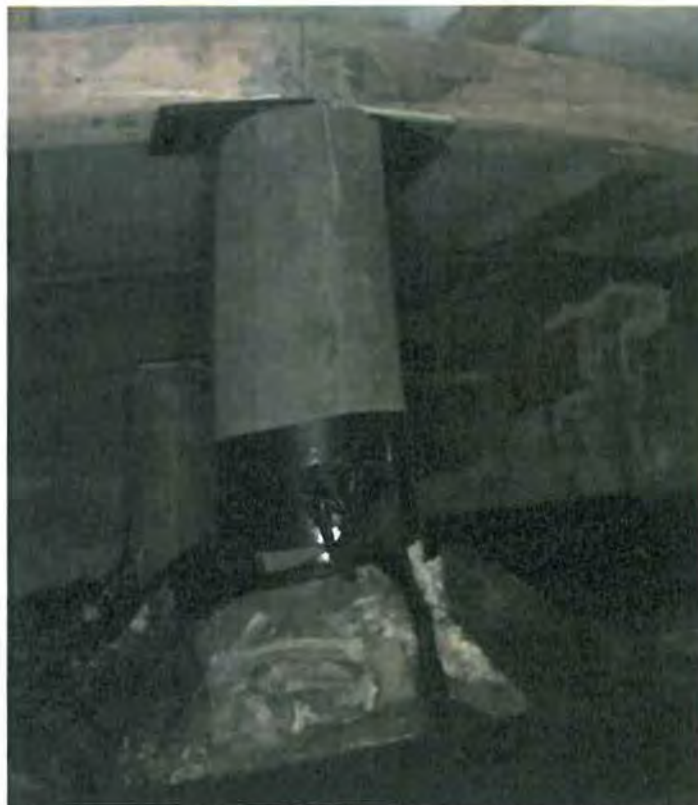
Photo 5: Packer and fixings not as per FEQR detail

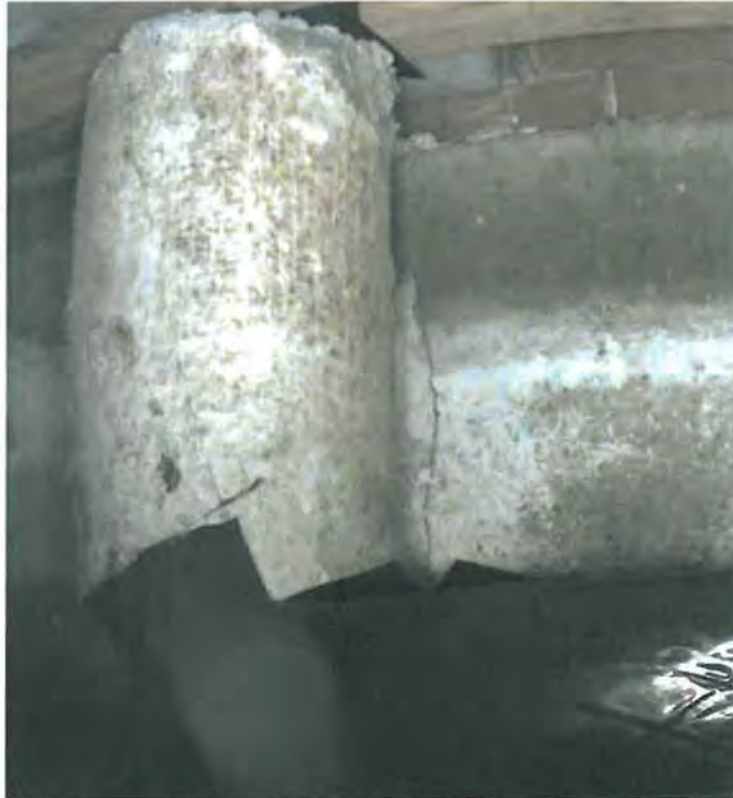
Photo 6: Concrete on inside face of concrete perimeter foundation wall
