# Building Inspection Report

## RESIDENTIAL INSPECTION

7 Palmside St  
Christchurch, Canterbury Region 8024

30/06/2025

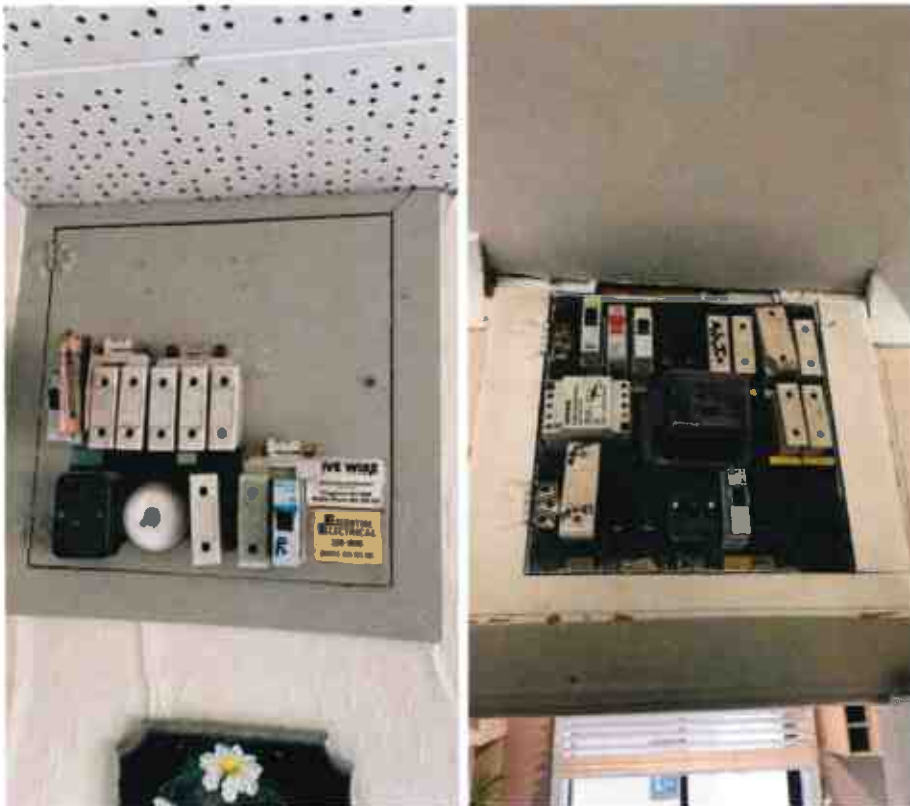
Older-style rewirable fuses are still in use at the switchboard.

It is recommended that these be replaced with modern circuit breakers by a licensed electrician to improve safety and compliance with current electrical standards.

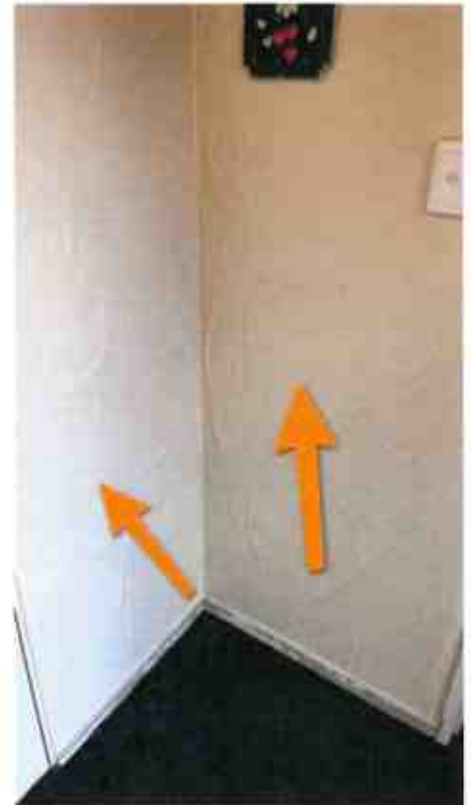
**WEAR IN WALL PAPER**

Wear or peeling of wall paper is occurring in areas. The wallpaper can be repaired if desired

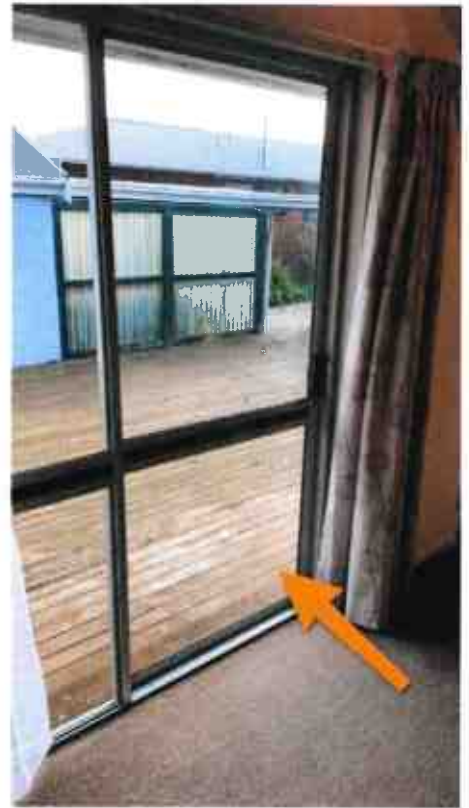
**ALUMINIUM BINDING**

The sliding door is binding and requires adjusting or repair to operate as designed

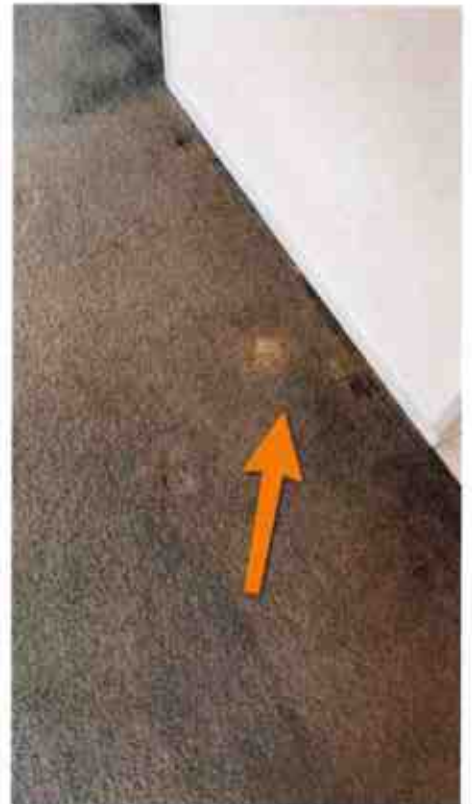
5.6.1 Floors

**MOISTURE DAMAGE TO FLOOR COVERING**

The flooring to the highlighted area has localised damage due to moisture. Repair or replacement to this area can be made if desired

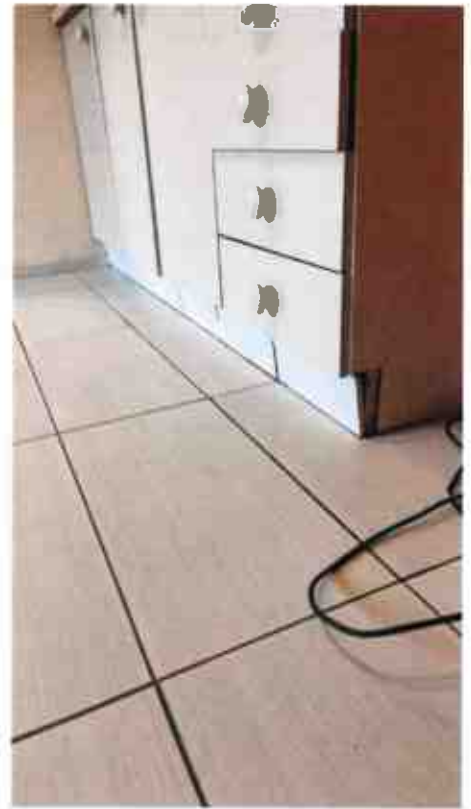
5.6.2 Floors

**TILED KICKBOARD LOOSE**

The tiled kickboard is loose and requires repair or replacement

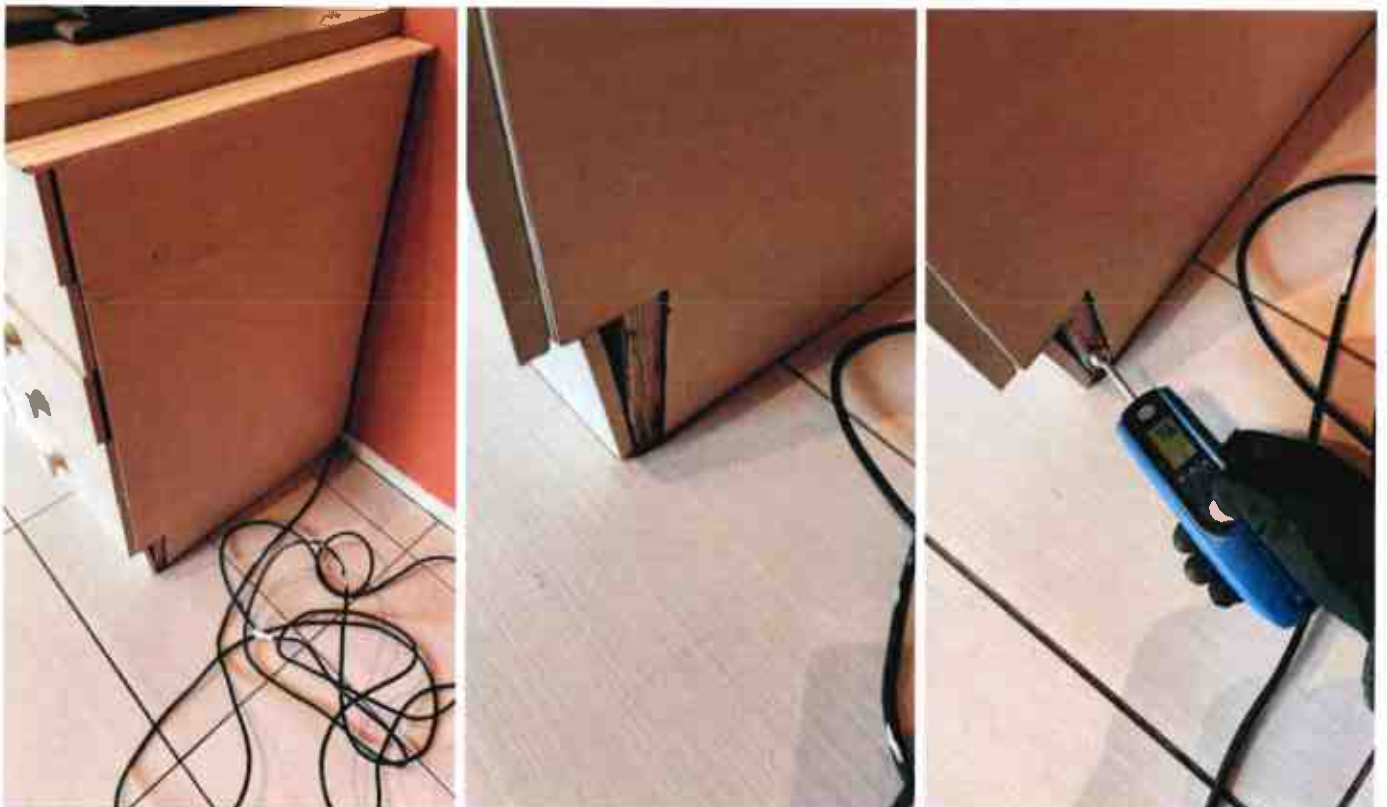
5.8.1 Bench Top/ Cabinetry

**DAMAGE TO CABINETS**

Damage to this cabinetry panel was observed. Localised repair to these areas can be made by a kitchen joiner

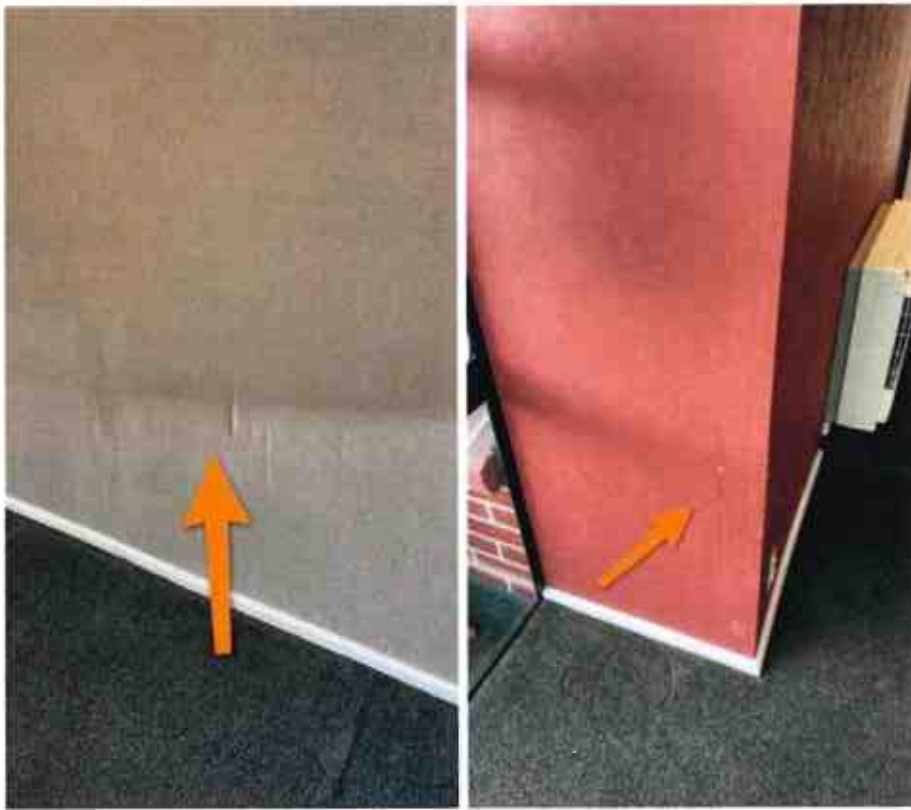
Wear or peeling of wall paper in areas. Repair can be made if desired

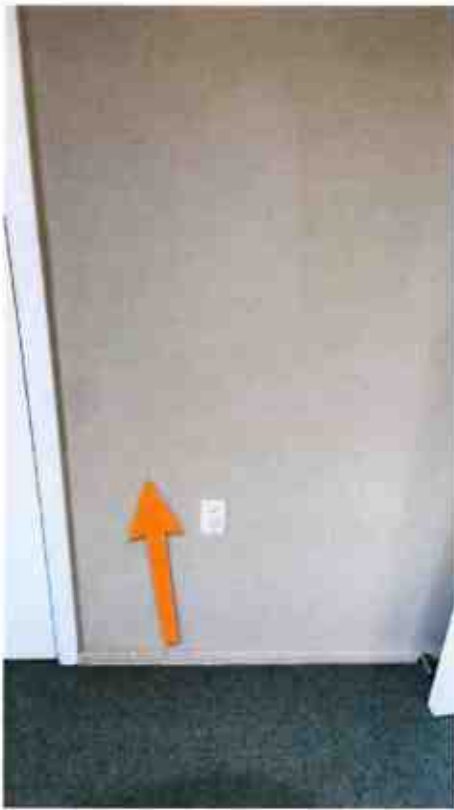
There is general wear observed to the wall linings consistent with the age of the dwelling. Cosmetic repair can be made if desired

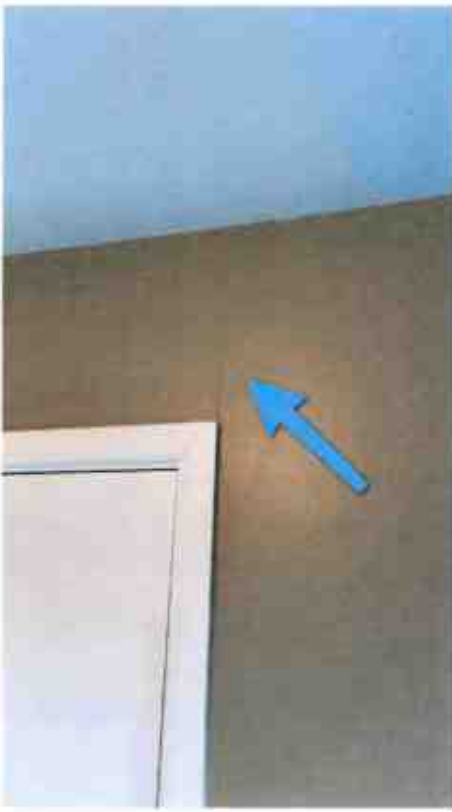
There is sheet joint cracking to the wall linings, which can be repaired.

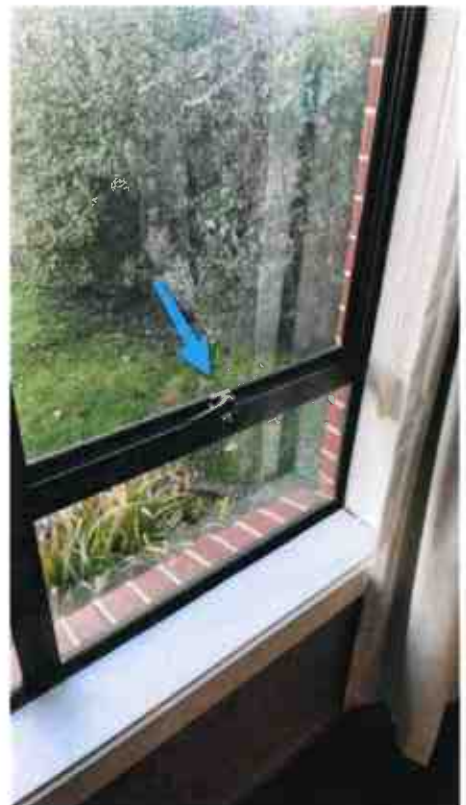
9.6.1 Windows & Reveals

**LOOSE HARDWARE**

Some hardware is loose and can be tightened or replaced.

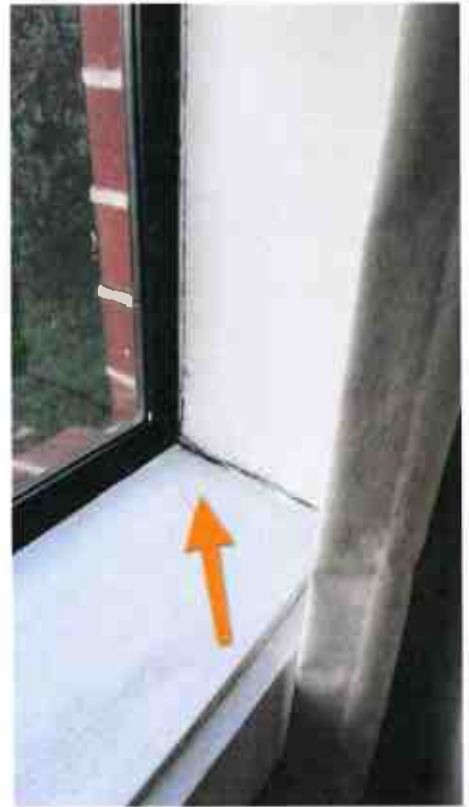
9.6.2 Windows & Reveals

**DAMAGED MDF WINDOW REVEALS**

Some of the MDF frames are damaged and will benefit from replacement. MDF is no longer used for this purpose, as it cannot tolerate prolonged exposure to moisture. The condition of any internal timber is not known.

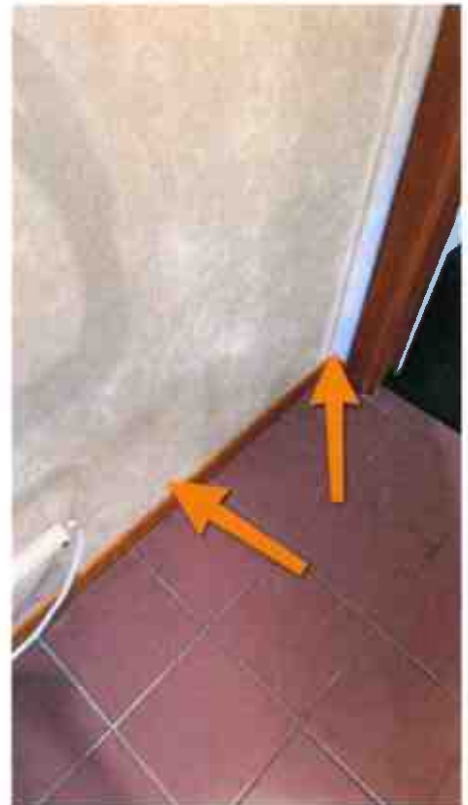
**WEAR IN WALL PAPER**

Wear or peeling of wall paper in areas.

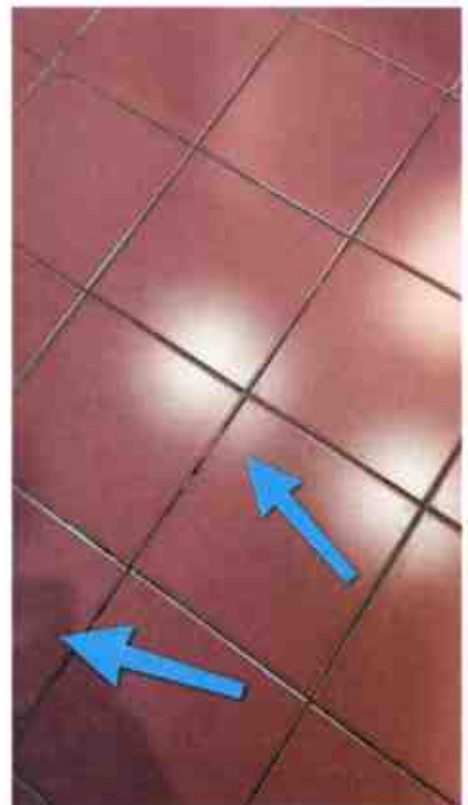
12.6.1 Floors

**GROUT REPAIR REQUIRED**

Some re-grouting and sealing is required to the tiles to localised areas

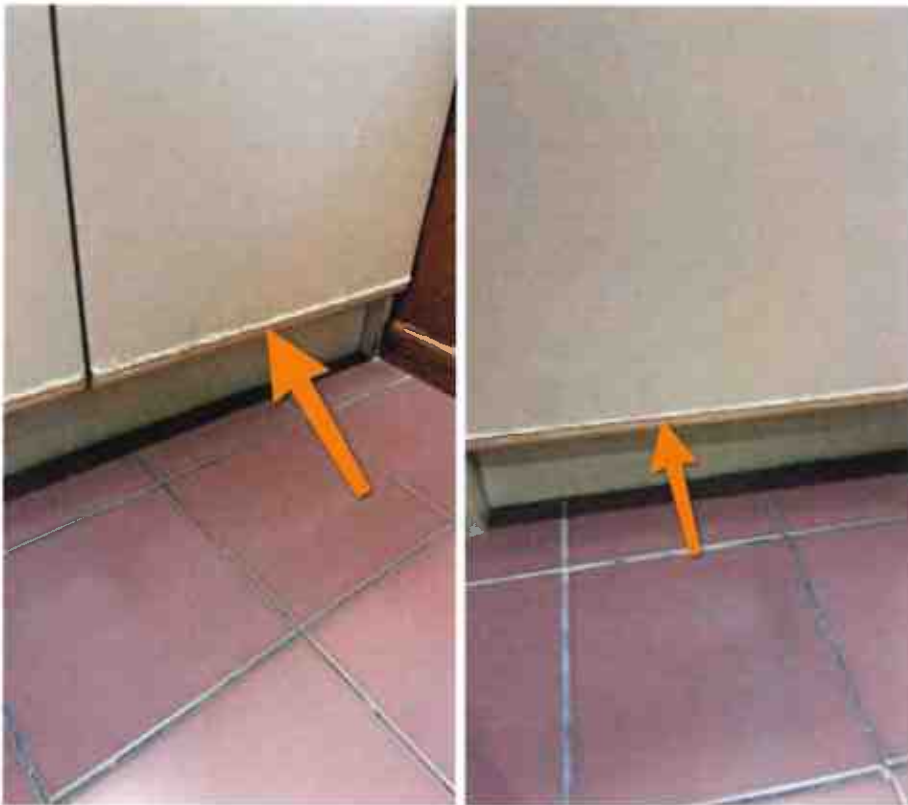
12.9.1 Vanity Unit

**DAMAGED VANITY DOORS**

The doors are damaged and can be repaired or replaced as desired

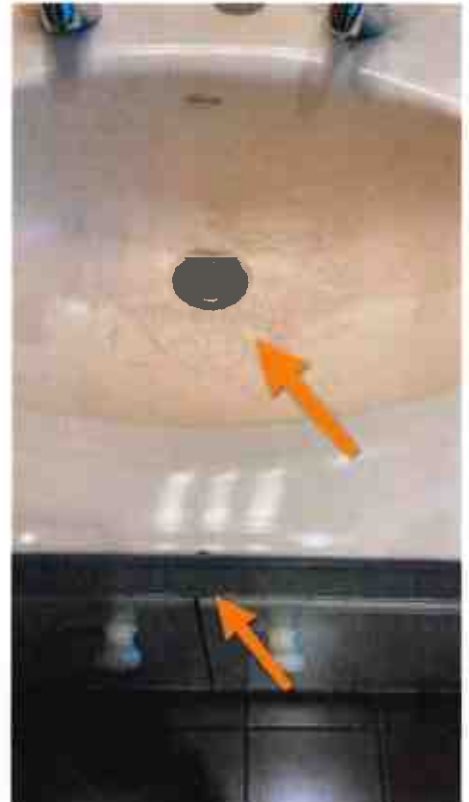
12.10.1 Sink & Tapware

**DAMAGED SINK**

There is damage to the sink bowl that may be repaired, or the sink replaced.

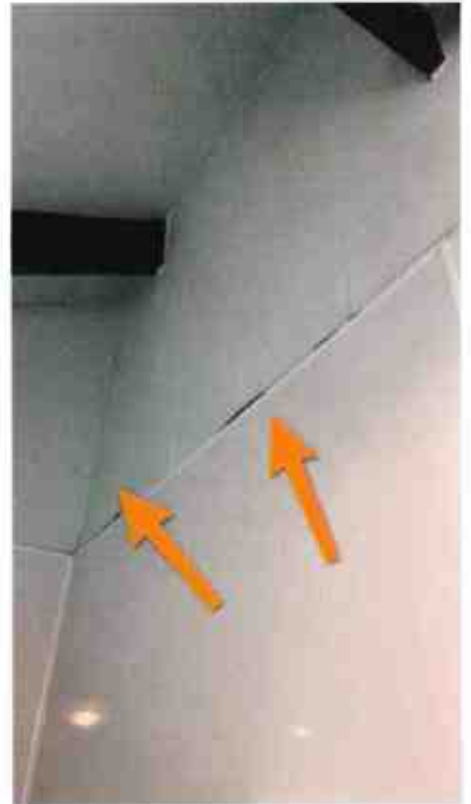
## 13.3.2 Walls

**WEAR IN WALL PAPER**

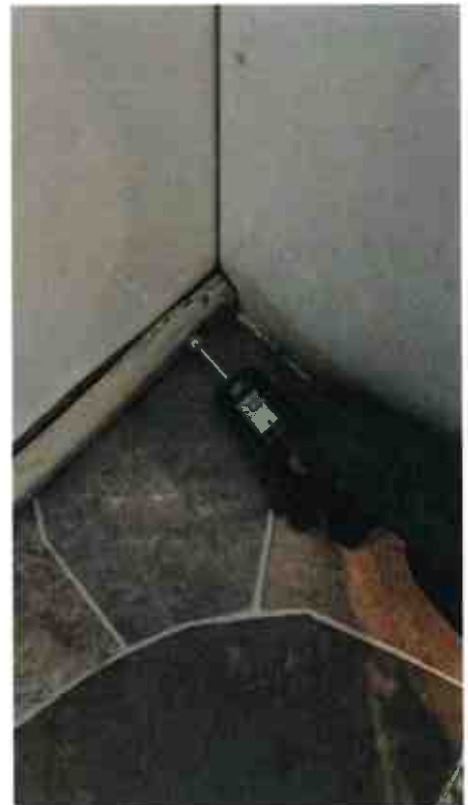
Elevated moisture levels were observed to the timber skirtings at the base of the wall. This is consistent with the placement of the washing machine. The elevated moisture readings were likely caused by a leak to the washing machine feed or discharge plumbing. Replacement of the MDF skirting is recommended, and monitoring of the area. The condition of the internal framing cannot be determined during this non-invasive inspection

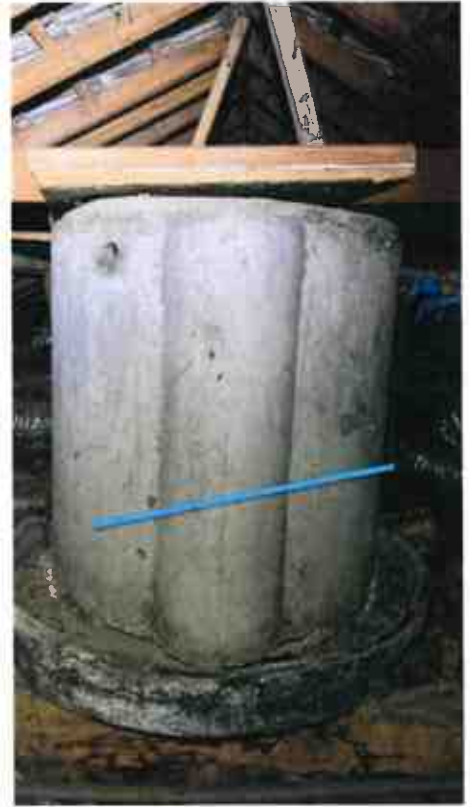
**NO SEISMIC RESTRAINTS**

We recommend fitting seismic restraints to prevent movement during an earthquake.

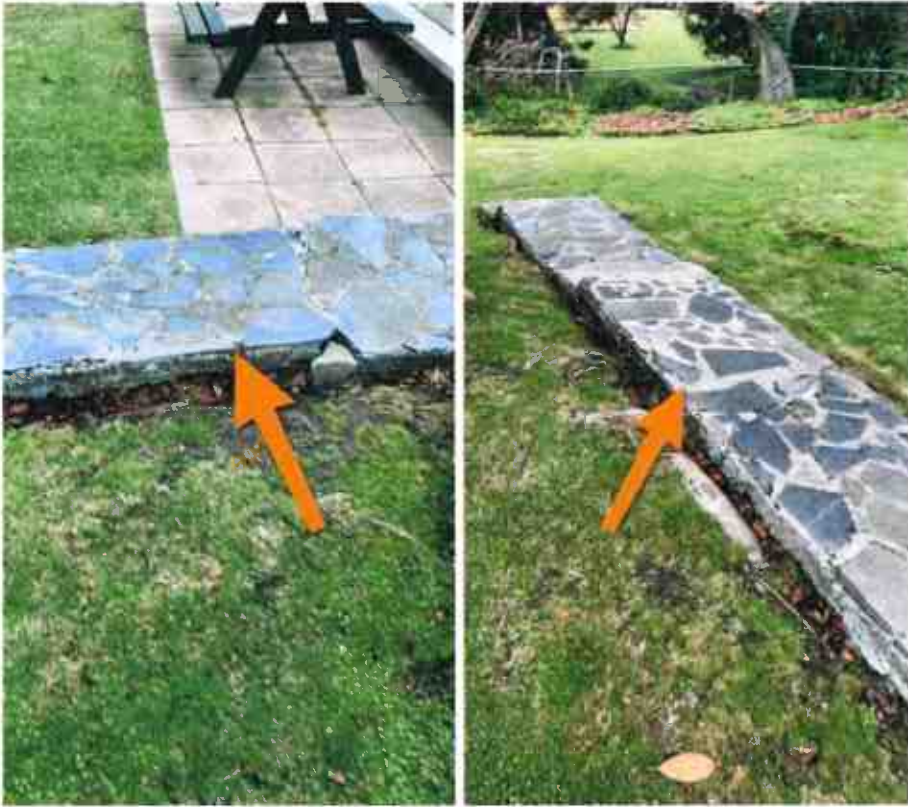
There is cracking and movement to the paths which can be repaired or replaced if desired

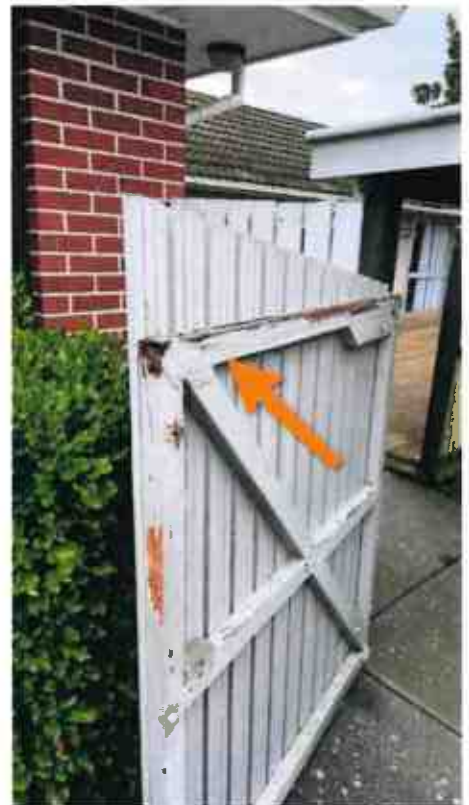
19.5.1 Fencing

**ROT TO TIMBER GATE**

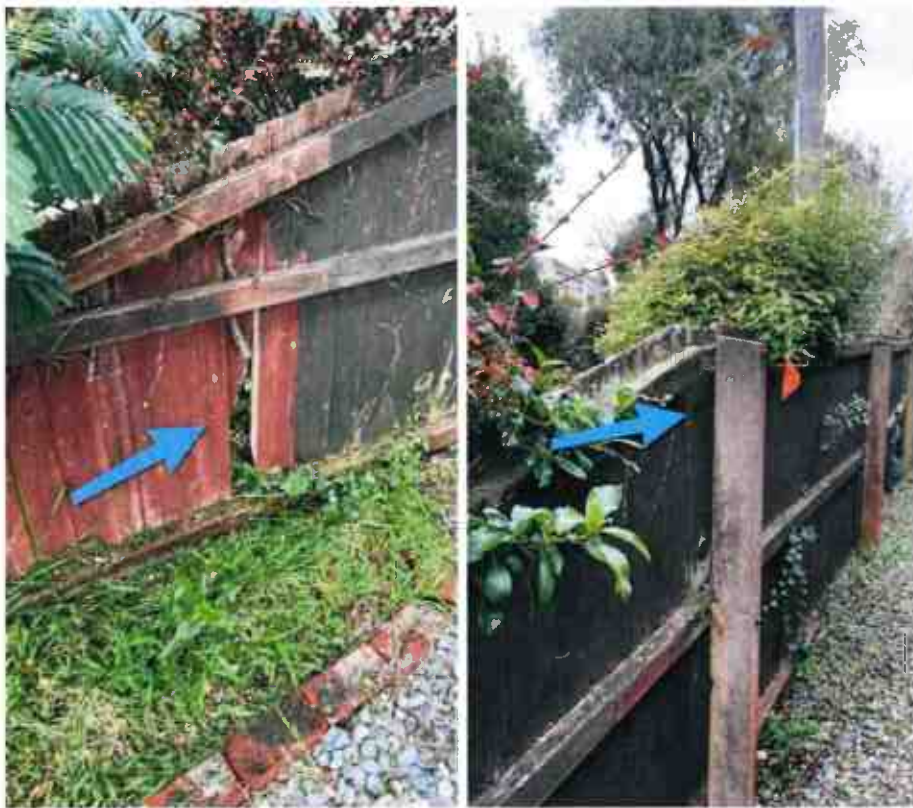
19.5.2 Fencing

**REPAIR TO FENCING REQUIRED**

Some general repair is required to bring the fencing up to standard.

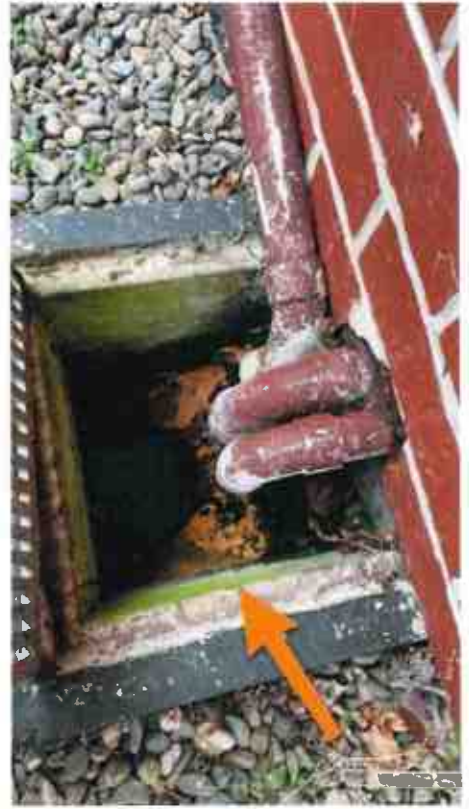
**EARTHENWARE DRAINAGE**

The drainage system is earthenware pipework. This material is prone to movement damage. We recommend that the drainage be camera inspected to determine its condition.

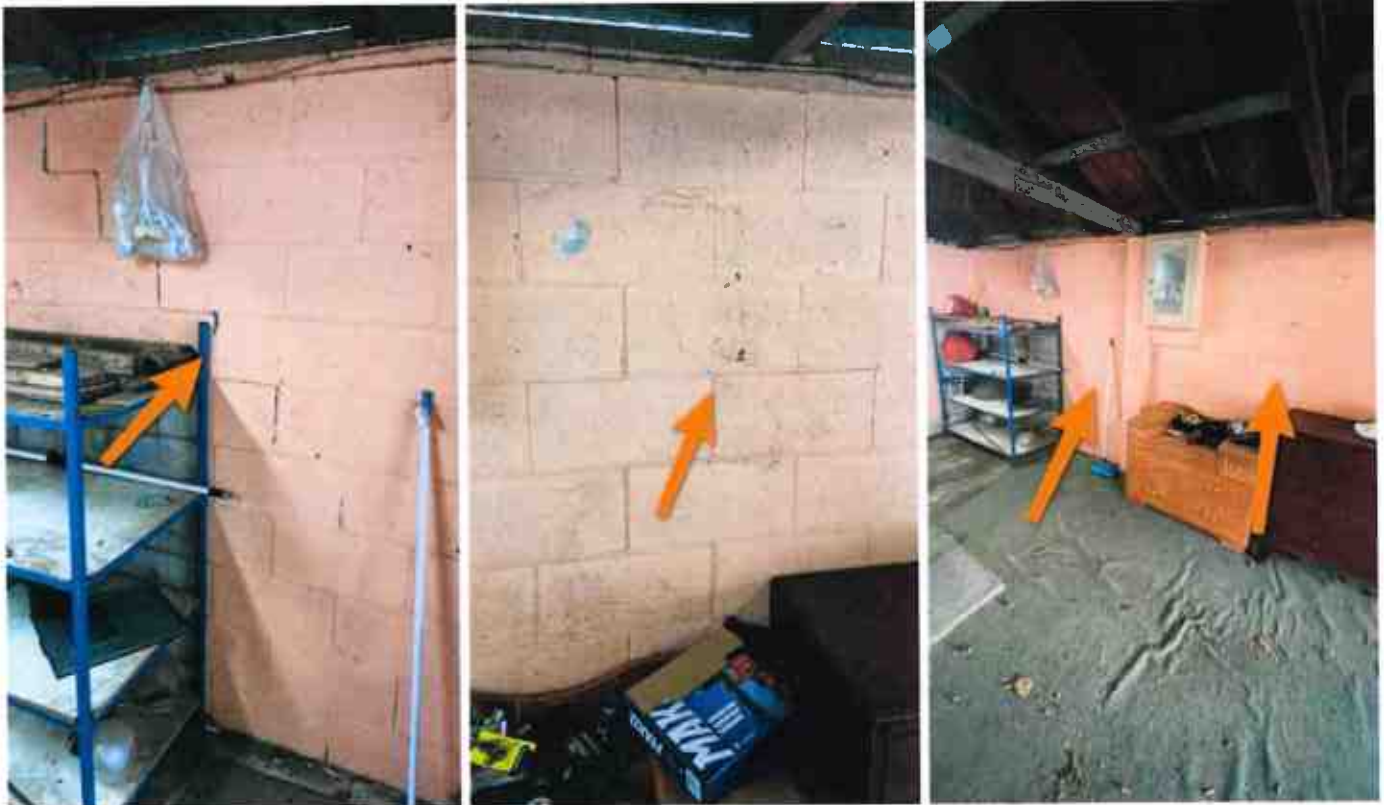
**STEP CRACKING TO CONCRETE BLOCK WALL**

Step cracking is observed to the northern concrete block wall. Repair to this area is required by a concrete repair specialist

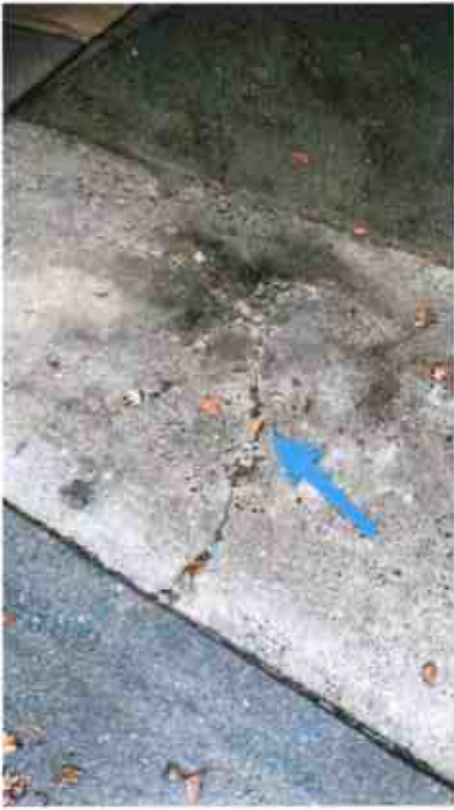
20.5.1 Floors

**CRACKING TO FLOOR SLAB**

Cracking was observed to the original concrete slab to the garage floor, as is common in older concrete. The cracked areas can be repaired by a concrete repair specialist if desired

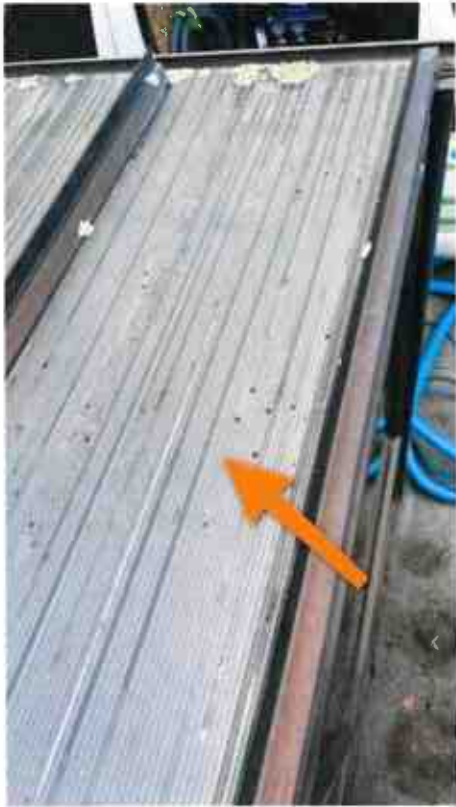
**DAMAGED POLYCARBONATE**

The polycarbonate roofing sheet is damaged and requires replacement

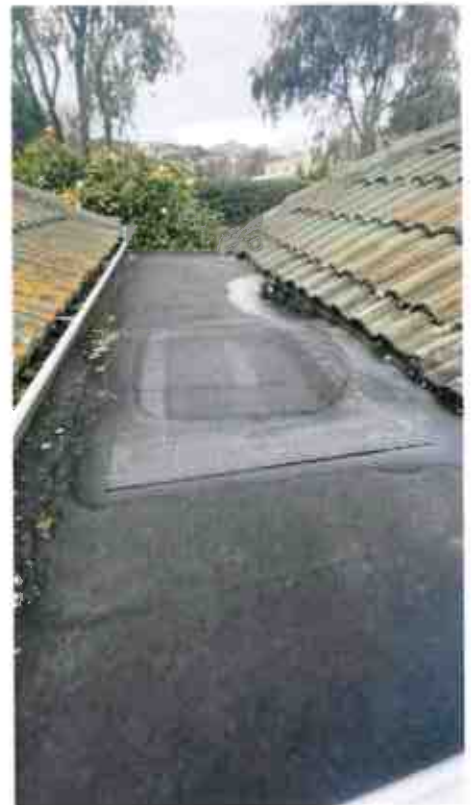
22.2,5 Roofing Material

**RAISED MEMBRANE**

The membrane roof covering is raised/has pulled away from the substrate to the highlighted area. Moisture may be present beneath the membrane to the raised area. Further investigation and repair by a licensed roofing contractor is required

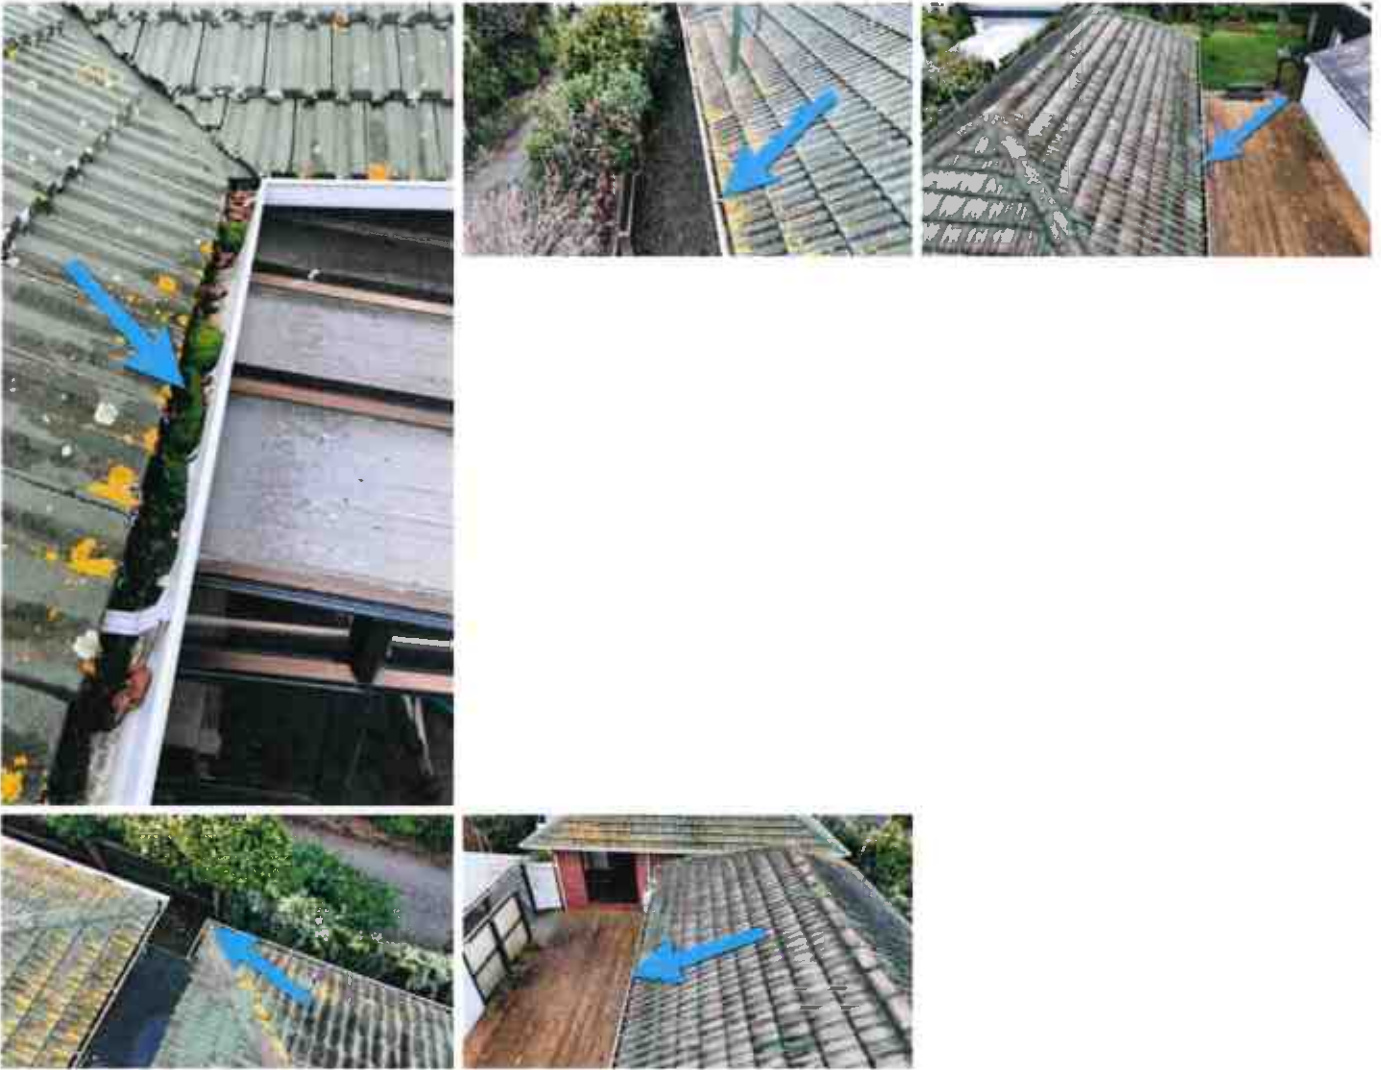
22.5,1 Gutters & Spouting

**BLOCKED SPOUTING**

Recommendation

Contact a qualified roofing contractor

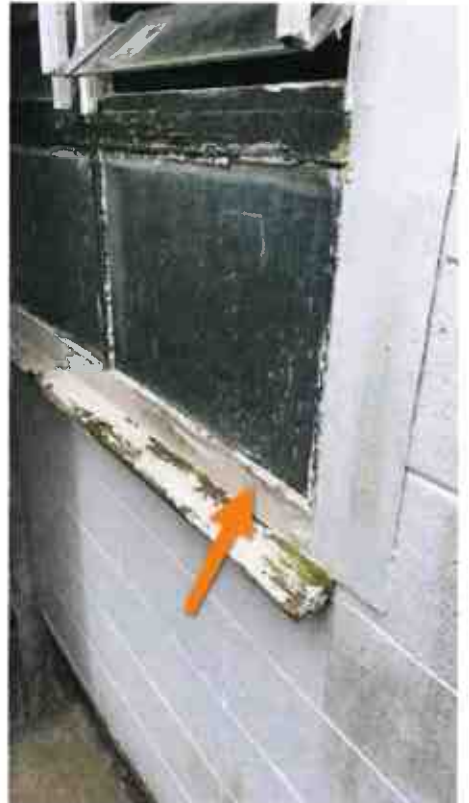
**ROT TO TIMBER WINDOW SILLS**

There is rot damage to some joinery, which is best repaired by cutting the damaged timber out and replacing it with treated timber. Further rot damage may be located under closer scrutiny or when next painted. The condition of any internal framing behind the rot is not known.

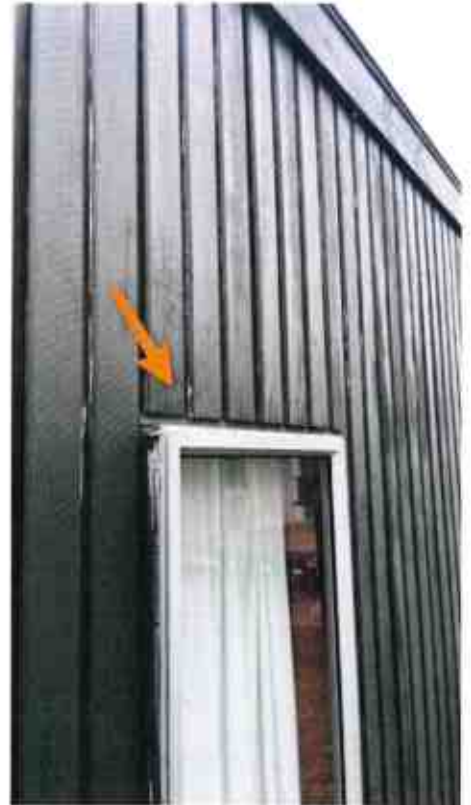
## 24.3.3 Joinery (Windows and Doors)

Some of the joinery is not fitted with head flashings and we recommend these be installed.

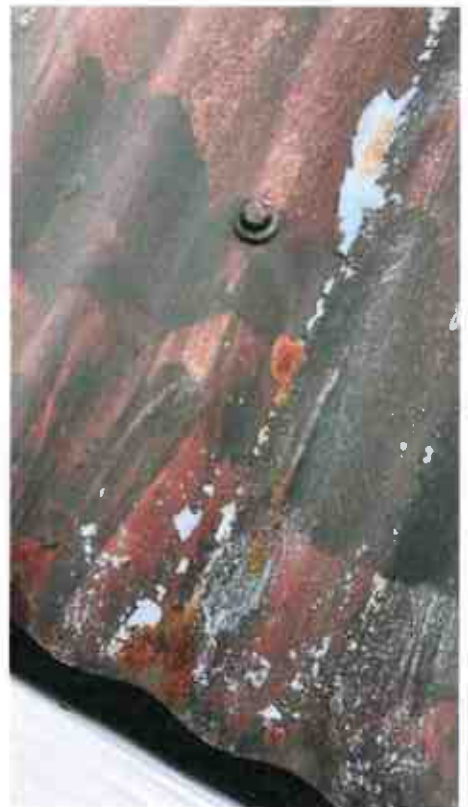
24.4.1 Roofing Material

**RUST DAMAGE**

There is rust damage and surface rust to the roof, which should be repaired.

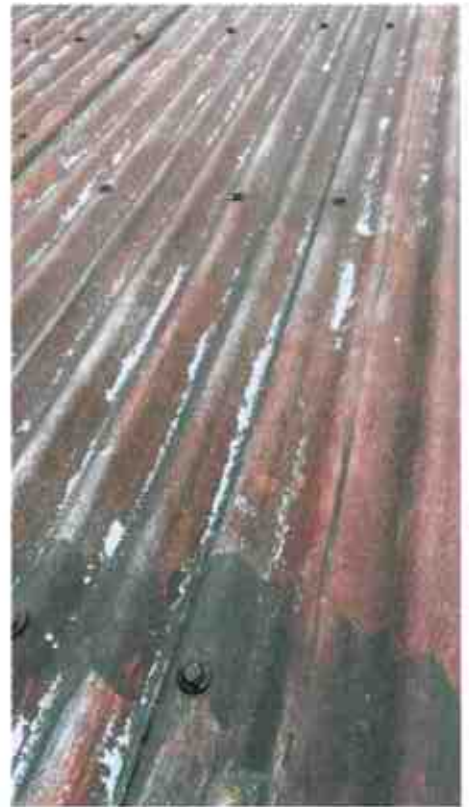
24.4.2 Roofing Material

**COATING DETERIORATION**

The coating has deteriorated - The roof requires prep and recoating to prolong the life of the material

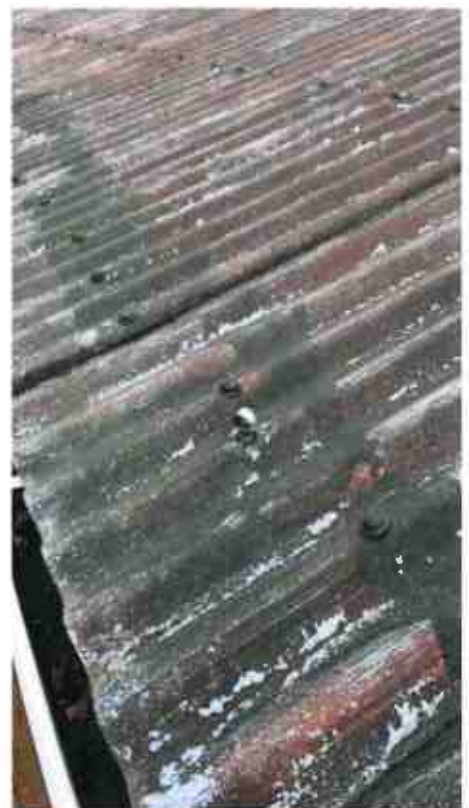
24.4.3 Roofing Material

### REPLACE LEAD HEAD NAILS

The lead head nails have corroded or the heads have snapped off. Replacement with a modern screw fixing is recommended

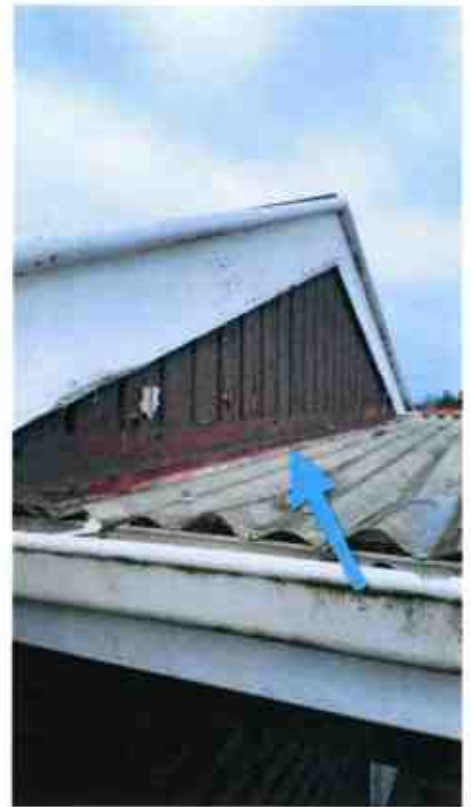
24.5.1 Cladding Type

### PEELING PAINT

Paint is peeling and the cladding can be cleaned back and painted.

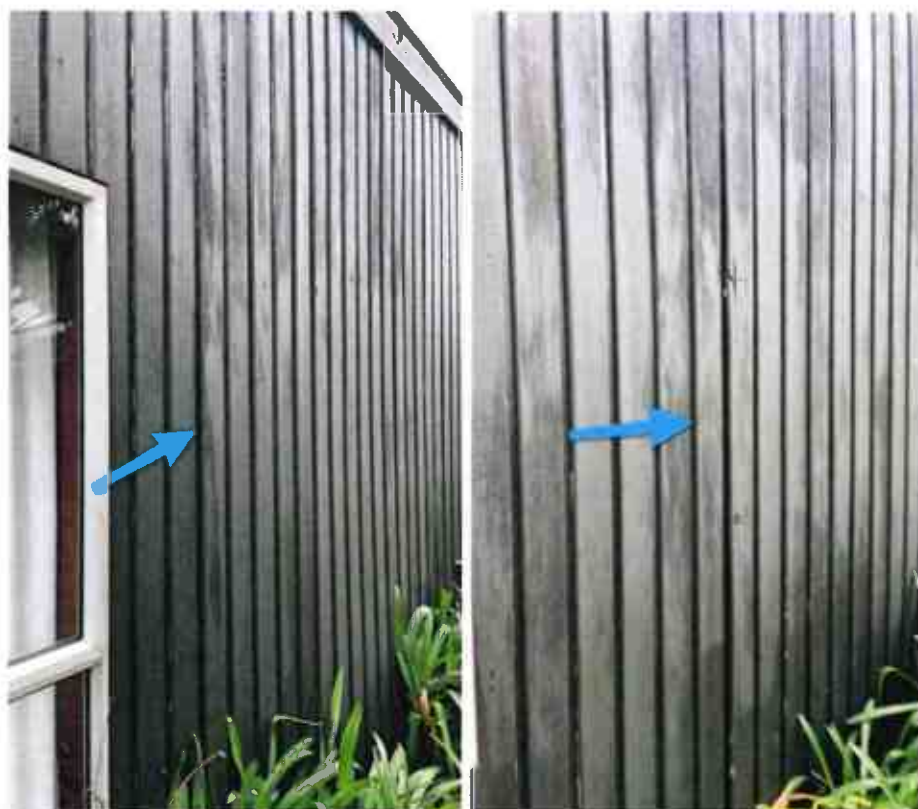
24.5.2 Cladding Type

**TIMBER CUPPING AND CRACKING**

The timber cladding is cupping and cracking due to deferred maintenance. This is a moisture ingress risk area. Replacement of the damaged timbers is required

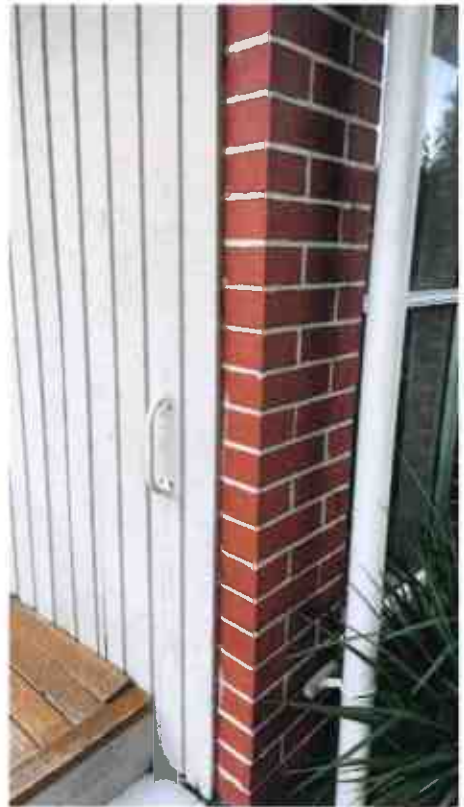
There is no flashings installed at the weatherboard/stone junction. This is a weahertightness risk. It is recommended that scribes or flashings be installed

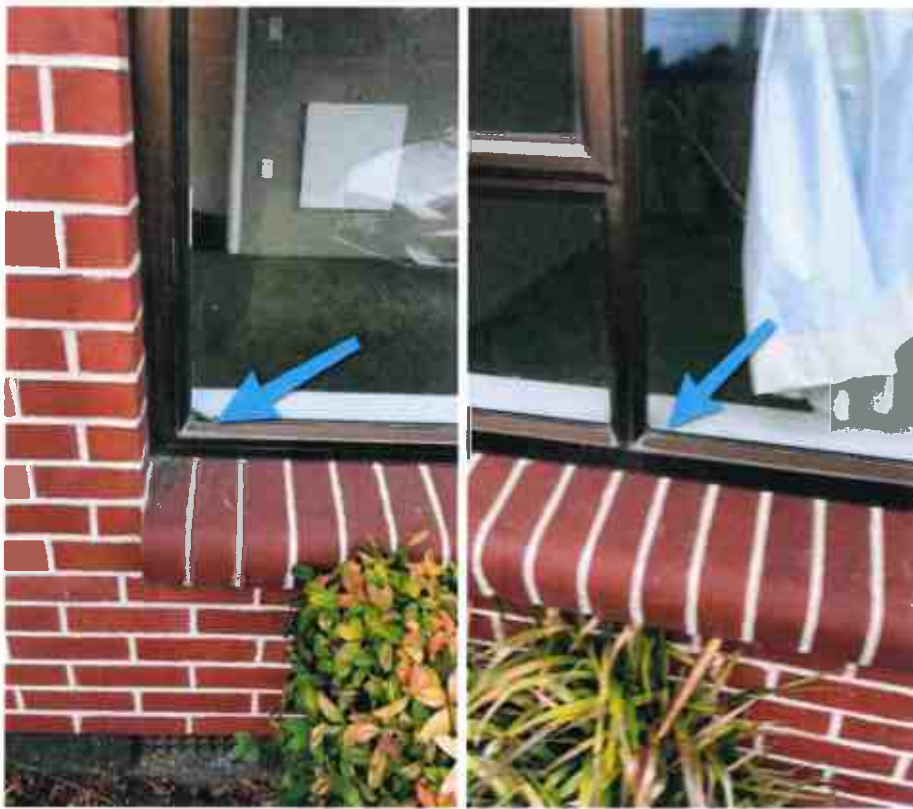
The rubber seals on the joinery are starting to deteriorate and can be replaced to ensure the joinery is weather tight.

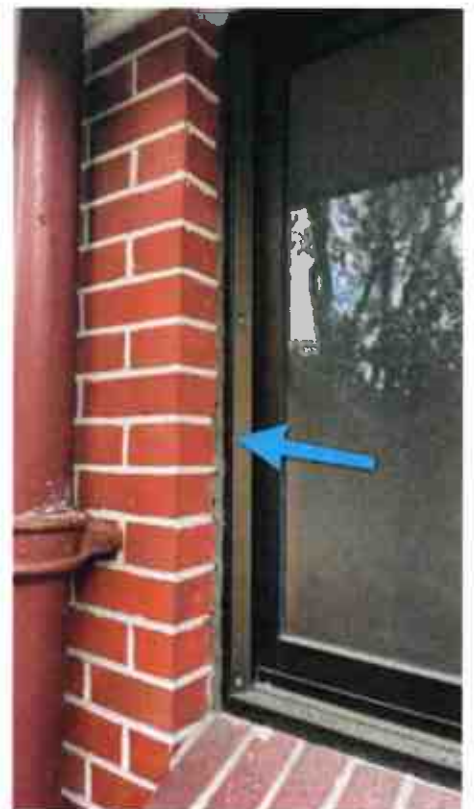
25.5.3 Joinery (Windows and Doors)

The joinery to cladding junction is poorly sealed. This is a weather tightness risk. It should be assessed and repaired by a licensed building practitioner.

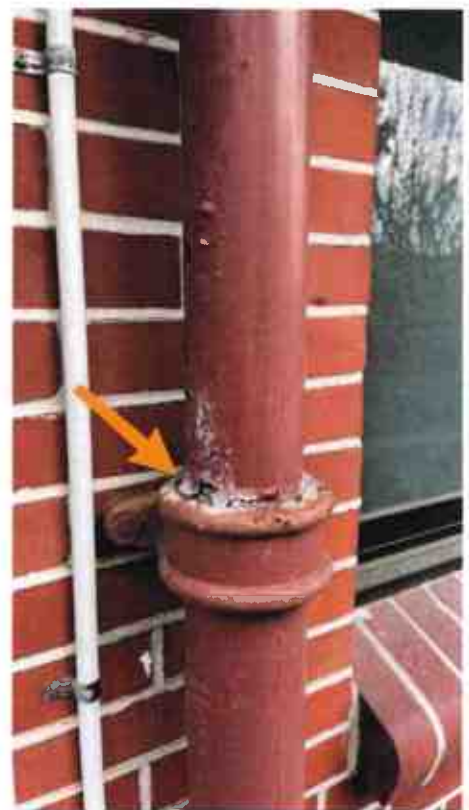
25.6.1 Vents

**DAMAGED VENT PIPE**

There is damage to a vent pipe that will require repair or replacement.

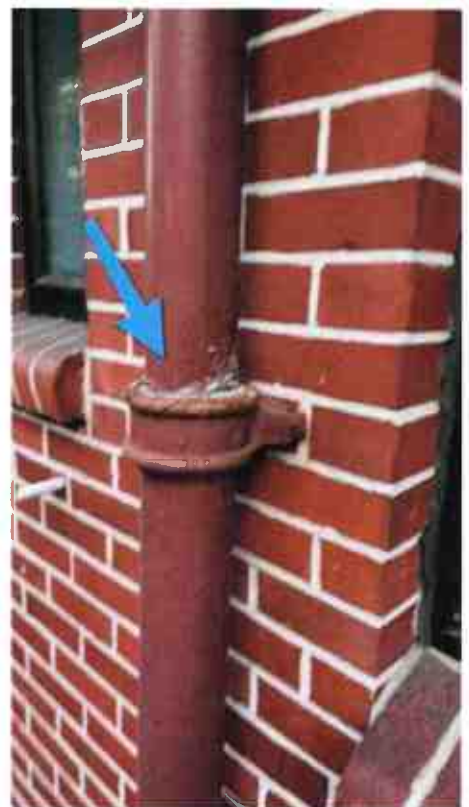
25.6.2 Vents

**CORRODED METAL VENT**

The metal vent is corroded and would benefit from rust treatment and recoating to prolong its life
