# Building Inspection Report

## RESIDENTIAL INSPECTION

7 Palmside St  
Christchurch, Canterbury Region 8024

30/06/2025

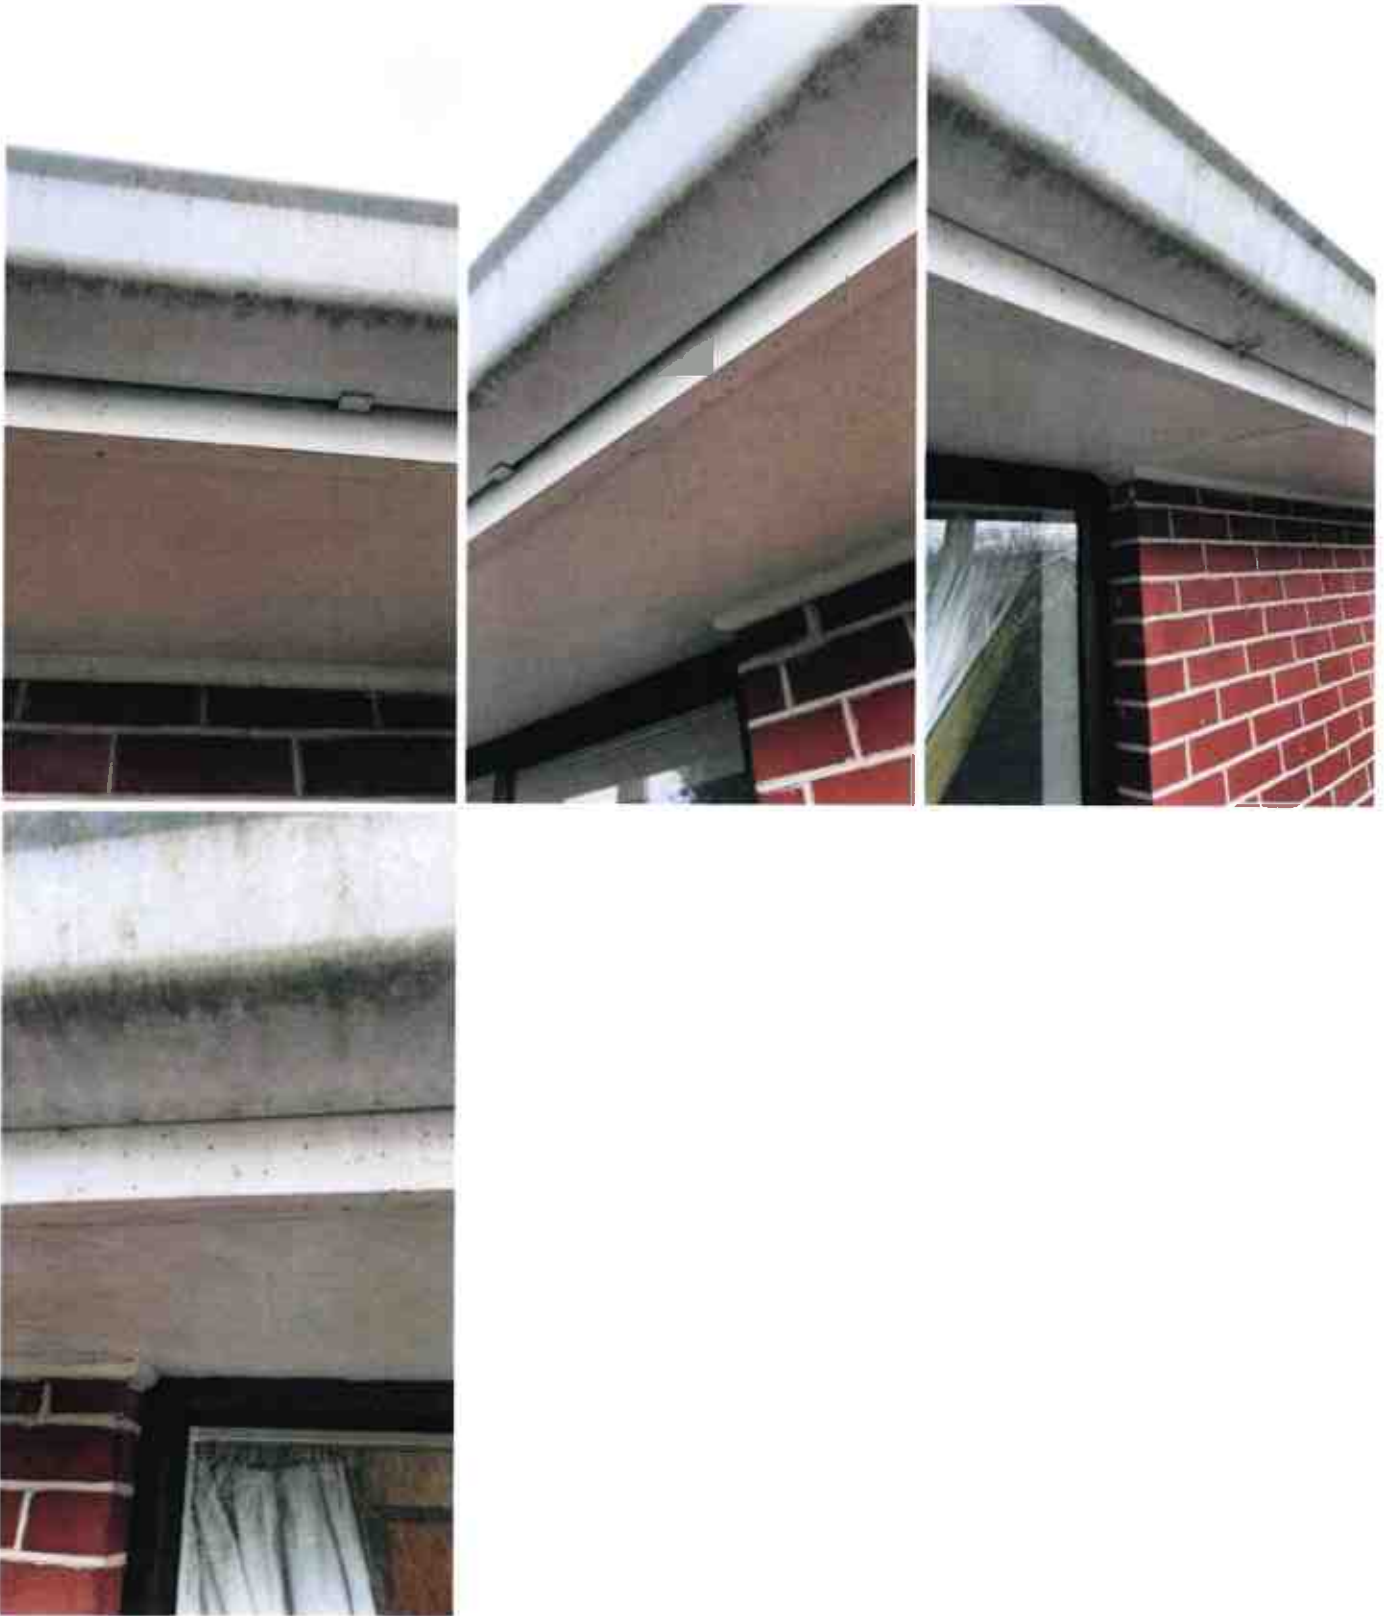
25.9.1 Fascias & Barge Boards

**BORER TO FASCIA**

There is borer present to the timber fascia across the extent of the dwelling. Treatment of the borer or replacement of these timbers is advised to help negate the further spread.

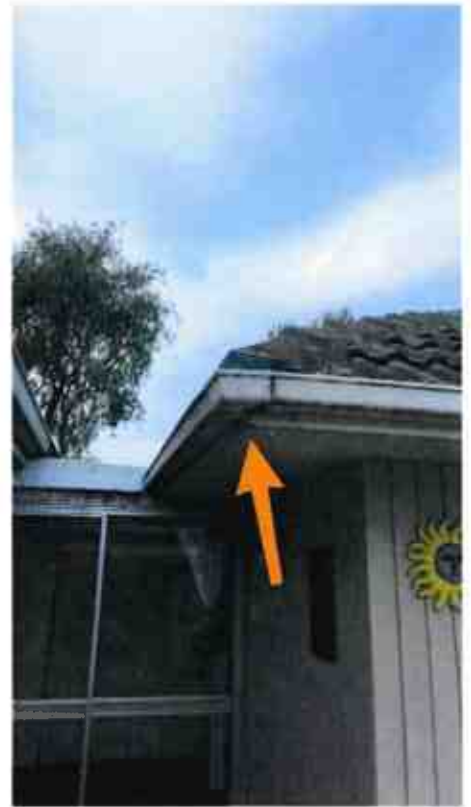
25.11.1 Downpipes & Spouting  
**LEAKING JOINTS**

The joins in the spouting are leaking and need repair.

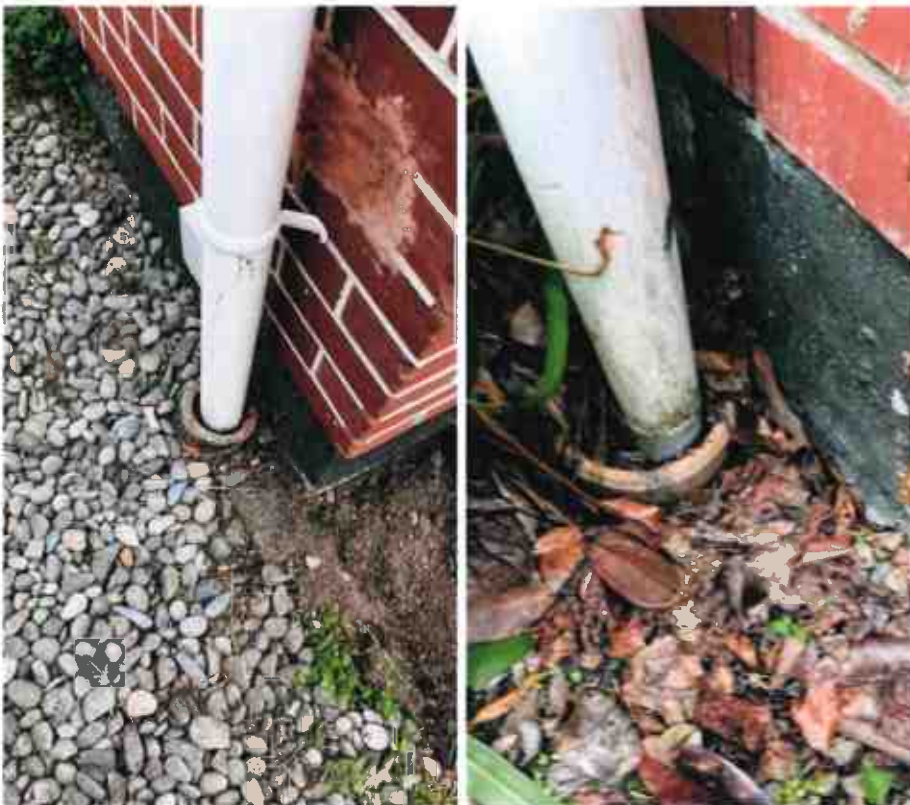
25.12.1 Visible Point of Discharges

### EARTHENWARE DRAINAGE

The drainage system is earthenware pipework. This material is prone to movement damage. We recommended it be camera inspected to determine its condition

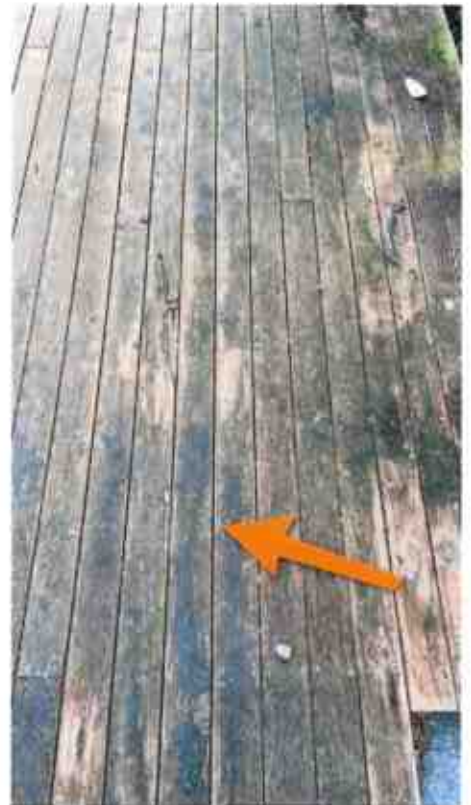
There is none or minimal gaps to the timber decking boards. This will cause water to pool and not provide sufficient ventilation to the deck subfloor. The decking boards can be lifted and relaid if desired
