Project Reference: 17850

17 July 2020

# SLOPE STABILITY ANALYSIS OF ACCESS ROAD Newton Road, Omapere

#### 1 Introduction

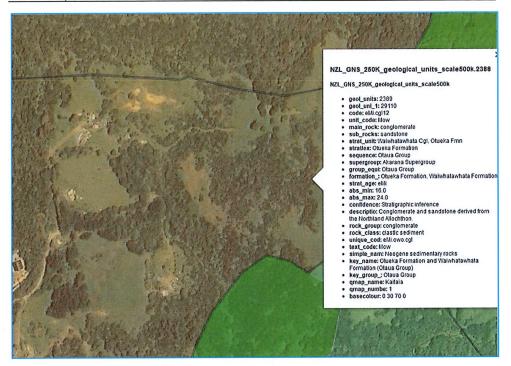
The geology of the site is conglomerate and sandstone of the Otueka Formation of the Otaua Group derived from the Northland Allochthon. This geological unit is notorious within Northland for being unstable at even low slope angles, being highly expansive during variations in moisture content and having perched water tables due to the very low permeability of the clay. Several locations of current and historic land movement within the conglomerate that covers much of the southern headland of the Hokianga Harbour are known to be currently monitored and under investigation.

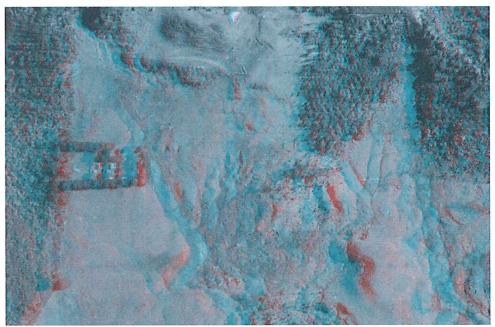
Stereographic interpretation was made of the 1942 aerial photos using StereoPhoto Maker Pro Ver6.02, for the purpose of geomorphological mapping. An extract of which is shown below. 3D visualisation shows a clear demarcation of a large historic land movement within the valley below the access road moving in a southerly direction. The age of this movement is at least 78 years prior to now, with the debris being unvegetated but no indication of recent movement at the time of the aerial photo. Earlier aerial photos were viewed but conclusions could not be drawn, due to the high altitude and low resolution of the photos.

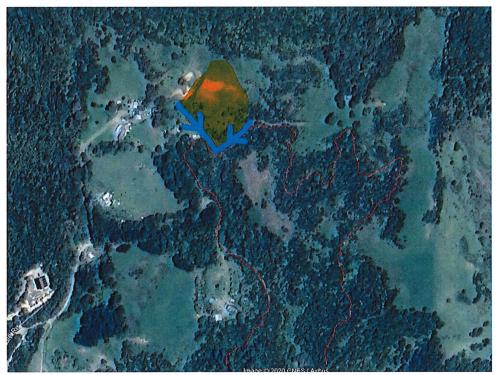
It is our interpretation that the headscarp below the access road has been caused by the construction of the access road altering the natural drainage patterns within the slope. The headscarp is at a low point along the access road alignment, which has intercepted the surface runoff and directed it to the low point where the slippage has occurred. Culverts were absent or ineffective, along this section of road, allowing runoff to flow towards the slip which is not a natural watercourse. The figure below shows the approximate catchment area (orange) and drainage paths (blue) directed towards the slip.

The access road should be realigned to the north as shown on the appended Scheme Plan (dated 28.04.20) and cut into the batter slope approximately 3m above the current elevation to divert surface runoff away from the headscarp. Culverts and table drains should be utilised to divert surface water into the natural watercourses either side of the headscarp.
