# RESIDENTIAL PROPERTY INSPECTION

**Inspection Address:** 2 Chilcombe Street, Christchurch

**Inspection Date:** Monday, 29 June 2026

**Inspector Name:** Sam Thomson

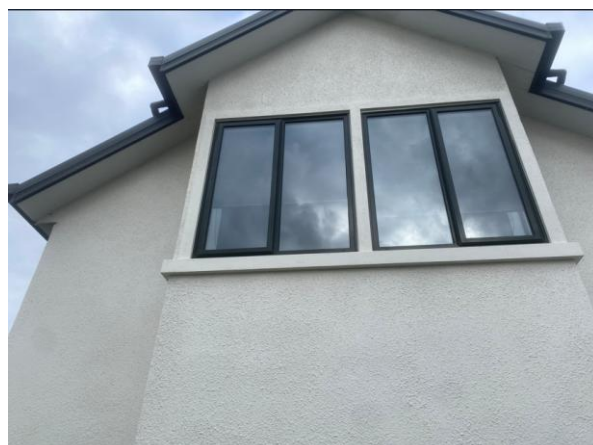
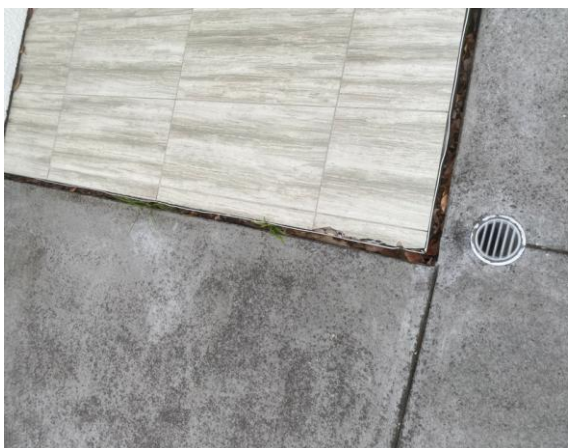
- Cracking to tiles and separation at entrance way.

| ITEM ASSESSED | DEFECT | COMMENTS/NOTES |
|---|---|---|
| Steps, Handrails, Paths, Driveway | Minor | Cracking to tiles and separation at entrance way. |

Chipped tile to entry way, external

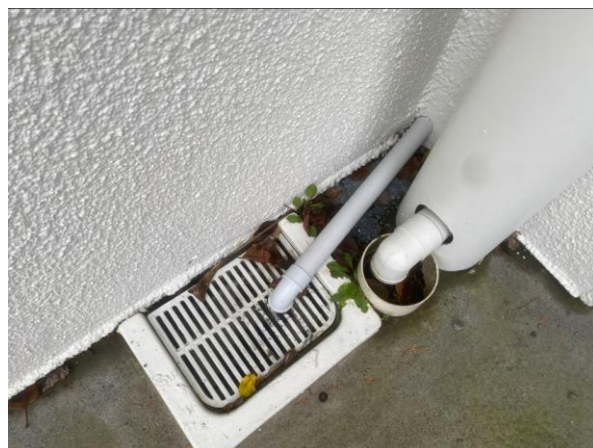
- Gully trap surround by garage requires sealing to sides.

| ITEM ASSESSED | DEFECT | COMMENTS/NOTES |
|---|---|---|
| Drainage – drains, haunching etc | Minor | Gully trap surround by garage requires sealing to sides. |

Gully trap not sealed at back

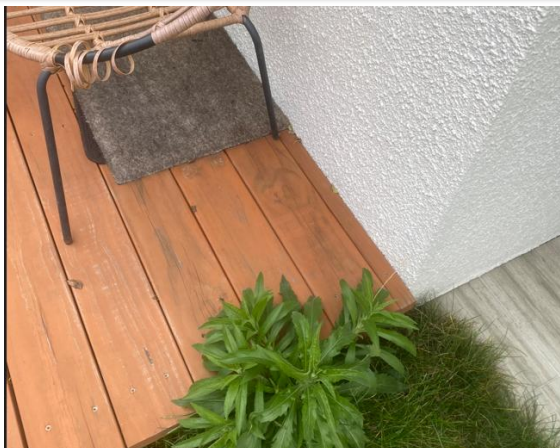
| ITEM ASSESSED | DEFECT | COMMENTS/NOTES |
|---|---|---|
| Balconies, Verandas, or patios etc. | Minor | The wooden deck is hard up against the dwelling cladding, not allowing moisture drainage. |

Deck hard against cladding

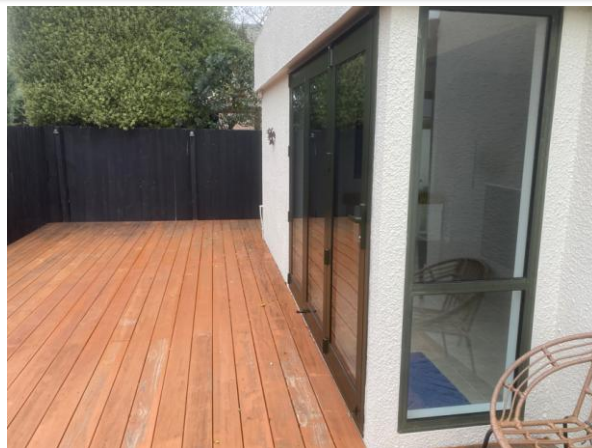
Smaller than required gap here

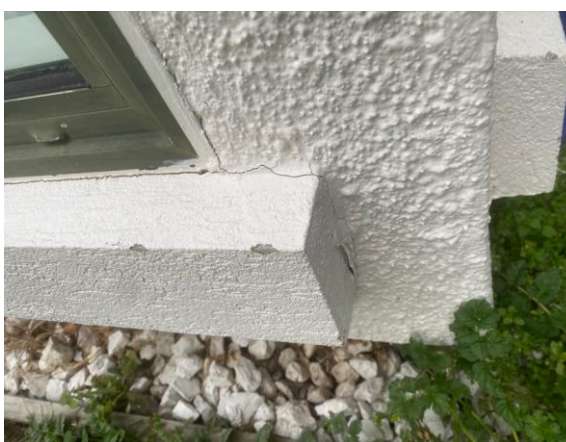
| ITEM ASSESSED | DEFECT | COMMENTS/NOTES |
|---|---|---|
| Wall Cladding (condition, tied to frame, weep holes.) | Minor | Cracking to plaster joins around some windows and sills and angle crack to plaster on southern wall. Gap above external door to garage |

Minor cracking/ potential moisture ingress points to cladding.

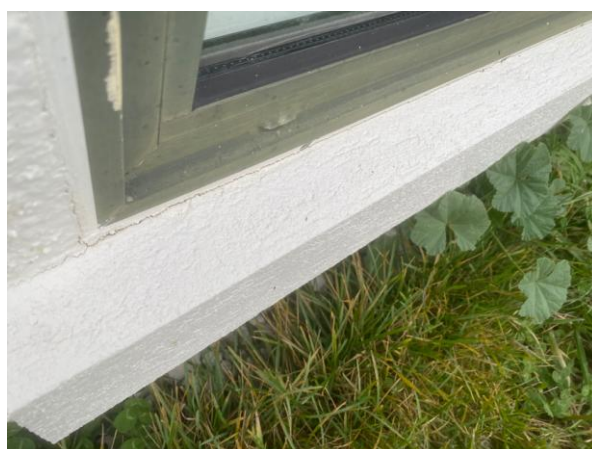
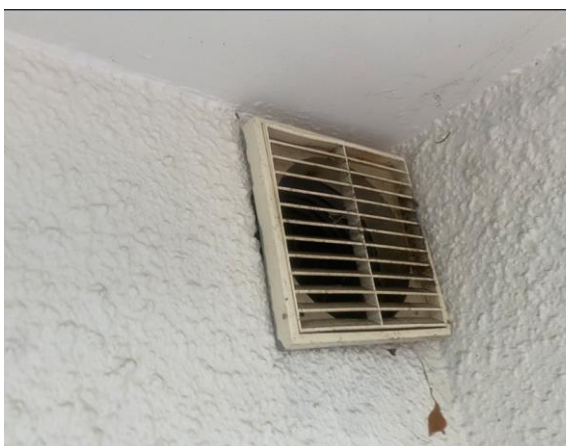
| ELEMENT | COMMENT |
|---|---|
| Penetrations | Numerous penetrations of the cladding. Check cladding penetrations regularly and seal when required. |

Ensure penetrations are sealed

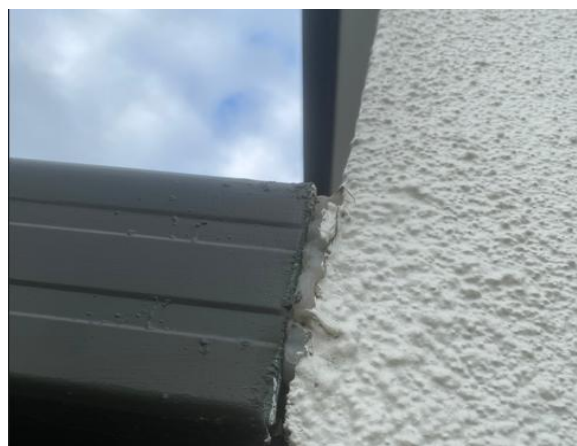
Silicone sealant in lieu of deflector flashing

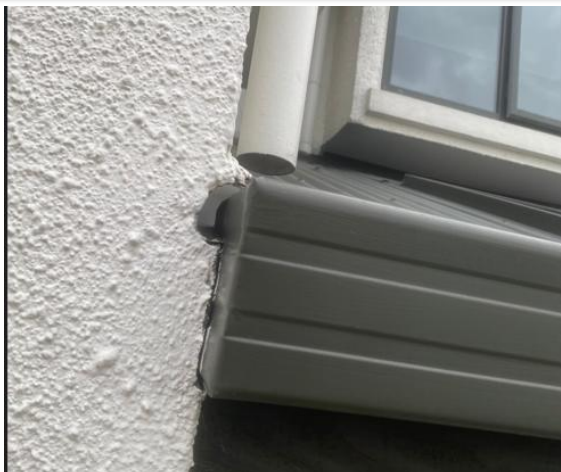
No deflector where fascia intercepts cladding

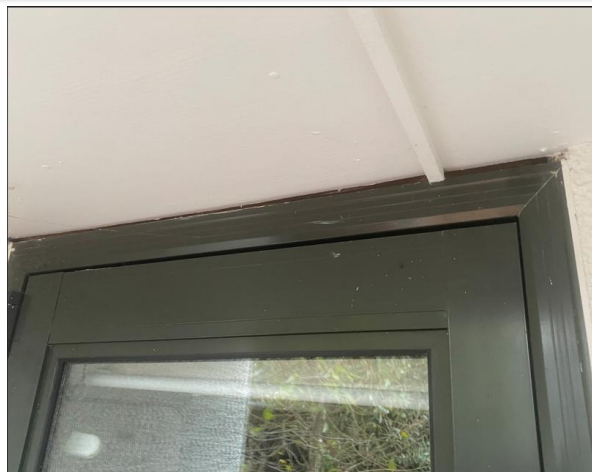
Gap above external door to garage

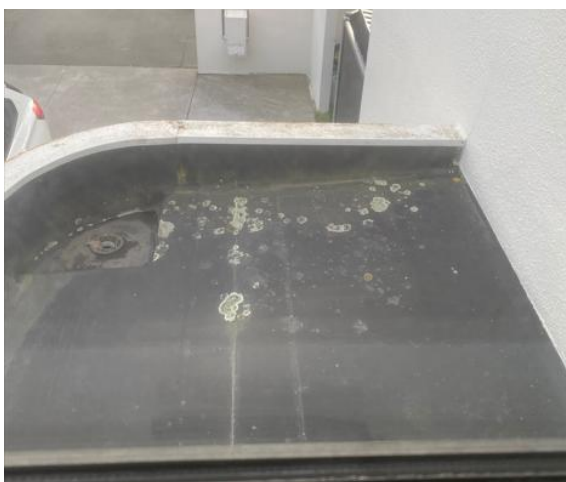
| ITEM ASSESSED | DEFECT | COMMENTS/NOTES |
|---|---|---|
| Roof condition | Minor | Butynol flat roofs shows signs of age and would benefit from preventative maintenance including moss/ mould treatment. |

Lichen growth

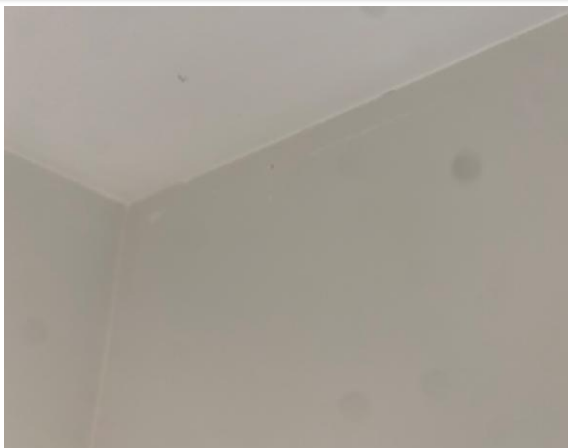
| Walls – condition, defects. | Minor | Minor blemishes to the walls and ceilings – normal wear & tear |

Wall blemishes

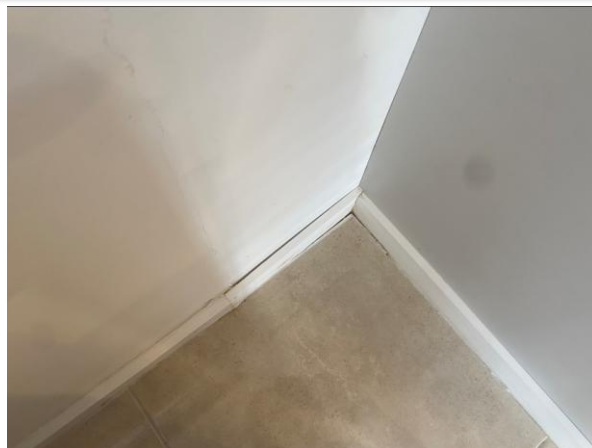
Internal wall blemish

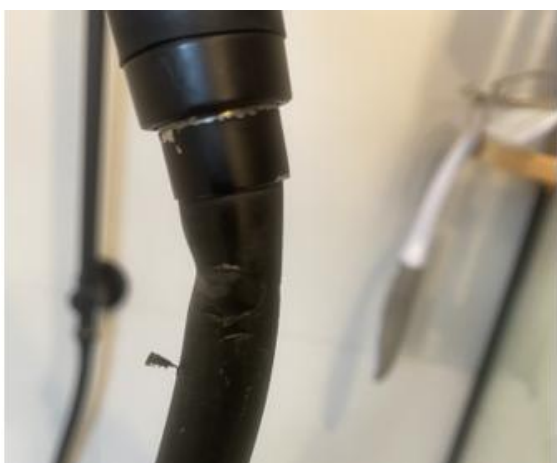
| ○ Shower (sealed & condition, pressure) | Minor | Small pin hole leak to glass on downstairs shower. Flexi hose to |

| | | shower is squashed by rainwater head in all showers due to poor design. |

Flexi hose to shower squashed from holder

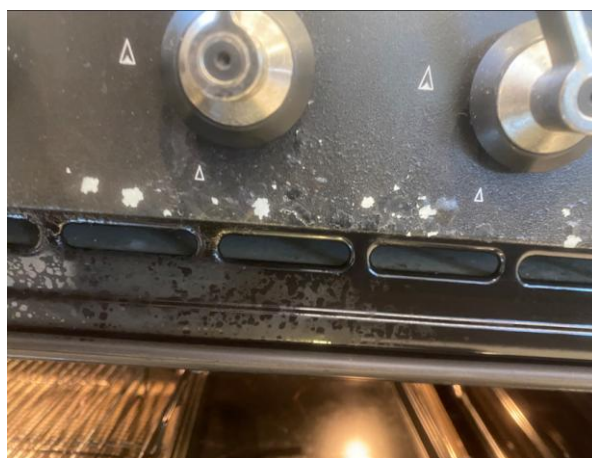
| ITEM ASSESSED | DEFECT | COMMENTS/NOTES |
|---|---|---|
| Freestanding Oven | Minor | Heat damage to surface of stove above oven. |

Heat damage to surface above top of oven door
