30 OPONONI HEIGHTS DRIVE

GEOTECHNICAL ASSESSMENT

Original Report Reference: SD1670 Issued on: 5 December 2023

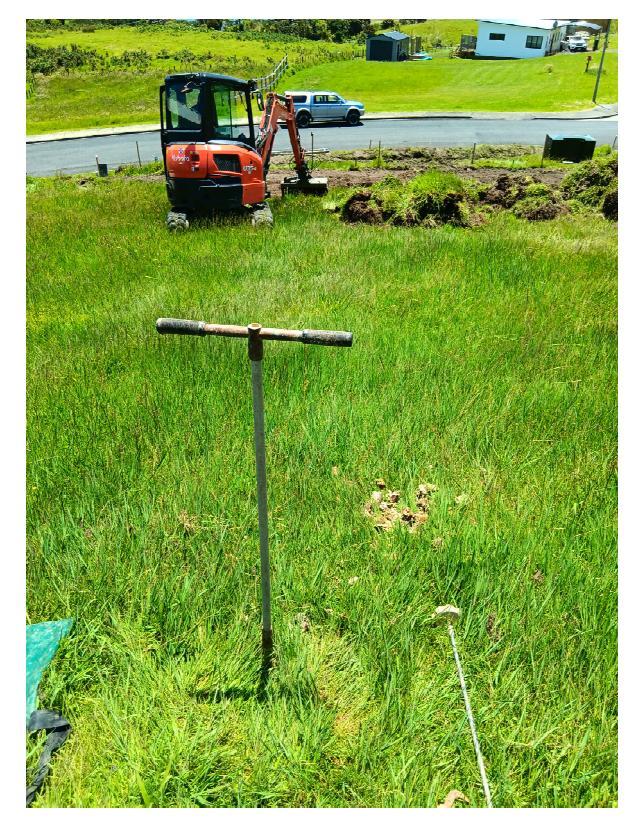
Photo 1 Typical view of site

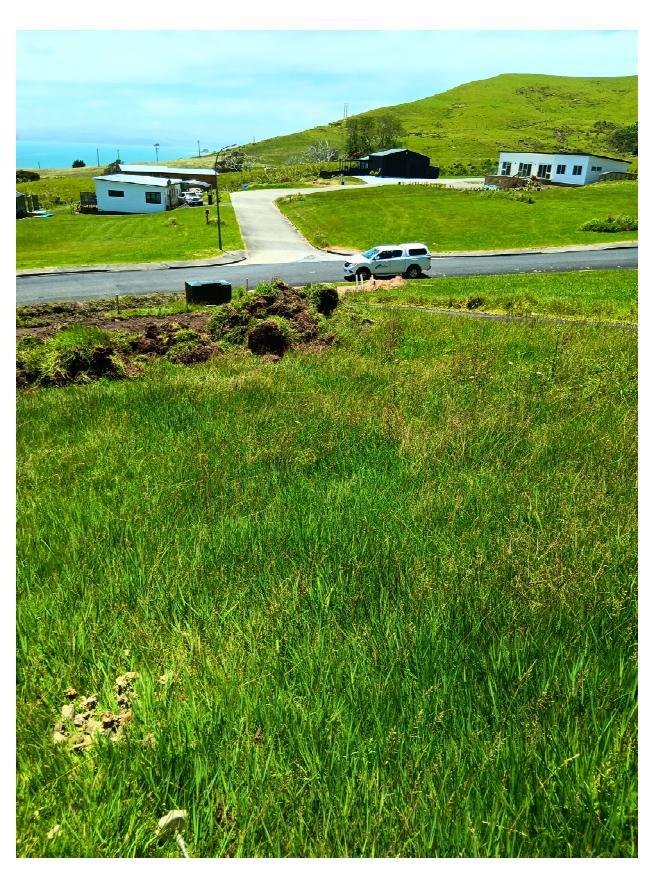
Photo 2 View of the site looking north towards Opononi Heights Drive.

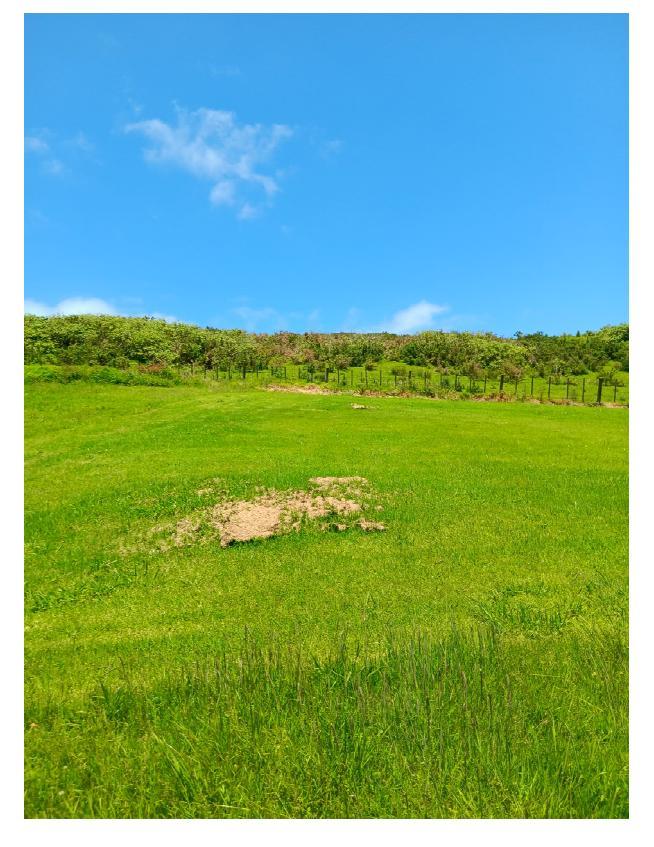
Photo 3 Looking south towards building platform.
