# Land Information Memorandum

# L252522

<b>Valuation No.</b>	2355230344
<b>Location</b>	6 Woodleigh Lane, Prebbleton
<b>Legal Description</b>	LOT 41 DP 502964
<b>Owner</b>	Gardner Jacinta Anne and Gardner Wayne Ronald
<b>Area (hectares)</b>	0.1081

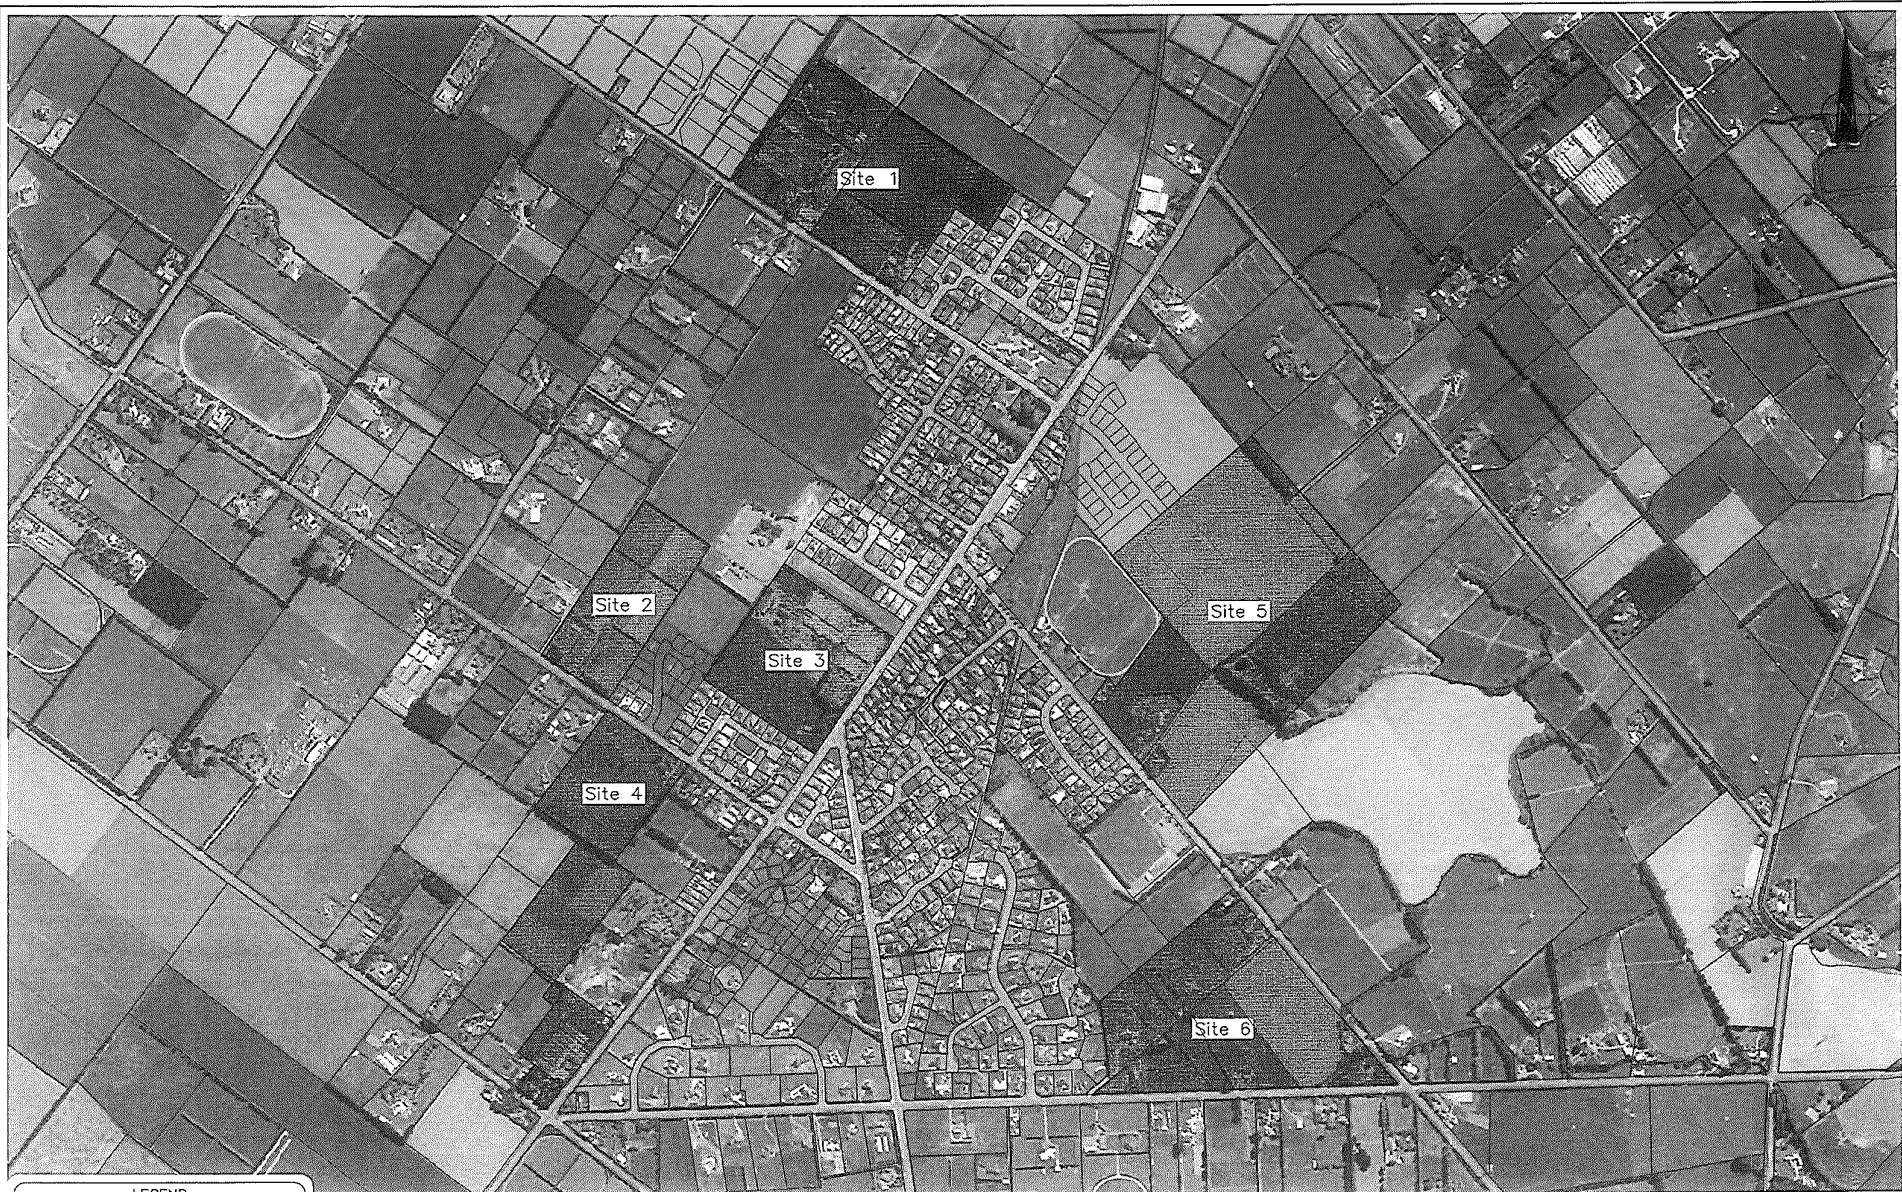
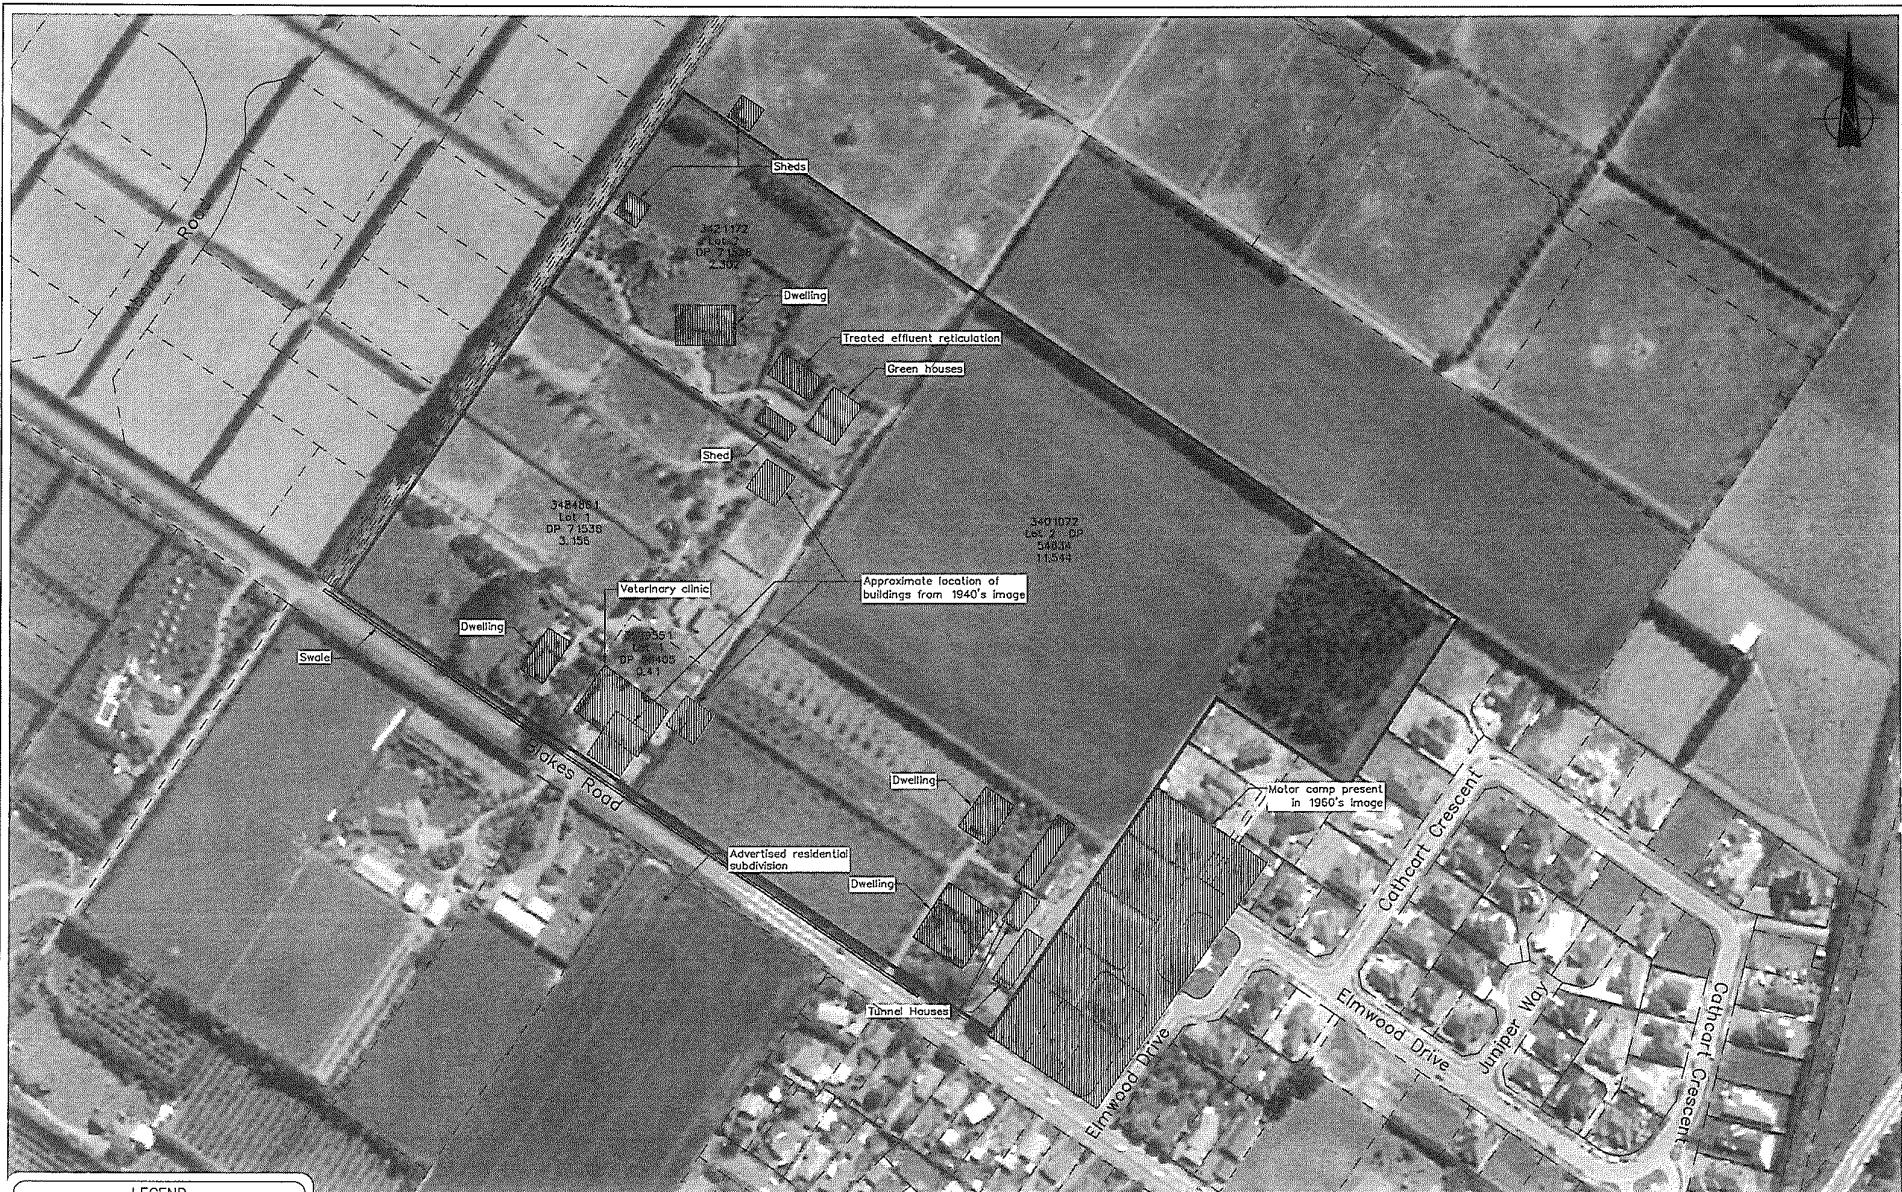
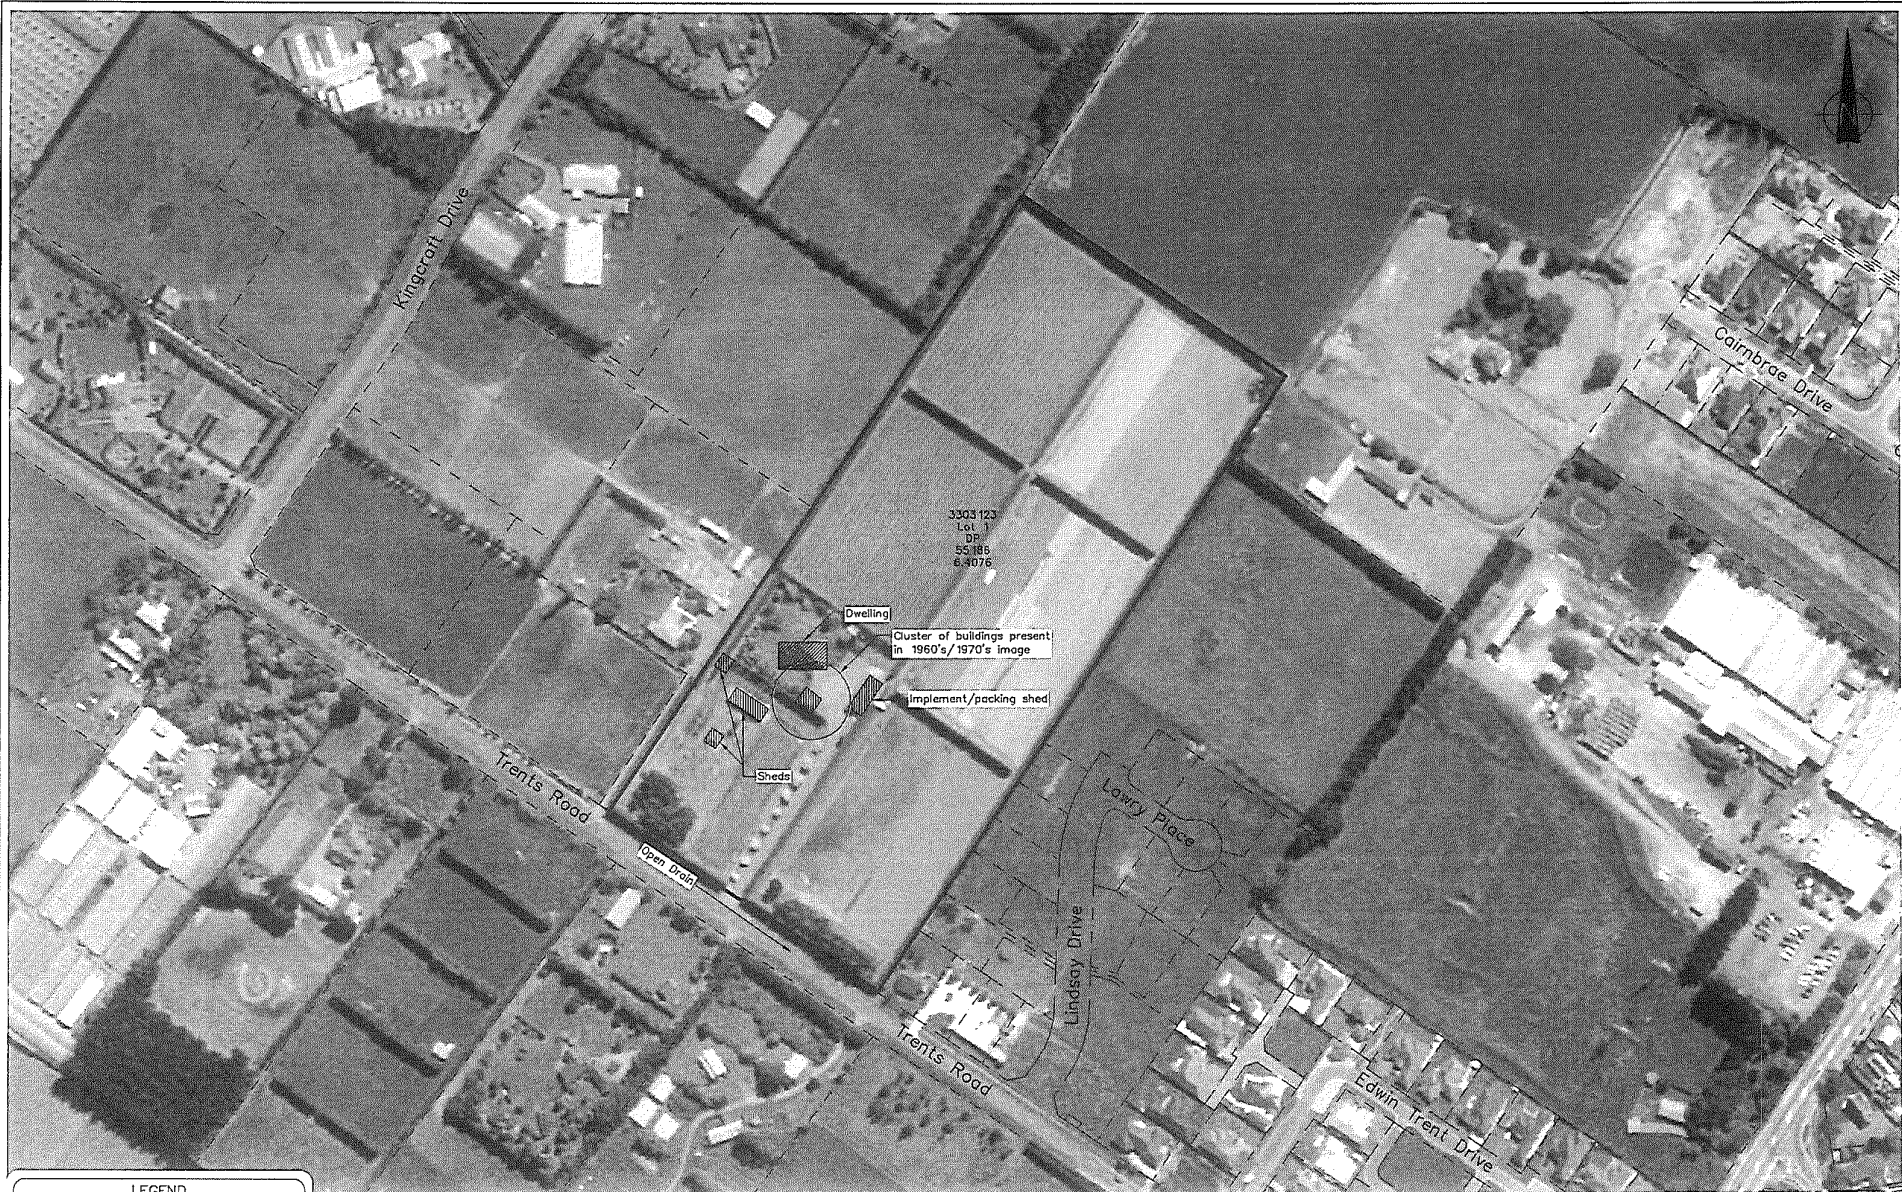
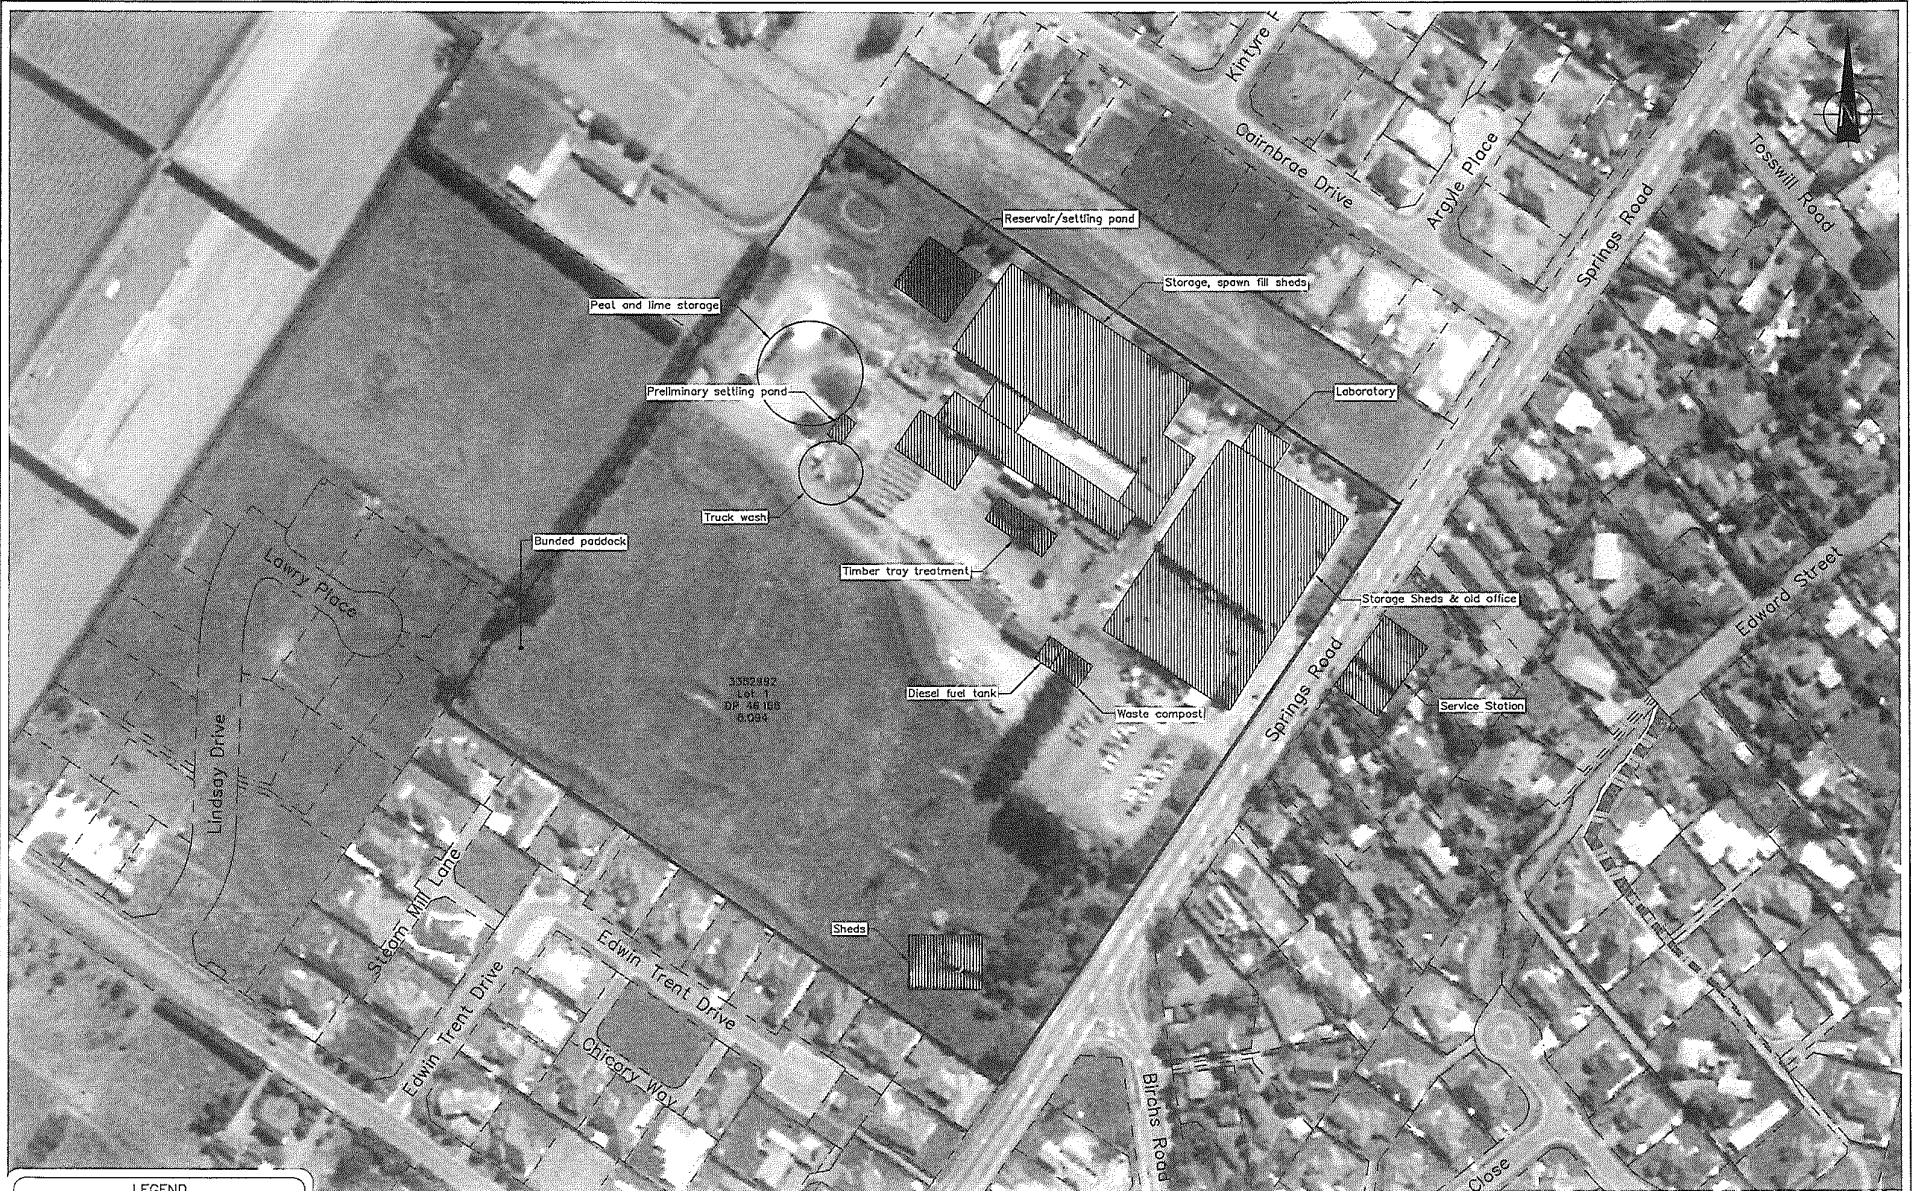
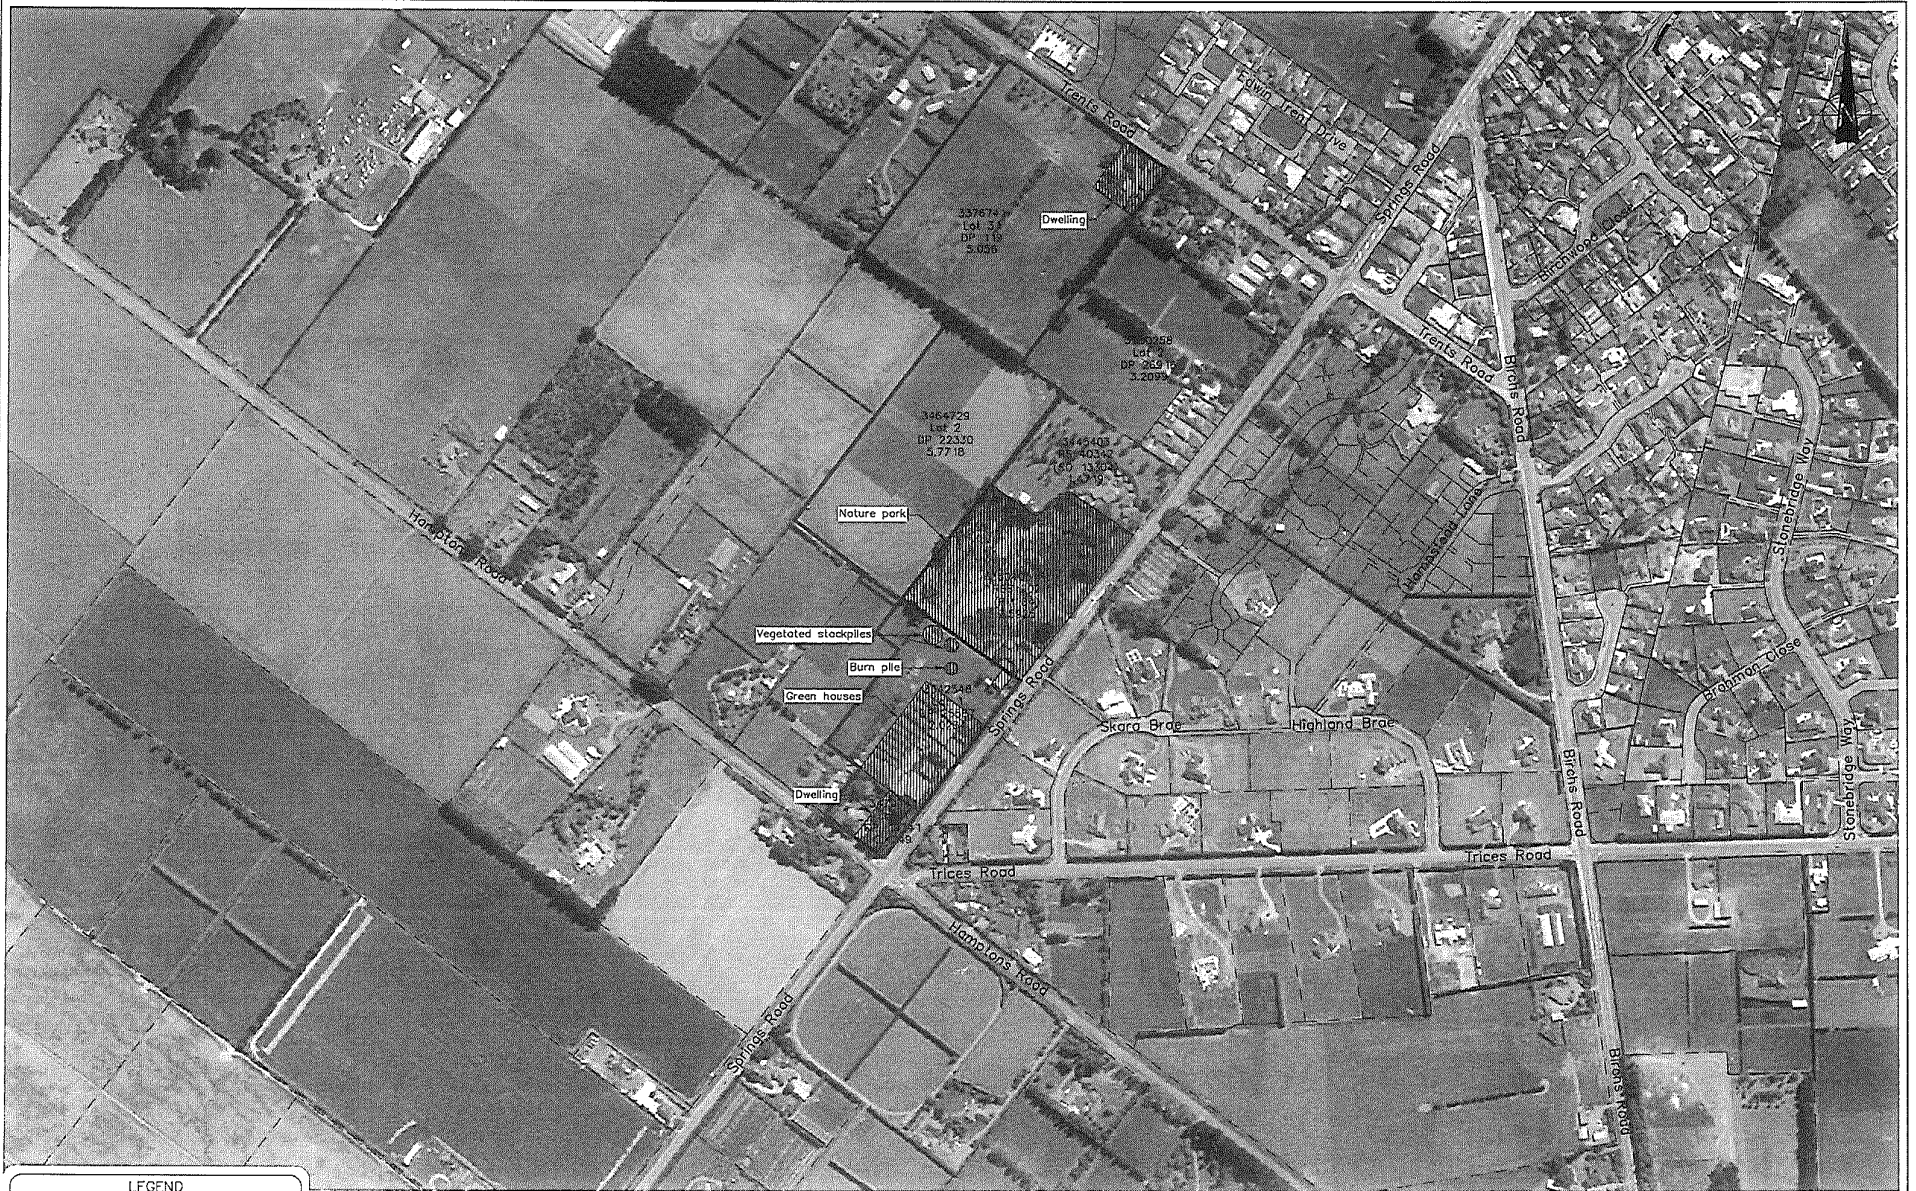
At all 6 sites, stormwater drainage is either via a swale or an open drain along adjoining roads. These are noted on Figures 1-6. All of the stormwater swales and drains lead to the town stormwater network or to Dawson Creek.
