Land Information Memorandum

1/378 Worcester Street

LIM number: H09024187

Christchurch City Council

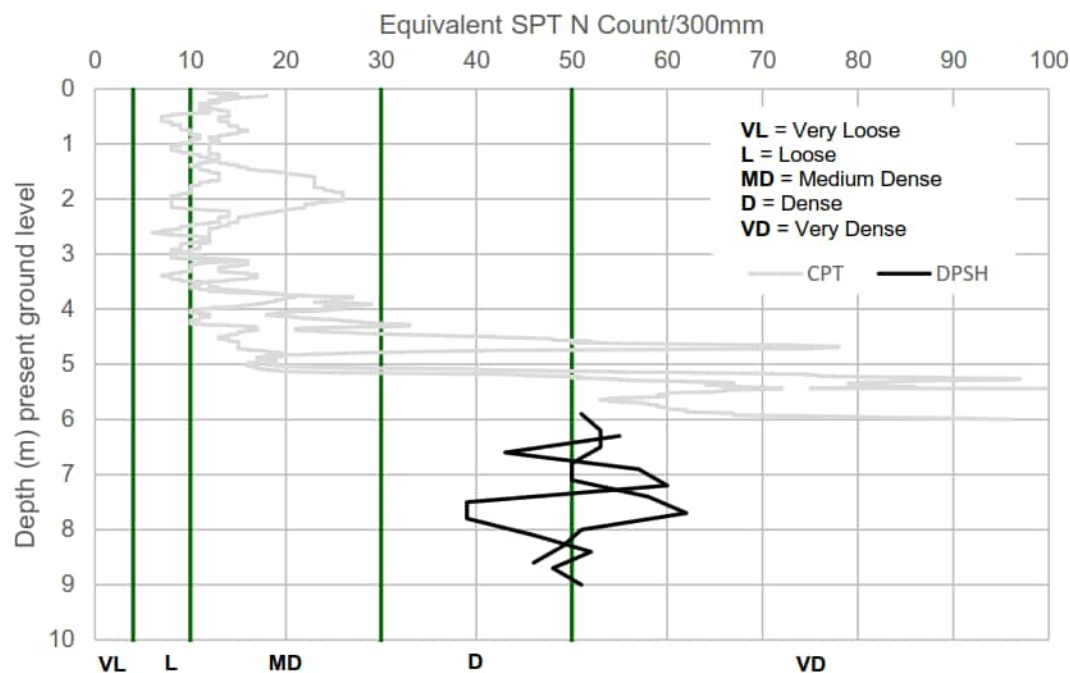
Graph 1: Relative density ground profile

The CPT data was interpolated via Geologismiki CPeT-IT Version 2.0 and a density profile representing both CPT and DPSH data is displayed in Graph 1 (below). The graph indicates loose to medium dense soil to approximately 5.0m, from this depth the relative density increases to dense to very dense. These horizons are inferred to be gravel and sandy gravel layers at depth. This inferral is based on the local NZGD borehole logs and CPT test inclination plot.

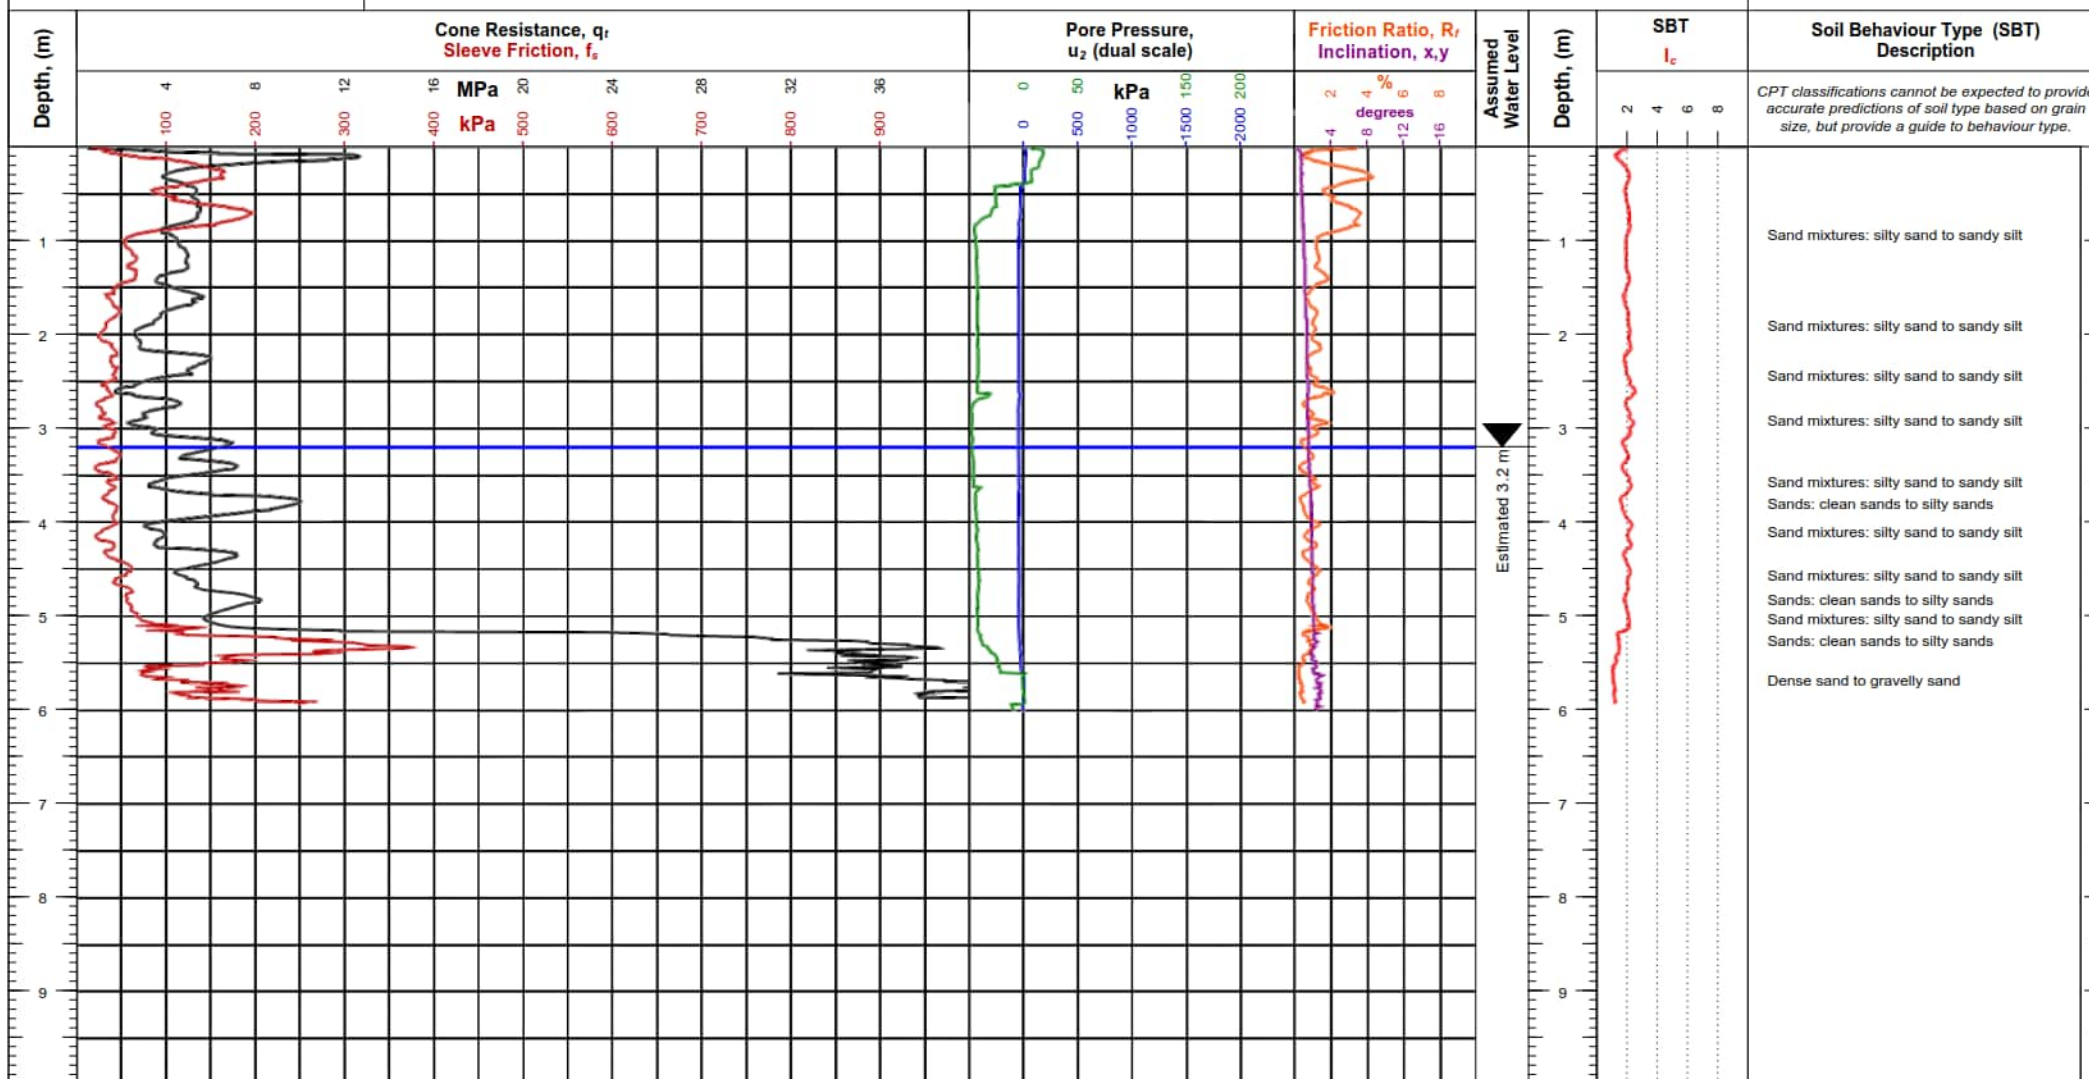
CONE PENETRATION TEST (CPT) LOG

Client: LandTech Consulting Ltd. Project: 378 Worcester Street Location: Linwood, Christchurch Engineer: Dwayne Wilson Contractor: Ground Investigation Ltd. www.g-i.co.nz Remarks: Continued with DPSH-02	Operator: Hayley Gray Cone Ref: MKJ311 Cone Type: 10 cm² Compression Area Ratio: 0.8 Filter Type: u2	NZTM2000 N,E (m): 5180135.18, 1572243.22 WGS84, (deg): -43.531210, 172.656487 Location Method: Handheld GPS Surveyor: N/A	Elevation (m): Unknown Date of Test: 20/12/2017 Depth (m): 6.01 Pre-Drill (m): N/A	Client Job Ref:
		Termination Reason: High cone end resistance		CPT Number: CPT-02
		G.I. Job Ref: 17-719
