Land Information Memorandum

Property address:
1 Teal Close

This report presents the results of a geotechnical investigation, liquefaction hazard assessment and foundation options assessment carried out by Coffey Geotechnics (NZ) Limited for 1 Teal Close, Woolson, Christchurch.

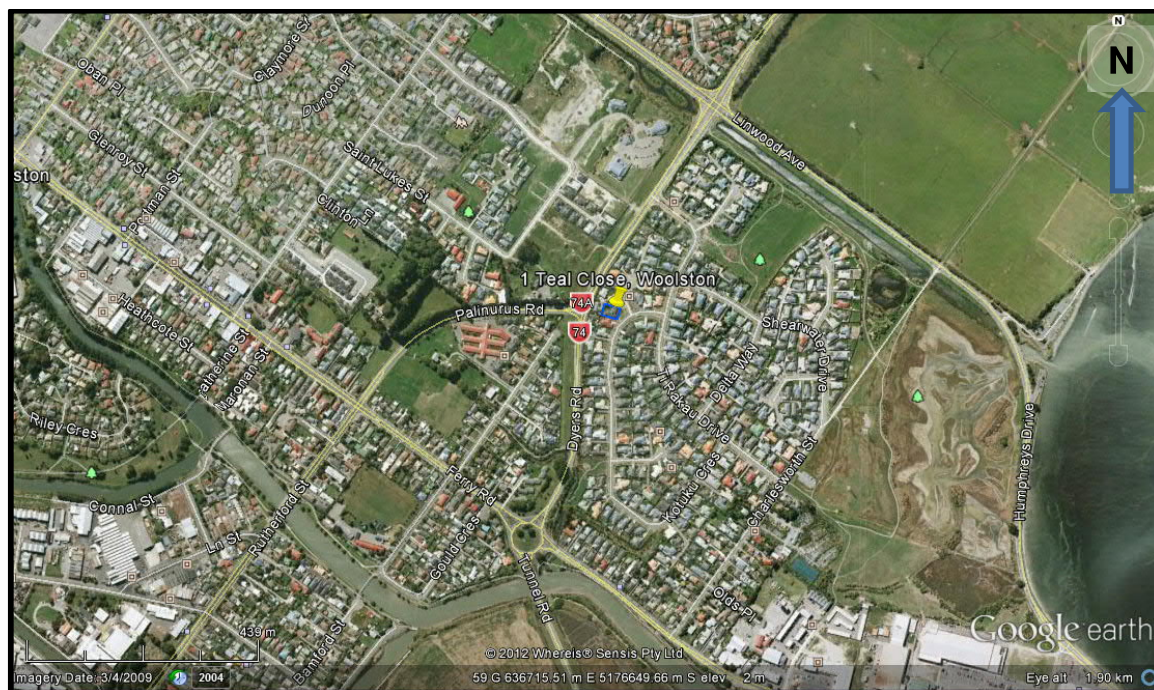
Figure 1 Site location plan (scale as shown)

The existing single-storey timber-frame dwelling has been constructed with brick cladding and a light iron roof. Foundations comprise concrete slab on grade. An attached double garage is located in the southeast corner of the house. The front of the house is facing southeast where the rear towards north and northwest. The site location is provided on Figure 1.

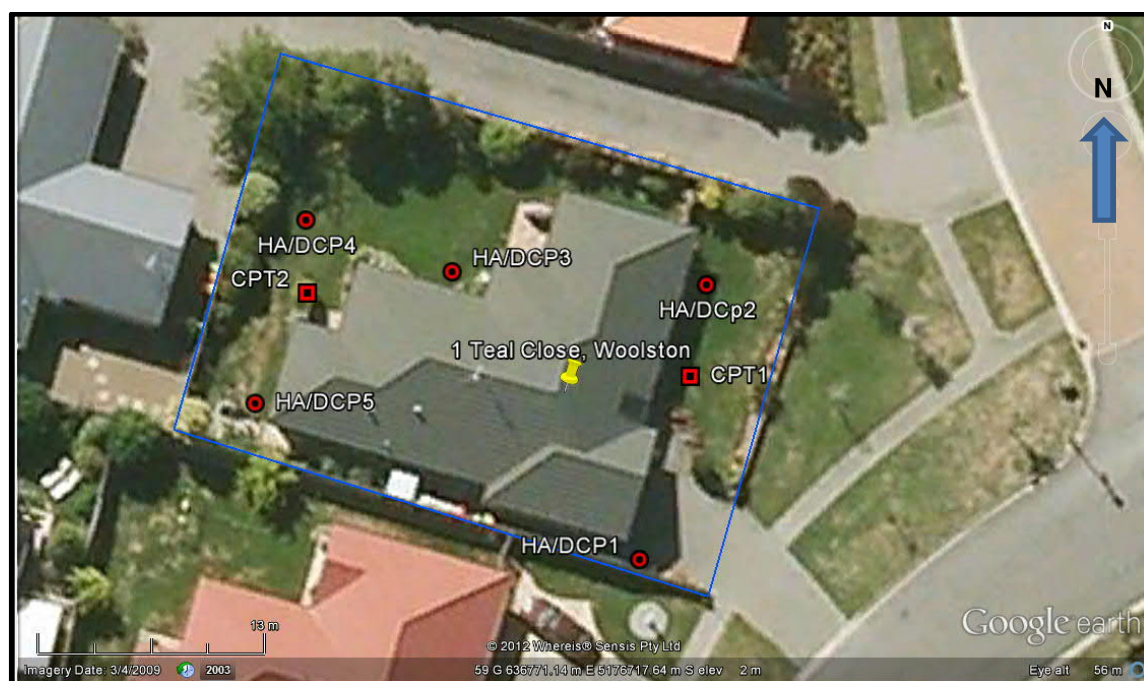
Figure 2 Ground investigation location plan (scale as shown)

A deep ground investigation comprising two piezocone penetrometer tests (CPTu) was carried out on 24 August 2012 by Perry Geotech Limited using a modular portable penetrometer. CPT1 reached 15.5mbgl and CPT2 15.1mbgl. The locations of the tests are shown below on Figure 2.

The ground conditions encountered during the investigation have been interpreted from the shallow hand-augured boreholes and CPTu signatures. The ground investigation confirmed that the site conditions are consistent with the published geological information.
