## Geotechnical Appraisal Report

139 Parnell Street, Rawene

*Ground and site feasibility for proposed minor development.  
Gumboots Consulting Engineers reference 1140*

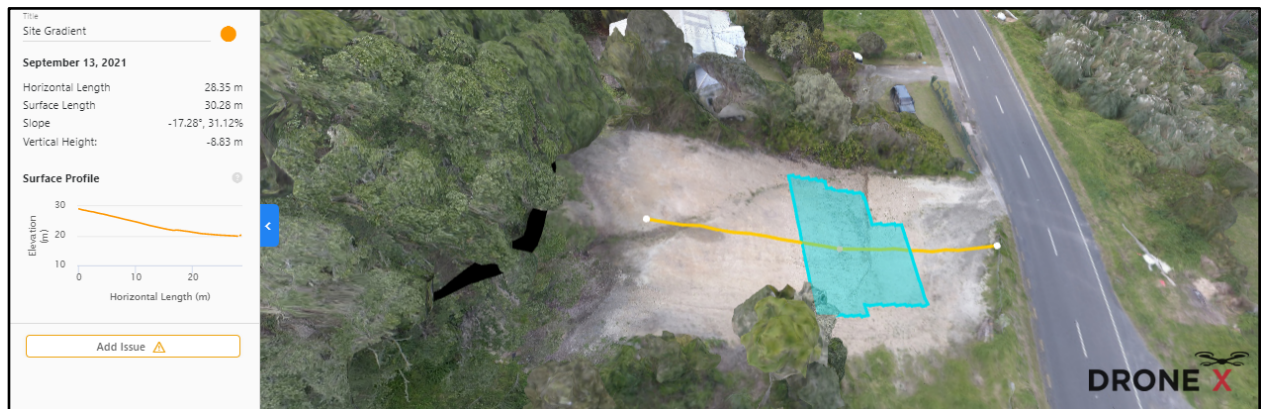
**Figure 1 - Site Gradient** (adapted from DroneX Aerial Survey).

The subject property (legal description Lot 2 Deposited Plan 10830) is an irregular shaped block (0.1180 ha). The property is moderately sloping ( $\cong 17^\circ$ ) eastward (as depicted in figure 1 below) and is located within the southern fringes of the Rawene Township.

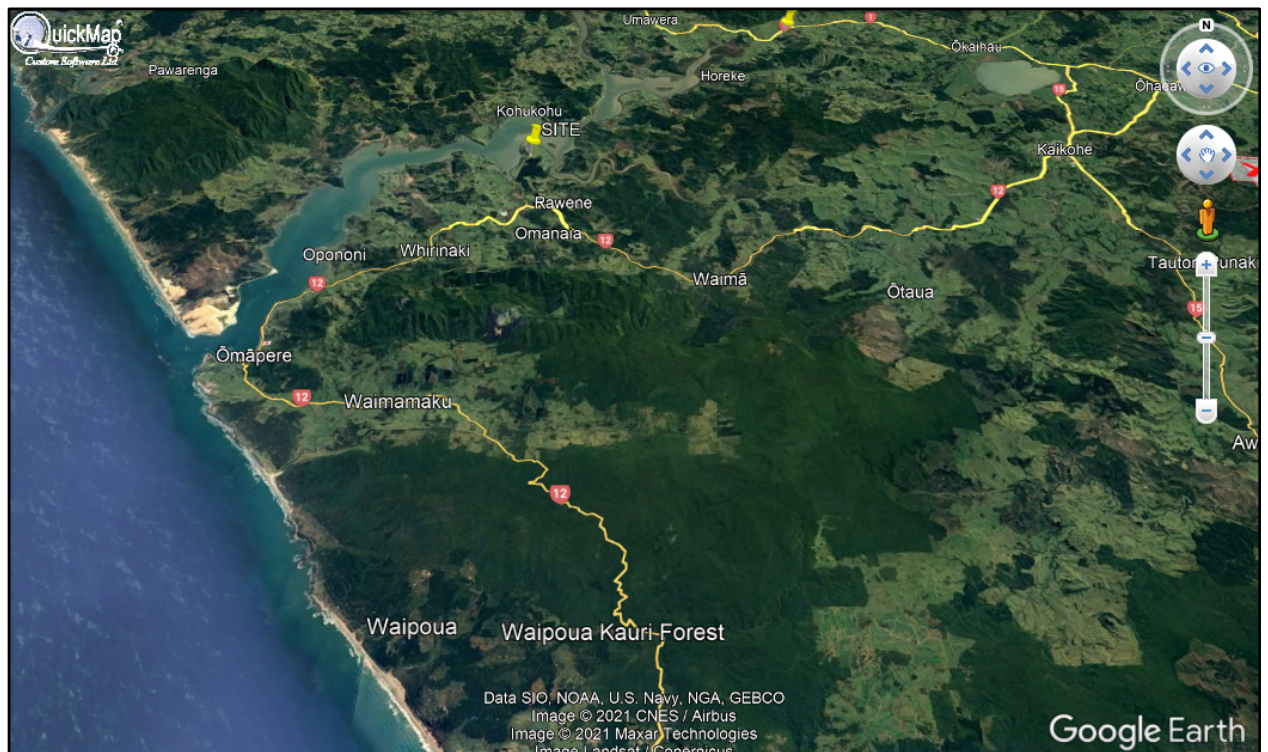
**Figure 2 - Macro Landscape** (maps adapted from Quick Map Enterprises and Google Earth Maps).

Depicts a prominent hilly country that is bisected by the Hokianga Harbour meandering inland [northeast-east].

Additionally, the higher overarching reaches of the adjoining Maungataniwha [Waima Forest] represent [within the wider north-north west] the overthrusting result of the Tangihua Complex (Kt) which overlies less dense sedimentary rocks of underlying thrust-bounded units.

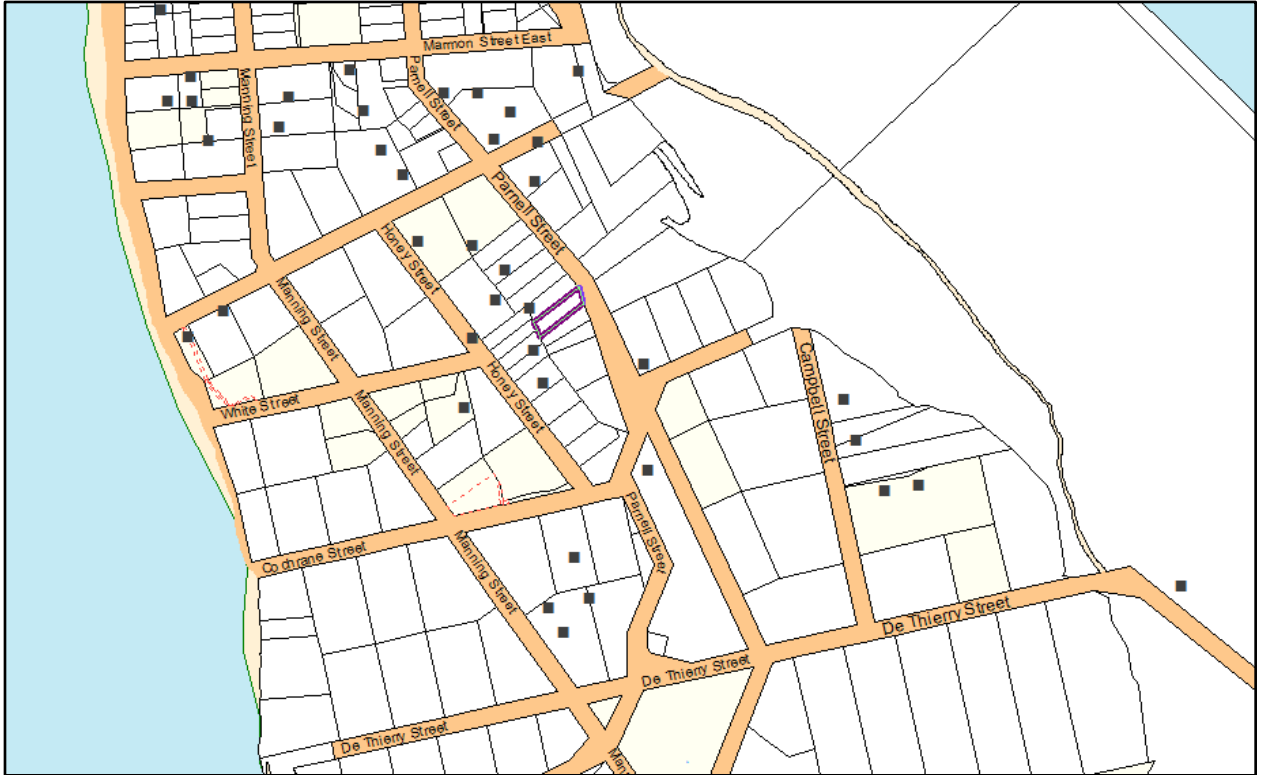
Plate 1 - South Rawene Settlement. (adopted from QuickMaps Enterprises).

Is predominantly residential living. A few houses had been implemented within the locale with the majority [older] along the northern/southern aspect.

The surrounding western aspect beyond Manning St is currently yet to be vacated allotments of the wider subdivision.

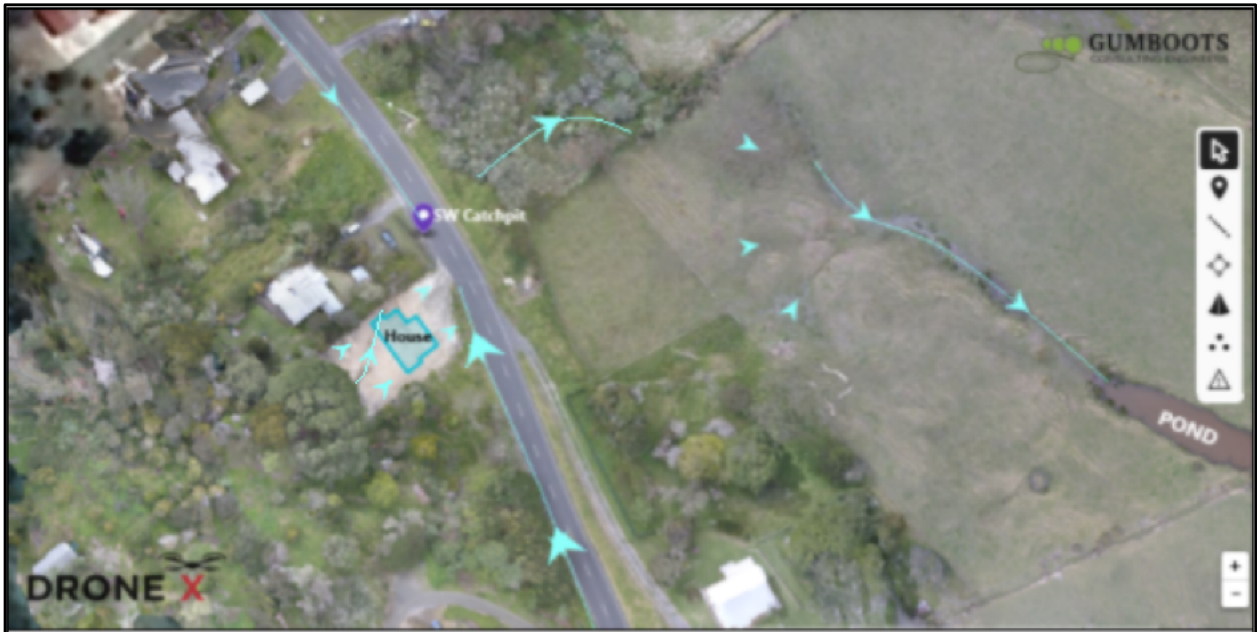
Figure 6 - PFP (map adapted from DroneX Aerial Survey).

The primary flow paths [PFP] are well defined and layed in a manner as to provide efficient conveyance of surface [storm] water away from the properties and eventual discharge into the Hokianga Harbour. As depicted in figure 6 below, PFPs are depicted in aqua.

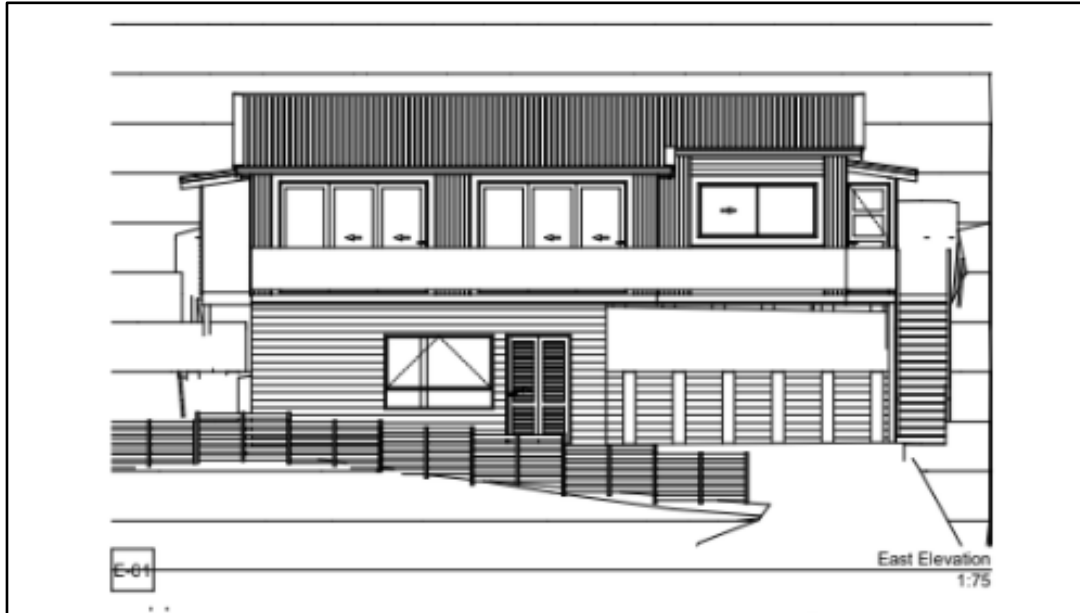
**Figure 7 - Site Development Proposal** (adapted from Hans Mitt Architectural Design 'Proposed New Home' Plans dated 17/09/21)

The proposed development is to erect a 3 bedroom home on a piled foundation system with parking/hardstand areas.

Primary flow paths are well defined/established in support of the property. It can be conceived that the proposal intention shall incorporate these features as vital to equilibrate the implementation and the existing land in sustaining LIFE in all aspects.

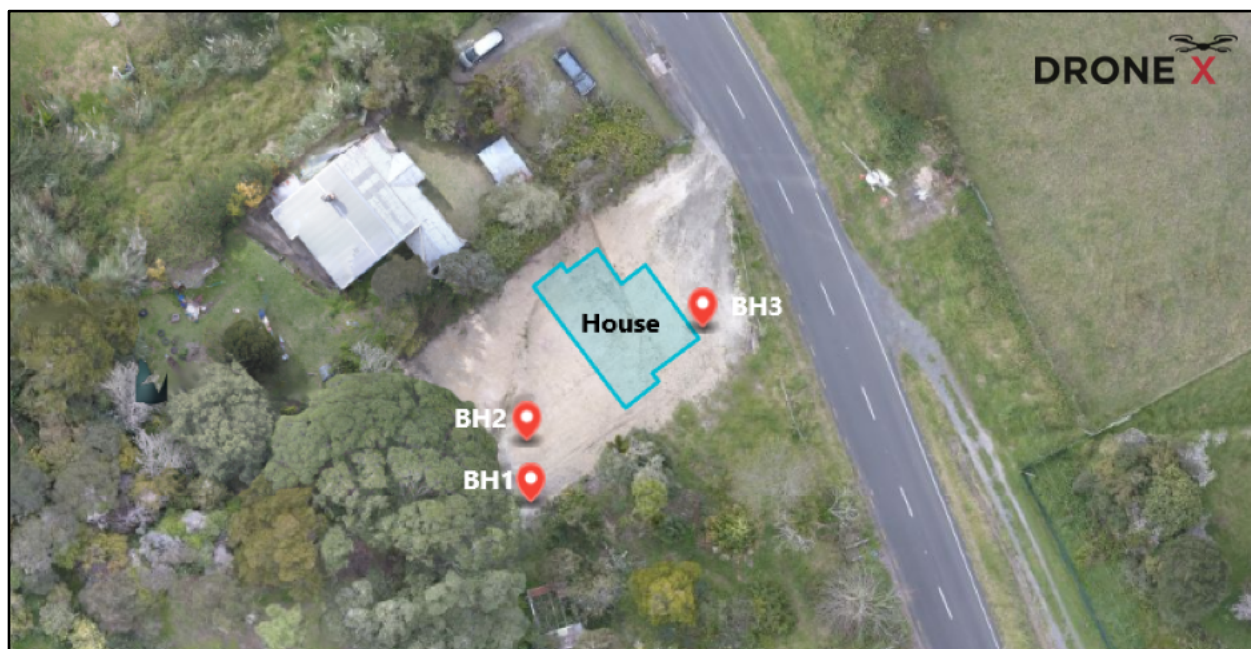
Figure 8 - Borehole Location Overview (adapted from DroneX aerial survey.)

Further advancement within the BH1-BH2 were achieved through a series of DCP<sup>3\*</sup> tests at terminated depths in the order of 1.10m to 1.60m within the respective boreholes.

In addition, an aerial survey was also carried out to enable further observations of the estate.

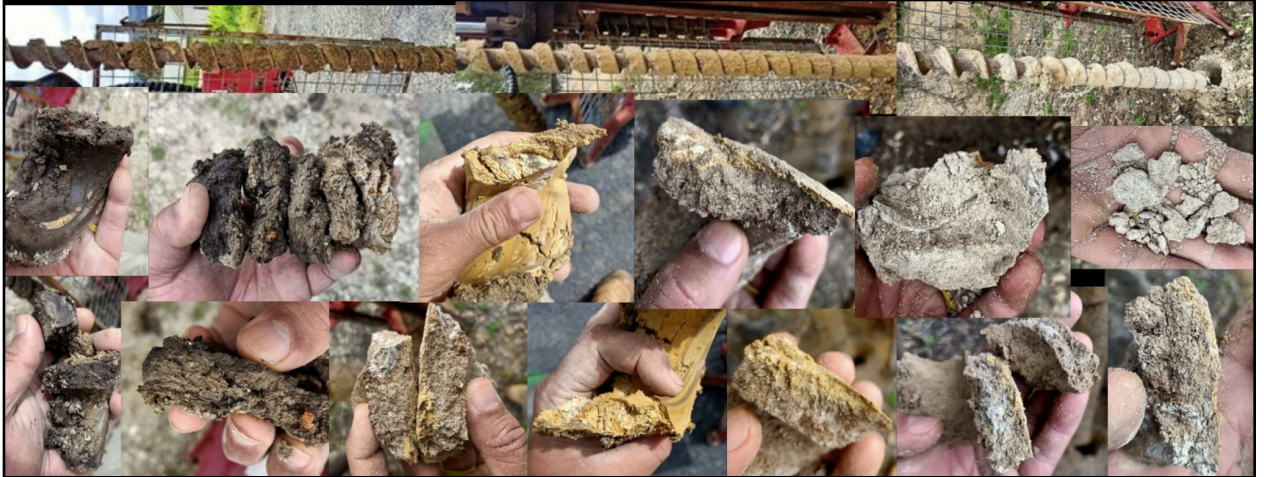
Figure 9 - Natural Soils Onsite - BH1 borings (adapted from the DroneX Survey).

The mechanical auger met refusal within this range [0.70m -1.20m] below ground level. The soil mantle is considered shallow along the ridge line as opposed to the lower relief side [BH3]. As depicted in Figure 9.

The cream coloured soils depict the highly weathered well cemented mud/sandstone.

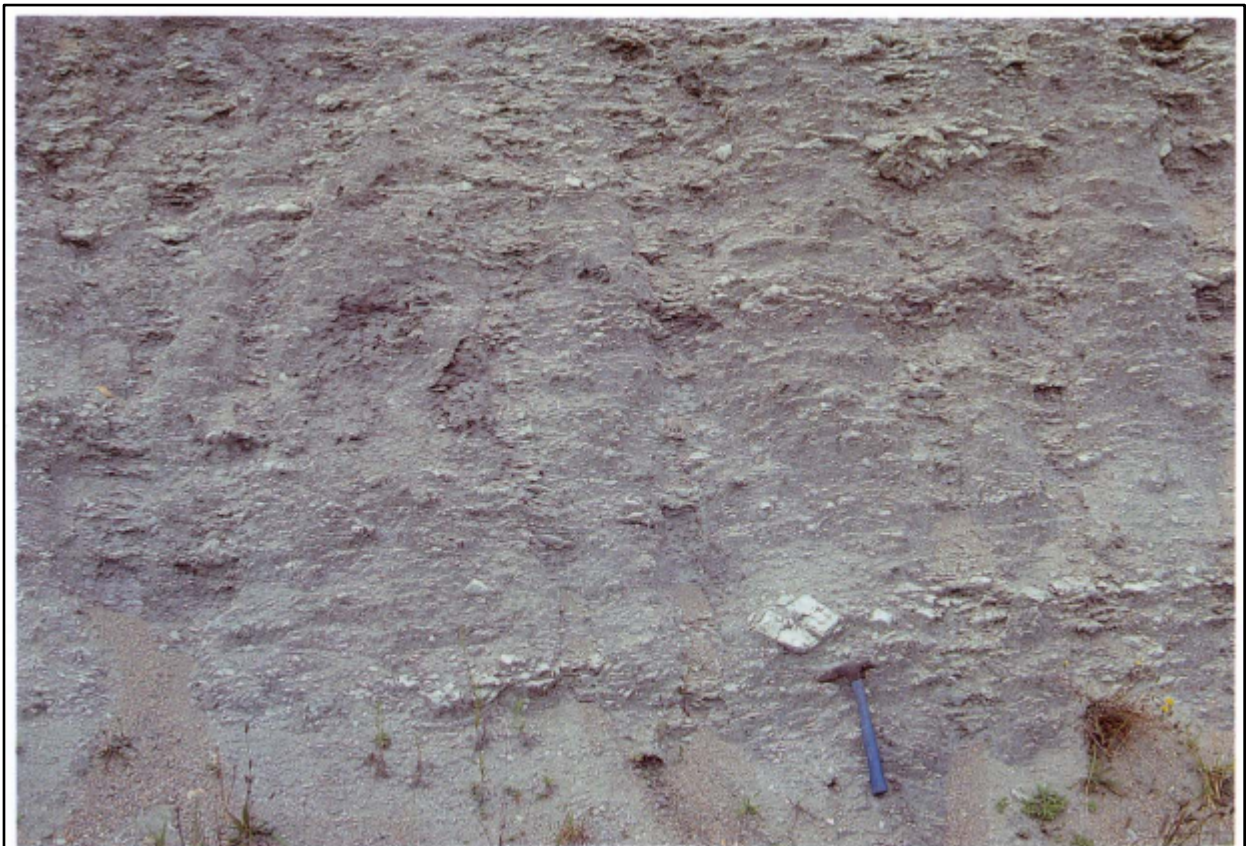
**Plate 2 - Whangai Formation.**- [Geology of the Kaitaia Area. Institute of Geological & Nuclear Sciences; 1: 250,000 geological map 1. Lower Hutt, New Zealand.].

**Figure 16** Broken formation of originally well bedded siliceous mudstone of the Late Cretaceous Whangai Formation results from layer-parallel shearing during allochthon emplacement. This road cut exposure at Mohuiti is close to the Maungataniwha Thrust, which here separates Whangai mudstone from overlying rocks of the Tangihua Complex (O05/542593).

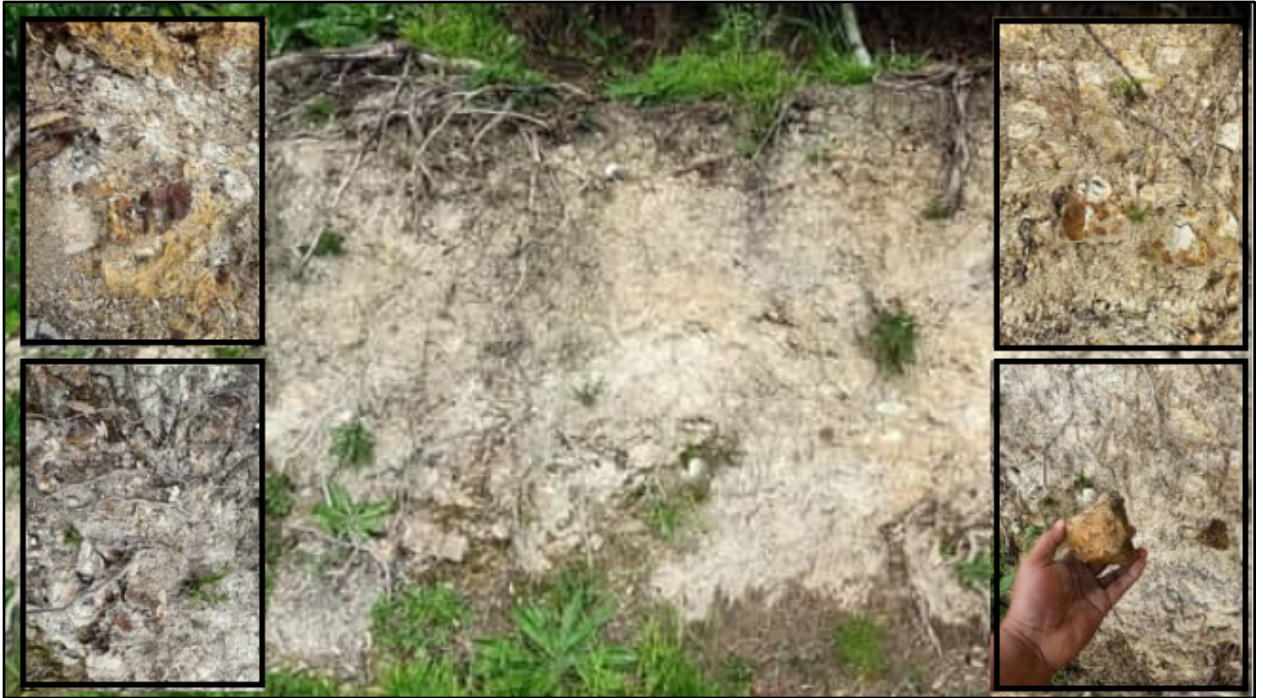
Plate 2 - Natural Soil Stratification Onsite (Adapted from DroneX Aerial Survey)

Whangai formation is typically 300-500m thick. The siliceous mudstone is commonly quarried for low-grade roading material. Below depicts the bedded mudstones observed within the mantle [site cut] onsite.

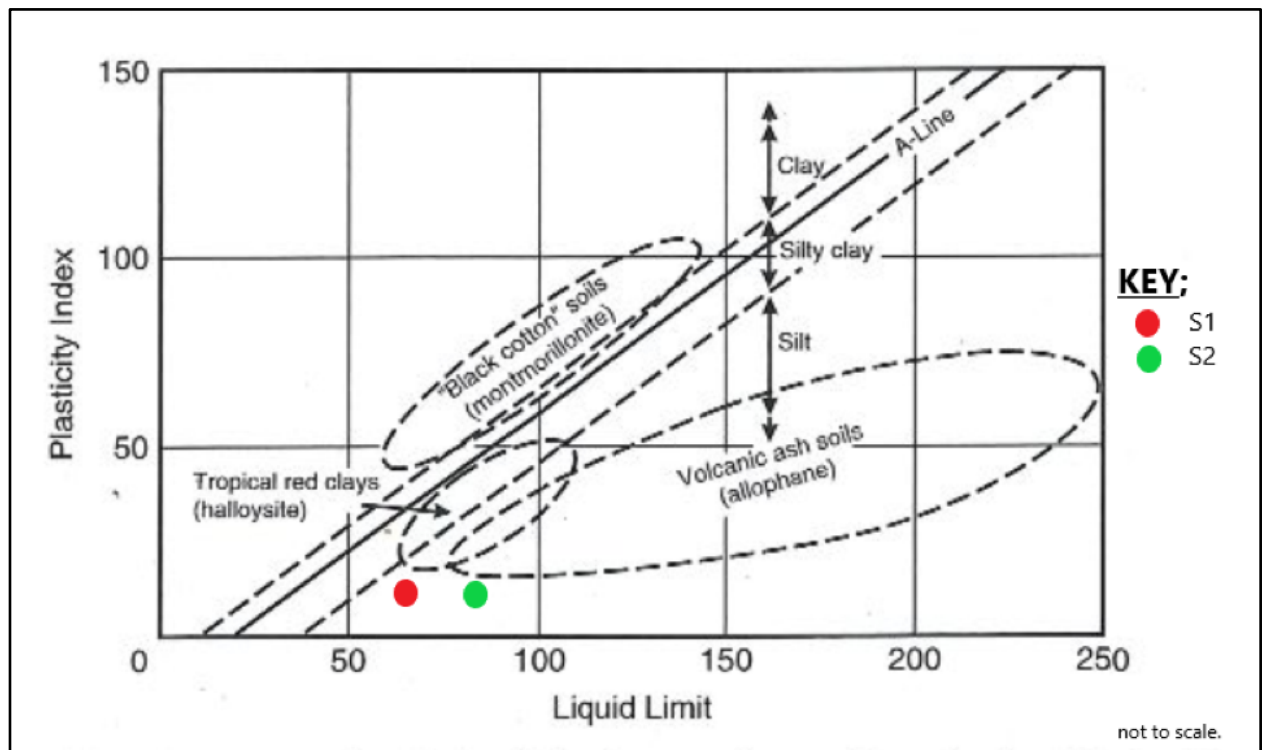
Plate 3 - Plasticity Chart.- [Cassagrande].

Soils that plot below the A-line generally have *good engineering* properties. The opposite is true for soils plotted above the A-line.

All in all, it can be concluded that the soils encountered onsite are in a *compact state*<sup>5</sup>. Consequently, the natural moisture content presented within at the [sampled] time is in the order of 21% - 22%.

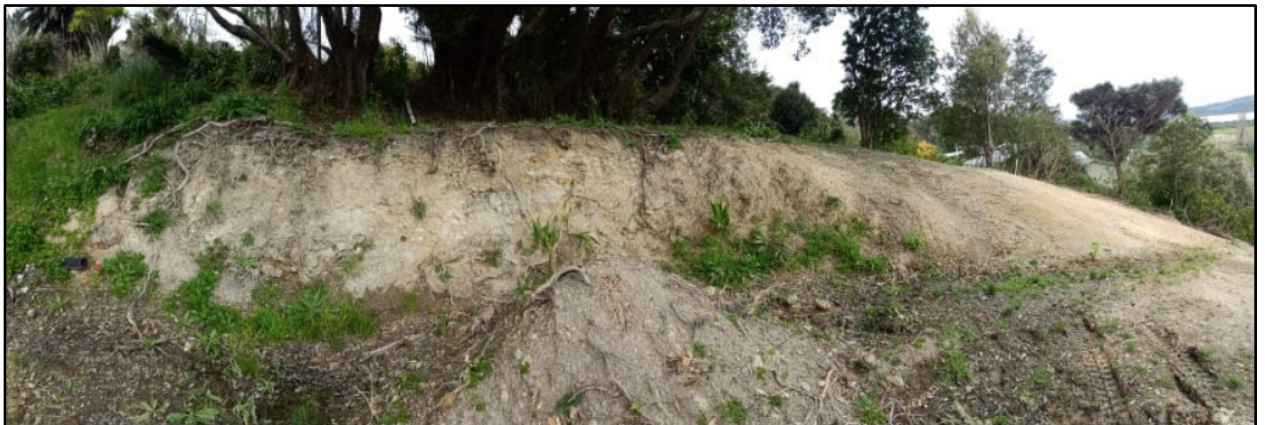
**Plate 4 - Site cut onsite** (Adapted from DroneX Aerial Survey)

Within the site shall be retained as appropriate. SED of retaining wall shall be undertaken for all cut phases subjected to surcharge.

The above plate depicts a site cut  $\sim 2.70\text{m}^6$  observed within the western portion of the site. This shall be retained as appropriate.

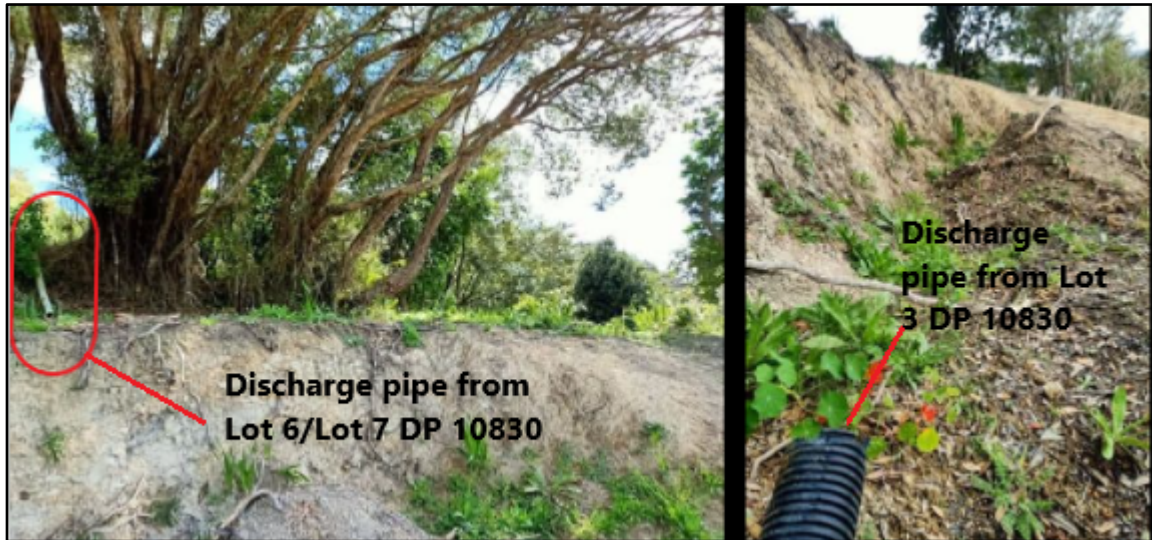
Figure 11 - Stormwater Discharge

Onto the site shall be redirected away from the property as appropriate. As depicted below, two pipes assumed as overflow were observed to discharge directly onto the property at present.

It is recommended that this is taken into account and addressed within the overall site development/design plans.

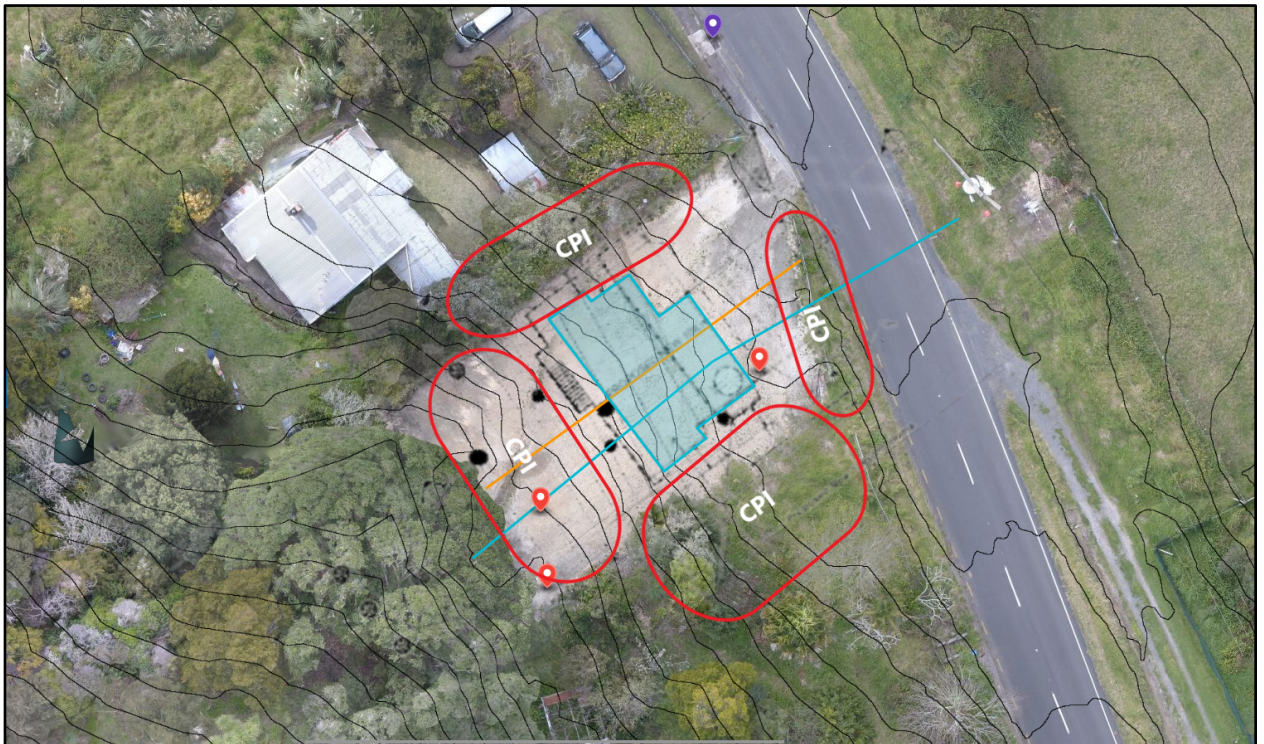
**Figure 13 - Critical Areas** - (adapted from the DroneX Survey).

In this instance, the *critical point of interest [CPI]* primarily lies within Lot 1 DP 10830 and Lot 3 DP 10830. Anthropogenic i.e. excavations/undercutting activities in this space shall be carefully understood wholly [undermining effects] prior execution of work.

Specifically in account of resultant adverse effects of such undertakings to the subject property and allowing for safeguard provisions hereon.

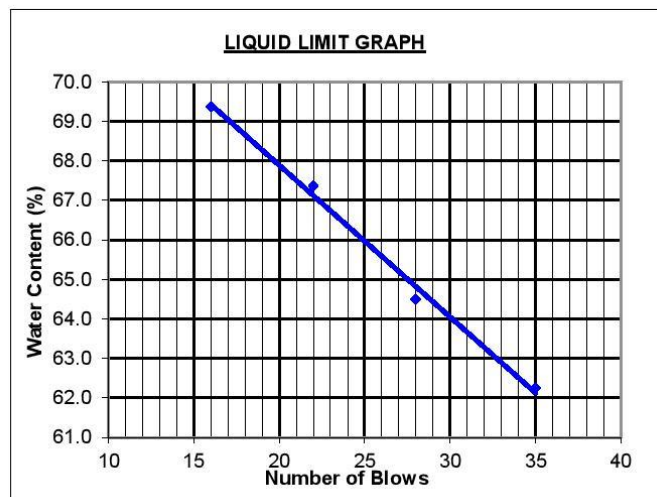
**Description of Sample:** Silty CLAY, minor sands to 2mm, grey mottled brown and yellow, dry

Liquid Limit				Plastic Limit		NWC	16.5
No. of blows	16	22	28	35			Liquid Limit	66
Water content (%)	69.4	67.4	64.5	62.2	22.2	22.4	Plastic Limit	22
							Plasticity Index	44

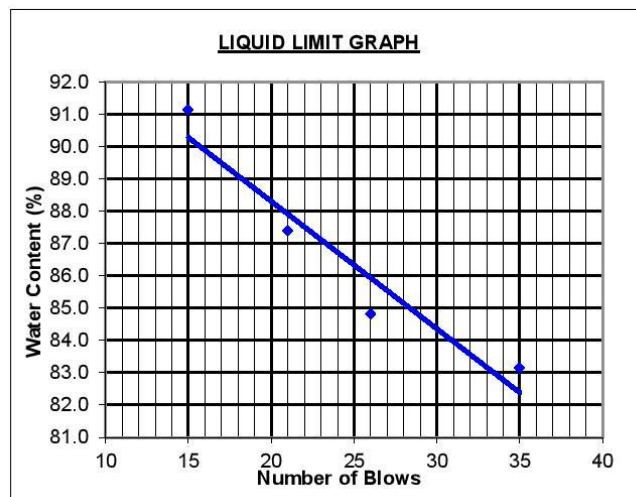
**Description of Sample:** Silty CLAY, traces of sands to 2mm, light yellow brown mottled orange and grey, moist

<b>Liquid Limit</b>				<b>Plastic Limit</b>		<b>NWC</b>	<b>32.4</b>
<b>No. of blows</b>	15	21	26	35			<b>Liquid Limit</b>	<b>86</b>
<b>Water content (%)</b>	91.1	87.4	84.8	83.1	20.9	20.9	<b>Plastic Limit</b>	<b>21</b>
							<b>Plasticity Index</b>	<b>65</b>
