Tauranga City

Land Information Memorandum

Applicant	Bower Real Estate
Client	K Steward & A Burr
Property Address	16 Okataina Street Tauranga
Legal Description	Lot 2 DP 514907 1/2 Share of Lot 3 DP 514907 1/4 Share of Lot 973 DP 507200
Application Date	2 April 2026

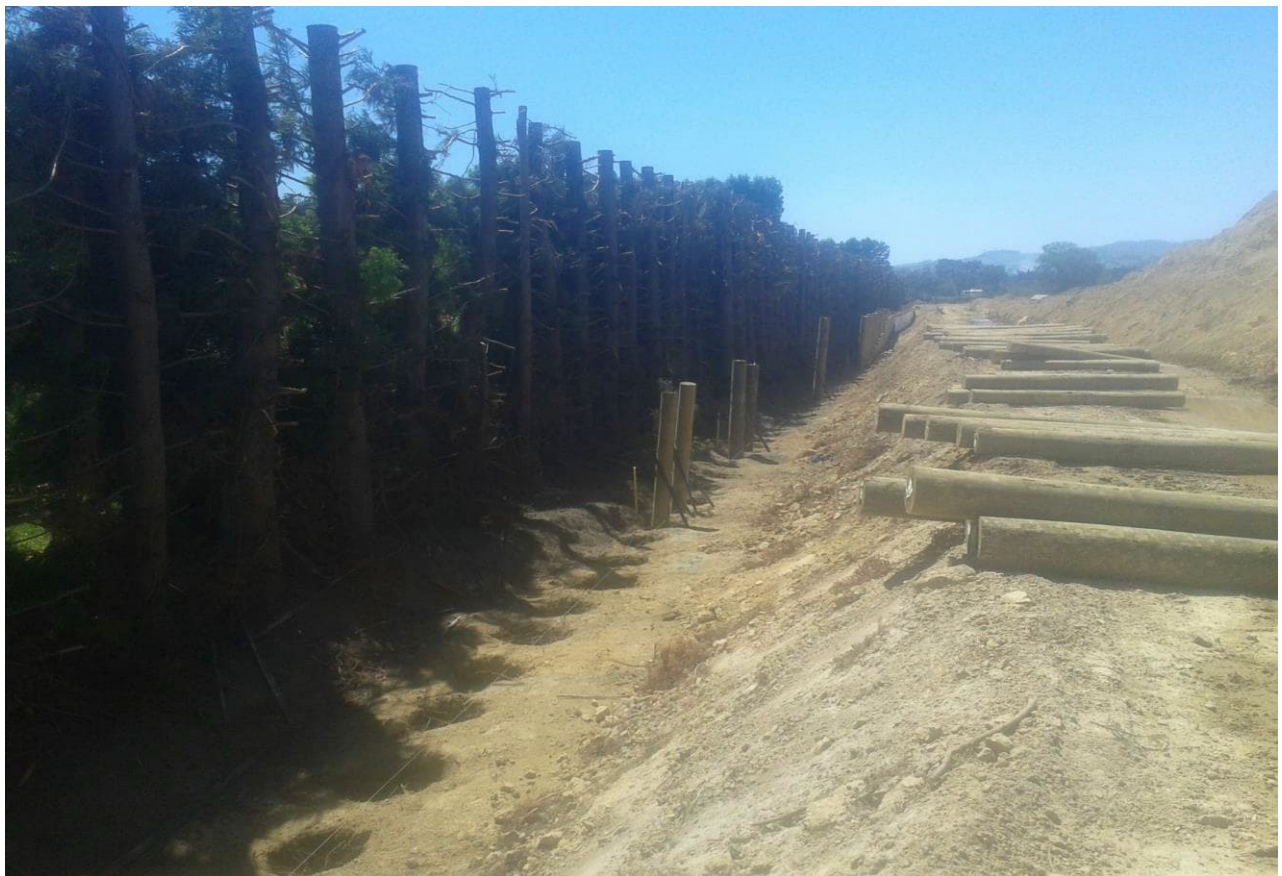
Photograph 2: Photo taken on the 22/11/16 of the placement of piles.

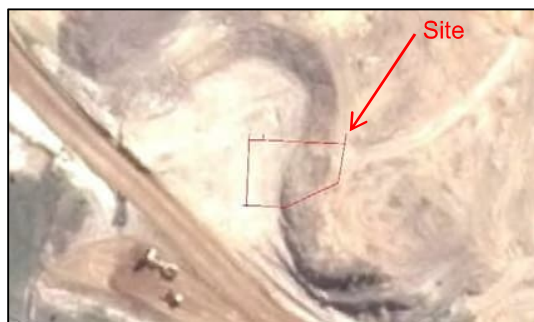
Photo 2: Aerial photo 6 March 2016

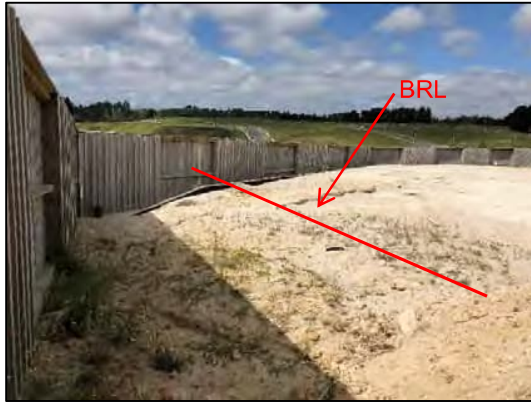
Photo 6: Site facing west

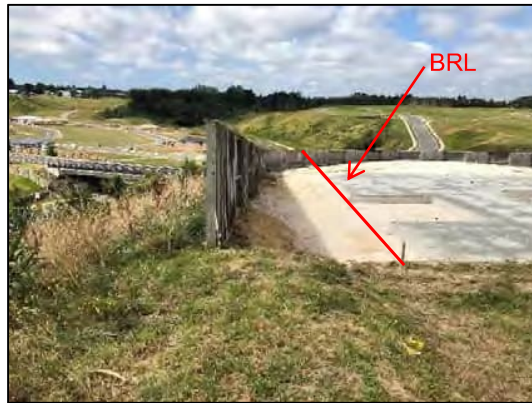
During the site visit, fill material was observed between the southern retaining wall and the privacy fence. This material had evidently collected as a result of erosion of fill from the building platform. The client had excavated a small pit which indicated the depth of this material was on the order of 0.5m. See photos 9 and 10 below. The fill material does not appear to have left the property. See photos 11 and 12. The client advised that this material would be removed from between the retaining wall and fence.

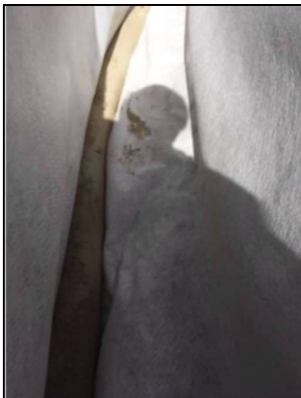
Photo 2: Drainage metal
