# Land Information Memorandum

Property address:  
55 Plynlimon Road

LIM number: H10911007

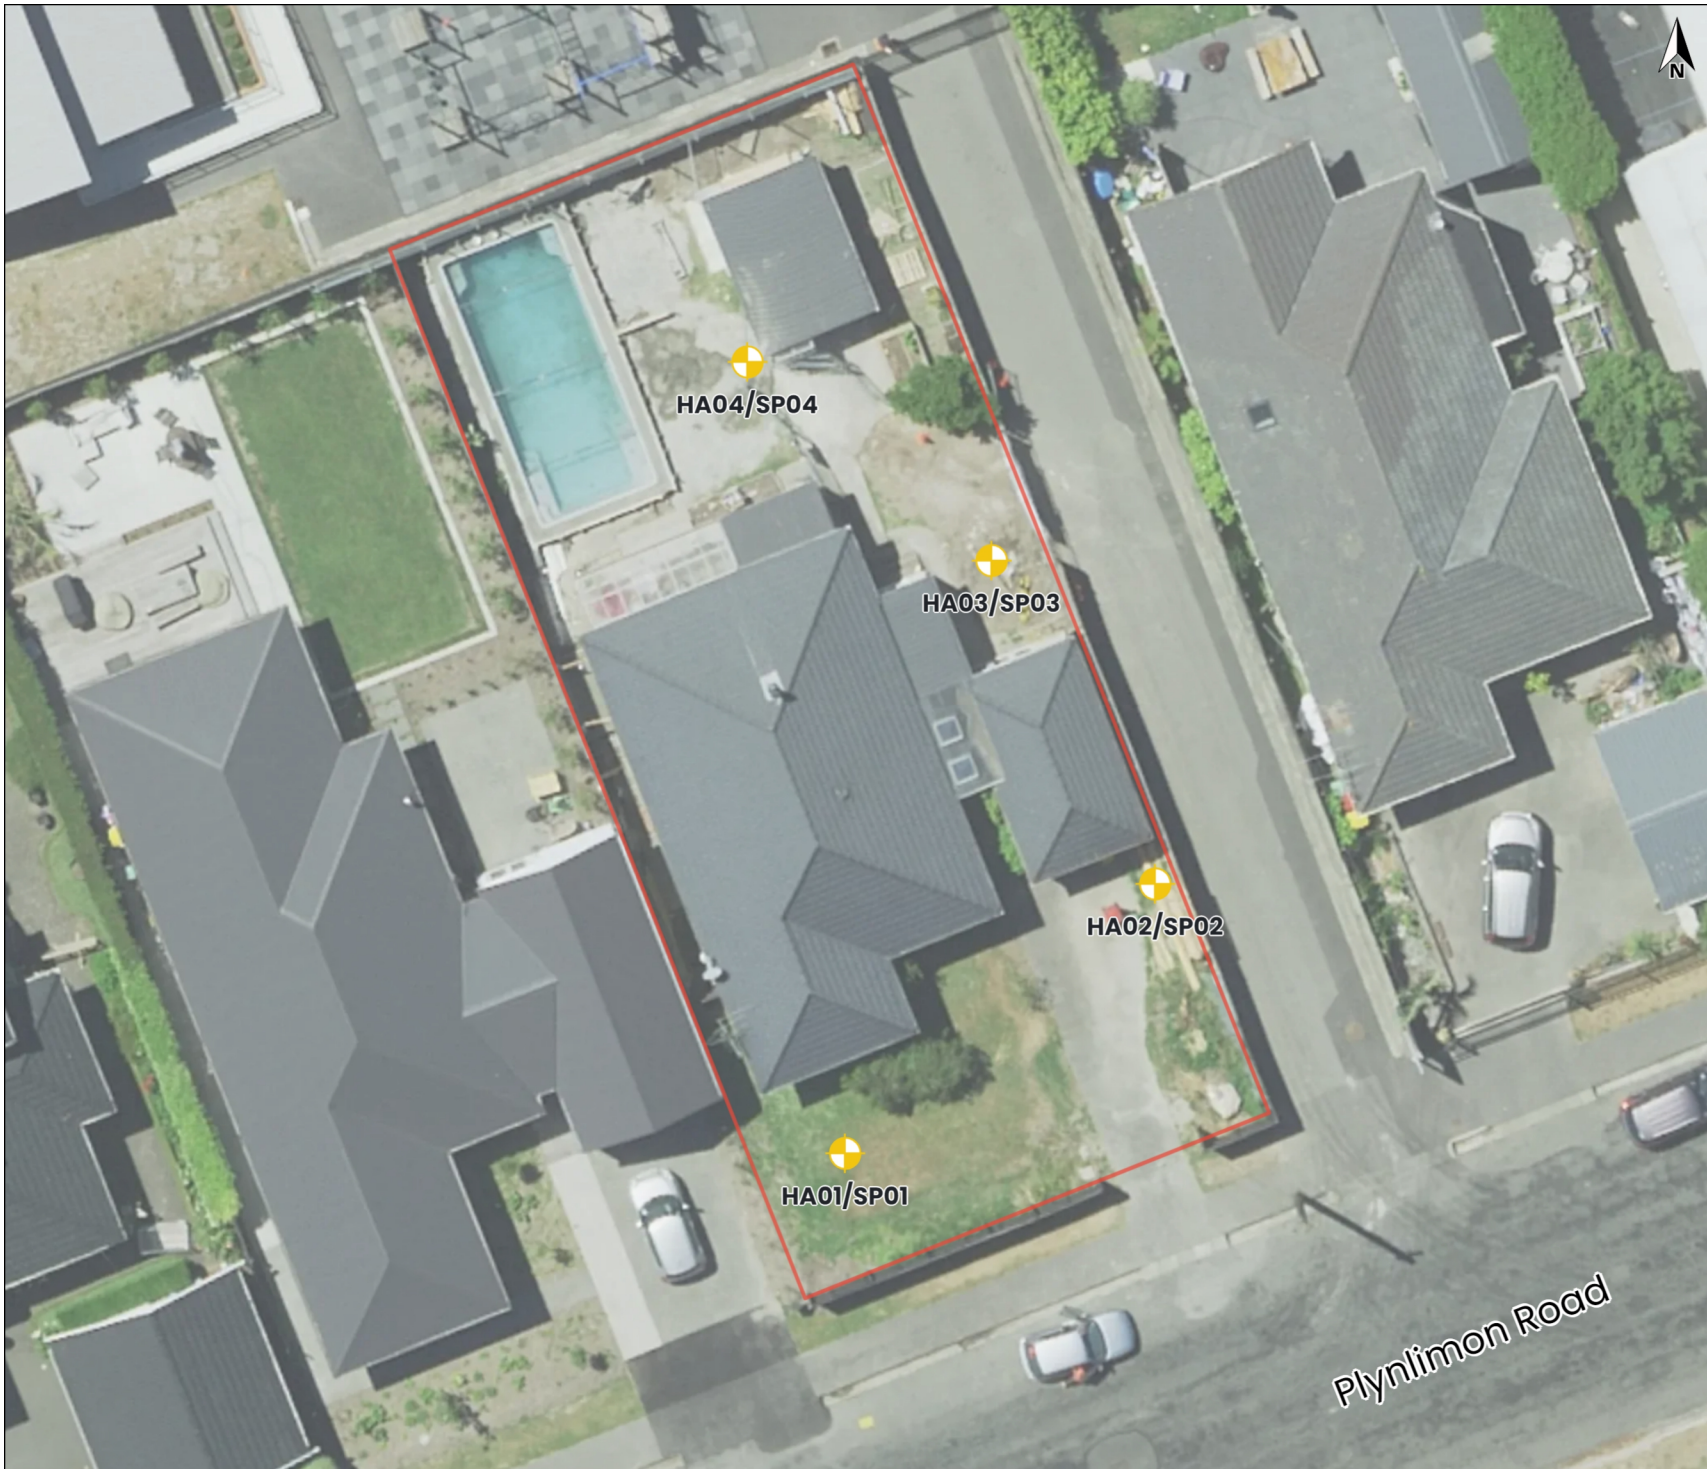
- ✚ Hand Auger Boreholes and Scala Penetrometer Tests
- Site Boundary

The exploratory test locations were selected to provide representative indications of the subsurface ground conditions within the area being assessed. The test locations are shown on our Site Plan.
