# Land Information Memorandum

Property address:  
4 Wherstead Road

# Geotechnical Report For Proposed Subdivision

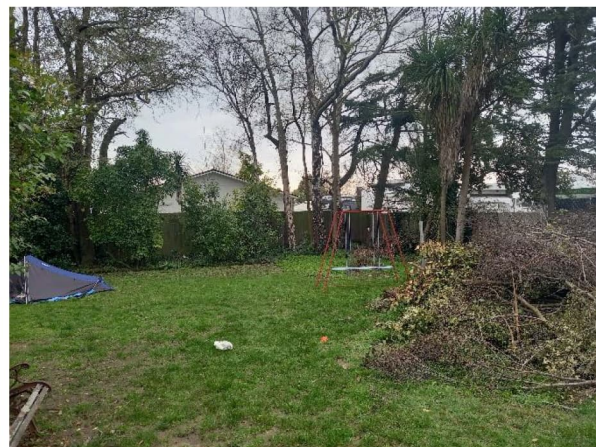
*Figure 5: View of the rear yard comprising the area to be subdivided, looking northeast*

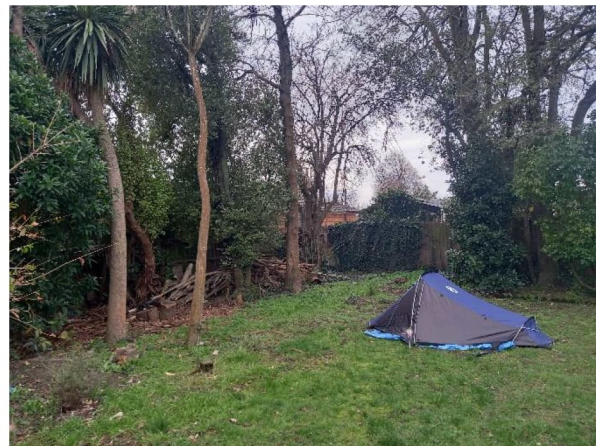
*Figure 7: View of the trees at the rear of the site looking north.*

The root systems of the trees on the northeast half of the site might pose a geotechnical constraint to the construction of a shallow foundation system. Due to the historic dwelling and residential land use, the presence of local areas of fill or buried rubbish cannot be ruled out, though no evidence of this was observed.
