# EARTHQUAKE RECOVERY (EQR) DOCUMENTATION

# EQR Property Overview Report

| EQC Property ID | Property Address | Vulnerable? | Property F Status | Property Finalisation Indicator | | |
|---|---|---|---|---|---|---|
| 2010027427 | 5 DUDLEY STREET, RICHMOND | | F3 - Complete & Finalised | Some Finalisation has taken place | | |

### 5 Dudley Street, Richmond

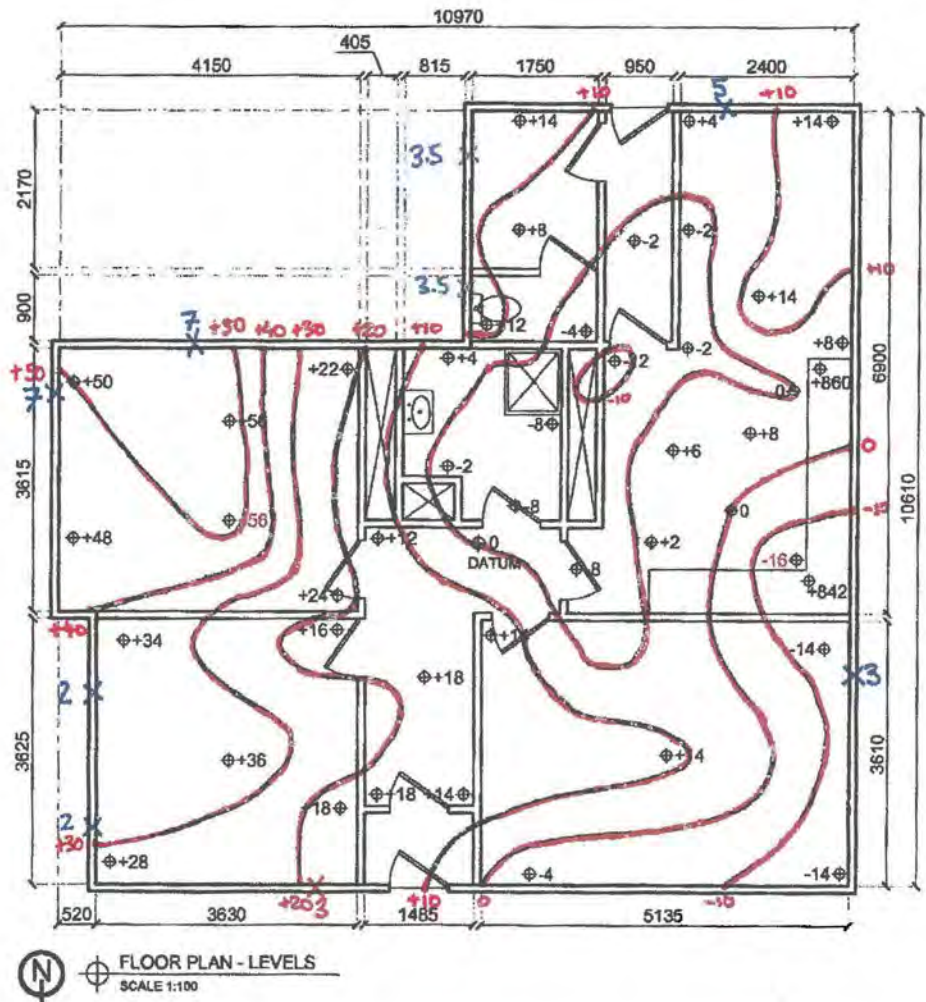
Notes:  
 Levels adjusted for floor coverings  
 Zero OK

~ 10mm contour lines  
 X Cracks in Ring Beam

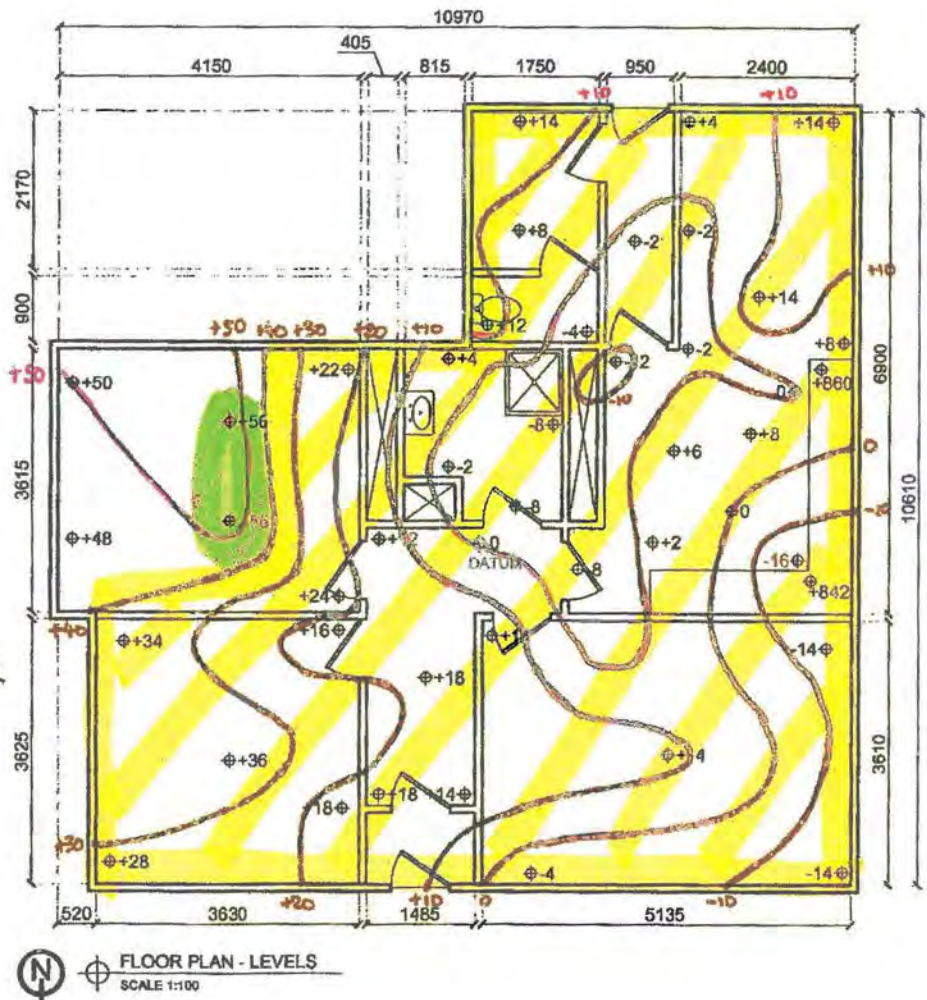
Notch Bearers T.L. = +50

\* Bricklite veneer to be removed completely.  
 Weatherboard to be removed as required to expose structure.  
 Ring beam top surface to be re-levelled with Sikka Monotop 412 to provide level surface for replacement cladding.

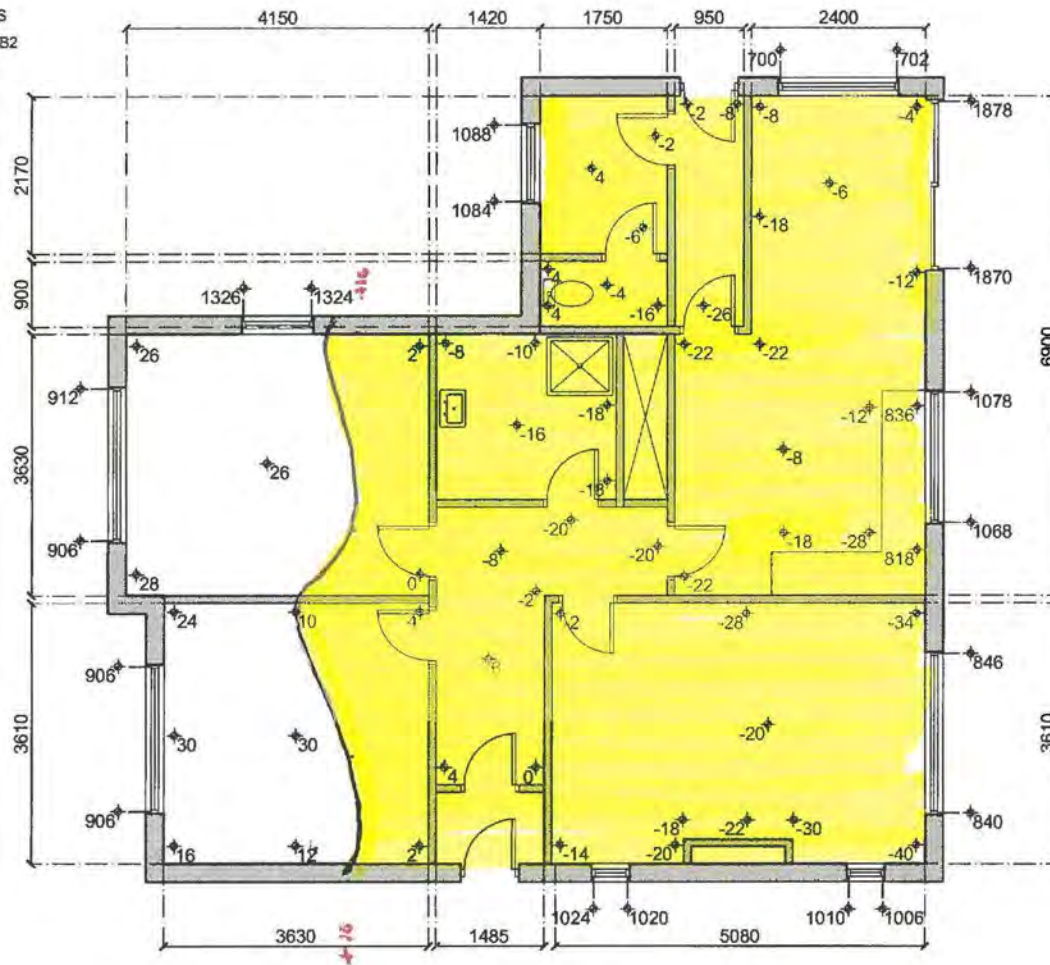
**LEVEL SURVEY - GROUND FLOOR**

A level check was undertaken to determine the relative variation in floor heights throughout the dwelling – refer to SK3. This check was conducted using a Zip level with an accuracy of  $\pm 2\text{mm}$ . Variations in height due to differential floor coverings and minor steps have been taken into consideration. The following was observed:

TARGET LEVELS PROVIDED ARE A GUIDE ONLY. IT IS THE RESPONSIBILITY OF THE CONTRACTOR TO MONITOR DOORS AND WINDOWS, ANY HORIZONTAL SURFACES AND ALL LININGS. IF DAMAGE IS RESULTING DUE TO FLOOR RE-LEVELLING, WORK SHOULD BE STOPPED IMMEDIATELY. RE-LEVELLING IS TO BE PERFORMANCE BASED AND FINAL LEVELS A RESULT OF RETURNING FUNCTIONALITY TO THE DWELLING.

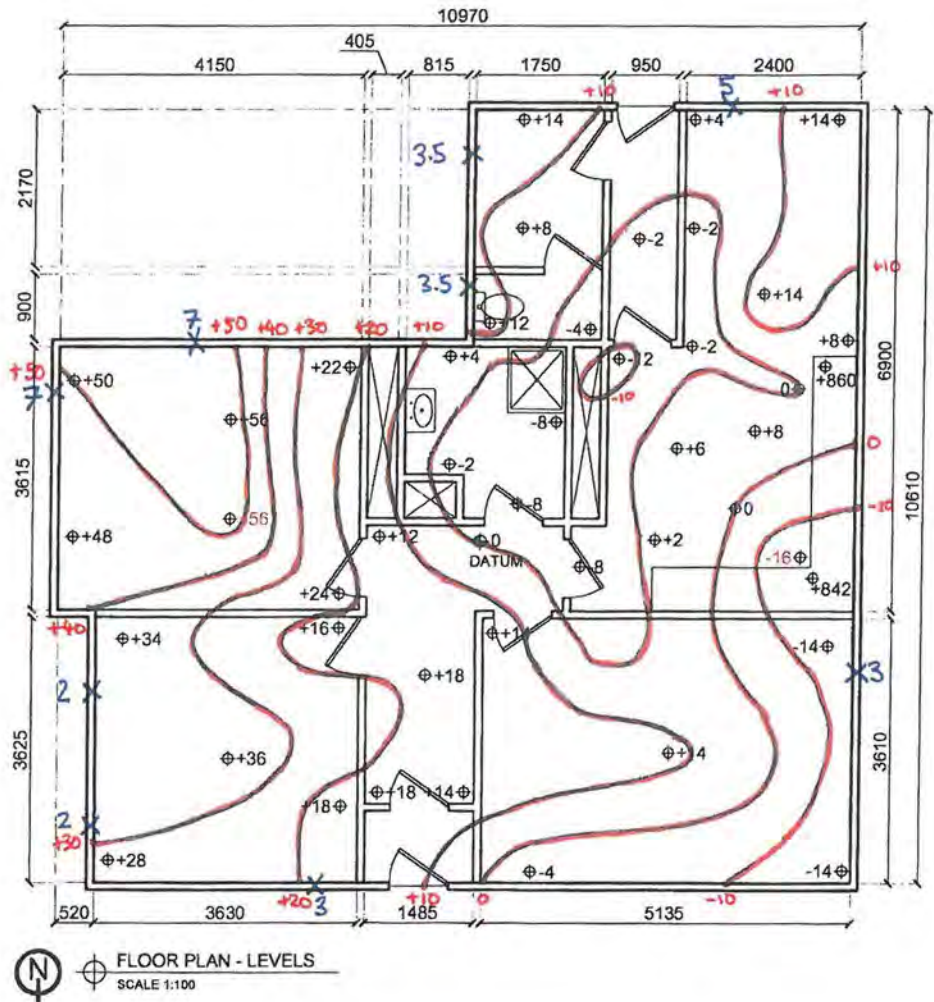
Levels adjusted for floor coverings  
 Zero OK

~ 10mm contour lines  
 X Cracks in Ring Beam

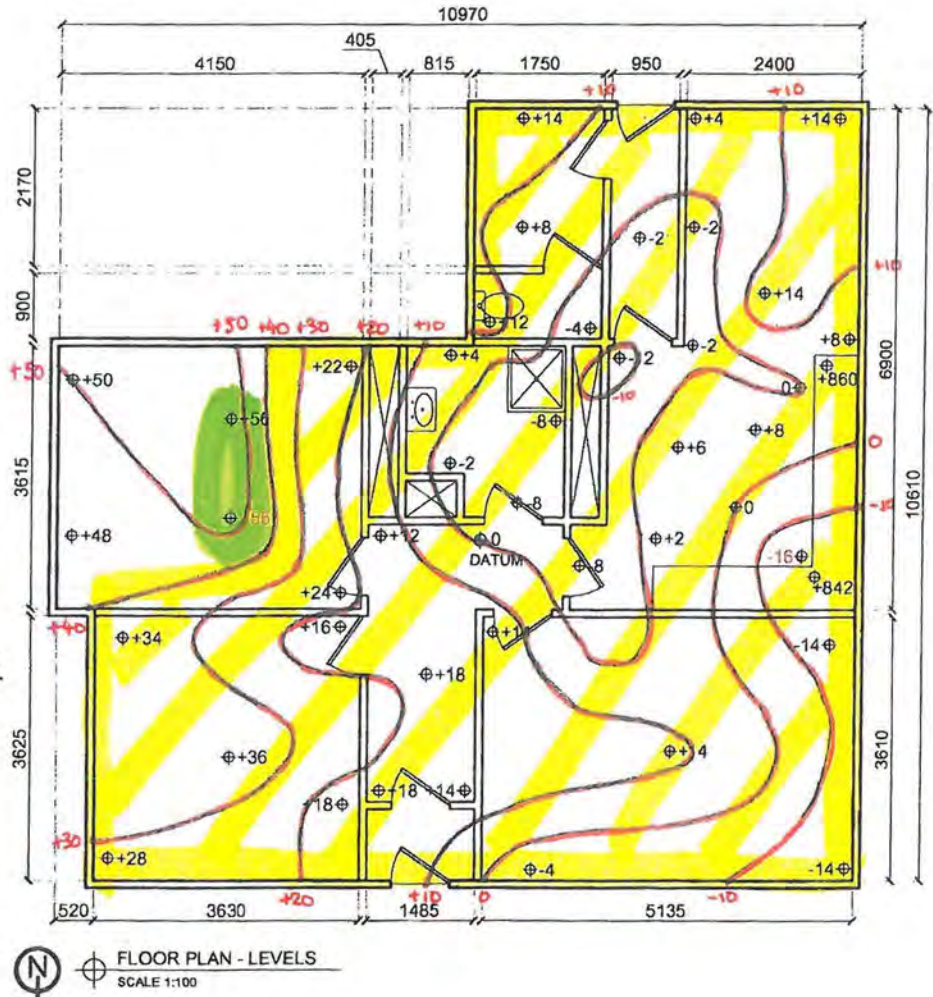
| TITLE | LEVELS DRAWING | CLM/2011/217456 LVLS | DESIGNED | DQ |
|---|---|---|---|---|
| | | | SHEET NO. | SK2 |

Notch Bearers T.L. = +50

\* Brickolite veneer to be removed completely.  
 Weatherboard to be removed as required to expose structure.  
 Ring beam top surface to be re-levelled with Sika Monotop 412 to provide level surface for replacement cladding.

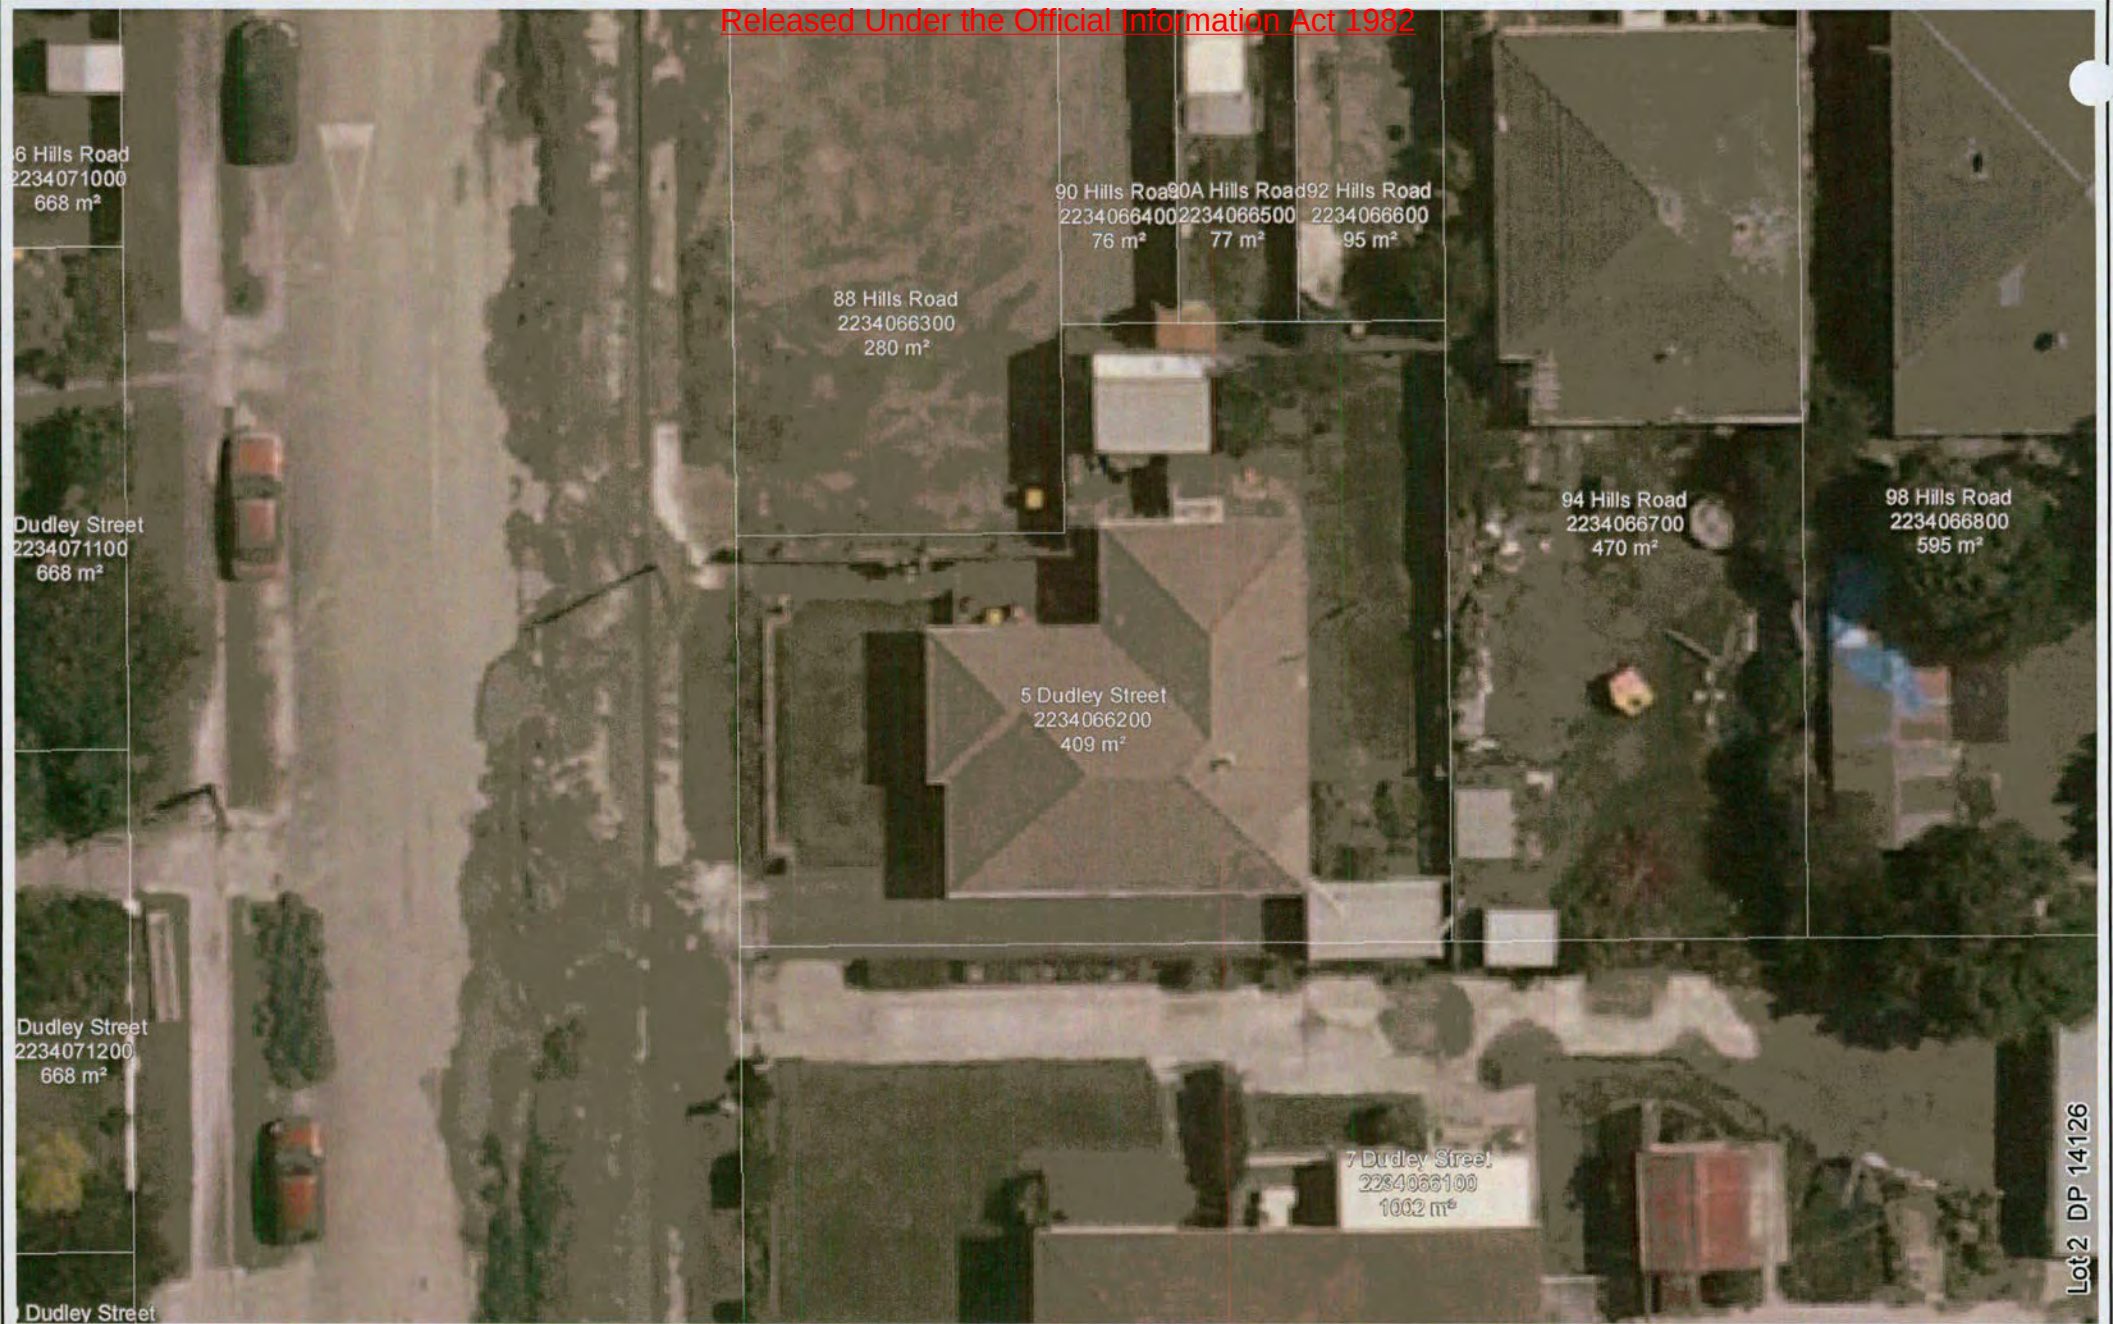
## Land Damage to Area A? If Yes, add details

Next action AWAIT Confirmation of Category 8 & 9 Status

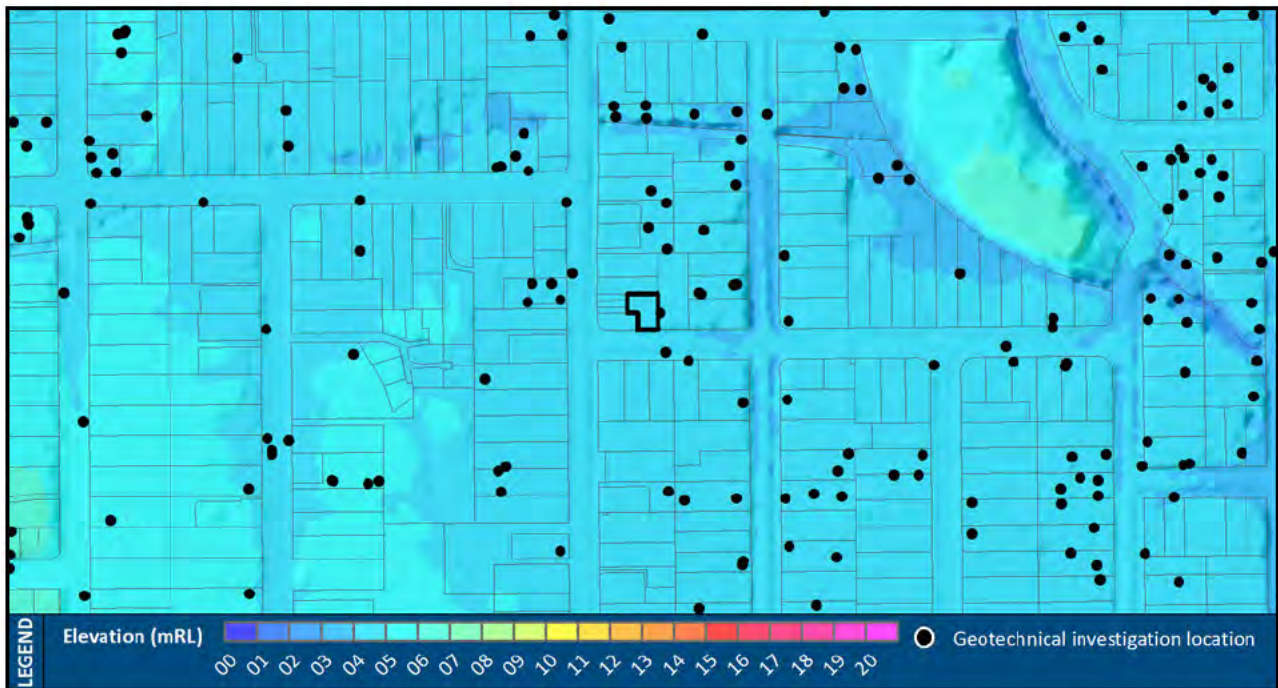
**Map 1: Post Canterbury earthquake sequence ground surface elevation and geotechnical investigation locations**

This map shows the ground surface elevation (i.e. the height of the land) following the Canterbury earthquake sequence. The elevation shown is the height above mean sea level.

The black dots show the locations of geotechnical investigations. These comprise a combination of Cone Penetration Tests (CPTs), boreholes and laboratory tests.

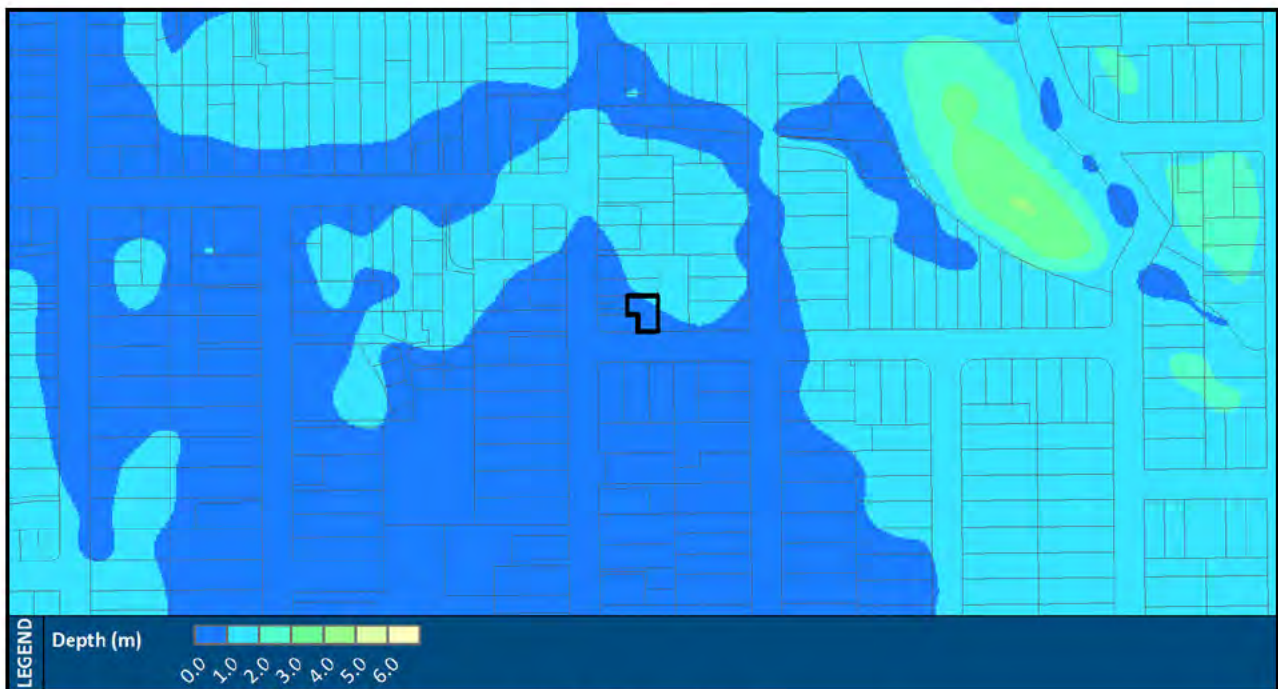
**Map 2: Post Canterbury earthquake sequence depth to groundwater**

This map shows the median depth to groundwater below the ground surface after the Canterbury earthquake sequence.

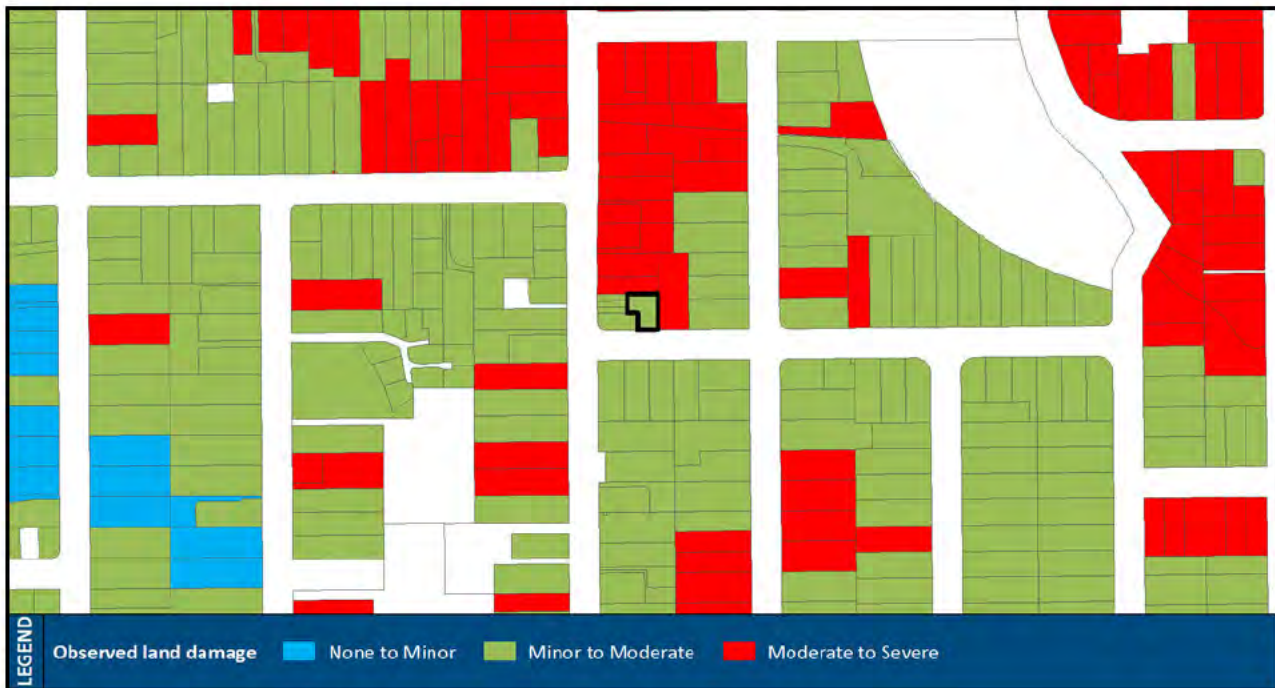
**Map 3: Worst observed land damage due to the Canterbury earthquake sequence**

This map shows the worst observed land damage recorded for the four main earthquakes during the Canterbury earthquake sequence. Descriptions of the observed land damage categories are: **None to Minor** – no observed liquefaction related land damage through to minor observed ground cracking but with no observed ejected liquefied material at the ground surface; **Minor to Moderate** – observed ground surface undulation and minor-to-moderate quantities of observed ejected liquefied material at the ground surface but with no observed lateral spreading; and **Moderate to Severe** – large quantities of observed ejected liquefied material at the ground surface and severe ground surface undulation and/or moderate-to-severe lateral spreading.

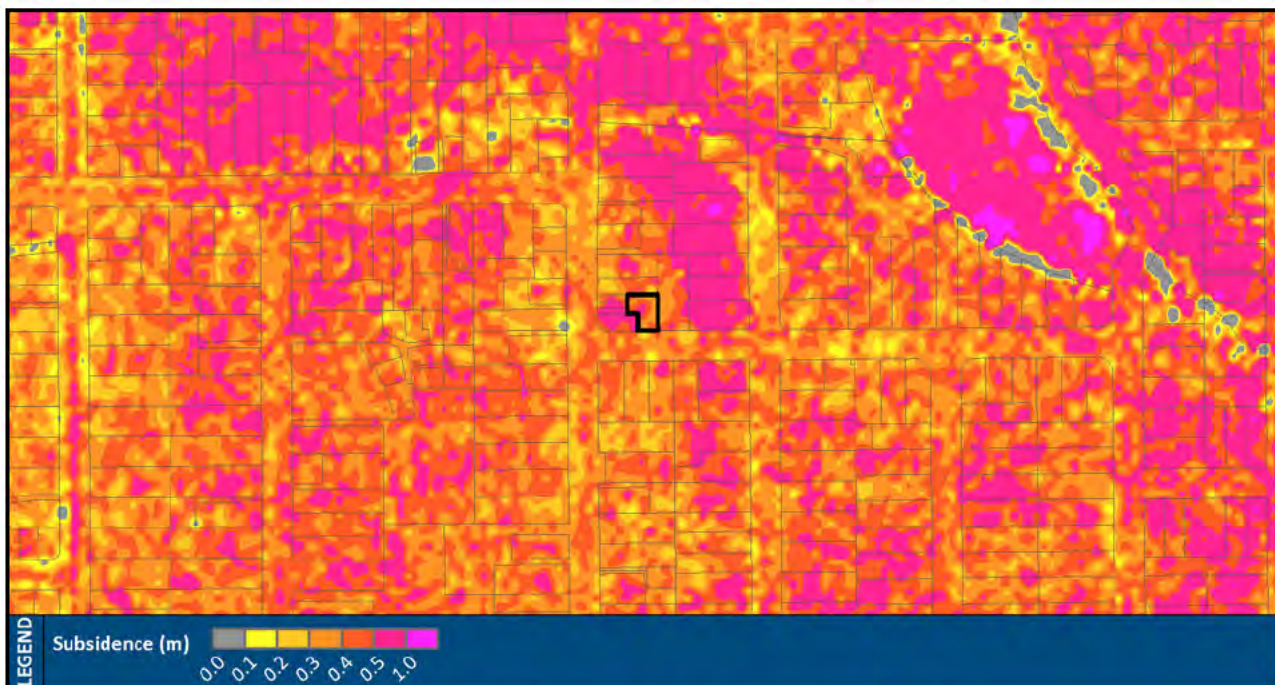
**Map 4: Total ground surface subsidence due to the Canterbury earthquake sequence**

This map shows the estimated total amount of ground subsidence as a result of the Canterbury earthquake sequence. Ground surface subsidence is estimated by comparing ground surface levels after each of the four main earthquakes. Adjustments have been made to the map to remove subsidence or uplift that is not as a result of the Canterbury earthquake sequence (e.g. man-made activities such as earthworks).
