# EQC Documents

Scope of Works

Completed by: Chris Armiga 0823  
 Date: 9 Apr 2013  
 Claim number: CLM/2012/194695

Assessment of Property at: 46 BAINE STREET, BURWOOD, CHRISTCHURCH 8083

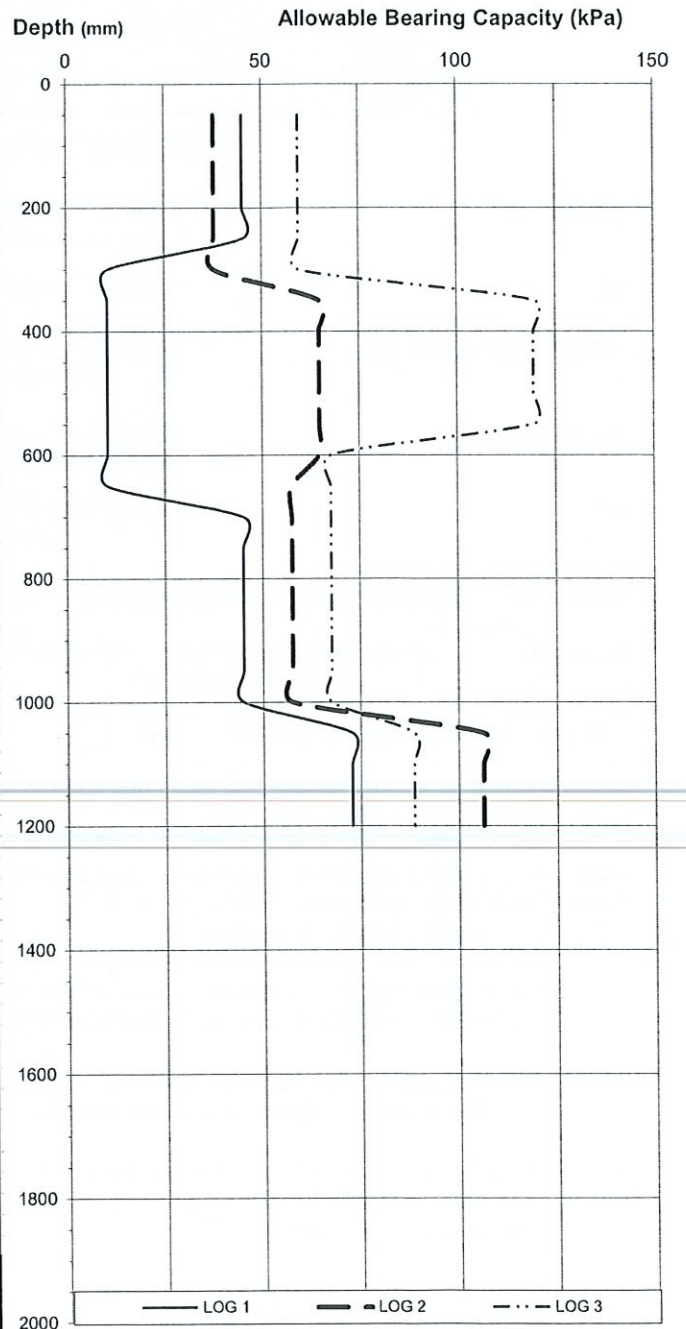
TEST PLAN LOCATION

Log 1	Log 2
0-300 DARK BROWN SILT	
300-1200 BROWN SAND	
1200 PENETROMETER TEST COMPLETE 1200-1800 SLIGHTLY WET GREY SAND	
1800 AUGER TEST COMPLETE	
<p>NOTE: IF ANY FILL OR SOILS OTHER THAN THOSE NOTED ABOVE ARE FOUND DURING ANY EXCAVATIONS THE ENGINEER SHALL BE NOTIFIED TO INSPECT AND ISSUE FURTHER INSTRUCTIONS</p>
