Far North Inspections LTD

Inspection Report

14 Nimmo Street , Northland, Rawene

Date of Inspection: 6/8/2019

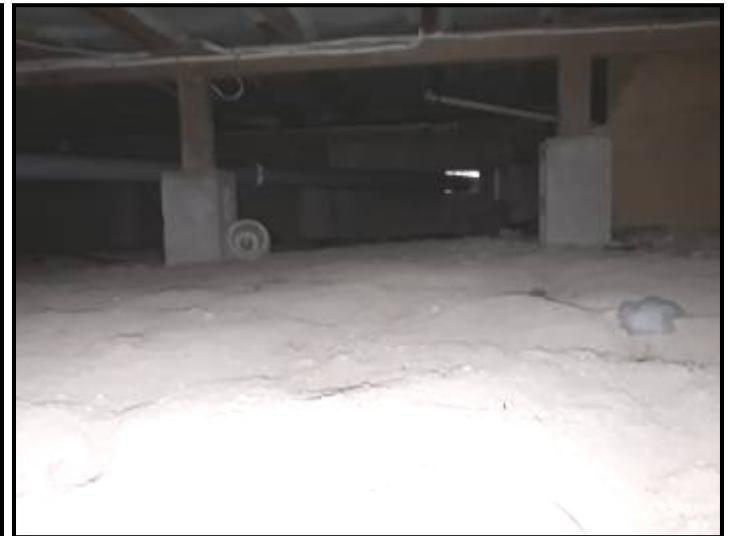
Structural timbers appear solid.

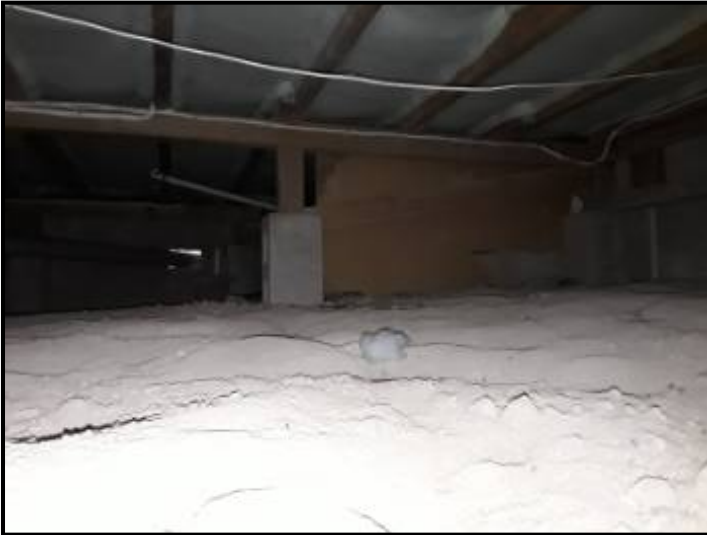
Posts and structural timbers appear solid.

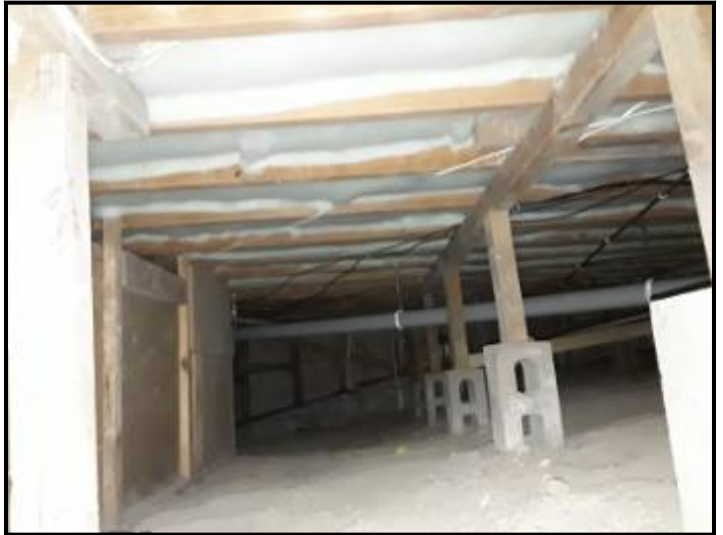
Insulation well installed.

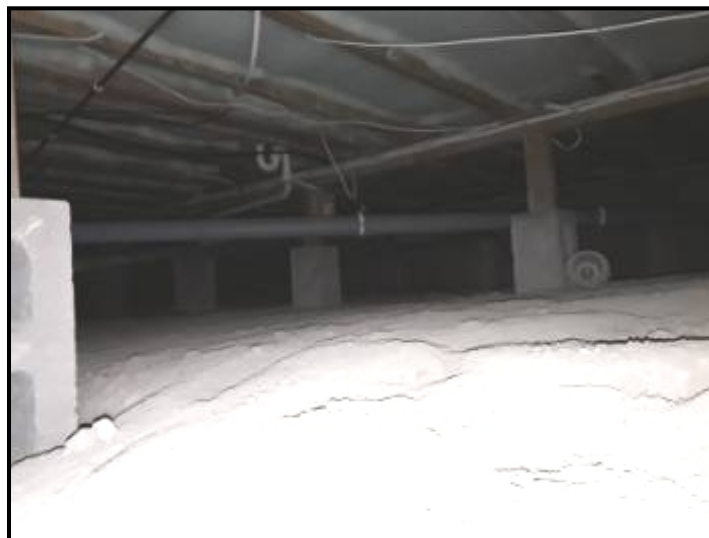
Plumbing pipes well supported.

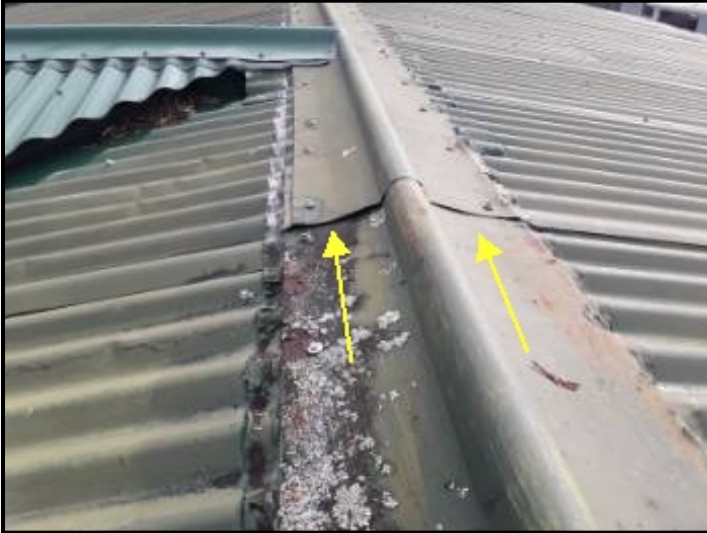
Ridge cap not sealed.

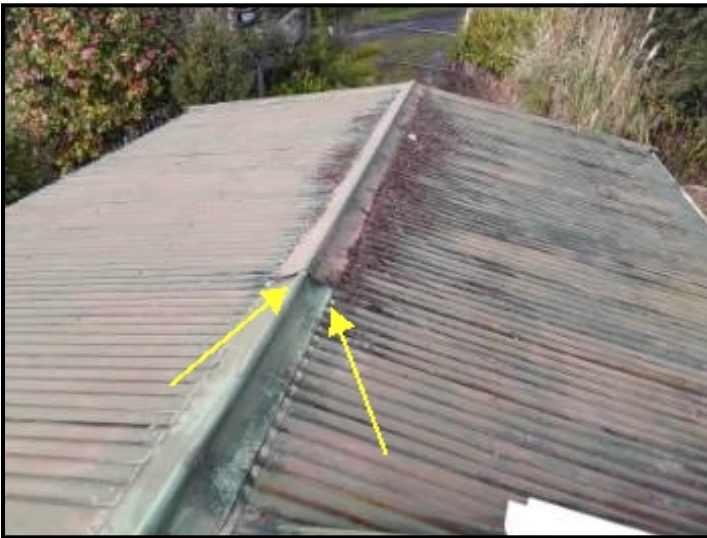
Garage roof same as main house roof

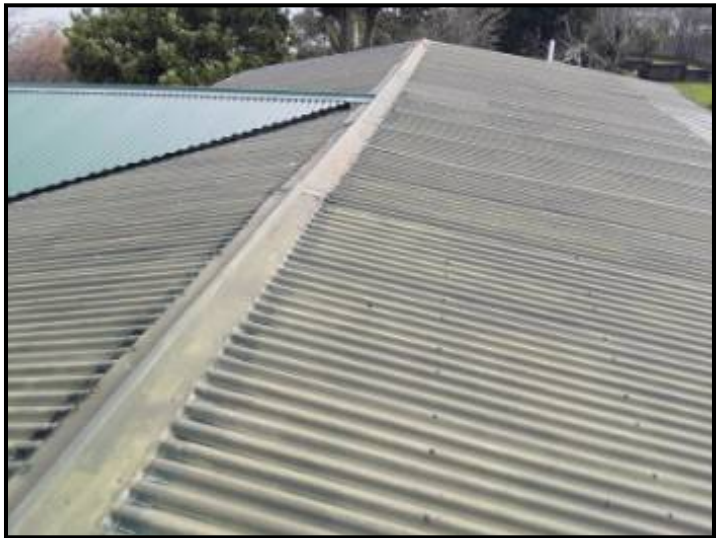
Roofing iron is in acceptable condition mostly.

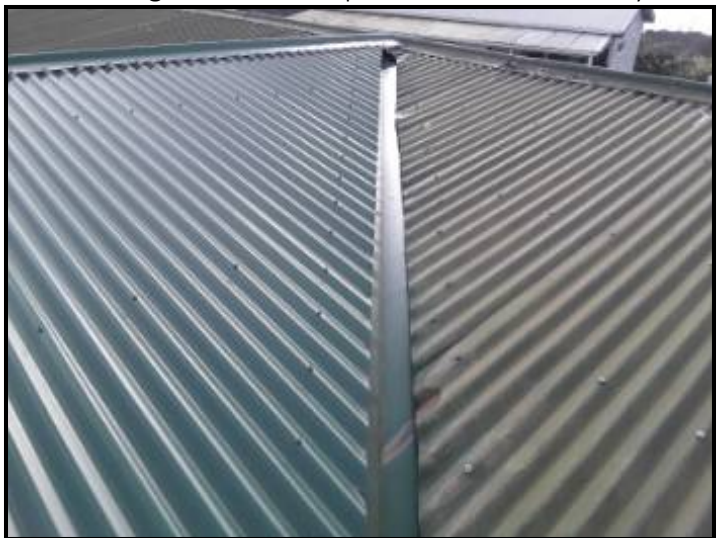
Valleys clear of debris.

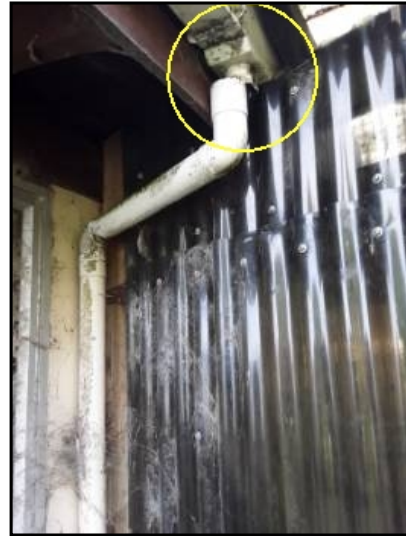
Downpipe not connected.

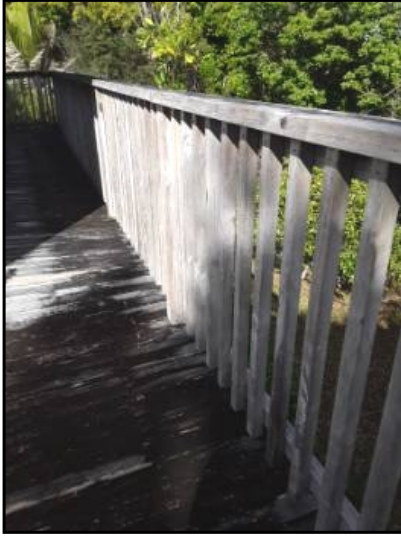
Handrails solid construction.

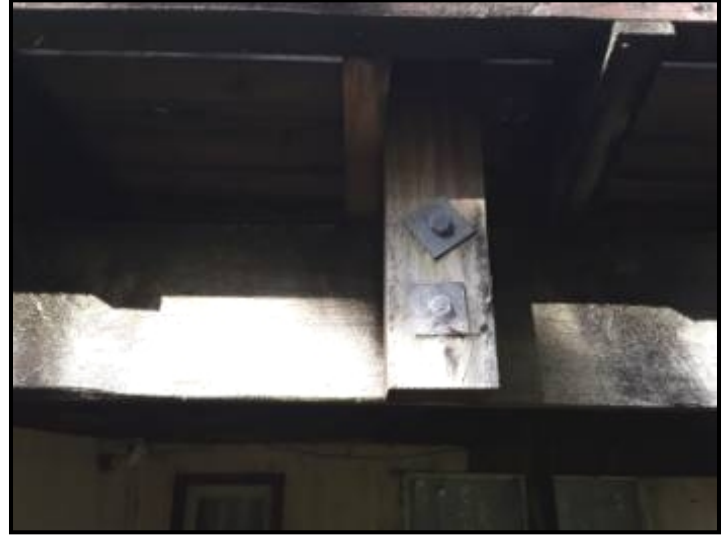
Solid bolting to handrail posts.

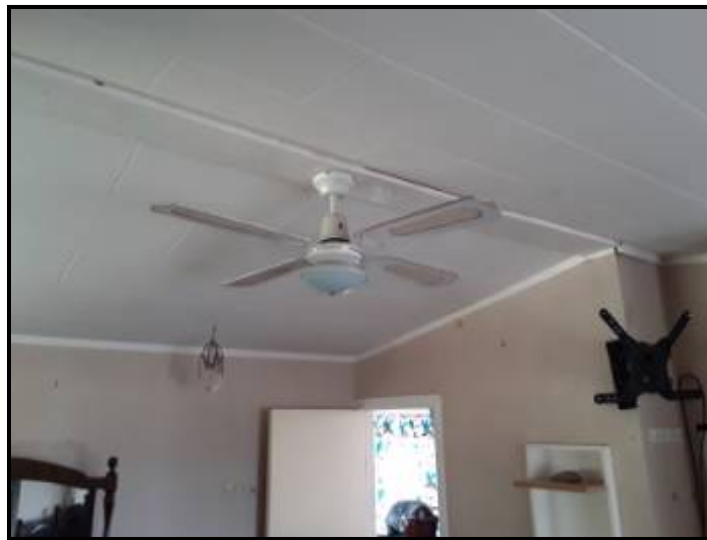
Bedroom ceiling tested dry at time of inspection.

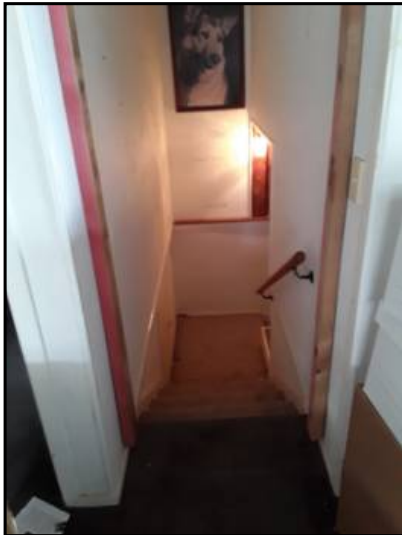
Handrail was secured correctly.

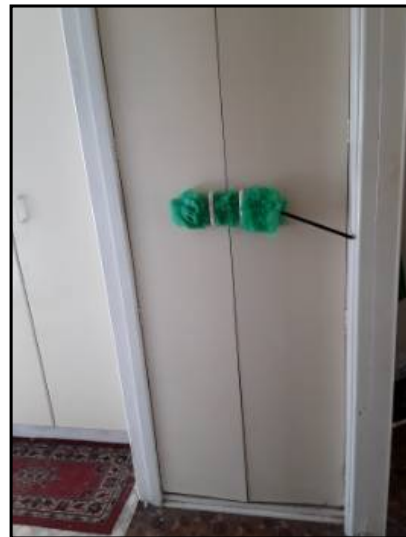
Novel door catch to hot water cupboard.
