## RESIDENTIAL HOUSE INSPECTION

11 Zinnia Way  
Christchurch, Canterbury 8025

25/10/2024

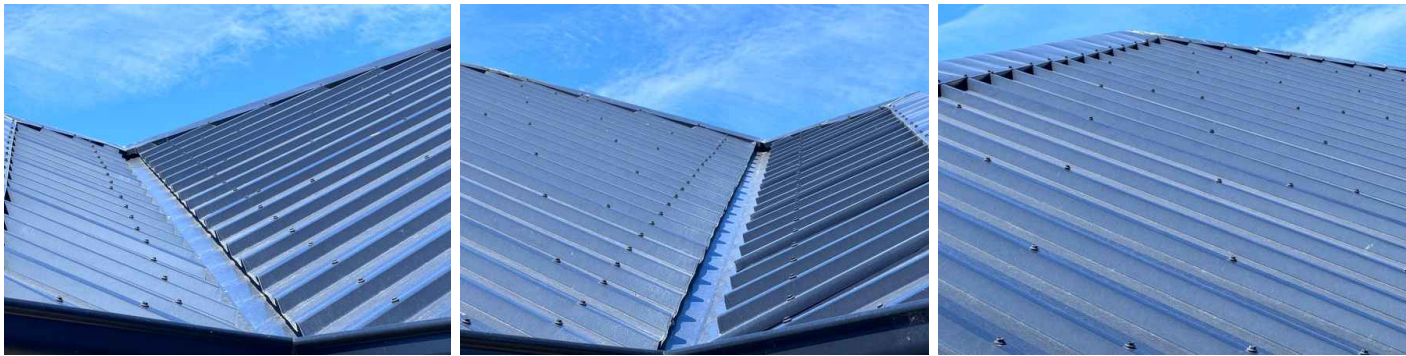
Roof System Images: Images Of The Roof System:

<b>Inspection Method</b> Ladder	<b>Roof System: The Roof is Constructed of:</b> Profiled Metal	<b>Roof System: Condition</b> Good, No issues noted at the time of inspection.
<b>Roof Drainage Systems: Condition</b> Good	<b>Soffits &amp; Fascia: Material:</b> The Fascia is a roll formed metal, Soffits are a painted fibre cement sheet	<b>Roof Drainage Systems: Material:</b> External, Metal Spouting
		<b>Soffits &amp; Fascia: Condition</b> Good, With no visible issues at the time of inspection

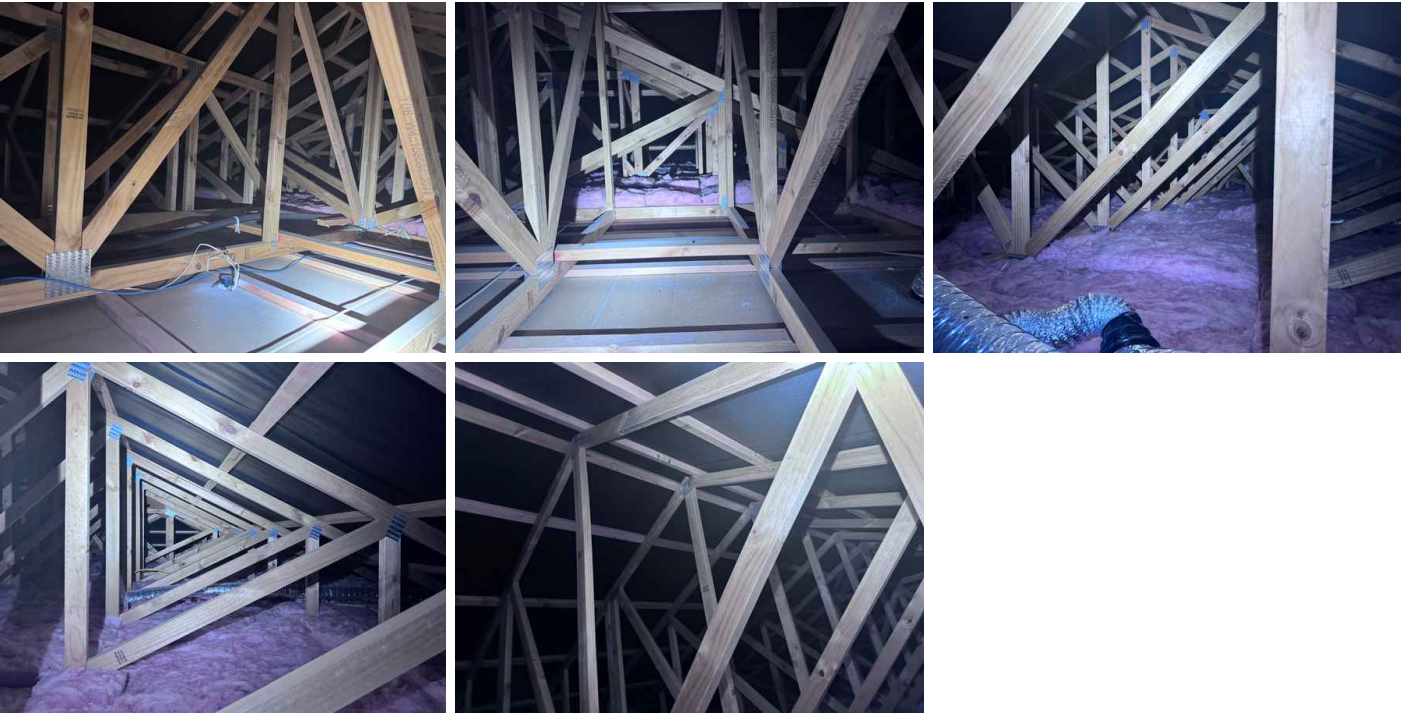
Roof Space Images:: Images

<b>Inspection Method</b> From a ladder at the access point located in the	<b>Roof Framing : Roof Construction</b> Timber Trusses	<b>Roof Framing : Condition</b> In good condition with no visible issues noted at the time of inspection
<b>Roof Insulation: Consists of a:</b> Glass Wool	<b>Roof Insulation: Condition</b> No insulation above garage area, Good	<b>Roof Underlay: Roofing Underlay</b> Roof underlay is a self supporting bitumen paper
<b>Roof Underlay: Condition</b> Good

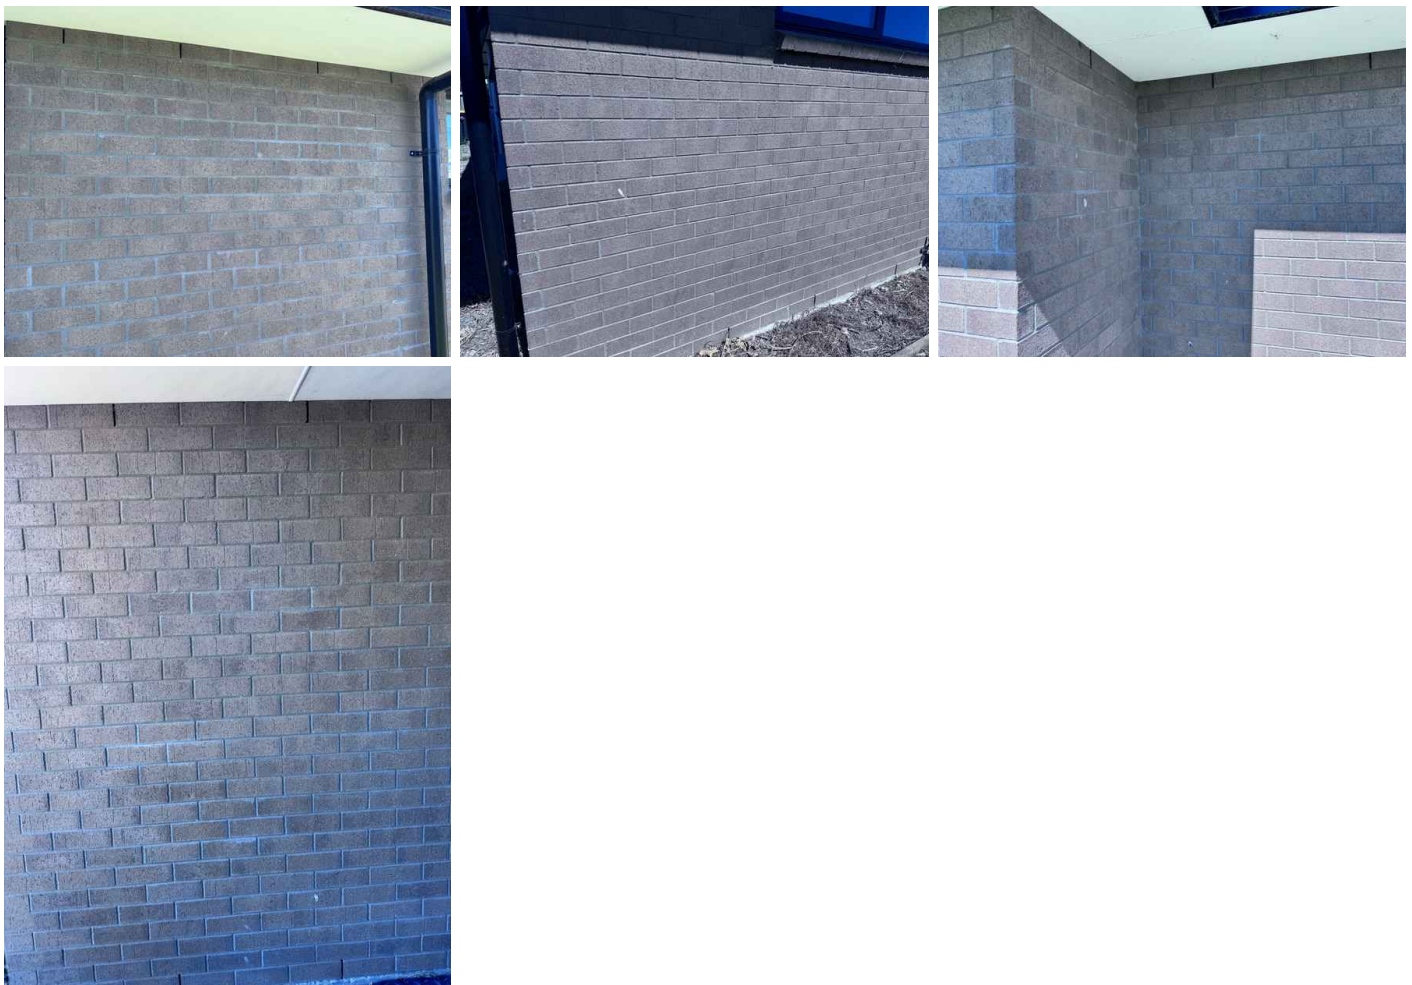
#### Exterior Cladding Images: Images

**Brick Veneer: No visible issues were noted at the time of inspection.**

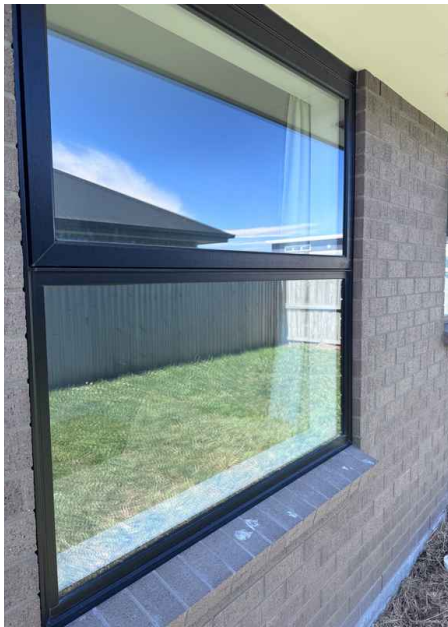
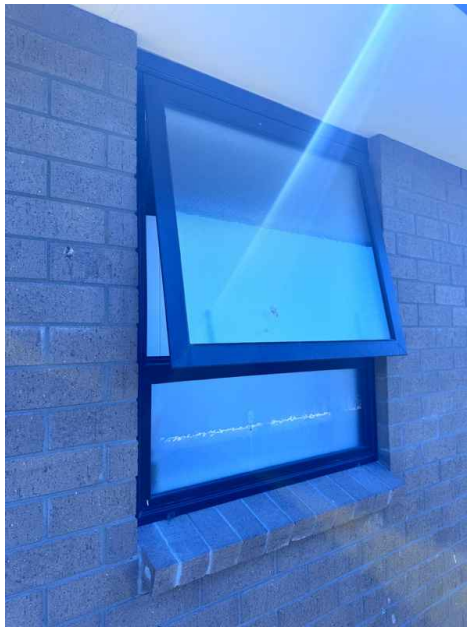
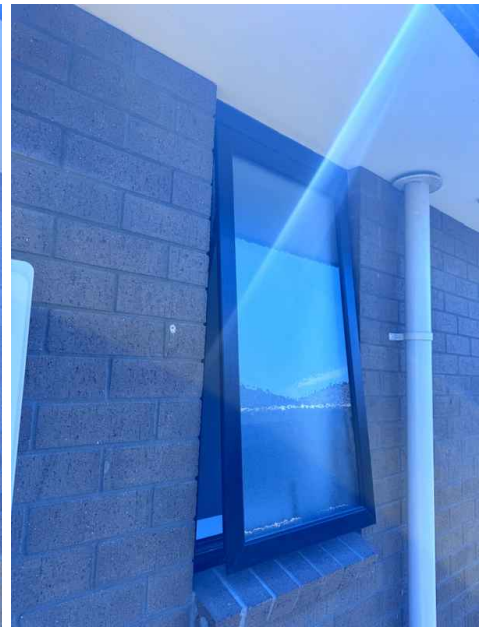
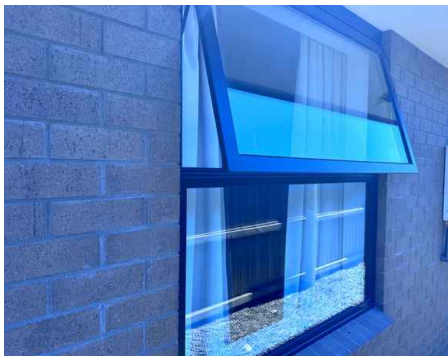
### Exterior Joinery Images: Images

**Exterior Joinery: Condition**  
Good, With no visible issues  
noted at the time of inspection.

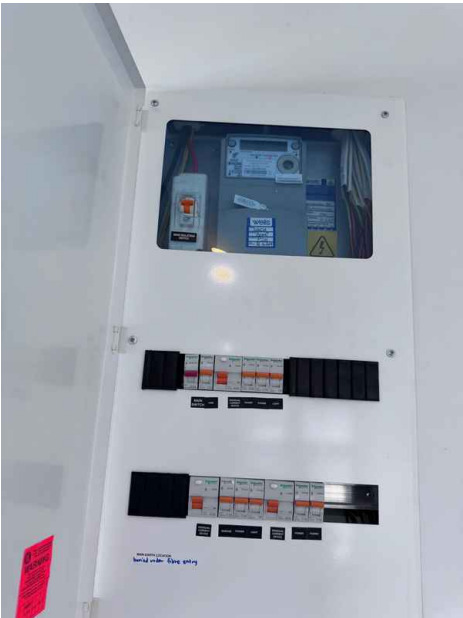
**Electrical Images:: Images**

Circuit Breaker, Located in the garage, no visible issues were noted at the time of inspection

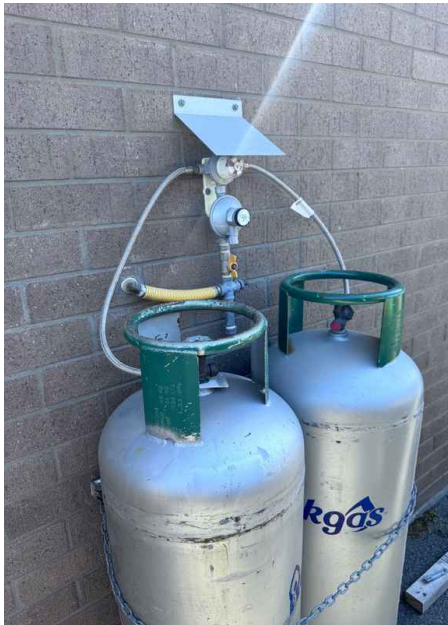
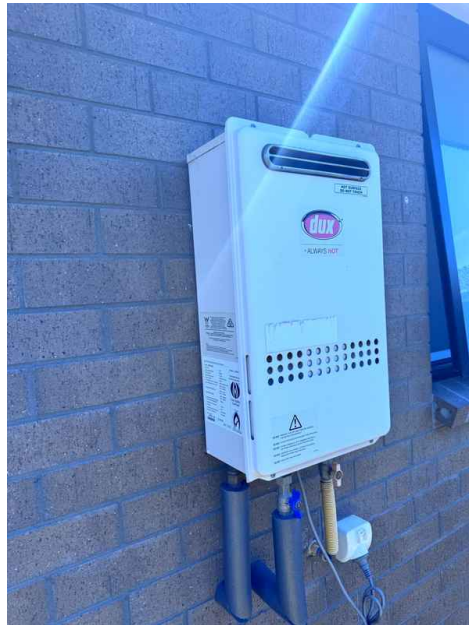
#### Water Heating Images: Water Heating Images

The water heater is installed to the exterior of the dwelling, it is in good condition with no issues noted at the time of inspection.

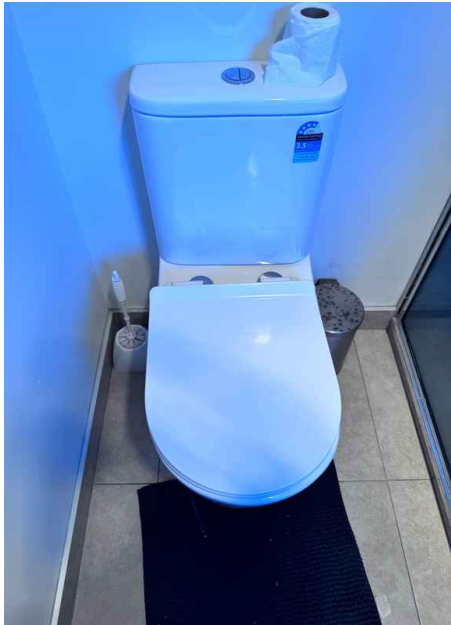
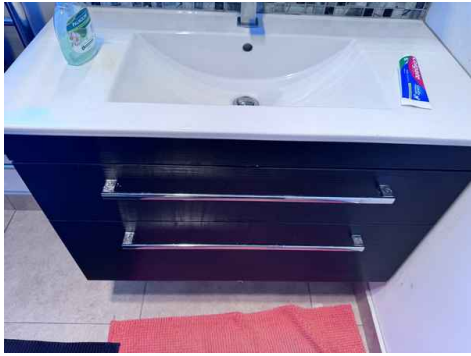
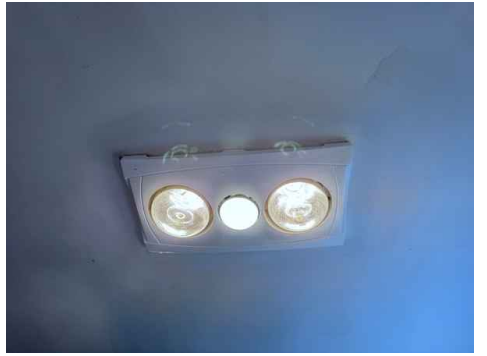
Bathroom Images: Images

<b>Wall &amp; Ceiling Linings: Walls and ceilings consist of</b> A plasterboard with a paint finish	<b>Wall &amp; Ceiling Linings: Condition</b> Good	<b>Floor Coverings: Floor Coverings</b> Tiles
<b>Electrical: Mechanical Ventilation</b> Installed	<b>Electrical: Light Fixtures</b> In good working condition	<b>Electrical: Heater</b> No heater installed
<b>Windows &amp; Doors: Condition</b> Good	<b>Electrical: Heated towel rail installed but not tested.</b>	<b>Windows &amp; Doors: Windows</b> Aluminum, double glazed
<b>Fixtures: Shower</b> Tiles, in good condition	<b>Windows &amp; Doors: Interior Door</b> In working condition	<b>Fixtures: Bath</b> Not Applicable
	<b>Fixtures: Vanity</b> good condition	<b>Fixtures: Toilet</b> Working

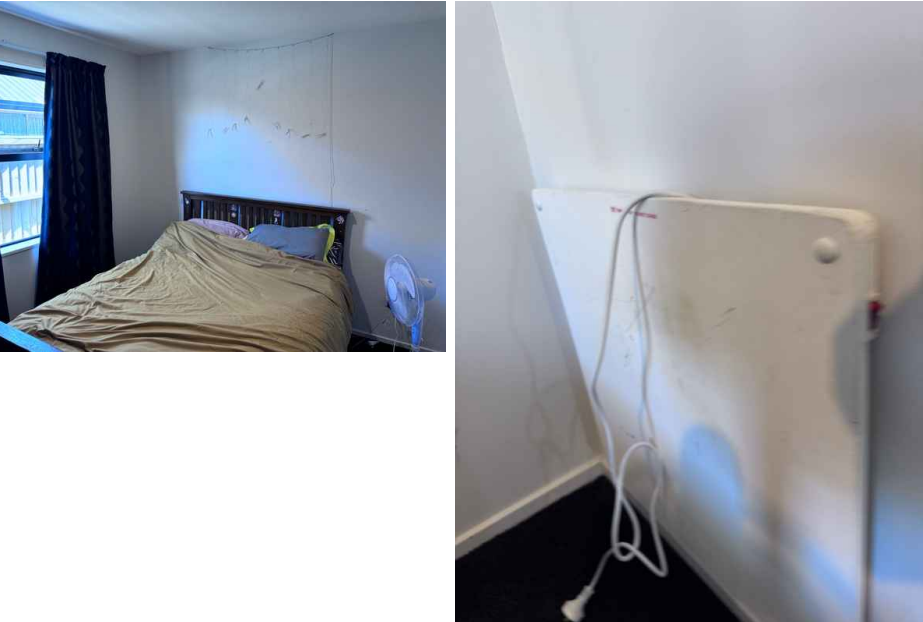
Interior Images: Images of room

<b>Walls and Ceiling : Walls and Ceilings Consist of</b> A plasterboard with a paint finish	<b>Walls and Ceiling : Condition</b> Good	<b>Exterior Joinery : External Windows &amp; Doors</b> Bedroom Aluminum, Double Glazed
<b>Exterior Joinery : Condition</b> Good	<b>Internal Doors: Interior Door</b> Good condition	<b>Internal Doors: Wardrobe Doors</b> Good condition
<b>Floor Coverings: Floor Coverings</b> Carpet	<b>Floor Coverings: Condition</b> Good	<b>Electrical: Light Fixtures</b> In good working condition

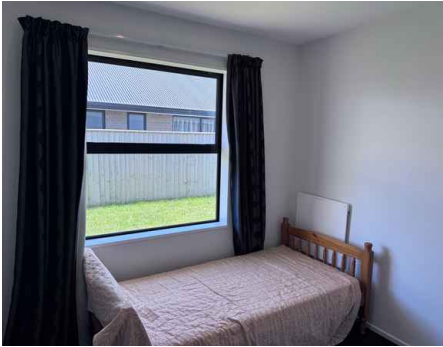
Interior Images: Images of room

<b>Walls and Ceiling : Walls and Ceilings Consist of</b> A plasterboard with a paint finish	<b>Walls and Ceiling : Condition</b> Good	<b>Exterior Joinery : External Windows &amp; Doors</b> Bedroom Aluminum, Double Glazed
<b>Exterior Joinery : Condition</b> Good	<b>Internal Doors: Interior Door</b> Good condition	<b>Internal Doors: Wardrobe Doors</b> Good condition
<b>Floor Coverings: Floor Coverings</b> Carpet	<b>Floor Coverings: Condition</b> Good	<b>Electrical: Light Fixtures</b> In good working condition

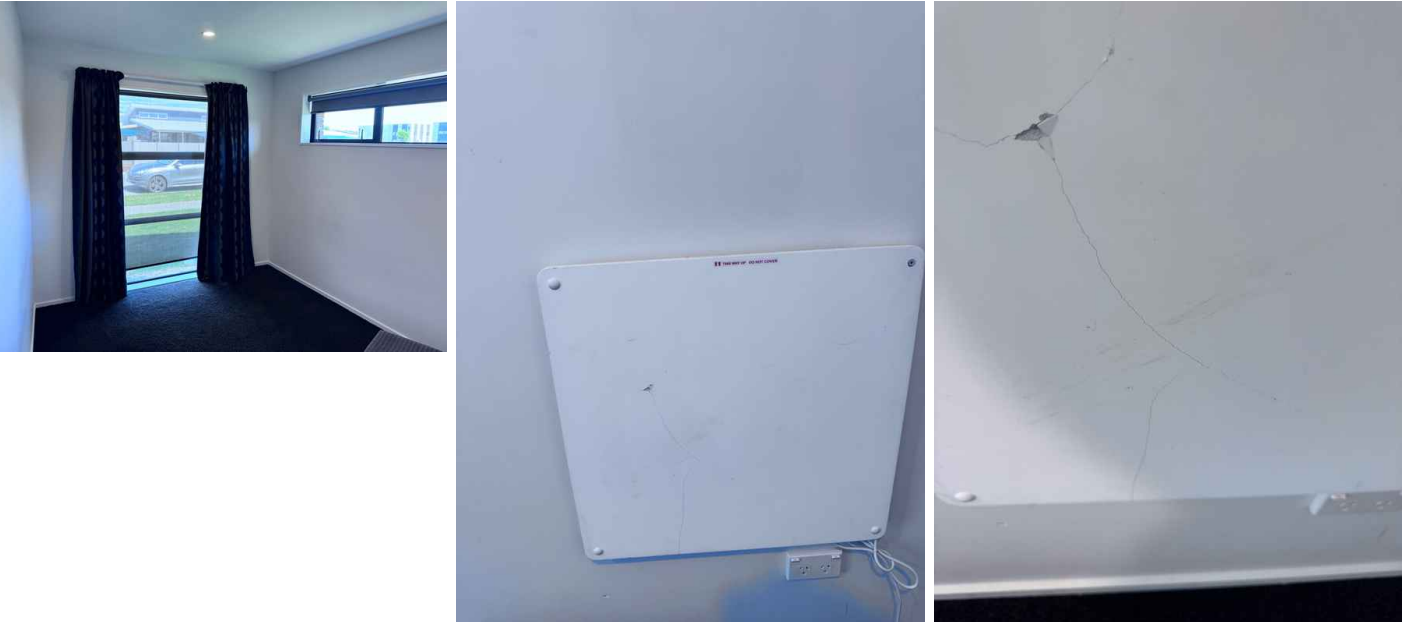
Interior Images: Images of room

<b>Walls and Ceiling : Walls and Ceilings Consist of</b> A plasterboard with a paint finish	<b>Walls and Ceiling : Condition</b> Good	<b>Exterior Joinery : External Windows &amp; Doors</b> Bedroom Aluminum
<b>Exterior Joinery : Condition</b> Good	<b>Internal Doors: Interior Door</b> Good condition	<b>Internal Doors: Wardrobe Doors</b> Good condition
<b>Floor Coverings: Floor Coverings</b> Carpet	<b>Floor Coverings: Condition</b> Good	<b>Electrical: Light Fixtures</b> In good working condition

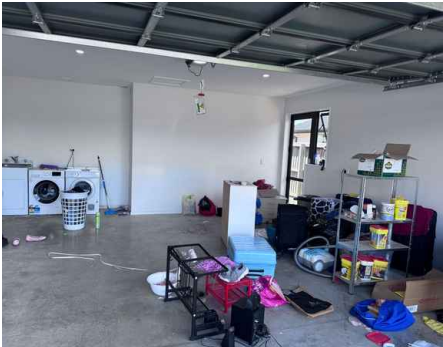
**Garage Images: Images**

**Floor System: Concrete Floor**  
In good condition

**Internal Linings: Wall Linings**  
Plasterboard, In average condition, Wear and tear observed

**Garage Door: DoorType**  
Sectional door, in good condition

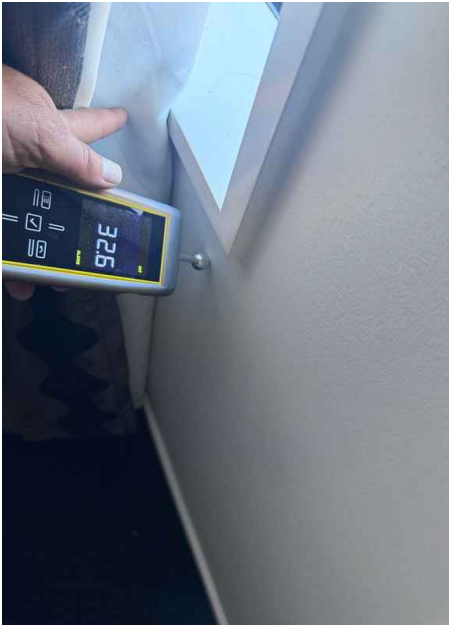
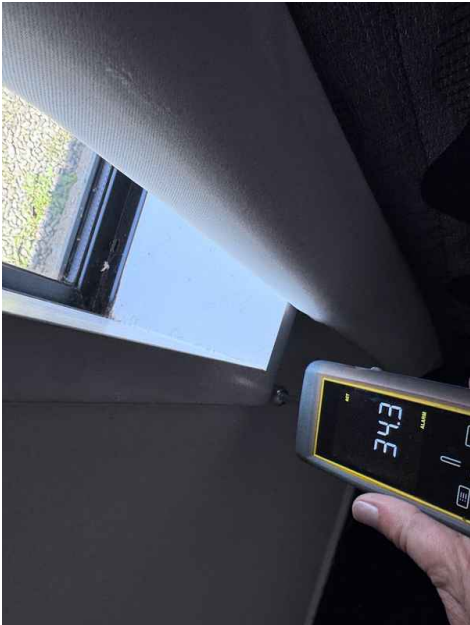
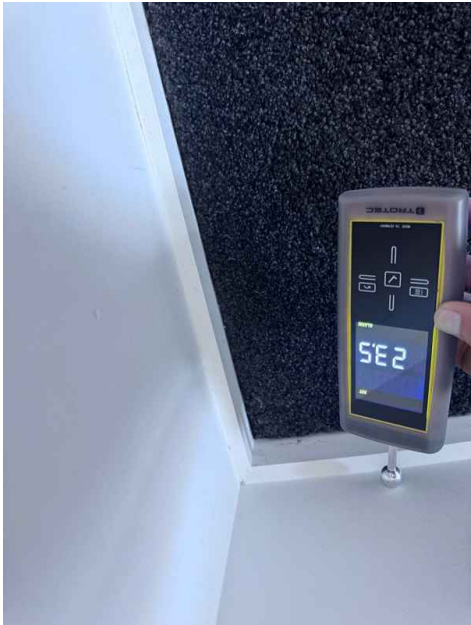
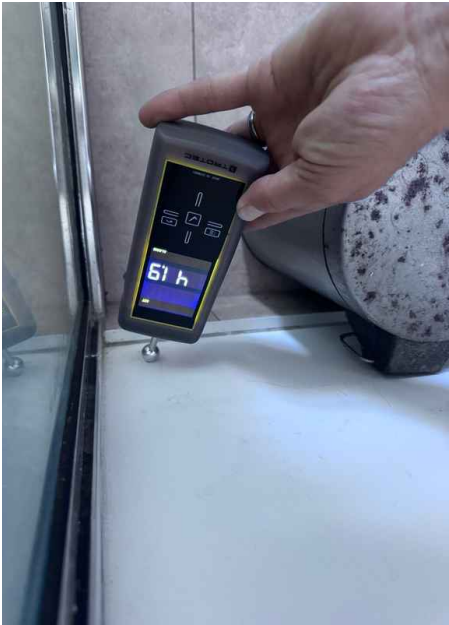
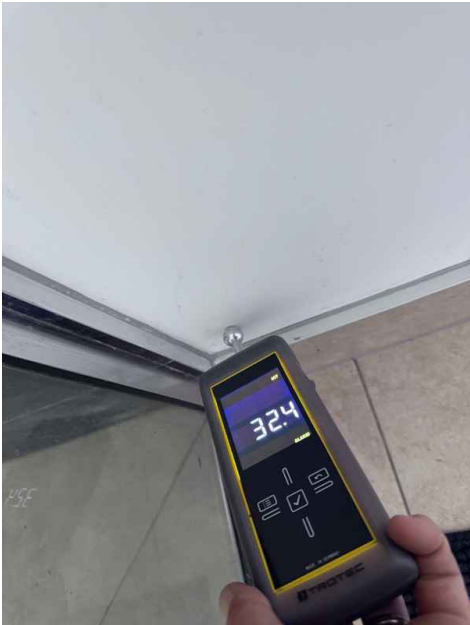
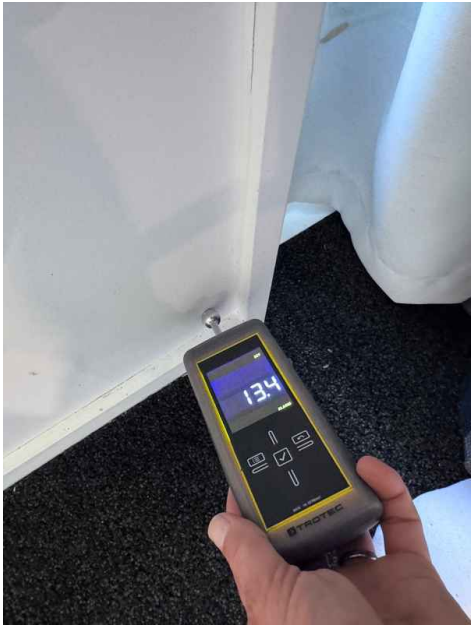
### Sample Of Readings: Sample Images

<b>Moisture : A base reading of</b>	<b>Moisture : Readings ranged from:</b>	<b>Moisture : No elevated moisture</b>
17	13-50	<b>levels were noted at the time of inspection.</b>
