# CASH SETTLED CLAIM(S)

CLM 2010/012667  
Claimant Name: P. Pen. 5h  
157 Church Rd  
Waipara.

This document provides a summary of the earthquake damage identified by the EQC assessment team. Land, building and room by room damage is listed along with an indication of how this damage is to be repaired. A glossary of terms describing the type of damage that may be listed on your Scope of Works is provided at the end of this document.

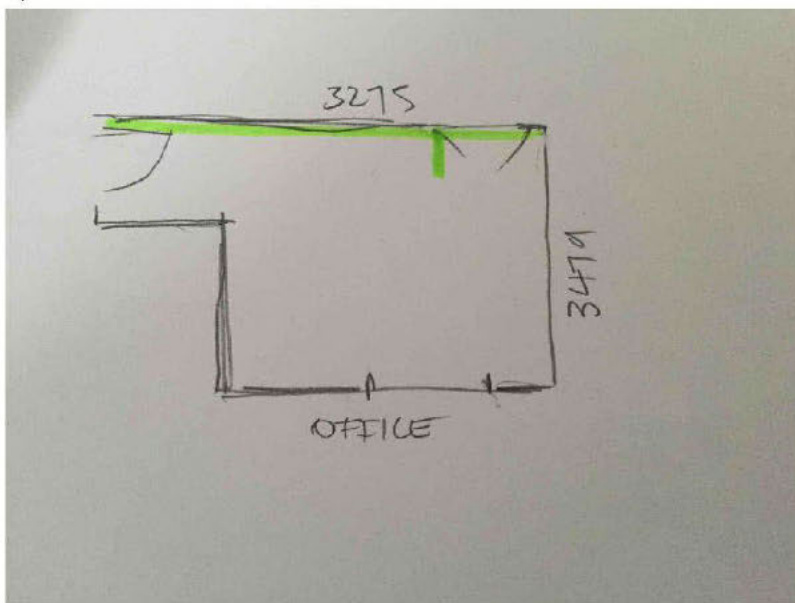
Figure 8 : Office layout sketch

The dwelling consists of lathe and plaster painted wall linings which displays cracking in the lounge family room, the kitchen/dining room and the office as a result of excessive shaking of the structure.

This damage can be remediated with targeted repair options.

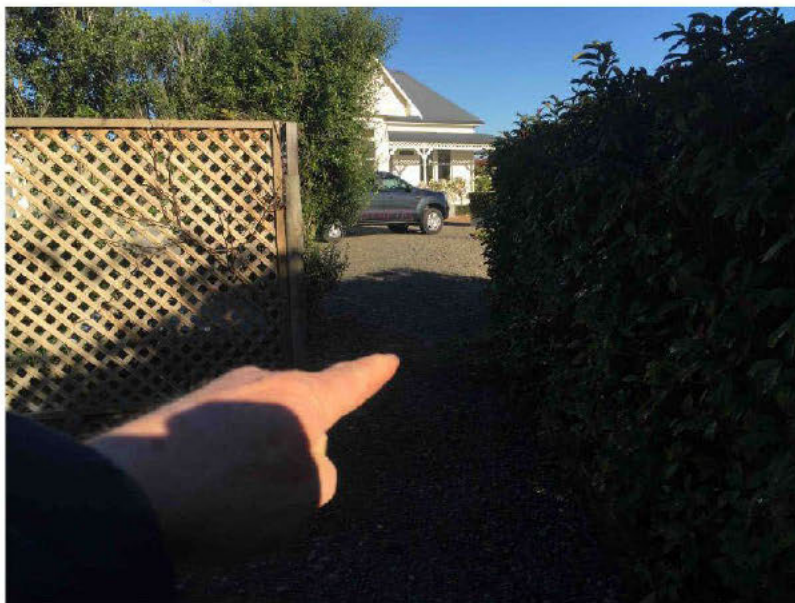
Figure 20 : Pointing to the location of the sewer junction from the house and the cottage to the main sewerage tank

We recommend waiting for the quotation from the drainlayers before we can provide an accurate cash settlement recommendation.
