NZ Residential Property Inspection Report

Inspection Date: Wed, 26 Feb 2025

Property Address: 7 Rollesby Street, Hoon Hay, Christchurch
8025, New Zealand

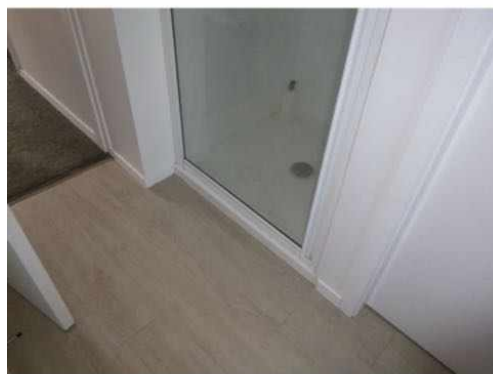
Defects 3.03

Building: Main Building
 Location: Bathroom > Centre
 Finding: Door - Seals - Showers
 Information: A new door seal should be fitted to the bottom of the door to prevent moisture getting under the door when the shower is operational.

Moisture was detected in the skirting at the time of the inspection. Once a seal is installed the moisture should dissipate over time.

This can be carried out by a general handy person.

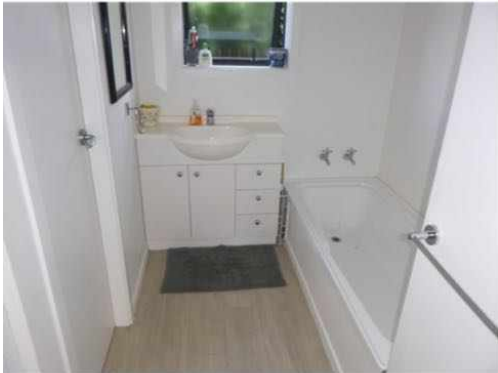
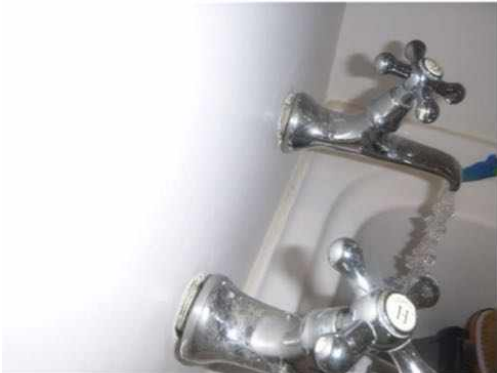
Defects 3.04

Building: Main Building
 Location: Bathroom > Centre
 Finding: Tap - Gap
 Information: The tap in this area have a gap .This tap having a gap creates potential for water leaks and subsequent water damage to the surrounding area.

A qualified plumber should be appointed to re-fix the plumbing fitting.

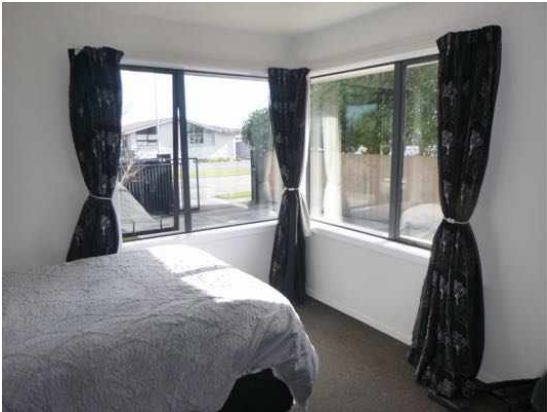
Noted Item

Building: Main Building
Location: NZ Only > All Areas
Finding: Additional Photos - Obstructions and Limitations
Information: These photographs are an indication of the obstructions and limitations which impeded full inspection of the property at the time of inspection. These obstructions can hide an array of defects and should be removed to allow full inspection to be carried out. A re-inspection is recommended once the areas are made accessible.

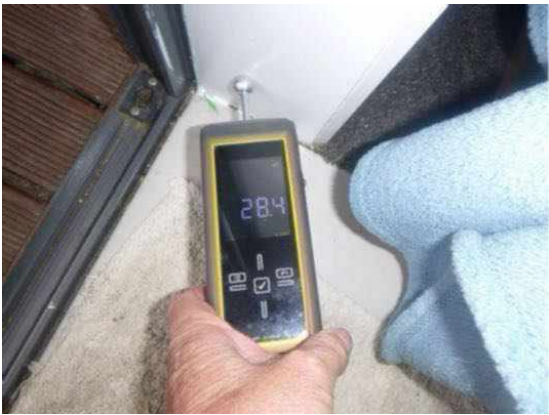
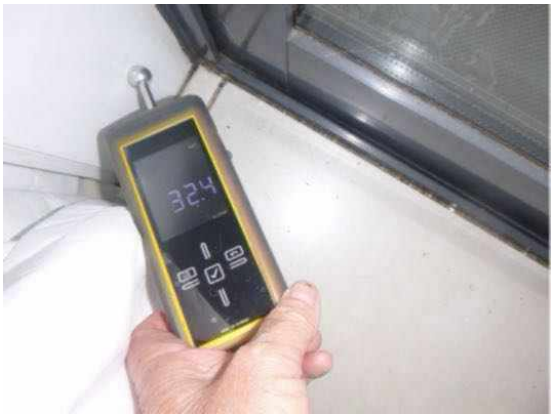
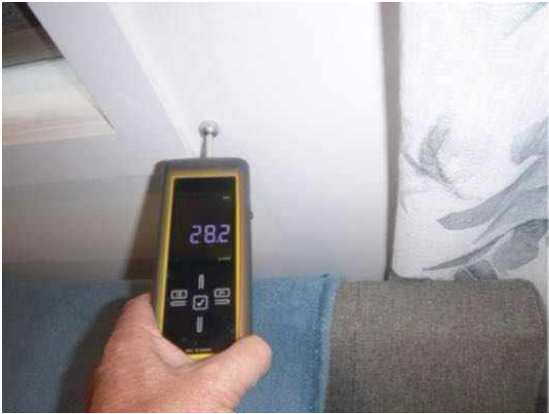
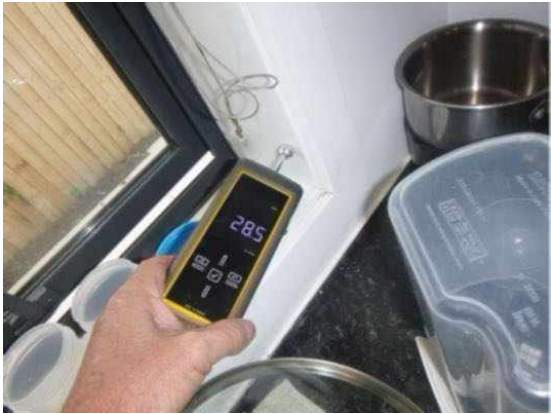
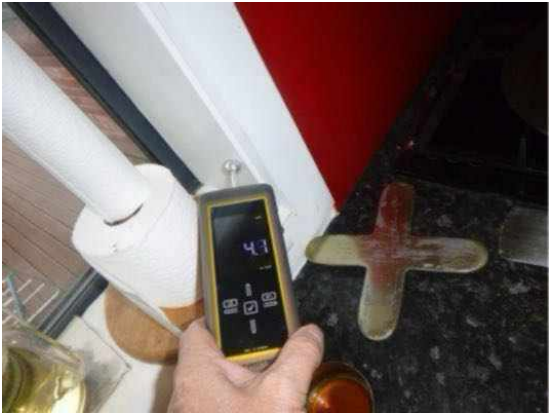
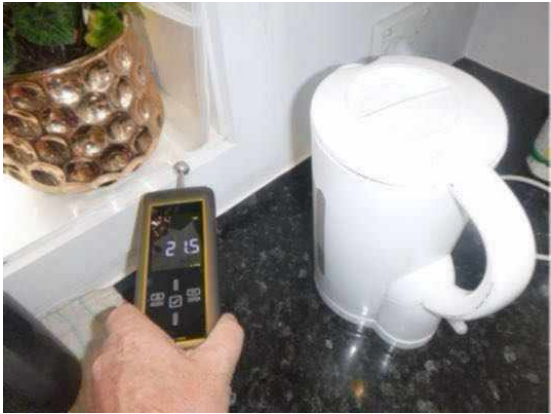
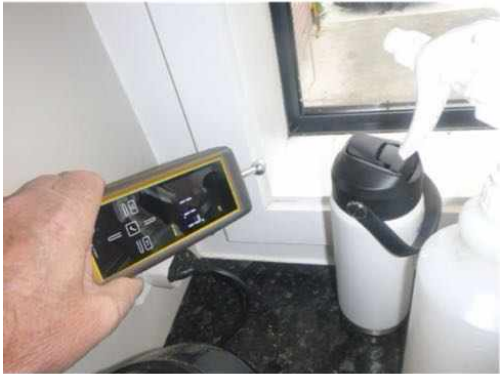
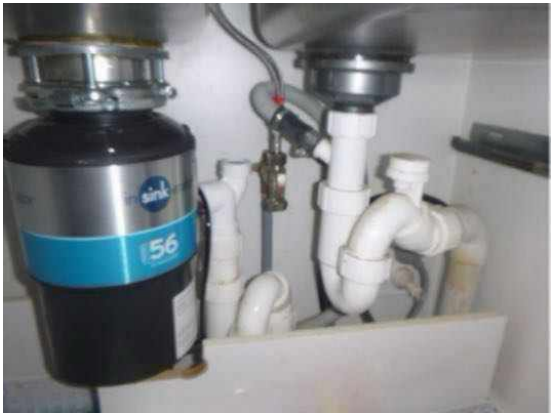
Building: Main Building
Location: All Areas > All Areas
Finding: Moisture - Testing
Information: TROTEC T660 Non-Invasive Moisture Meters

Moisture Test Result. Base reading is taken on an area which is known to be dry, from here all readings are relative to these base readings.

INTERPRETATION OF RESULTS: Generally, moisture content readings of timber materials that read up to 50 are

considered to be dry.

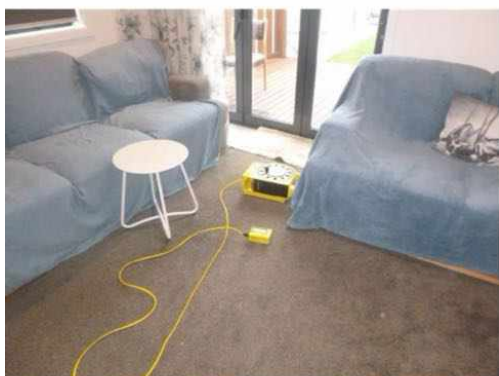
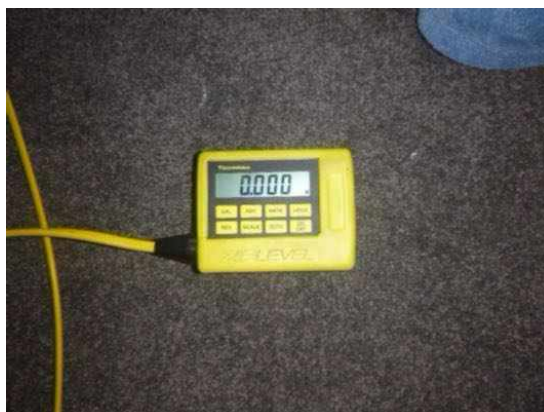
Building: Main Building
 Location: All Areas > All Areas
 Finding: Floor - Levels
 Information: Floor levels were randomly checked with a zip level in various locations throughout the dwelling, the dwelling is within the Ministry of Business, Innovation (MBIE) guidelines and tolerances, for variation in level less than 50mm over the overall floor plan.

Please note this is not a floor level survey, tolerances in measuring devices and benchmarks may occur.

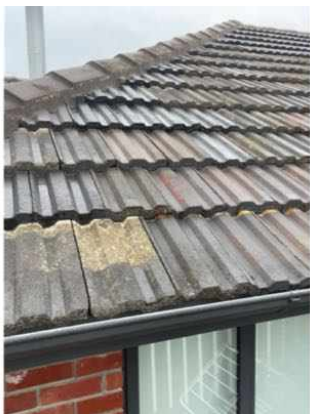
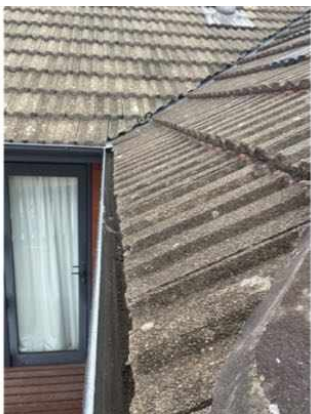
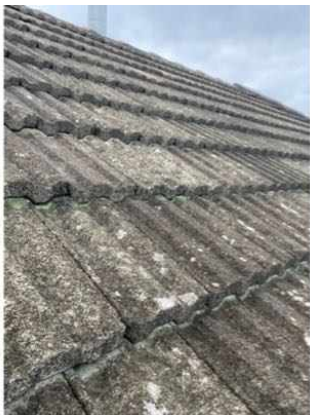
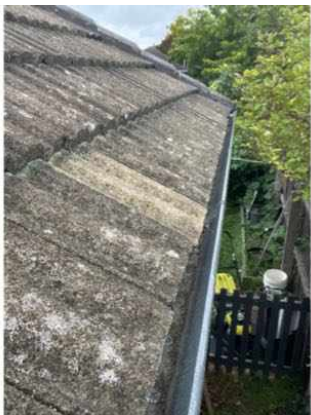
Building: Main Building
 Location: Roof Exterior > All Areas
 Finding: Roof - Tiles - Weathered
 Information: Upon inspection of the exterior roofing, the majority of roof tiles and gutters are considered to be in a good condition. While weathering of the older section of the roof is consistent with the age of the property, maintenance works are required.

The roof was weathertight on the day of the inspection.

Consultation with a roofing contractor is advised to gain advice on cost of remedial works that may be required in the short to medium term. Remedial works are likely to increase the longevity of the exterior roofing structure.

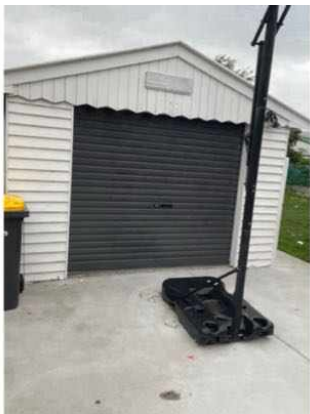
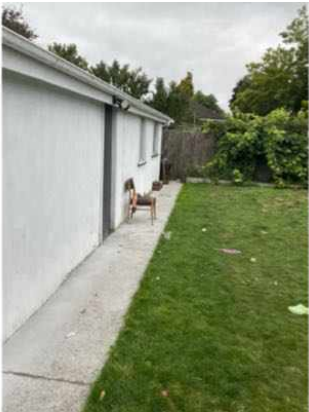
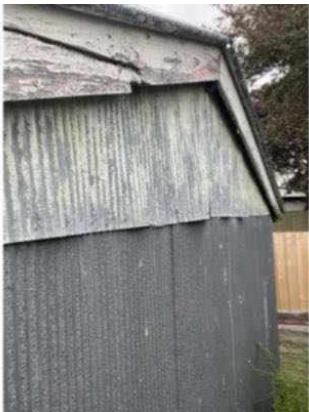
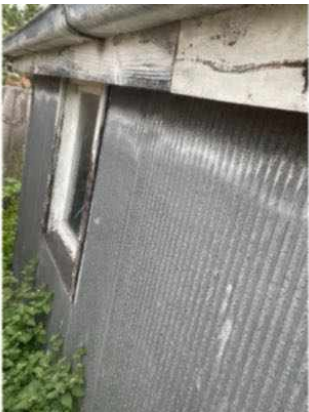
Building: Main Building
Location: Garage >
Finding: Garage
Information: The overall condition of the garage is fair/good with notable defects found that will need repair/replacement.

A section of the roof iron has been replaced ,the cladding at the rear of the garage has deteriorated and will need repairs.

The concrete slab has had a repair.

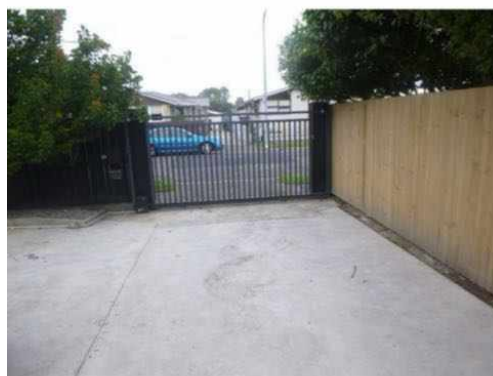
| Information: | Fine cracks were identified in external concrete . Although fine cracks are quite noticeable, they are often only considered to be an appearance defect, and usually do not indicate any structural damage. |

General age and expected deterioration of the concreted areas is a common cause of this type of cracking. However, expansion and contraction of the slab may also have occurred due to environmental factors. Such factors include variable moisture and weather conditions, the presence of trees and their roots having a settling or lifting affect on the soil, or the effect of load bearing, e.g. heavy vehicles over a sustained period of time.

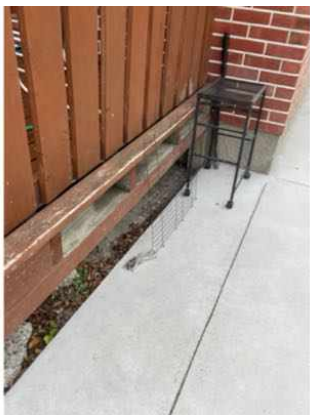
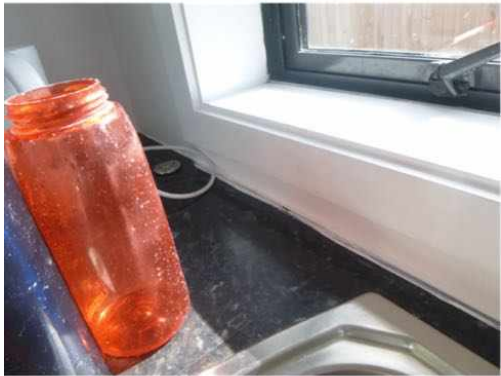
Building: Main Building
Location: All Areas > All Areas
Finding: General - Wear - Tear
Information: Superficial scuff marks were noted to the walls /ceiling and windows at the time of inspection.

Marked and scuffed surfaces, while detracting from the overall appearance of the affected building element, do not indicate any operational or structural damage.

This degree of surface damage is consistent with general wear and tear. Marked surfaces may be left at client discretion, as no repair/replacement is necessarily required.

Marked surfaces are unlikely to result in the development of secondary damage; however, the client may wish to seek quotations for the cost to refurbish the affected areas.
