## EQC Full Assessment Report

**Claim Number:** CLM/2011/102777  
**Claimant:** JASON SAIL  
**Property Address:** 26 HEMINGWAY PLACE  
 SPENCERVILLE  
 CHRISTCHURCH 8083

Our Ref: 170050

## **RESIDENTIAL ENGINEERING EVALUATION REPORT AND REPAIR METHODOLOGY FOR 26 HEMINGWAY PLACE, BROOKLANDS**

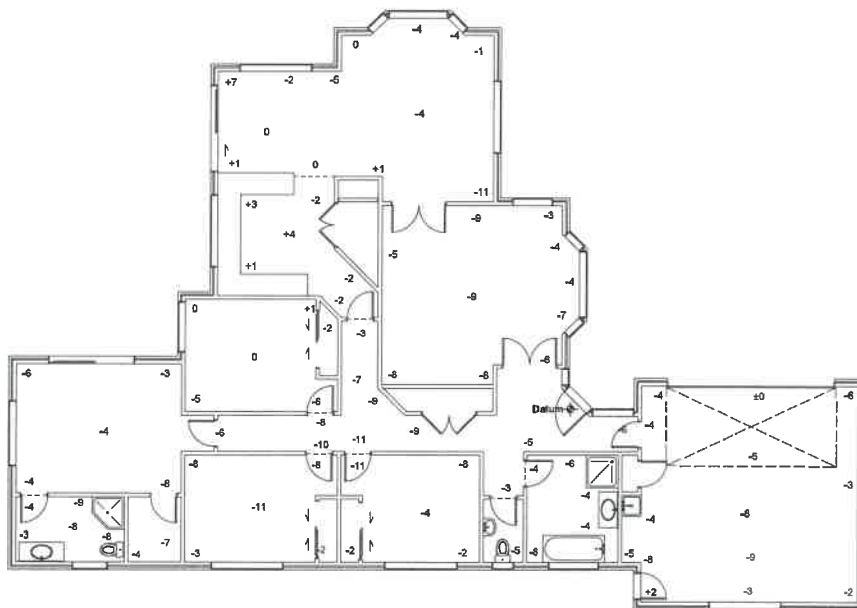
The MBIE has guidance around floor levels which takes into consideration non-earthquake related settlement, construction tolerances and serviceability requirements. The guidance recommends that where total differential settlement over the floor plan is between 50 mm and 100 mm, re-levelling is required.

Considering the recorded floor levels and observed damage at the Concrete Floor Slab and Concrete Perimeter Foundation Beam, it is Frontier Engineers opinion that the Residential Building may be re-levelled in order to achieve acceptable floor slopes as required by the current New Zealand Building Code and the MBIE Guidance for Residential Buildings damaged by the Canterbury Earthquake Sequence.
