Information request – CLM/2011/147051 - 7 Rollesby Street, Hoon Hay, Christchurch 8025

Subject: 7 Rollesby Street, Hoon Hay, Christchurch 8025
Project Number: 160520

ENGINEERING DESIGN 7 ROLLESBY STREET, HOON HAY, CHRISTCHURCH 8025

Increased Liquefaction Vulnerability (ILV) Engineering Assessment

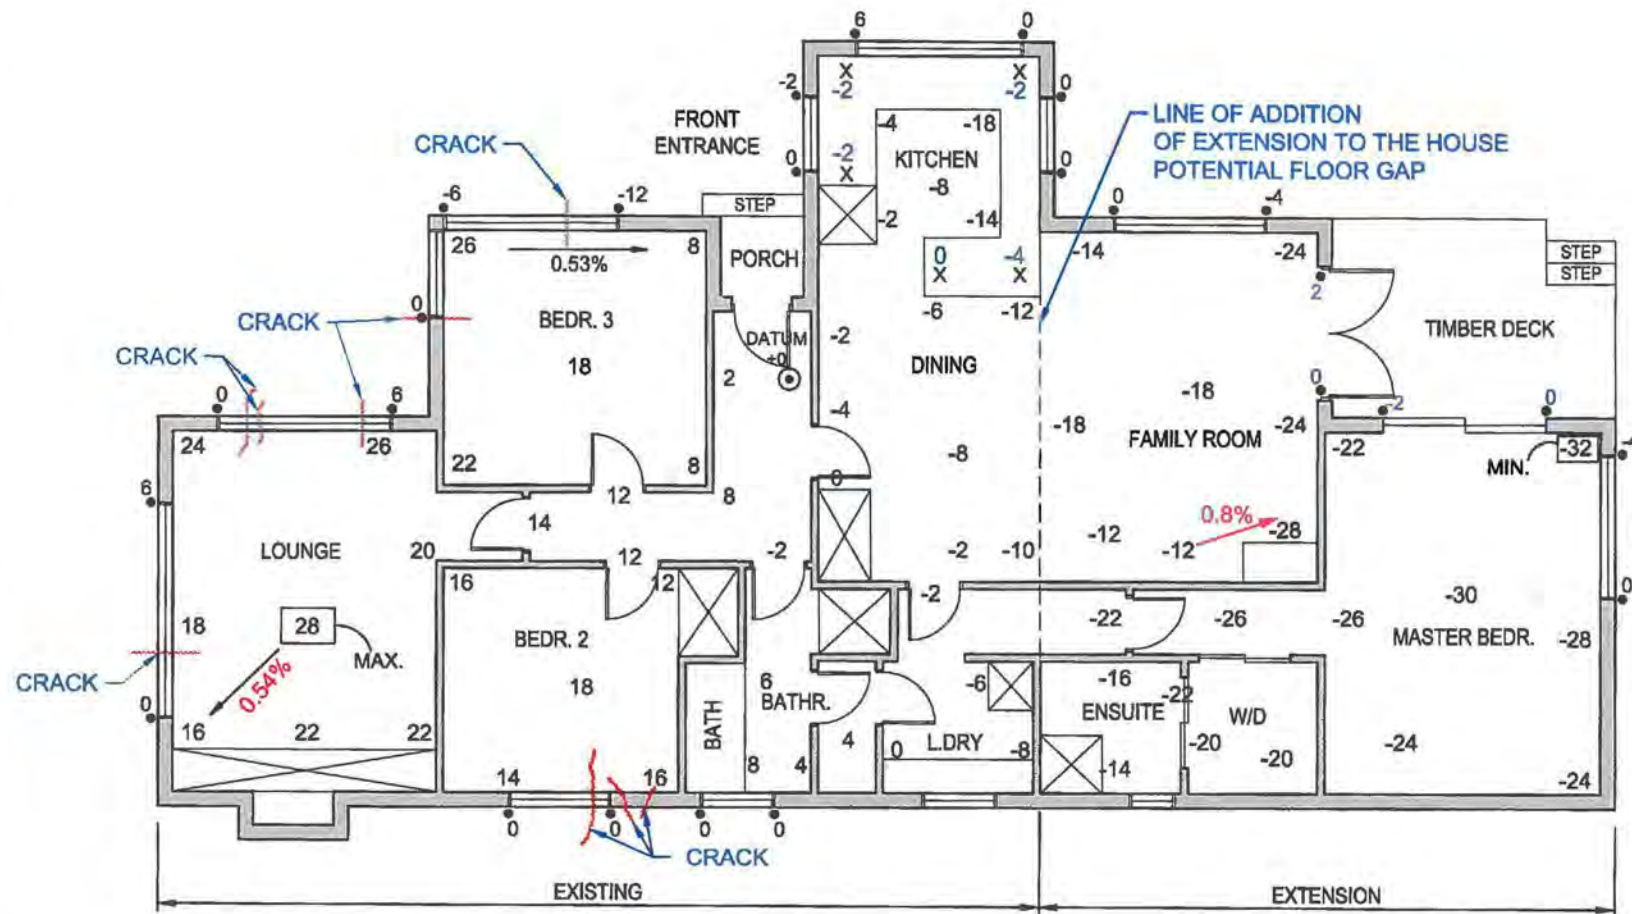
RS01

1 FLOOR LEVELS PLAN
1 : 100 @ A4

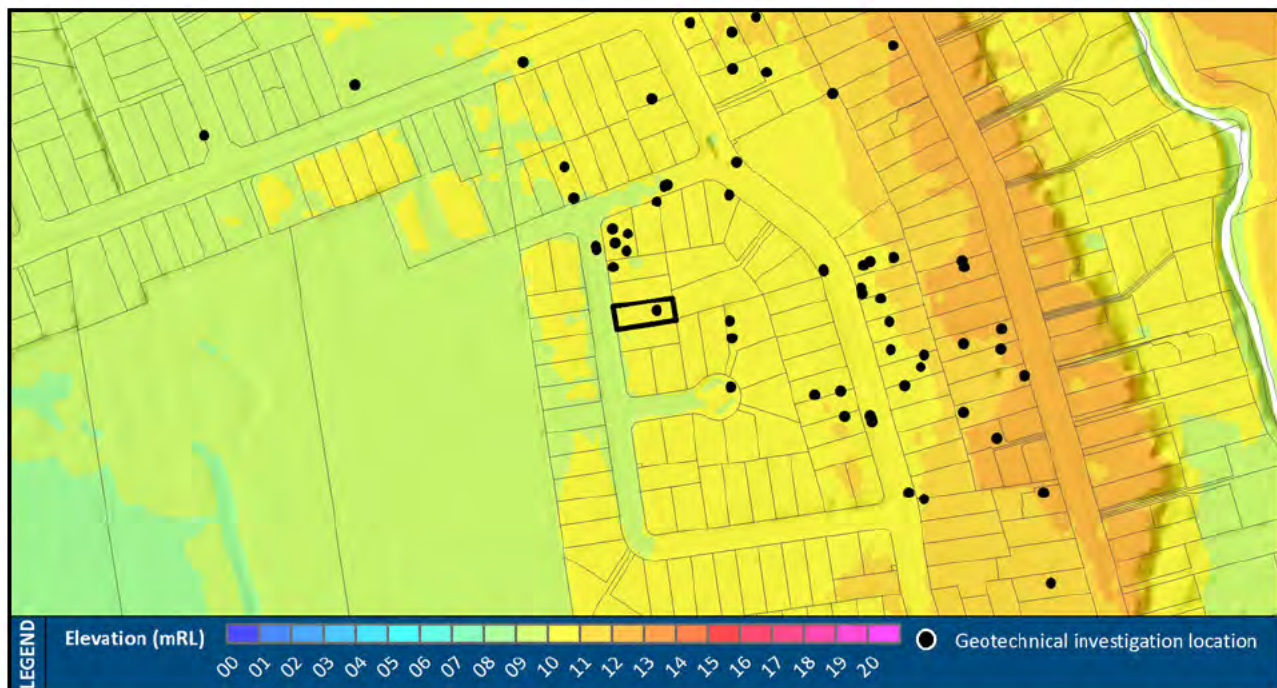
Map 1: Post Canterbury earthquake sequence ground surface elevation and geotechnical investigation locations

This map shows the ground surface elevation (i.e. the height of the land) following the Canterbury earthquake sequence. The elevation shown is the height above mean sea level.

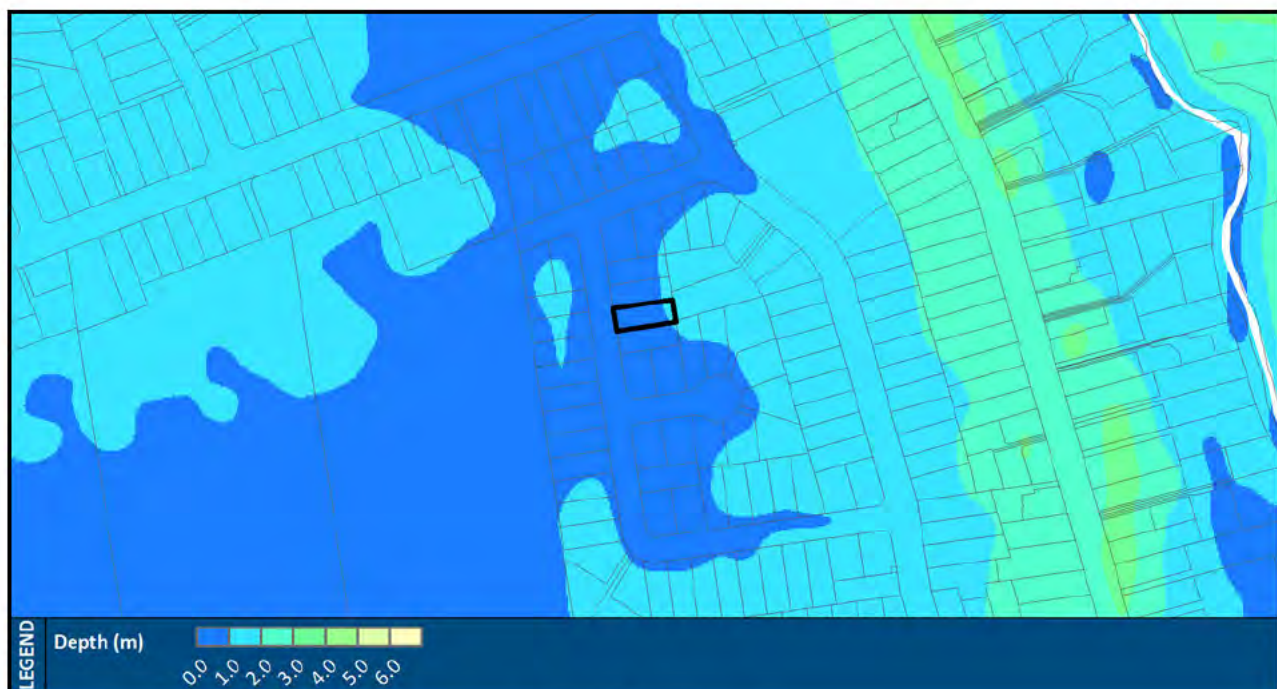
Map 2: Post Canterbury earthquake sequence depth to groundwater

This map shows the median depth to groundwater below the ground surface after the Canterbury earthquake sequence.

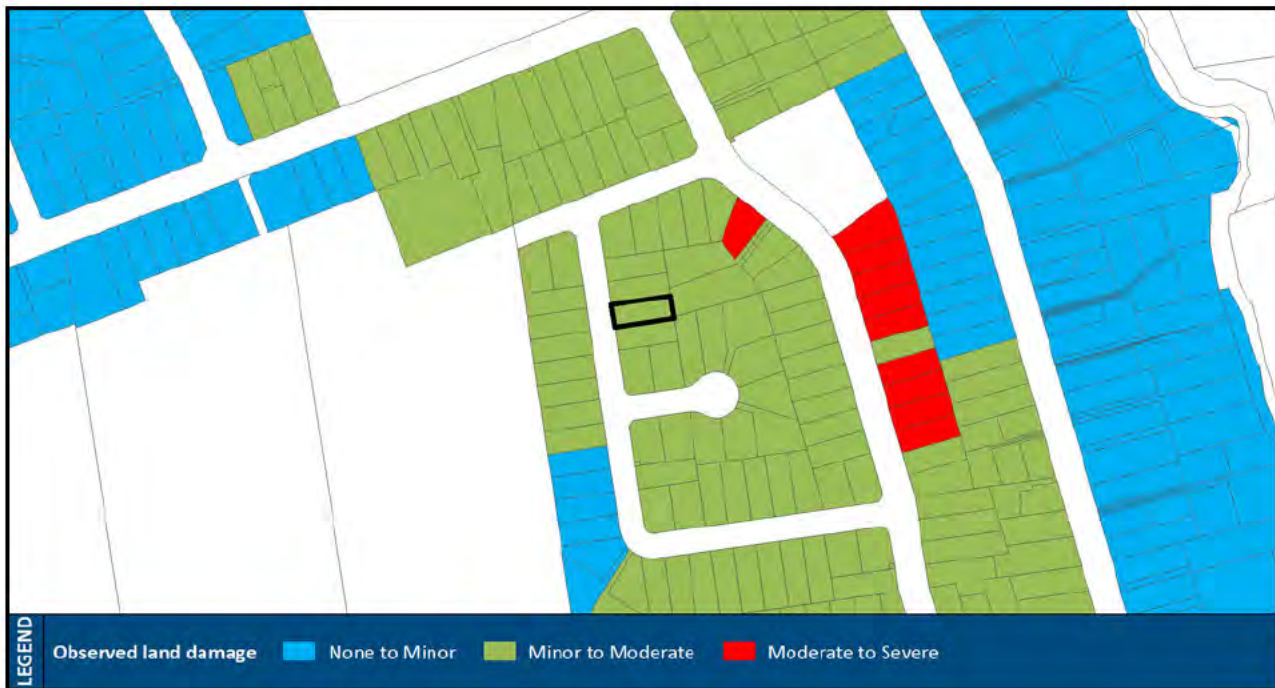
Map 3: Worst observed land damage due to the Canterbury earthquake sequence

This map shows the worst observed land damage recorded for the four main earthquakes during the Canterbury earthquake sequence. Descriptions of the observed land damage categories are: **None to Minor** – no observed liquefaction related land damage through to minor observed ground cracking but with no observed ejected liquefied material at the ground surface; **Minor to Moderate** – observed ground surface undulation and minor-to-moderate quantities of observed ejected liquefied material at the ground surface but with no observed lateral spreading; and **Moderate to Severe** – large quantities of observed ejected liquefied material at the ground surface and severe ground surface undulation and/or moderate-to-severe lateral spreading.

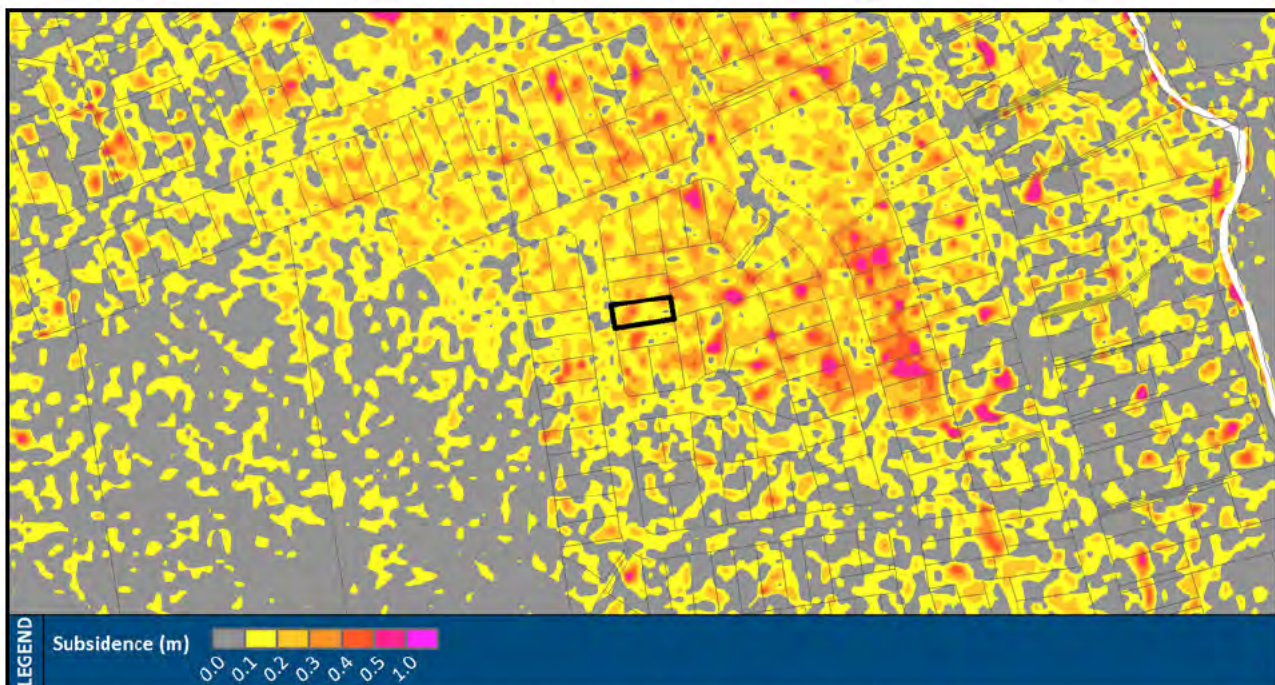
Map 4: Total ground surface subsidence due to the Canterbury earthquake sequence

This map shows the estimated total amount of ground subsidence as a result of the Canterbury earthquake sequence. Ground surface subsidence is estimated by comparing ground surface levels after each of the four main earthquakes. Adjustments have been made to the map to remove subsidence or uplift that is not as a result of the Canterbury earthquake sequence (e.g. man-made activities such as earthworks).
