# Building Inspection Report

## RESIDENTIAL INSPECTION

7 Palmside St  
Christchurch, Canterbury Region 8024

30/06/2025

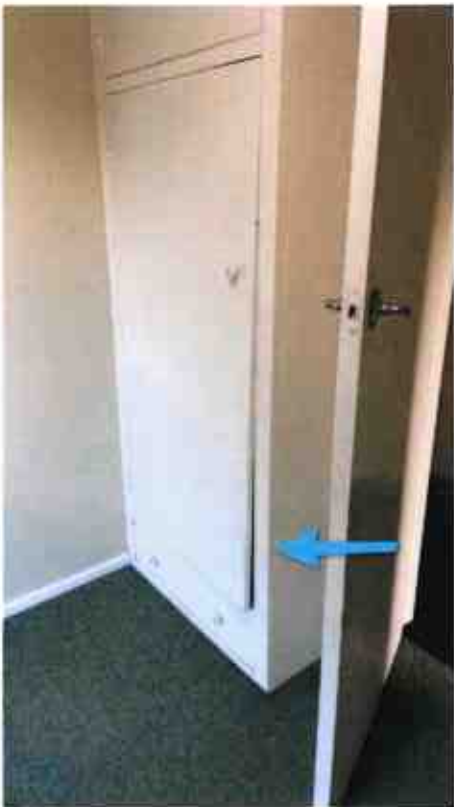
- ↗ 9.6.2 Bedroom Two - Windows & Reveals: Damaged MDF window reveals
- ↗ 10.4.1 Bedroom Three - Wardrobe: Warped door
- ↗ 12.3.1 Bathroom One - Walls: Wear in wall paper

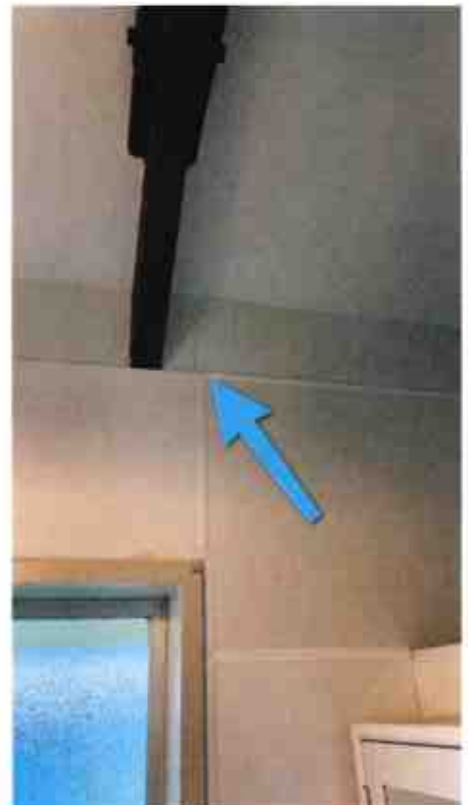
### 13.3.1 Walls

#### **SHEET JOIN CRACKING**

There is sheet joint cracking to the wall linings, which can be repaired.

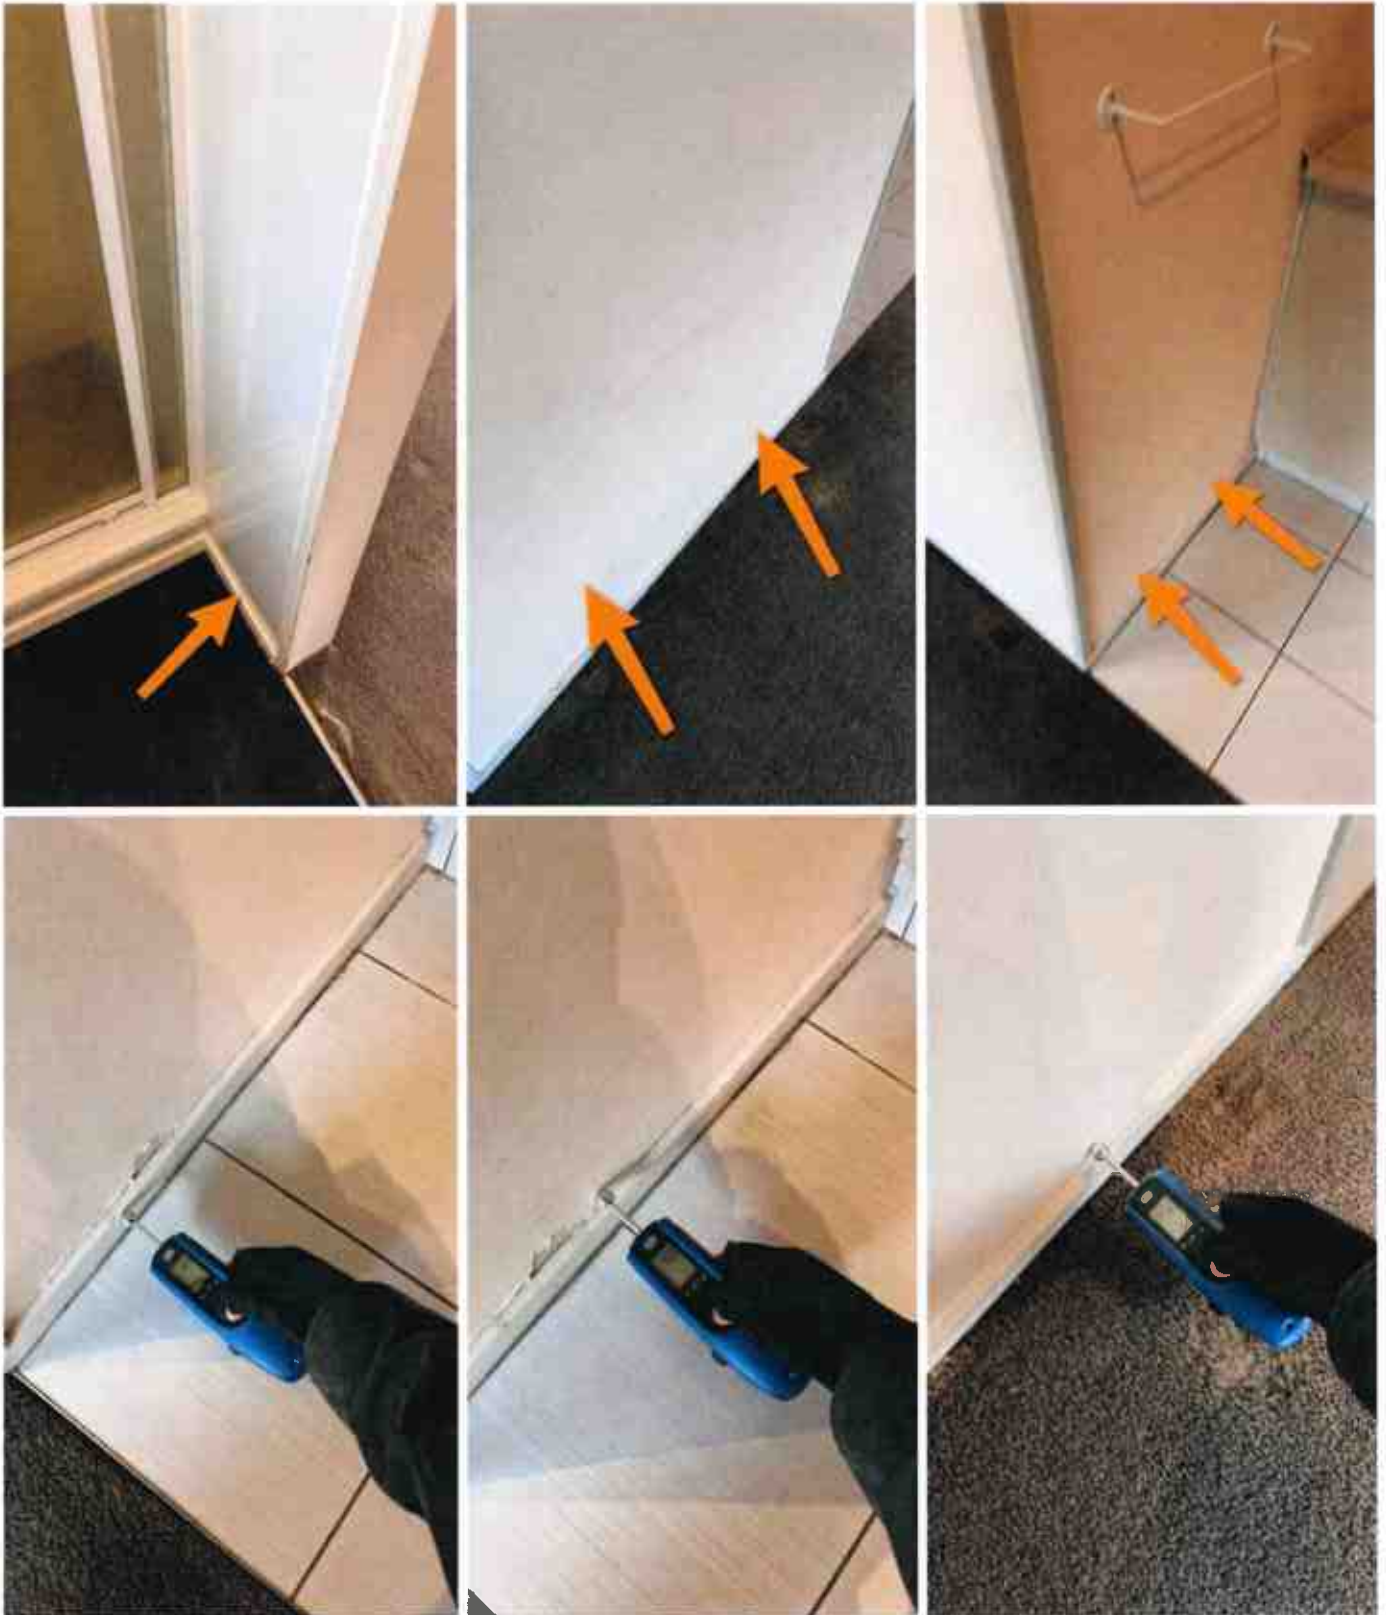
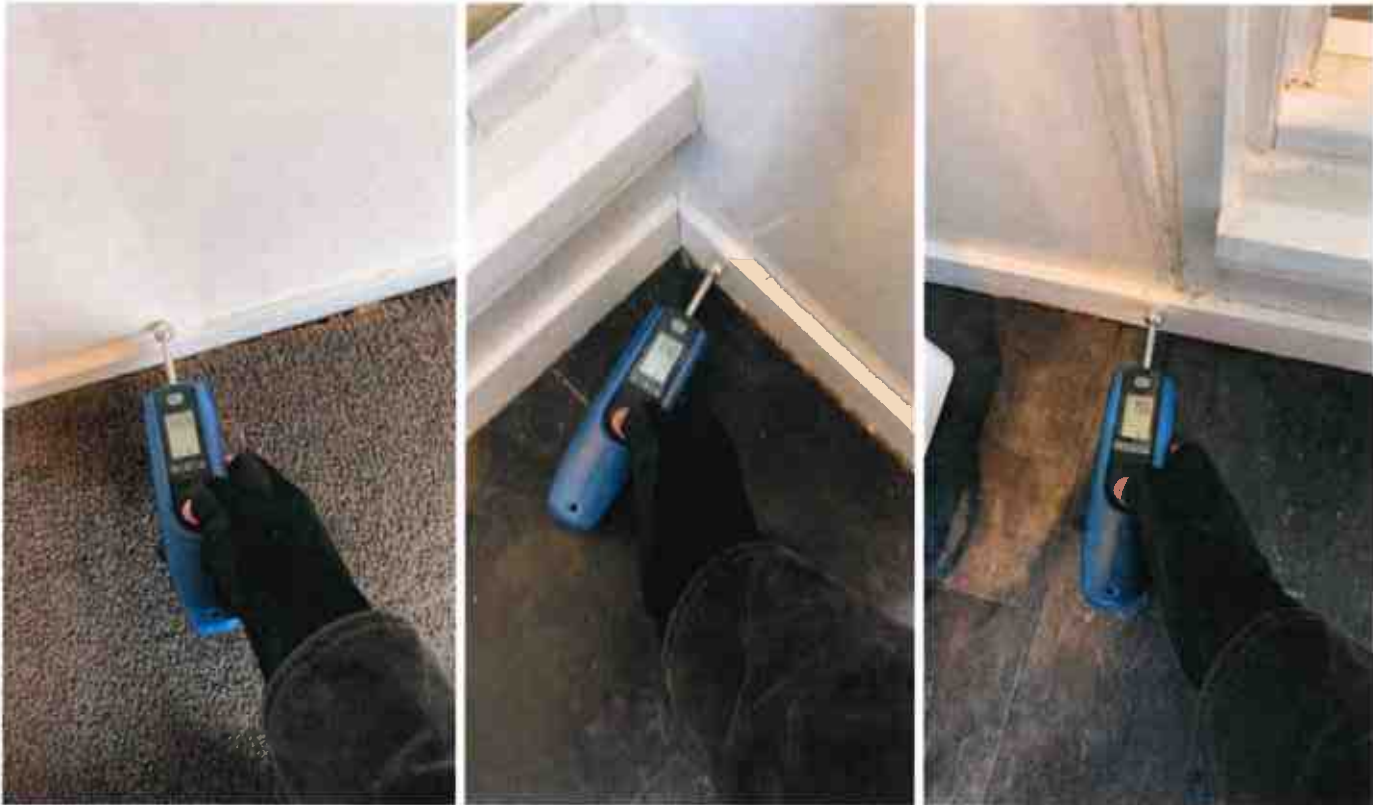
**ELEVATED MOISTURE LEVELS TO SHOWER AREA**

Elevated moisture levels were observed to both sides of the internal wall encompassing the shower enclosure. It is likely that either the shower screen is leaking during operation, or a plumbing leak has occurred within the wall framing. Further invasive investigation by a licensed plumber is required to determine the source of the leak and repair as necessary. The condition of the internal framing cannot be determined during this non-invasive inspection

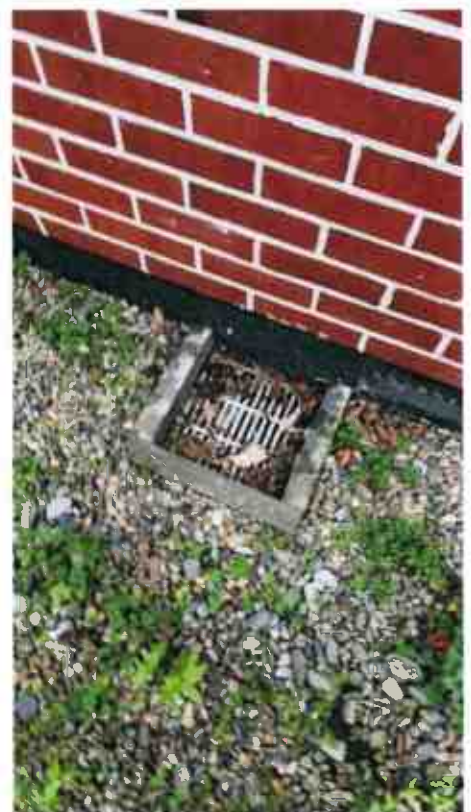
#### **LOW GULLY TRAPS**

The gully is set to low and surface water may enter the sewer system, the trap should be raised or a plinth installed.

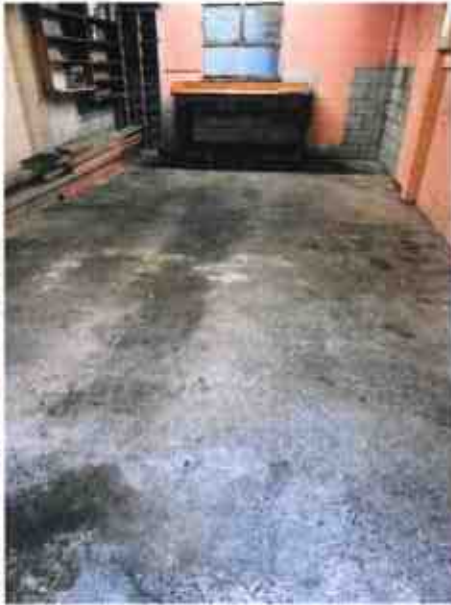
**CRACKING TO FLOOR SLAB**

Cracking was observed to the original concrete slab to the garage floor, as is common in older concrete. The cracked areas can be repaired by a concrete repair specialist if desired

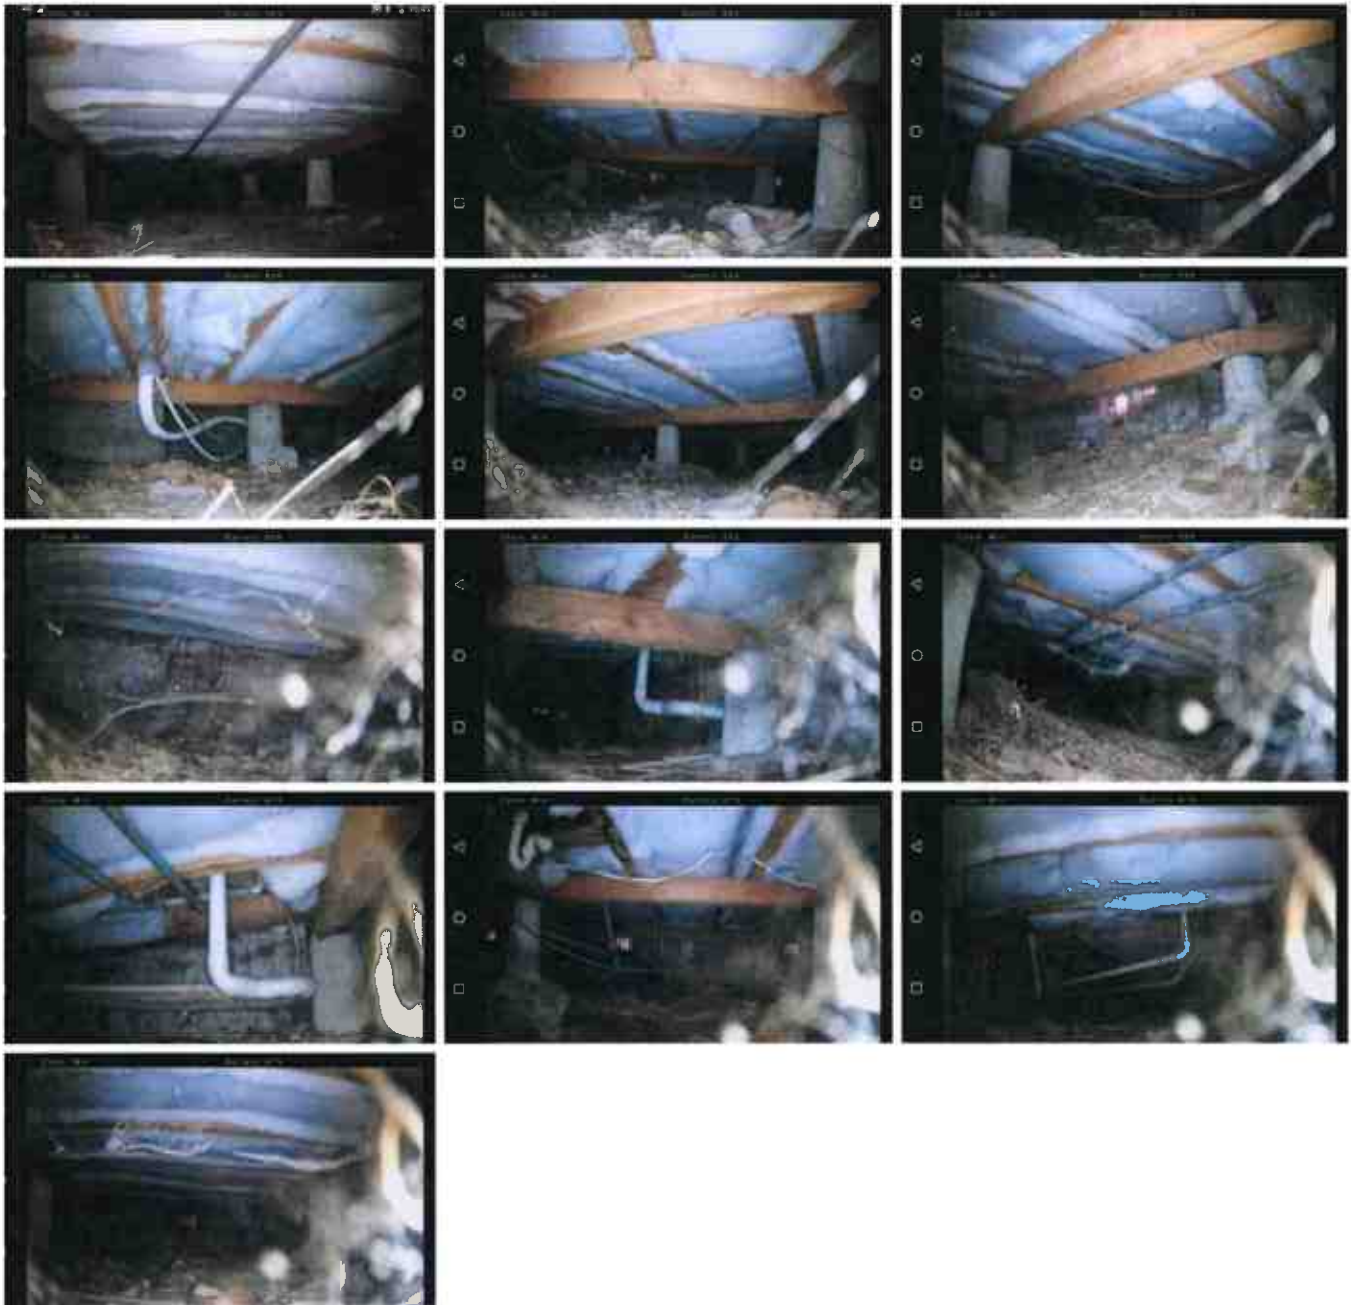
**Foundation Type: Foundation type**

Concrete ring, Concrete pile, Concrete slab, Timber framing

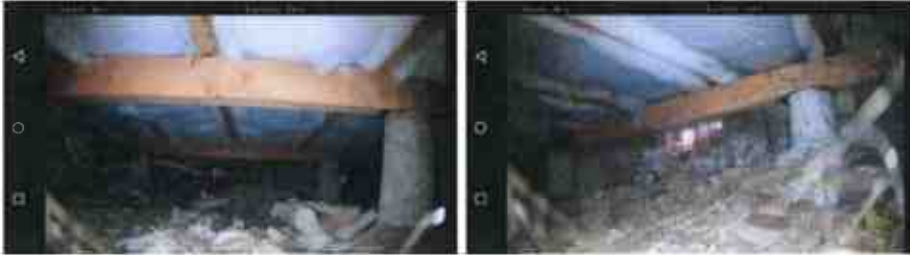
21.4.1 Condition of foundation space

Debris was observed in the foundation/subfloor space.

All loose materials, rubbish, or stored items should be removed to maintain ventilation, reduce fire risk, and discourage pests. A clear subfloor also allows for easier future inspection and maintenance.

Contact a qualified handyman.

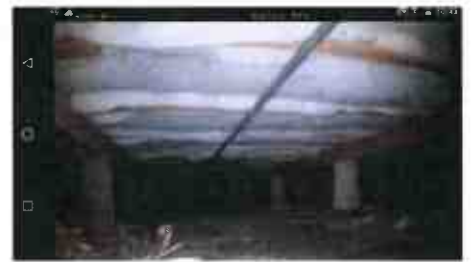
21.8.1 Insulation

**NO VAPOUR BARRIER**

No vapour barrier is installed to the subfloor area. Installation of a vapour barrier is recommended to improve the thermal performance of the dwelling and negate rising damp

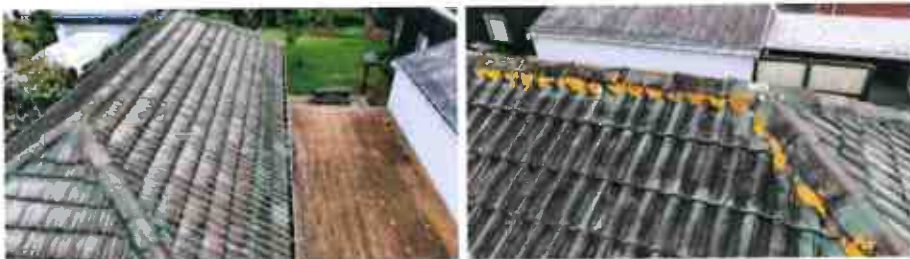
**ERODED TILES**

Tiles are eroded and have become porous and brittle with time. Re-coating is recommended with a specialised roof tile coating to prolong the life of the material

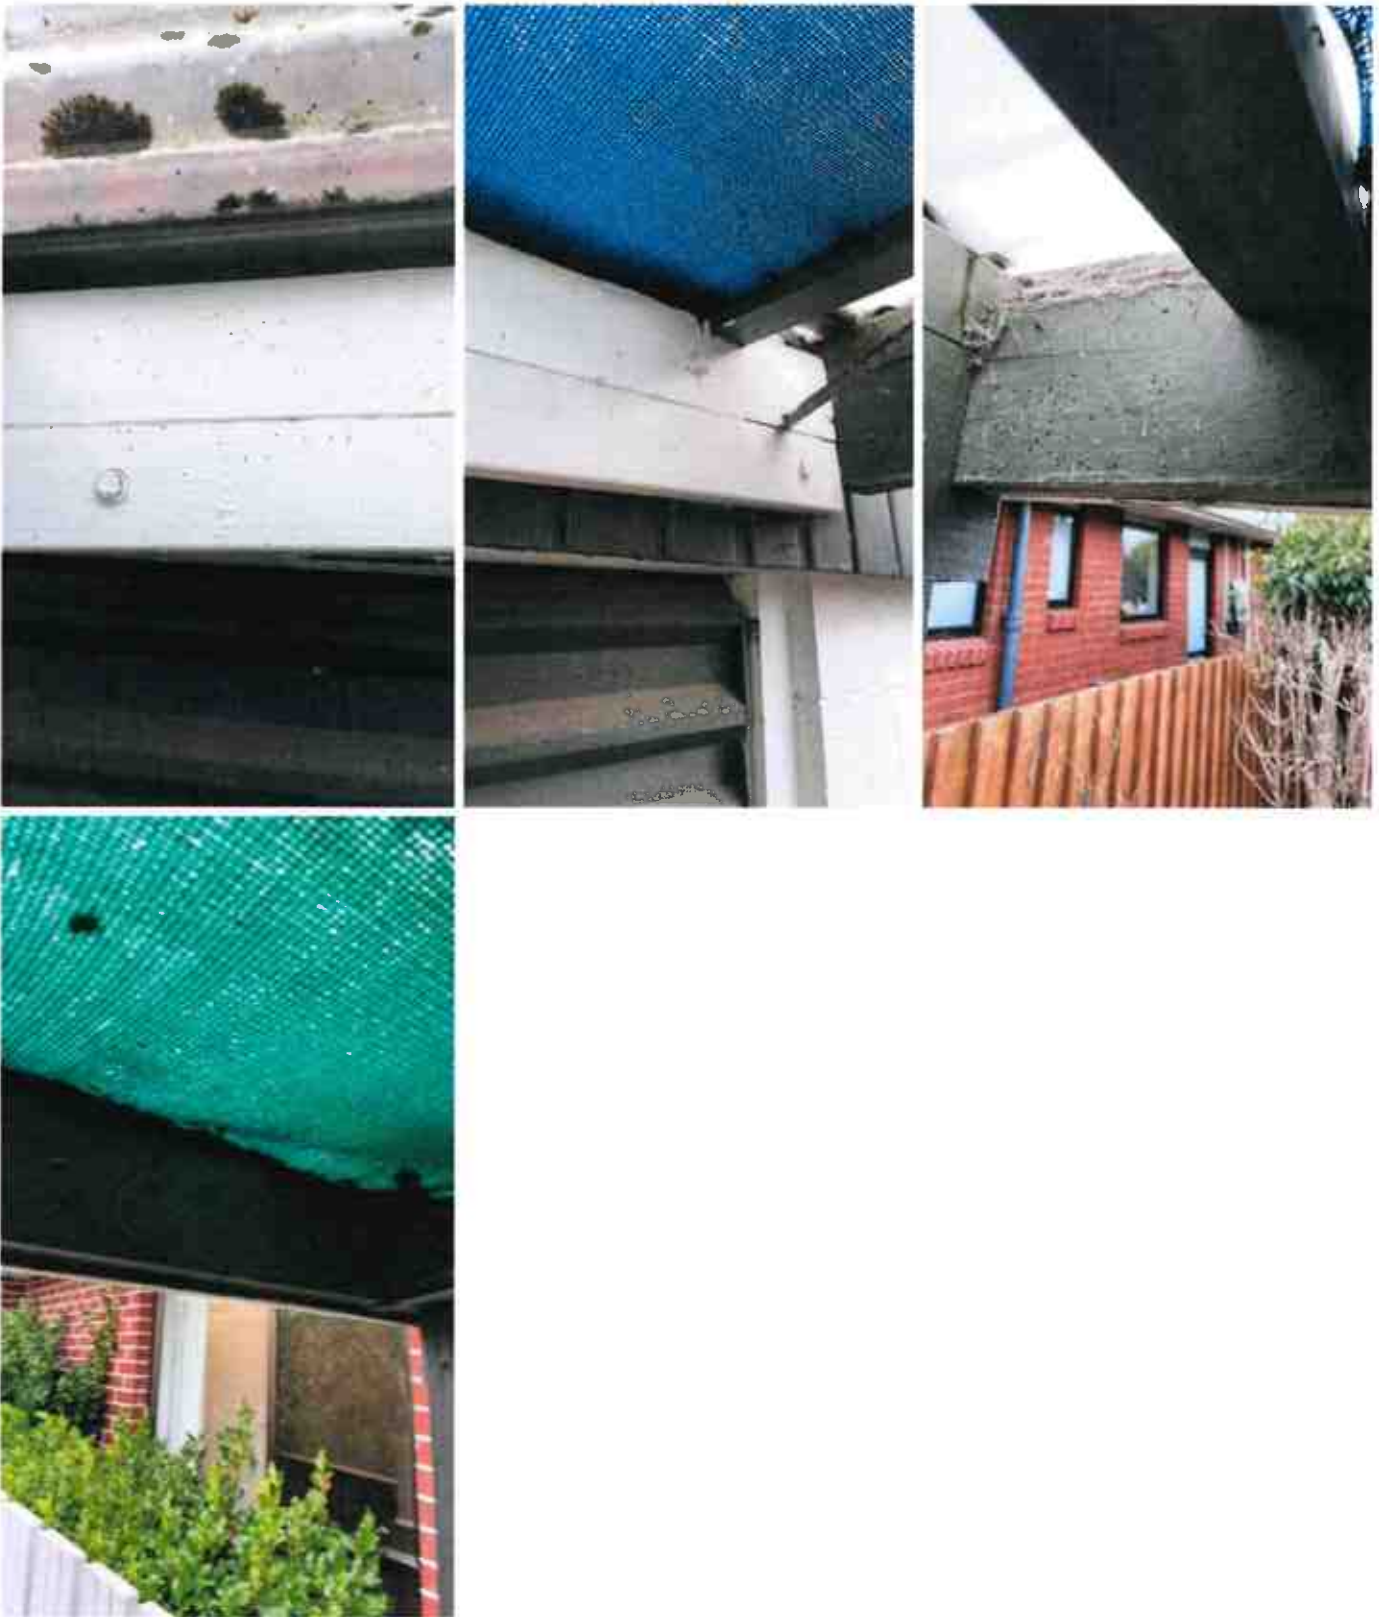
23.2.1 Construction Type

Borer is present to the timber framing. Treatment/replacement of the effected timbers is required to negate the further spread

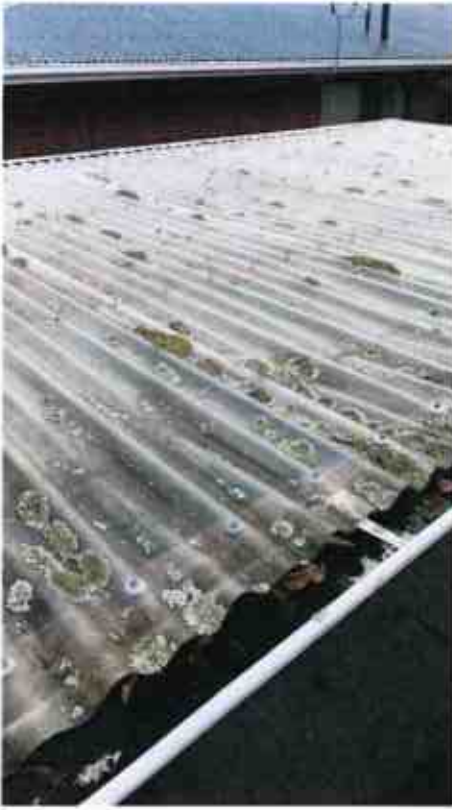
23.3.1 Roofing Material

**LICHEN**

There is lichen and moss growth, which can be chemically treated to remove it and prevent damage to the roofing material.

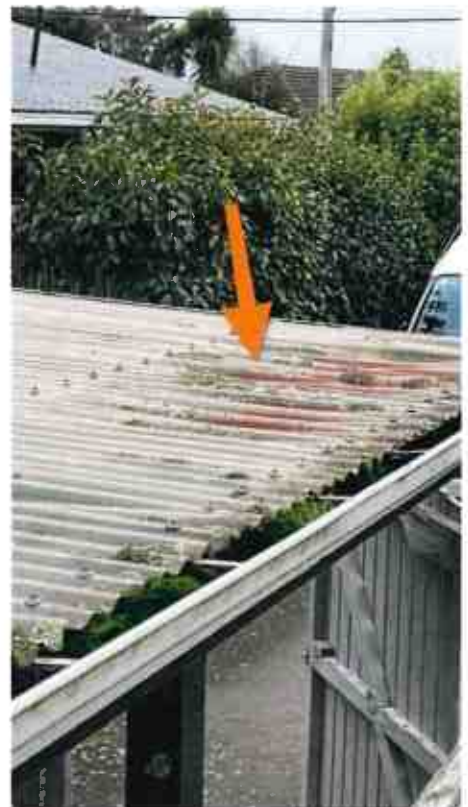
23.3.2 Roofing Material

**DENTS IN THE ROOF**

The polycarbonate roofing is dented and is causing water to pool. Replacement of the effected sheets is required

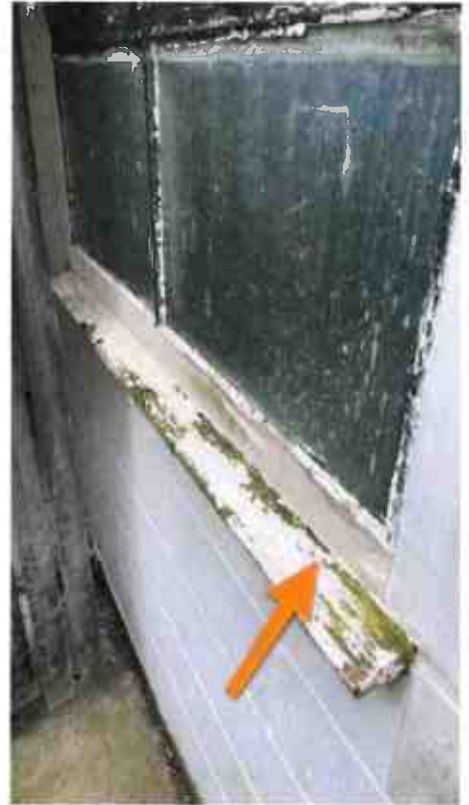
## 24.3.1 Joinery (Windows and Doors)

**PAINT PEELING**

Paint is peeling in places, and the joinery can be sanded back and re-painted.

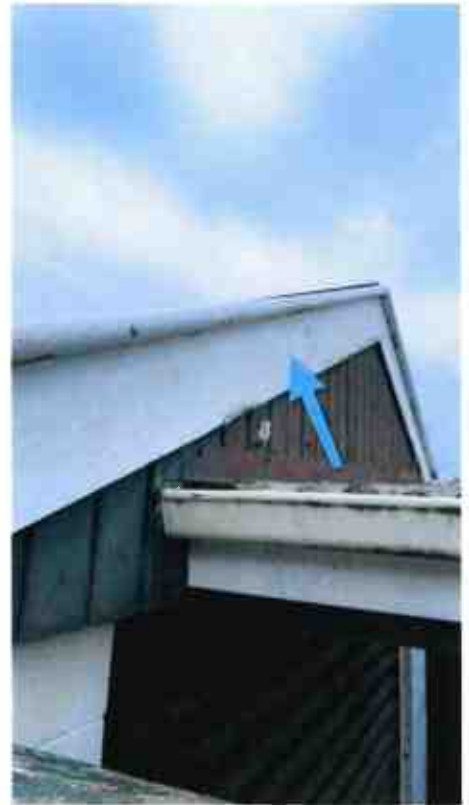
**PAINT PEELING**

Paint is peeling. This could be prepared and re-painted.

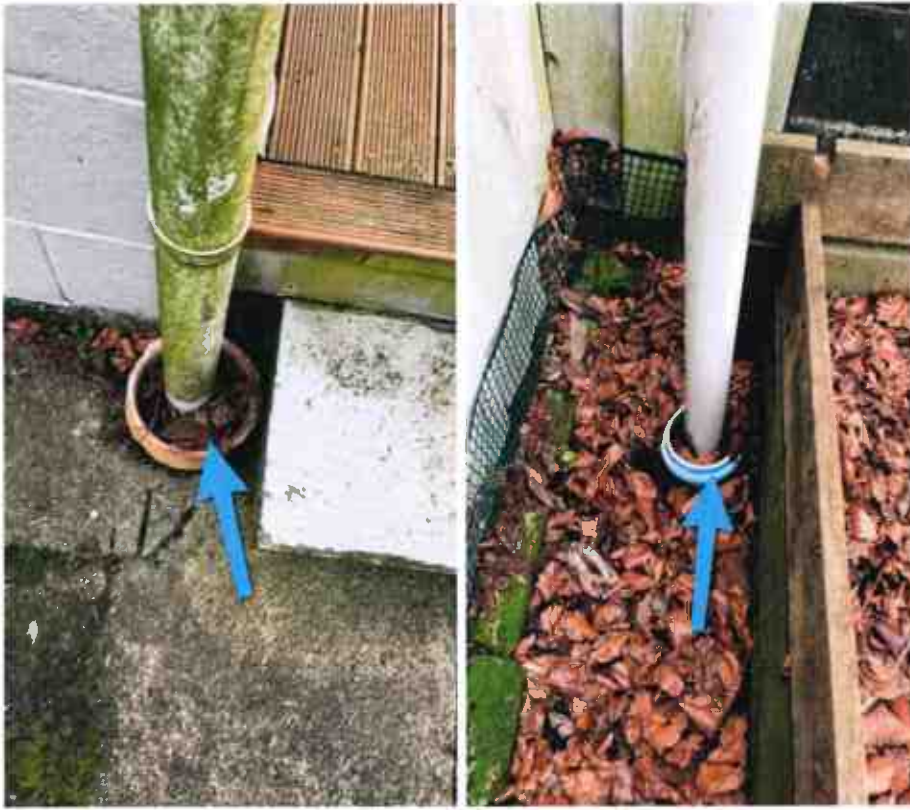
24.8.1 Visible Point of Discharges

**BLOCKED STORMWATER RISER**

The stormwater riser is blocked with debris and requires clearing

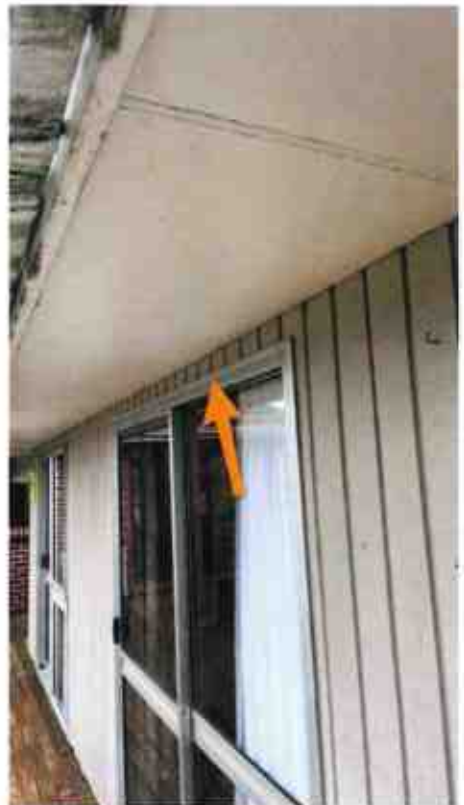
**NO HEAD FLASHINGS**

Some of the joinery is not fitted with head flashings but due to the wide eaves the junction is considered low risk

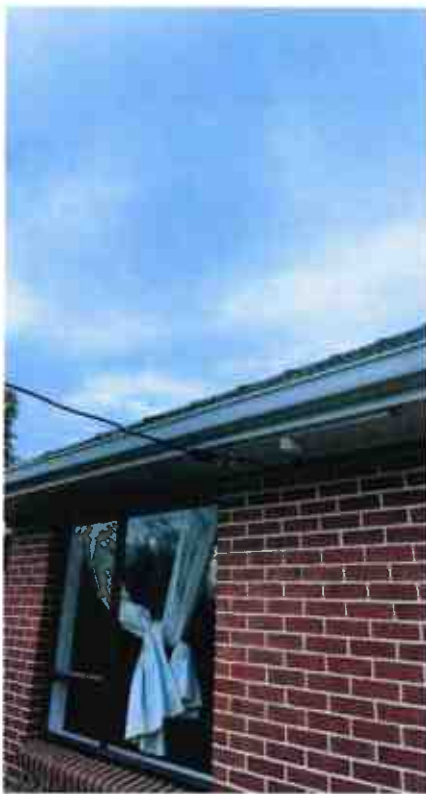
**Supply: Entrance**  
Over head

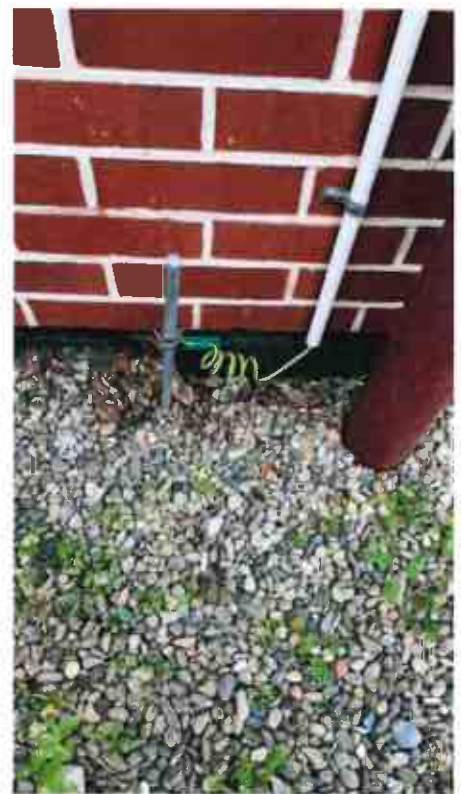
**Earthing Rod: Type**  
Left side of home

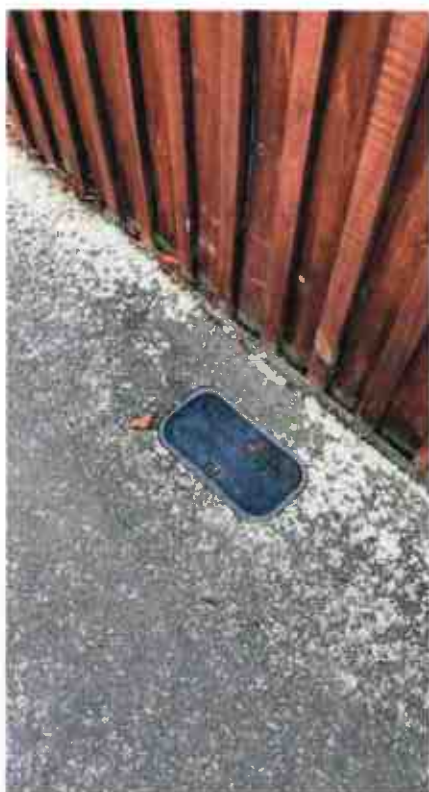
### Water Toby: Location

At the street frontage

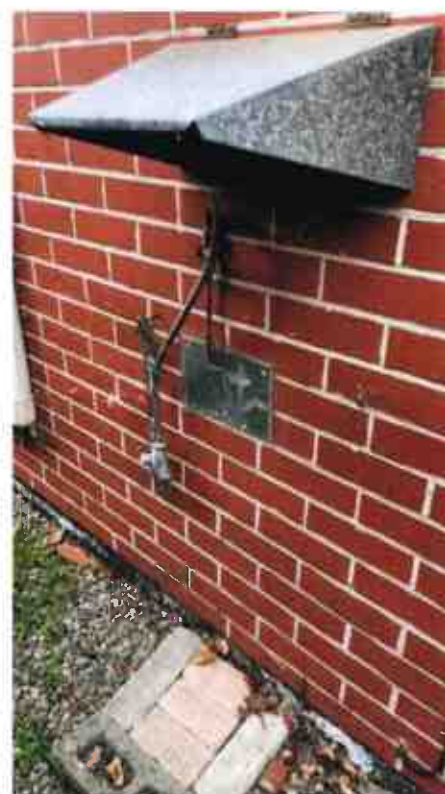
### Gas bottles: Gas bottles

Obtain gas compliance certificate from vendor

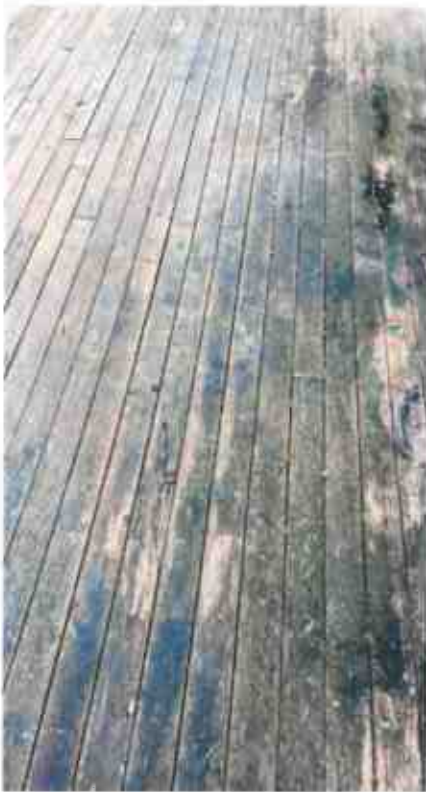
**Decking: Material**  
Timber

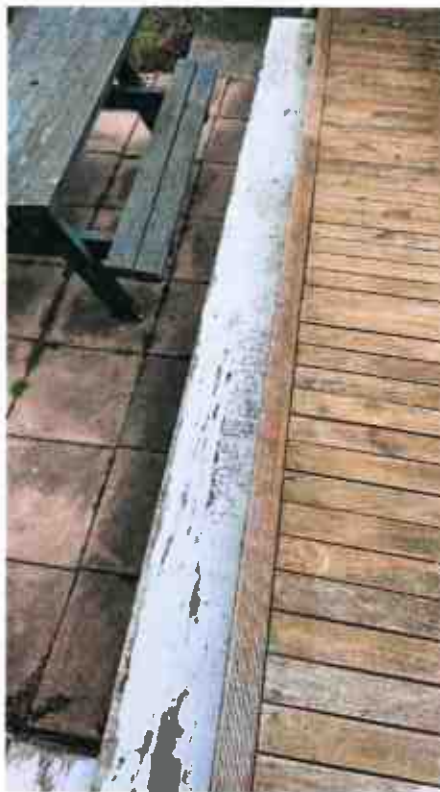
**Steps: Material**  
Timber

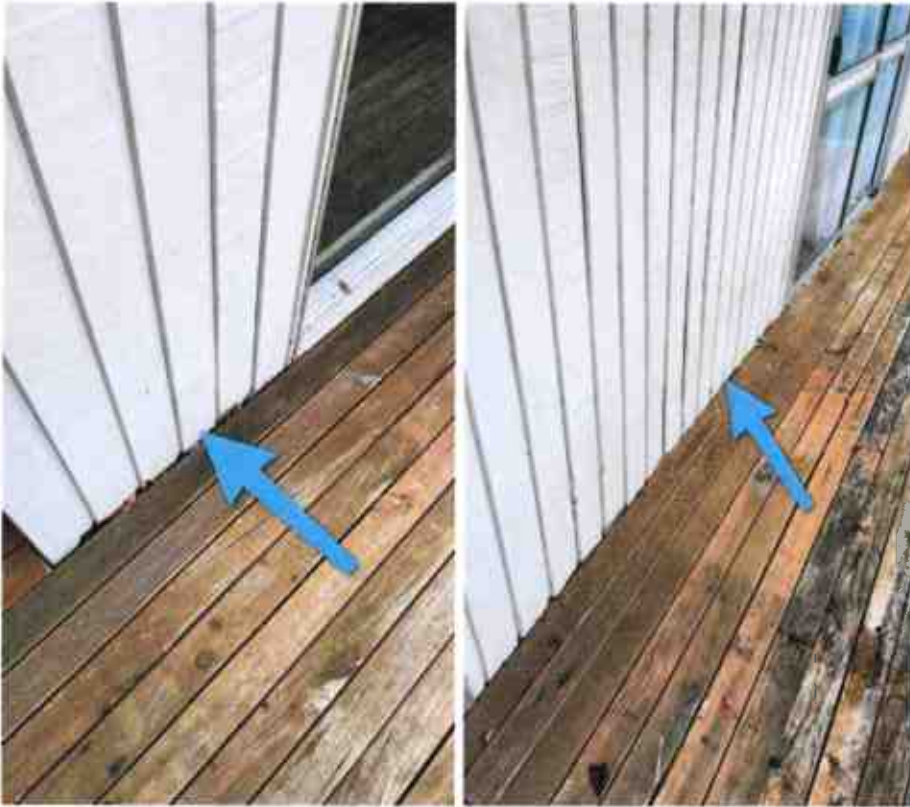
28.3.1 Decking

The decking has been installed hard to the cladding in areas. 12mm minimum clearance from the cladding is required to be compliant to negate moisture being trapped between the materials. Trimming of the decking boards to allow clearance is required

Maintenance Item
