# RESIDENTIAL PROPERTY INSPECTION

**Inspection Address:** 2 Chilcombe Street, Christchurch

**Inspection Date:** Monday, 29 June 2026

**Inspector Name:** Sam Thomson

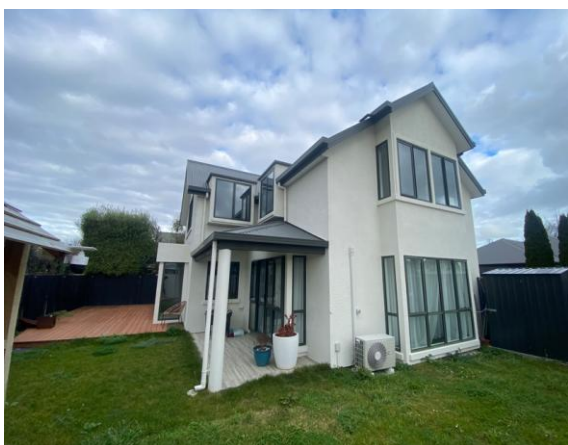
| ELEMENT | COMMENT |
|---|---|
| Cladding condition | Cladding has minor cracking and the wooden deck is hard up against the dwelling cladding, not allowing moisture drainage. Periodically check for any cracking and seal. Paint using an Elastomeric paint in accordance with the manufacturer's specifications, every five to seven years. |

Cladding and windows – general view

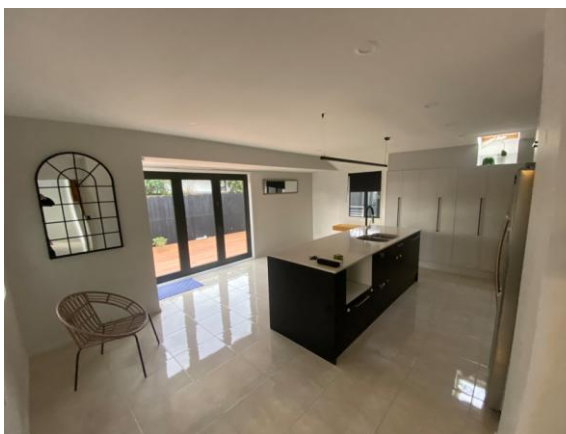
Walls and ceilings – general view

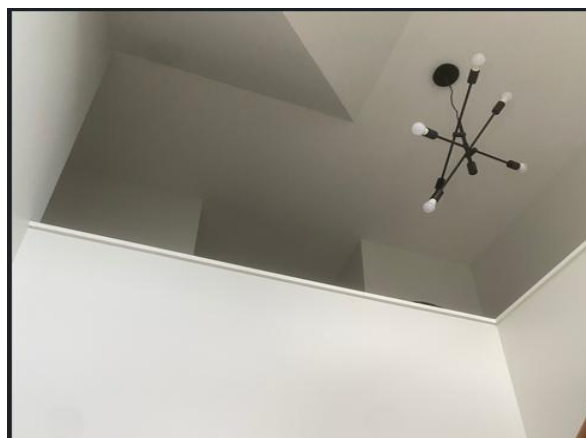
- Minor blemishes to the walls and ceilings – normal wear & tear
- Noticeable tile infills in kitchen flooring where alterations completed
- Cavity sliders to bathrooms would benefit from adjustment and replacement of floor runners. Hand-pull handles are loose
- Non soft close drawers with child latches left on. Goose neck tap to kitchen requires tightening at base
- Small pin hole leak to glass on downstairs shower. Flexi hose to shower is squashed by rainwater head in all showers - due to poor design
- No splashback behind the WC handbasin
- Some window catches not functioning as intended

Wall blemishes
