# EARTHQUAKE RECOVERY (EQR) DOCUMENTATION

**Released under the Official Information Act 1982**  
**EQR Property Overview Report**

53 Brockworth Place, Riccarton

# Increased Flooding Vulnerability (IFV) Engineering Assessment

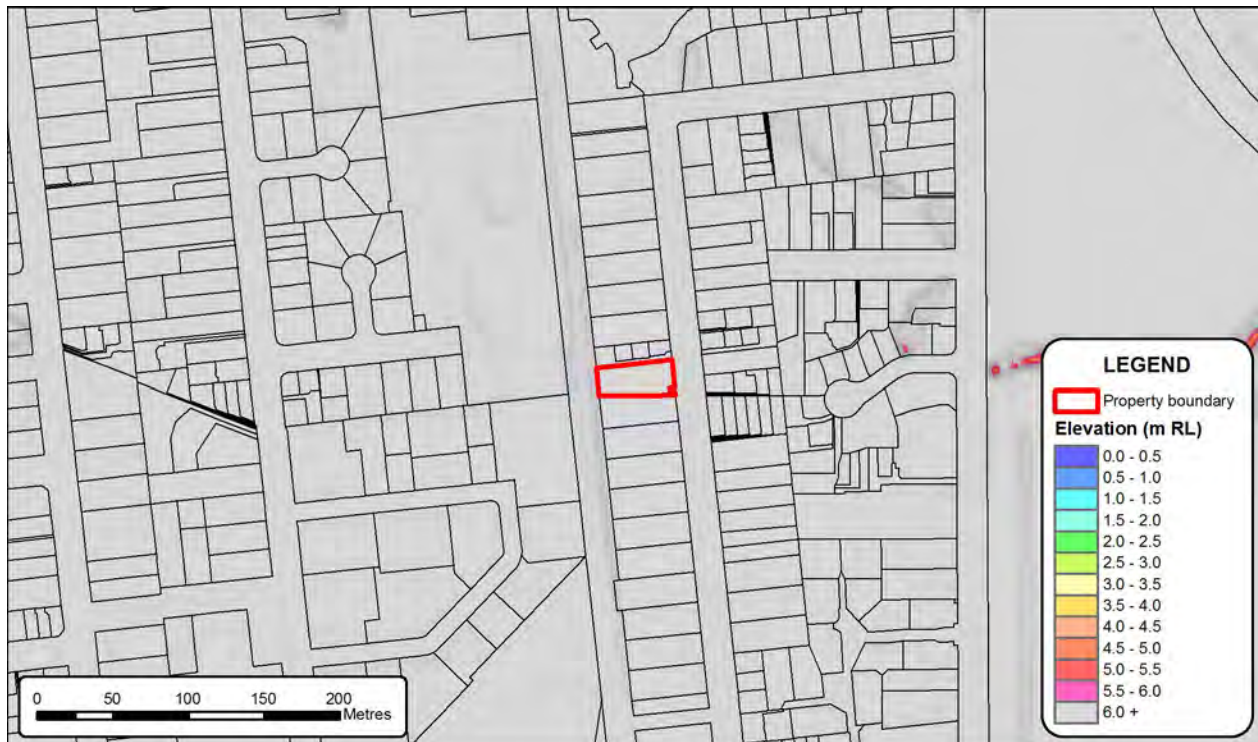
Map 4: Ground surface elevation post December 2011

Map 4 shows the ground elevation (i.e. the height of the land) following the Canterbury earthquake sequence. The ground surface elevation was measured using an aerial LiDAR survey (which involved scanning the ground surface

from an aircraft). This post-earthquake ground elevation survey is a key input into the modelling of the post-earthquake flood depth. Similar surveys were used as an input into the modelling of pre-earthquake flood depths.
