## **Geotechnical Appraisal Report**

## 63 Fairlie Crescent, Opononi

Ground and site feasibility for proposed minor development. Gumboots Consulting Engineers reference 1103

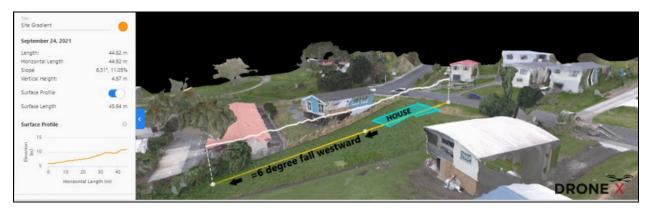
The subject property (legal description Lot 11 Deposited Plan 107852) is an irregular shaped block (0.0914 ha). The property is moderately gentle sloping ( $\approx 6^{\circ}$ ) westward (as depicted in figure 1 below) and is located approximately 0.49 km south of Opononi Township.

Figure 1 - Site Gradient (adapted from DroneX Aerial Survey).

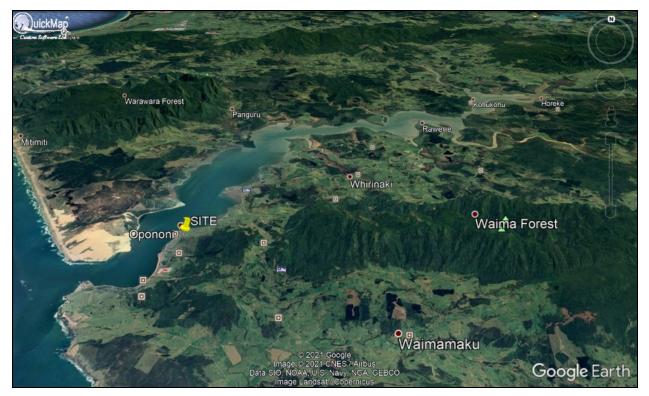
Additionally, the higher overarching reaches of the adjoining Maungataniwha [Waima Forest] represent the overthrusting result of the Tangihua Complex (Kt) which overlie less dense sedimentary rocks of underlying thrust-bounded units.

Figure 3 - Macro Landscape (adapted from Quick Map Enterprises and Google Earth Maps).

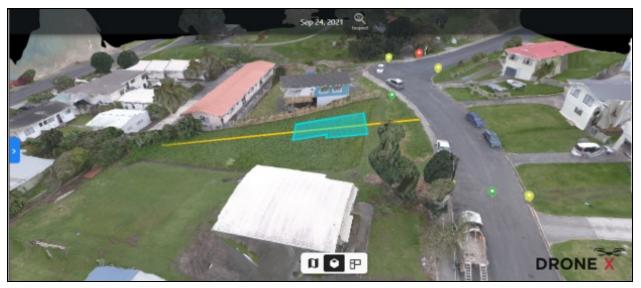
Figure 5 - Micro Landscape (maps adapted from Quick Map Enterprises and Google Earth Maps).

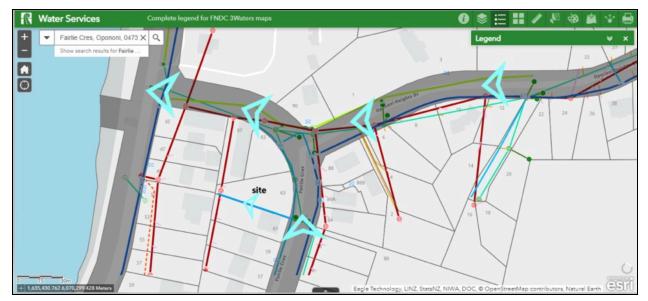
The primary flow paths [PFP] are well defined and layed in a manner as to provide efficient conveyance of surface [storm] water away from the properties and eventual discharge into the Hokianga Harbour. As depicted in figure 7 below, stormwater management applications are depicted in green.

Figure 7 - PFP (map adapted from Quick Map Enterprises and Google Earth Maps).

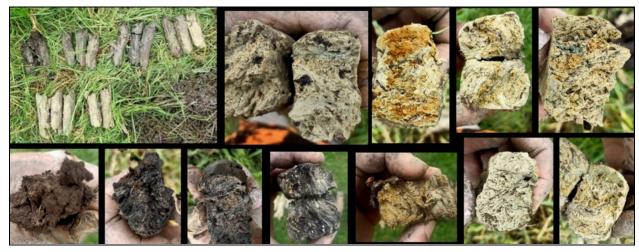
The natural (cohesive) subsoils encountered generally comprise stiff, light orangish brown and highly plastic. At depths  $\geq$  1.50 meters, soils became light grey and becoming white and silty at refusal drilled depths. As depicted in Figure 9.

Figure 10 - Natural Soils Onsite (adapted from the DroneX Survey).

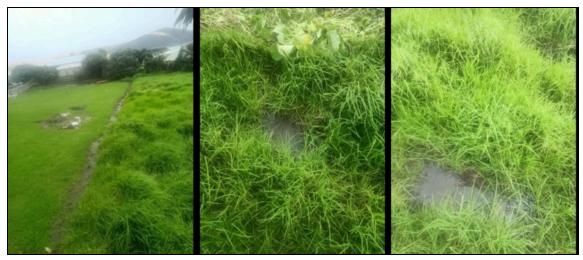
It can be considered that the wetter than normal seasons [prior ground testing], land topography within the locale and existing ground surface cover [thick kikuya] may contribute to the ground conditions.

Figure 11 - Ground Cover (adapted from DroneX aerial survey.)

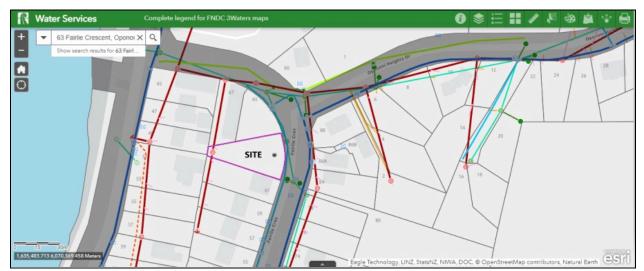
Runoff conveyance shall utilise sealed pipes and discharge appropriately<sup>7</sup> to the existing stormwater points onsite. This shall include [not limited to] retaining wall toe drainage and hard standing areas.

Figure 12 - 3 Waters Map - site outlined in purple (adapted from FNDC Water Services Map).

That is; roads, wastewater and stormwater reticulation serving the community are well established and considered adequate in context of the proposed home. As depicted in figure 12.

Shall engage through the reticulated infrastructure in place. See Figure 12 below.

Shall engage directly through the reticulated stormwater infrastructure in place. See Figure 12 below.

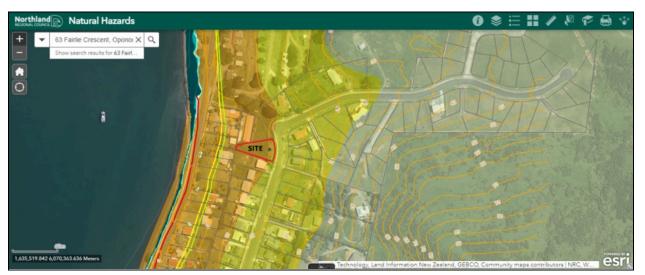
Upon review of the Northland Regional Council Hazards maps, it indicates the subject area as not being within a flood extent area. As depicted in Figure 13 below.

Figure 13 - Natural Hazard Map - site outlined in red (map adapted from NRC Natural Hazard Maps).

The site is however within a critical evacuation zone in the event of a tsunami i.e. highlighted orange. Respectively, if a 500 year return period<sup>8</sup> were to eventuate. As indicated within the NRC natural hazards map area above.

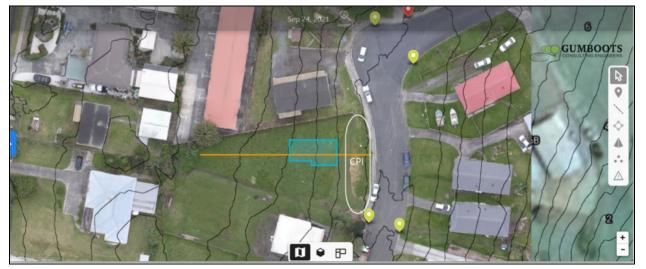
Figure 14 - Critical Areas - (adapted from the DroneX Survey).
