# Land Information Memorandum

Property address:  
26 Hemingway Place

LIM number: 70242732  
Page 1

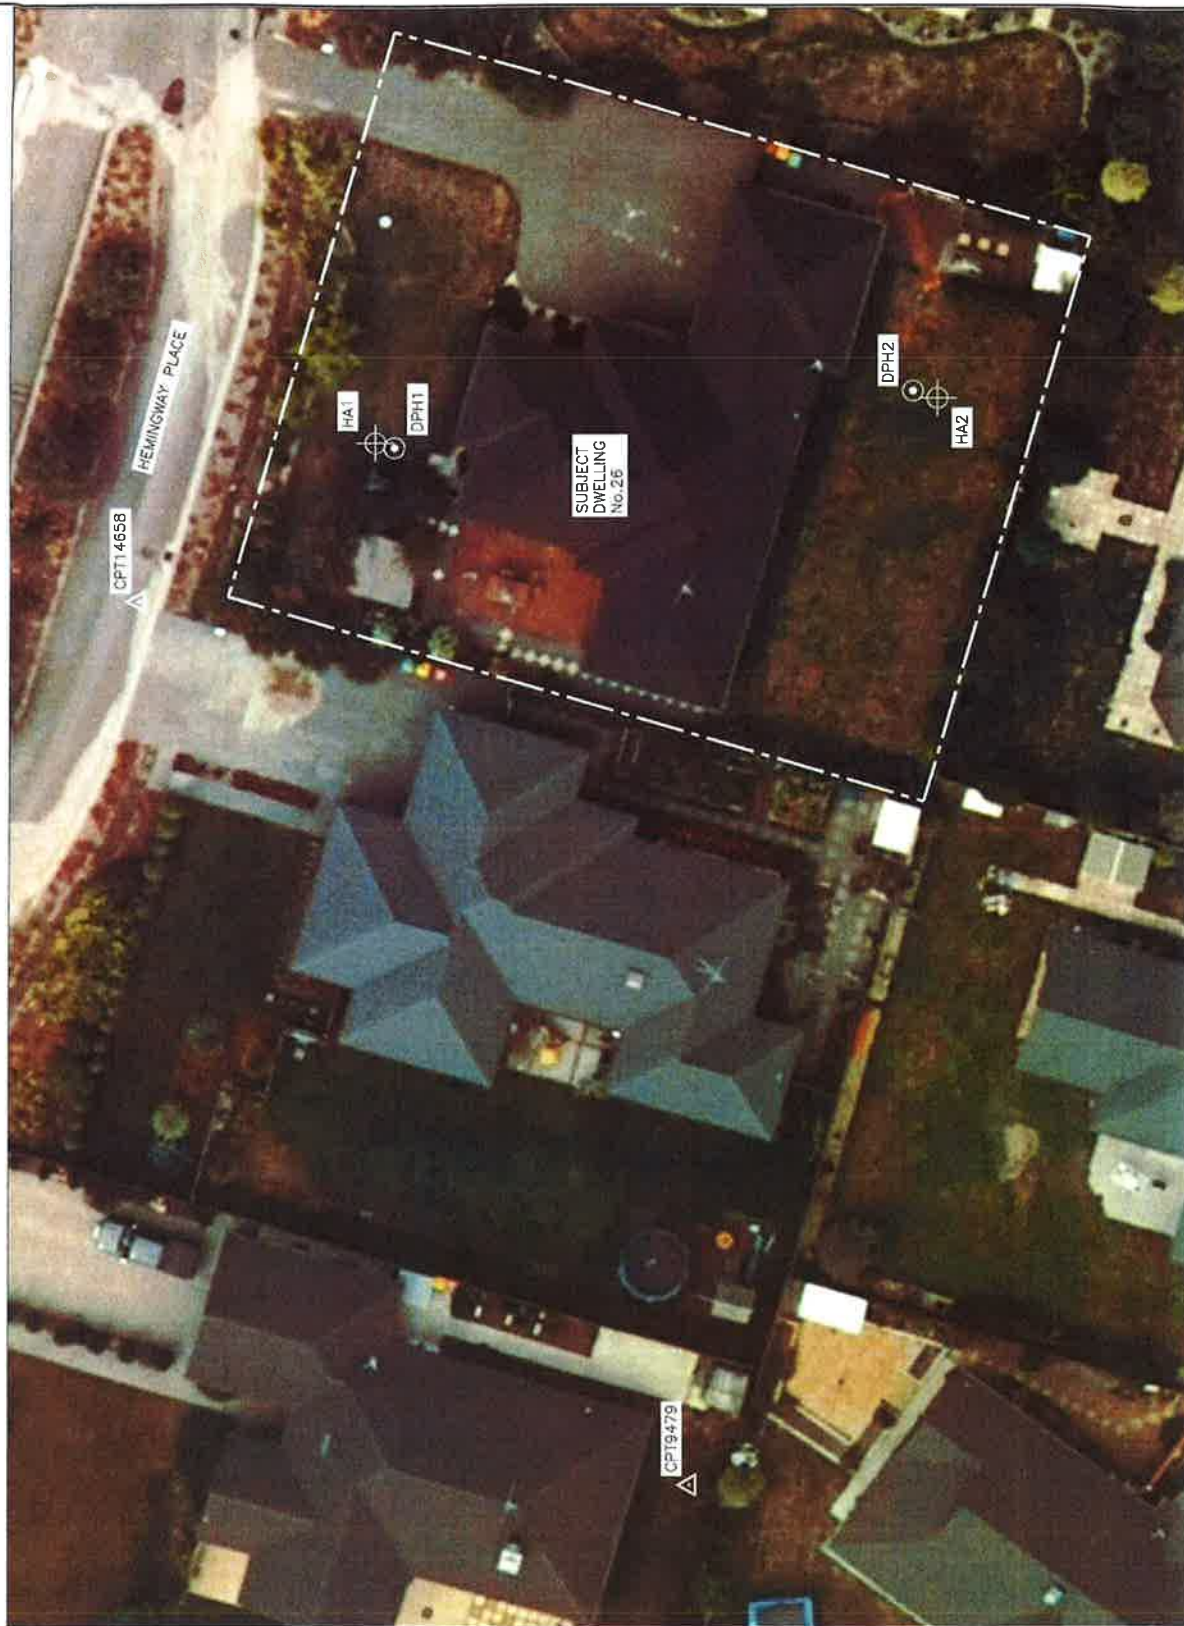
- HA1 HAND AUGER HOLE LOCATION
- DPH1 DYNAMIC PROBE (HEAVY) TEST LOCATION
- CPT CONE PENETRATION TEST LOCATION (SOURCED FROM CANTERBURY GEOTECHNICAL DATABASE)
- PROPERTY BOUNDARY
