EQC Information

CASH SETTLED CLAIM(S)

Scope of Works

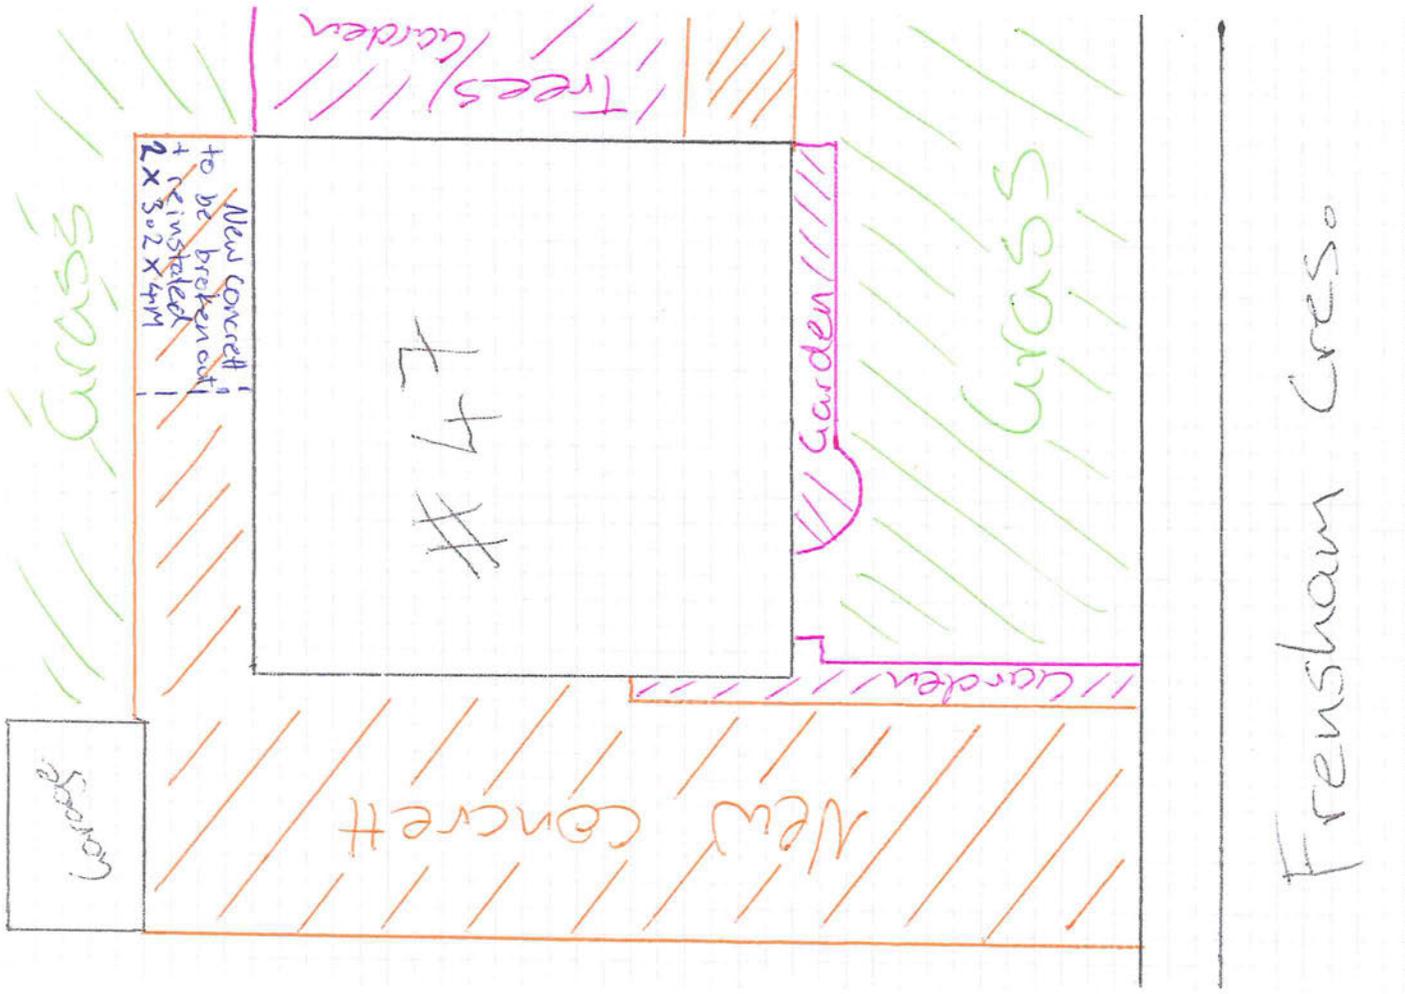
As Built (Damage) / Proposed Repair
 Sewer / Stormwater / Surfaces

Due to earthquake damage, relay the sewer and stormwater

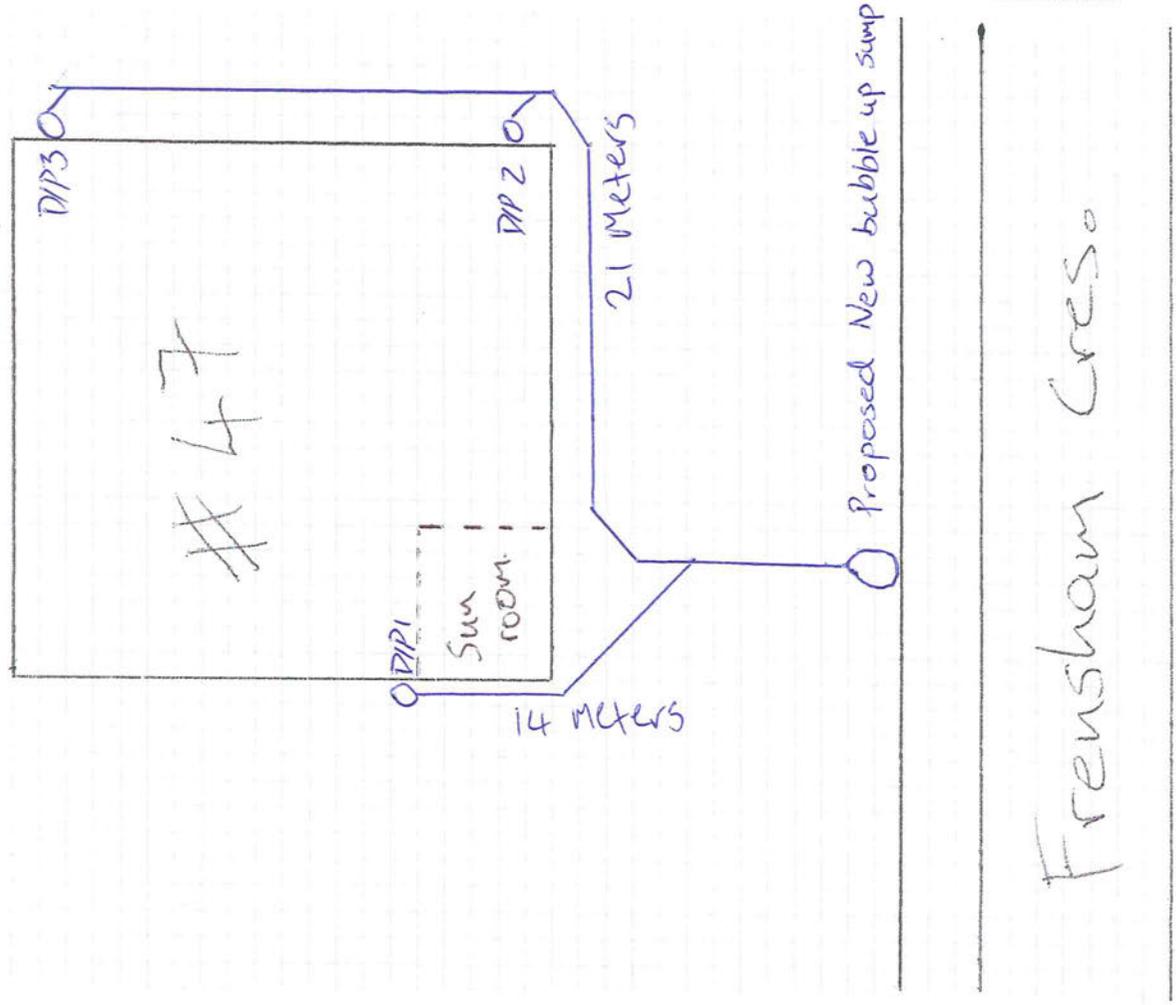
SITE SKETCH - STANDARD DRAINS

Sketch Type (Circle Applicable)
 As Built (Damage) / Proposed Repair
 Sewer / Stormwater / Surfaces

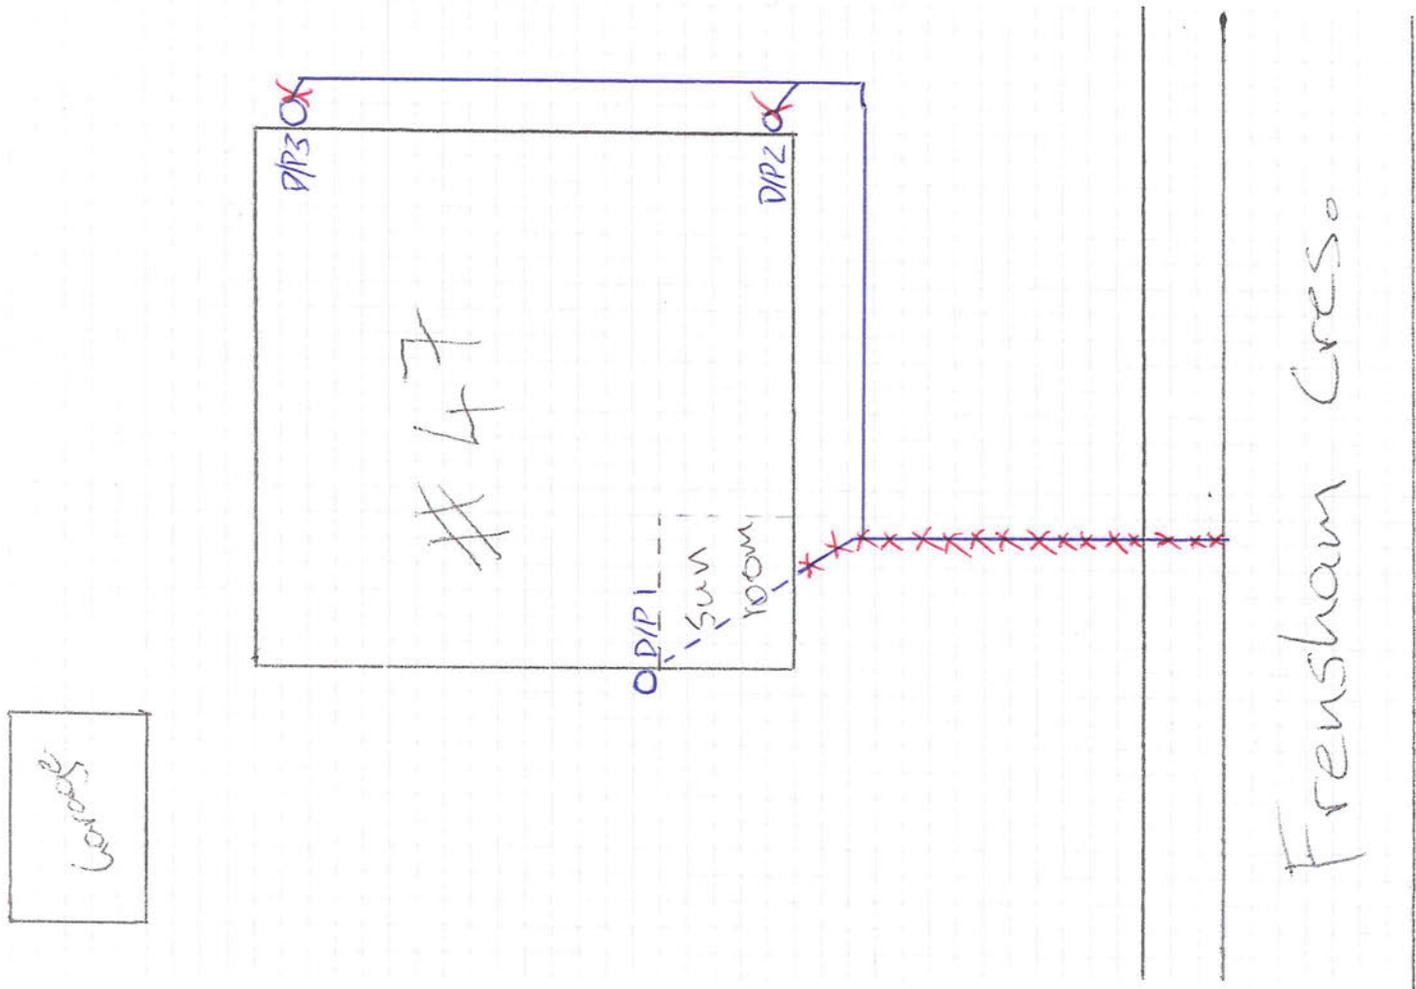
SITE SKETCH - STANDARD DRAINS

Sketch Type (Circle Applicable)
 As Built (Damage) / Proposed Repair
 Sewer / Stormwater / Surfaces

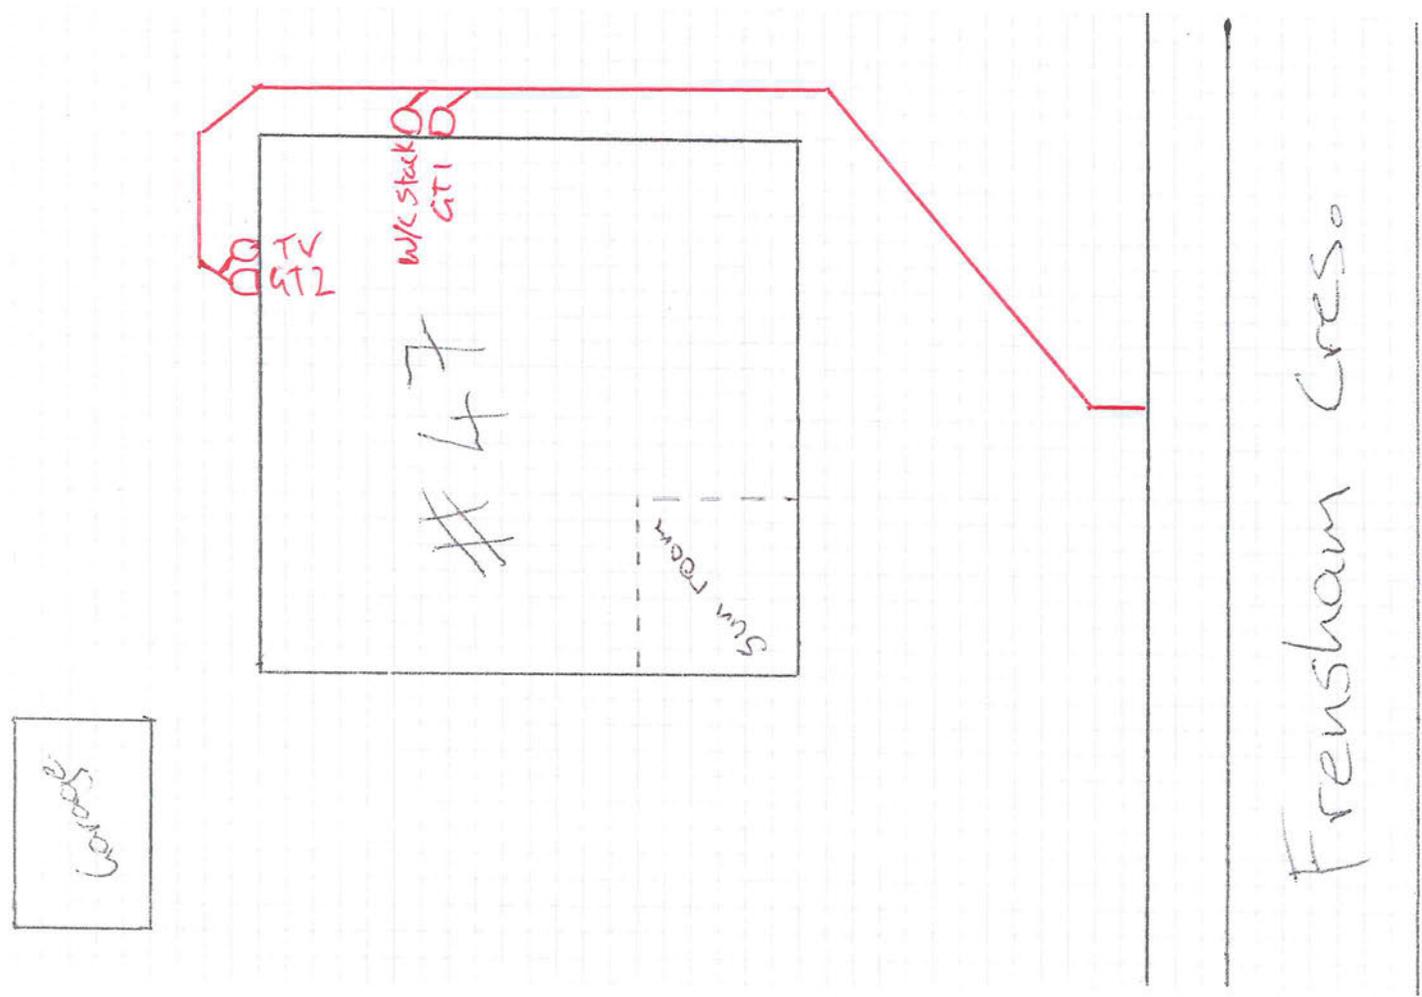
Sketch Type (Circle Applicable)
 As Built (Damage) / Proposed Repair
Sewer / Stormwater / Surfaces
