Far North Inspections LTD

Inspection Report

14 Nimmo Street , Northland, Rawene

Date of Inspection: 6/8/2019

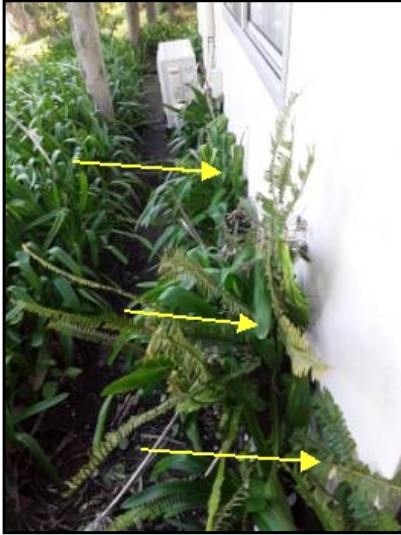
Cladding needs to ventilate to stay dry.

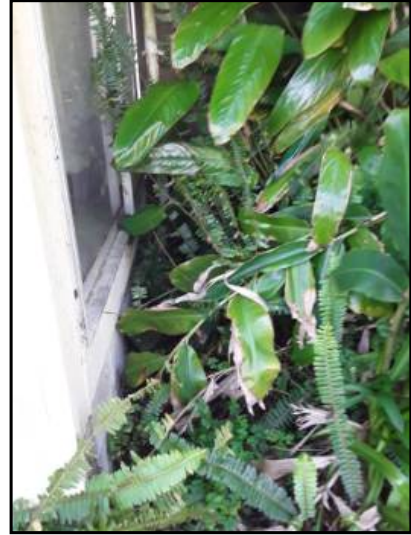
Cut plants back.

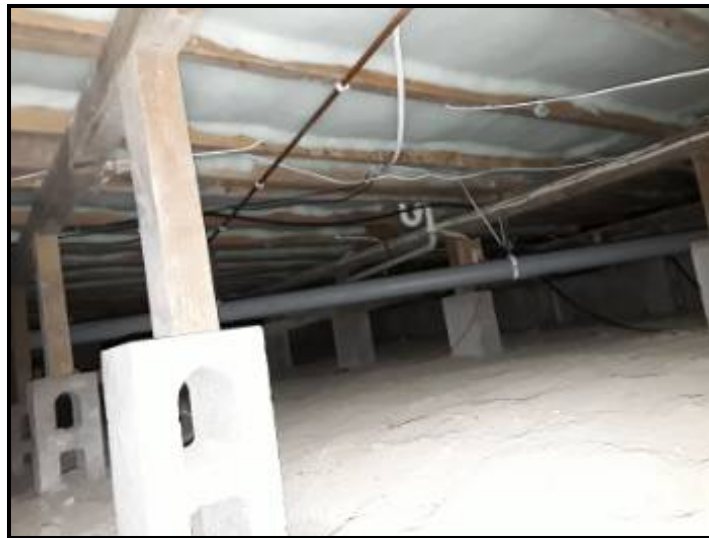
Green Stuff glass fibre insulation.

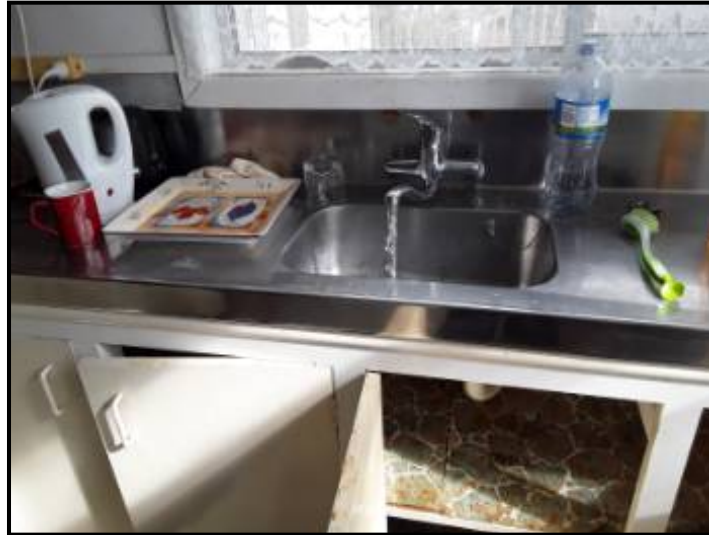
Tap functioned correctly.
