# Property Inspection Report

**- Habit Christchurch Limited -**

***6 Woodleigh Lane, Prebbleton***

***Prepared for: Wayne and Jacinta Gardner.***

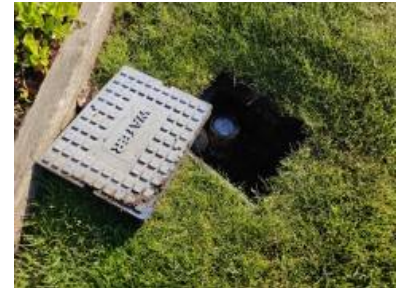
*Main Water Supply, On/Off Control:*

Road side area, no leaks evident.

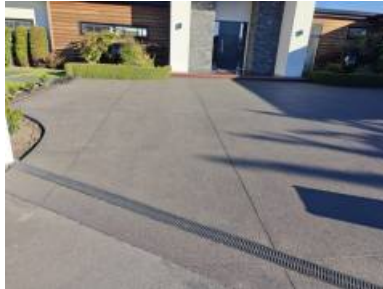
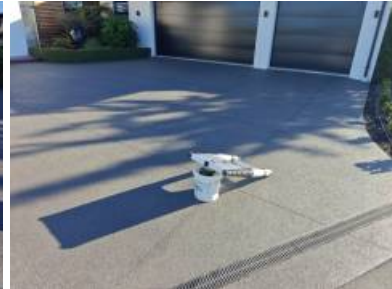
*Driveway:*

Exposed aggregate concrete, Driveway in good condition. Drainage installed in the driveway.  
Good fall on the surface for drainage.

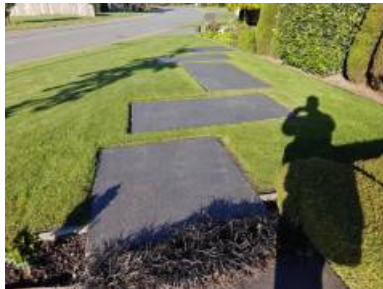
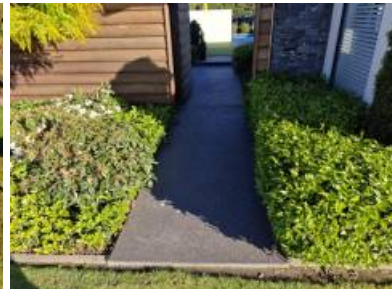
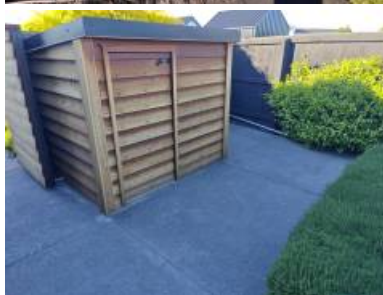
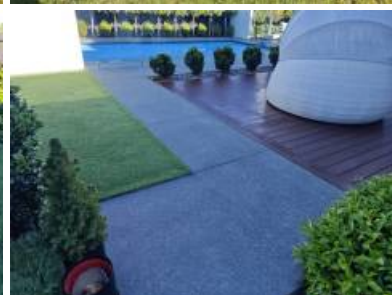
*Paths:*

Exposed aggregate concrete, Path(s) in good condition.

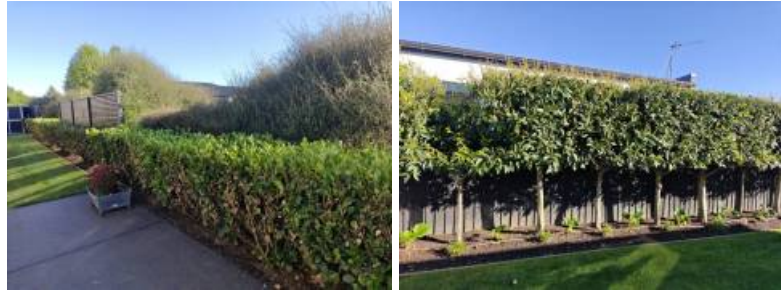
***Fencing General:***

Combination, Timber, Trellis, Hedging, Fence material in good condition. Fence height: Up to 1.8 Metre

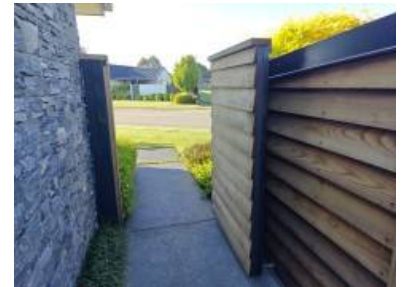
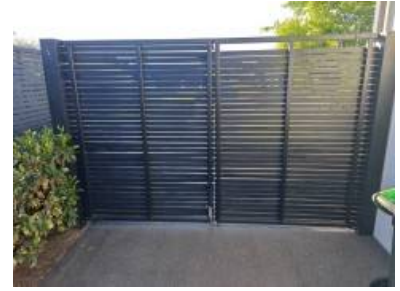
***Gates Installed:***

Timber, Hinged gates. Function as designed. Gate material in good condition.

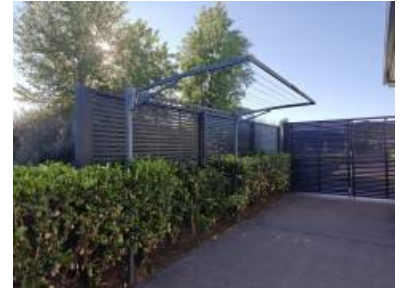
*Clothesline:*

Fold away, function as designed.

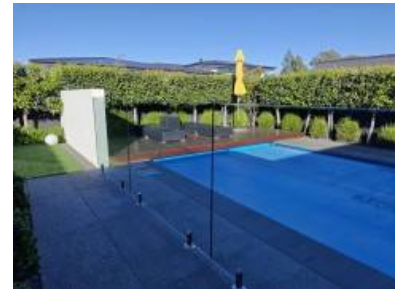
*Swimming Pool:*

The gate & fence complies with current rules. Current regulation states that height of fence & gate must be above 1.2 metres.

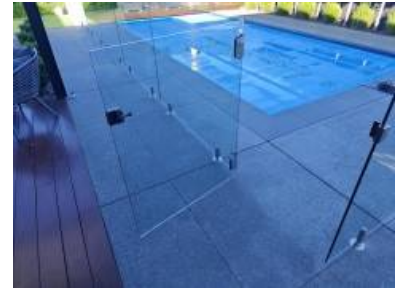
Pool fencing is installed with a safety gate and a child proof latch.

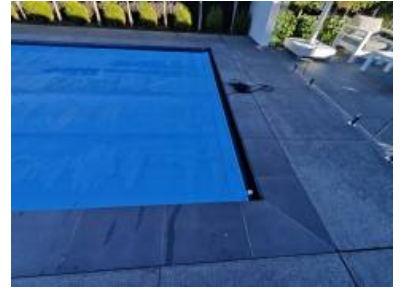
Pavers and concrete around the pool is in good condition.

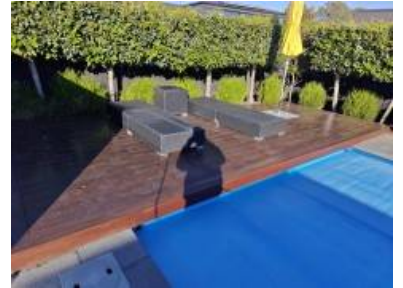
Timber decking in good condition.

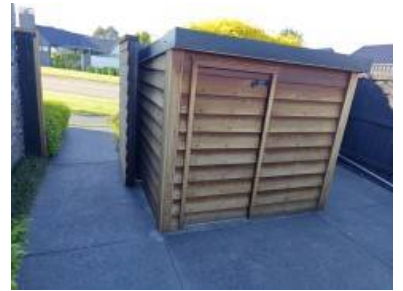
Swimming pool pump shed, not inspected.

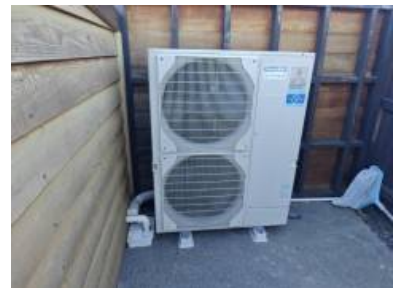
Heat pump for swimming pool heating, securely installed. Heat pump not tested.

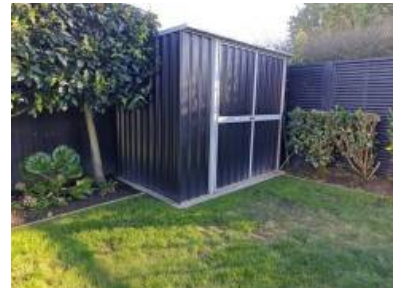
*Sheds:*

Shed(s) are not inspected. This report focuses on the dwelling and garage.

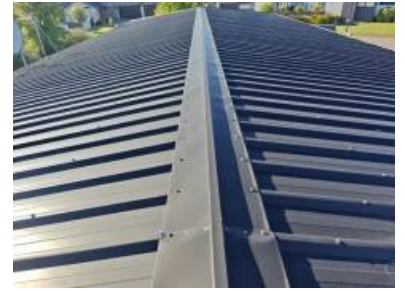
*Ridge Capping:*

Ridge Capping: Good condition.

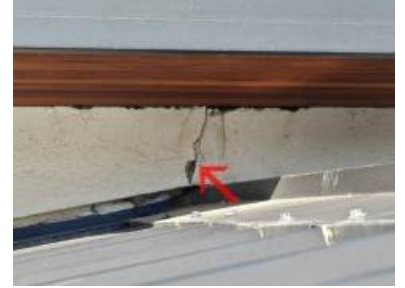
Above hallway.

Plaster above roof has been damaged, probably done during construction, suggest repair here.

This fault does not affect weathertightness as eaves is covering over the area, cosmetic only.

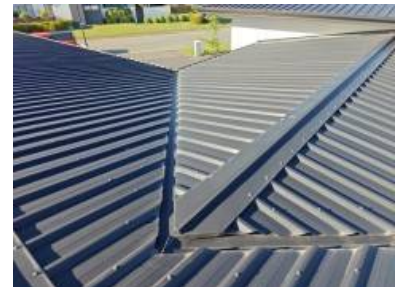
*Valley:*

Valley: Colour Steel, Good condition.

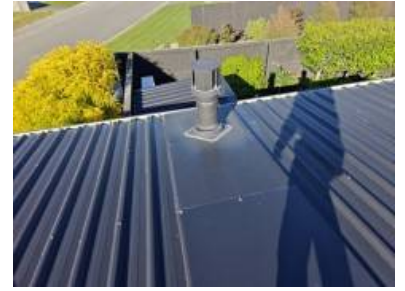
*Chimney:* Colour Steel, Flashed.

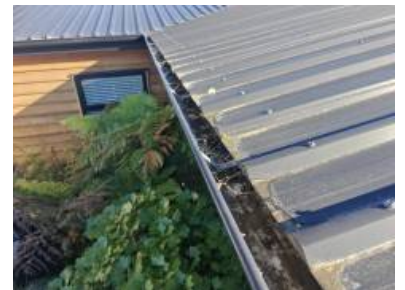
*Guttering:* Gutter: Colour Steel.

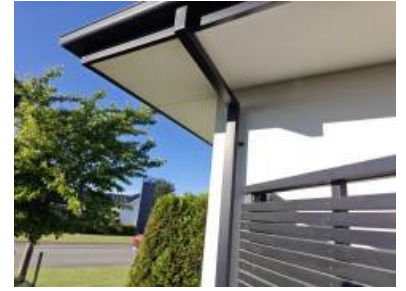
*Downpipes:*

Downpipe: Colour Steel, Secured.

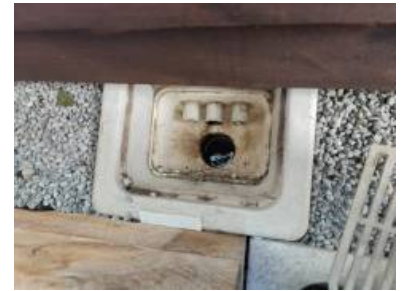
*Gully Traps:*

The gully traps in this dwelling is flowing freely.

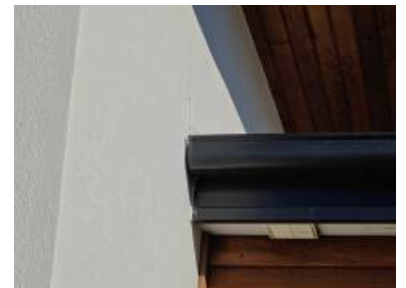
*Fascia:*

Fascia: Metal.  
Not penetrated into cladding, good.

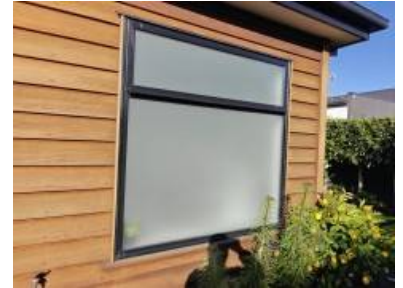
*External Joinery, Window Sills & Flashings:*

External Joinery: Aluminium, Flush Mounted Design.  
Window Sills: Timber.  
Flashings: Well fitted flashings.

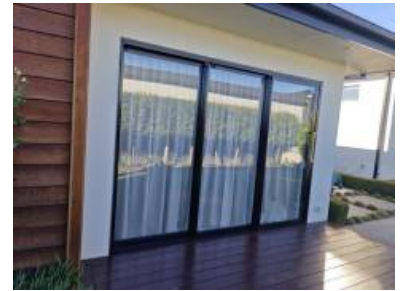
External Joinery: Aluminium, Recessed Design.  
Window Sills: None installed  
Flashings: Well fitted flashings.

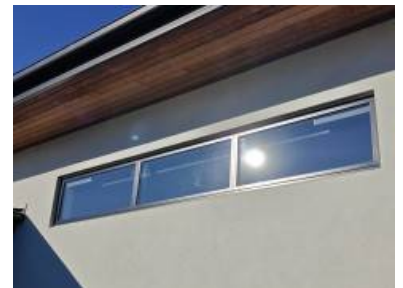
External Joinery: Aluminium, Recessed Design.  
Window Sills: Plaster finish.  
Flashings: Well fitted flashings.

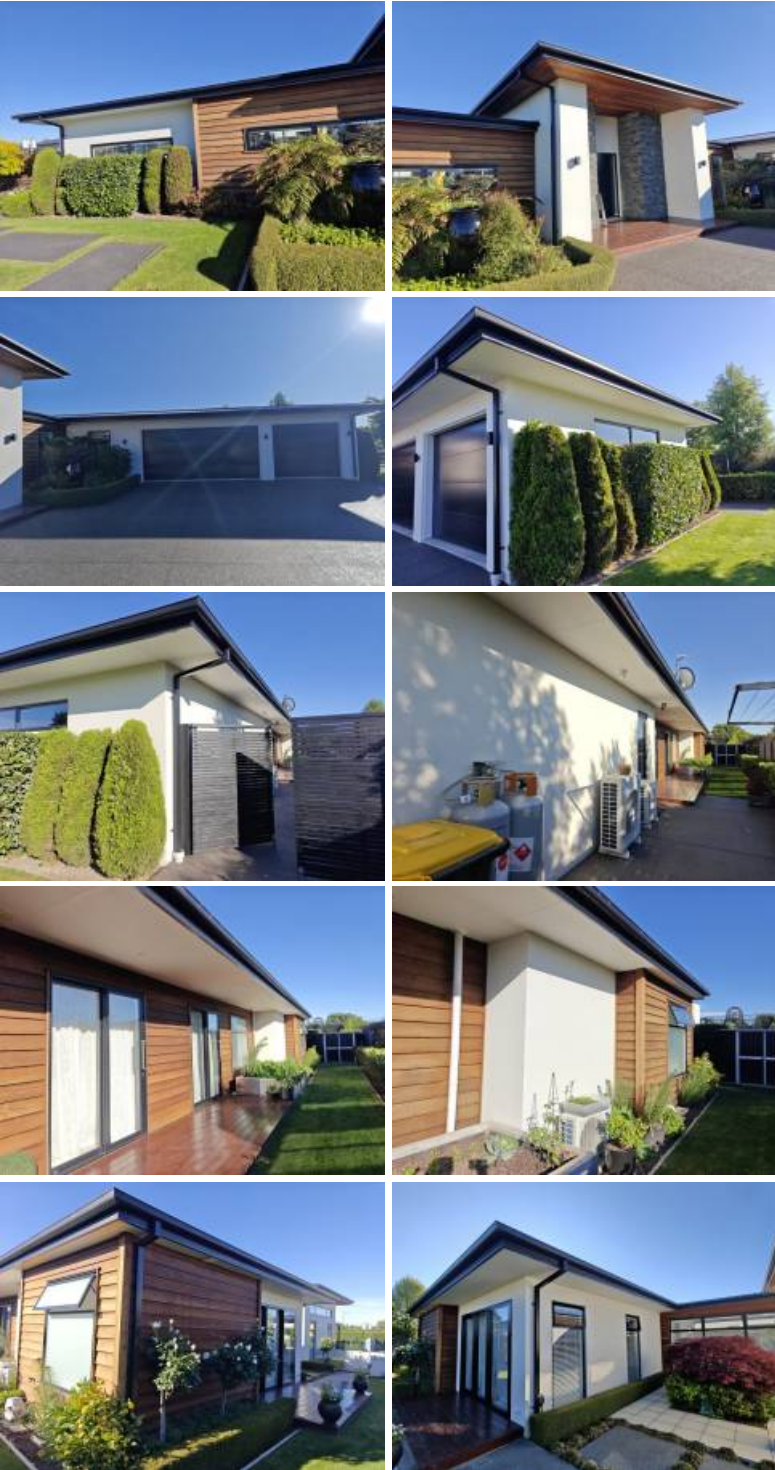
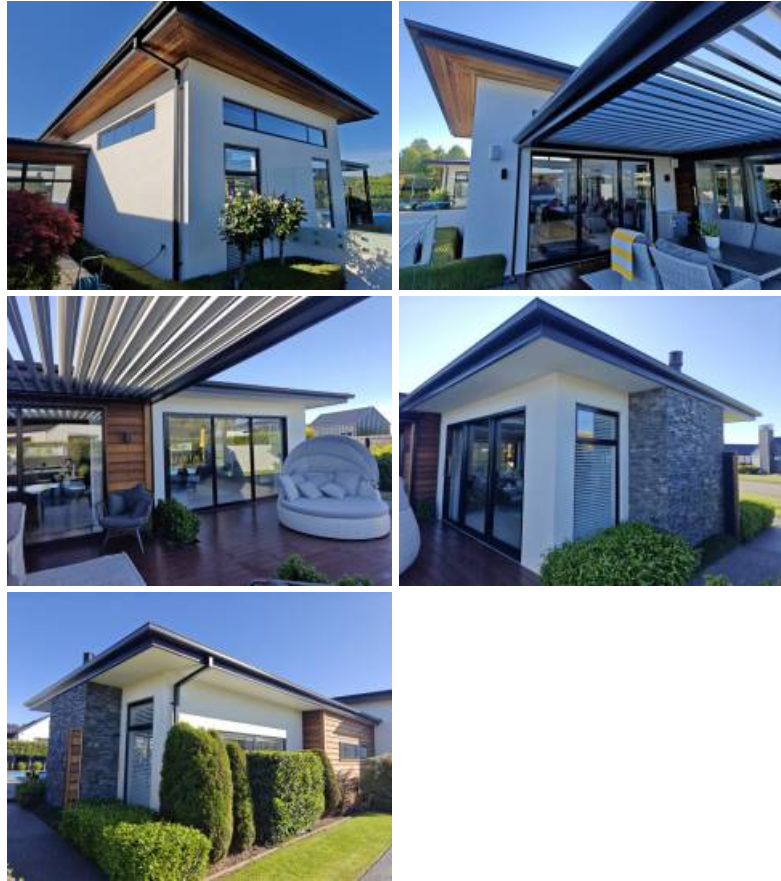
*External Wall Cladding:*

Cladding: Combination, Cedar, Rockcote, Surface finish in good condition.

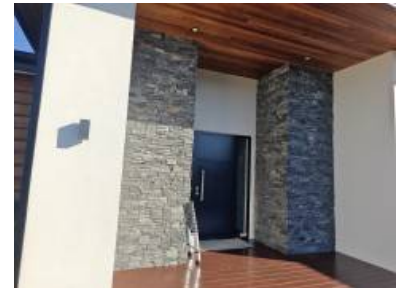
*External Wall Cladding  
(Feature Wall):*

Cladding: Schist stone, good condition.

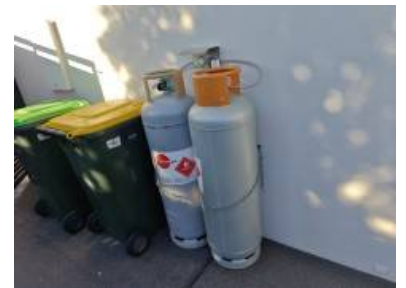
*Gas External Connections:*

Gas installed. Suggest a gas installation professional is engaged if any further information is required in this area.

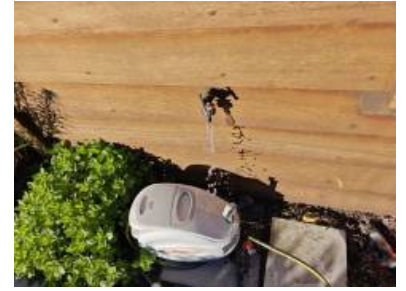
*Exterior Taps:*

Tested, working.

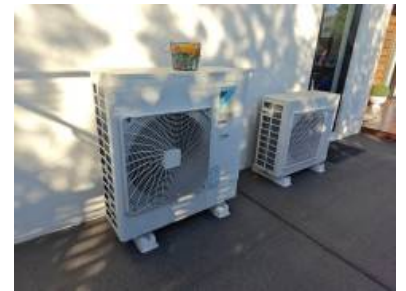
*Heat Pump:*

Securely installed.

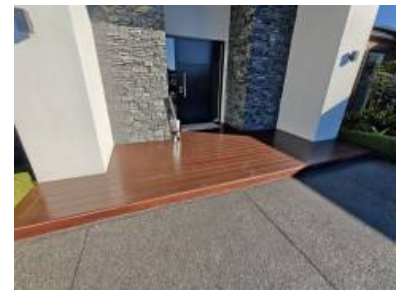
*Steps & Porch:*

Location: Front entrance, Timber, Steps in good condition.

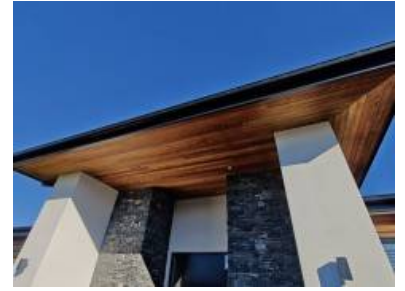
Porch installed here, Porch in good condition.

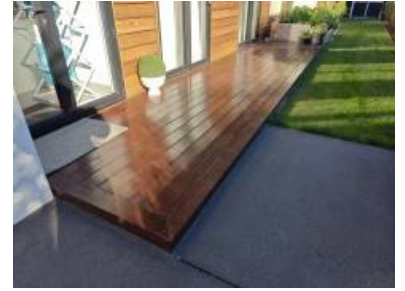
*Decking:*

Timber Decking, Deck in good condition.

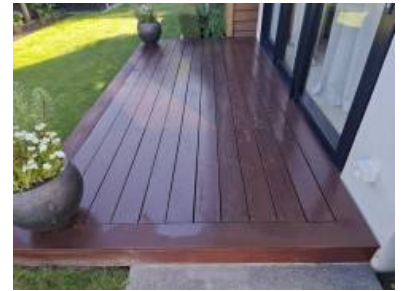
*Decking 2:*

Timber Decking, Deck in good condition.

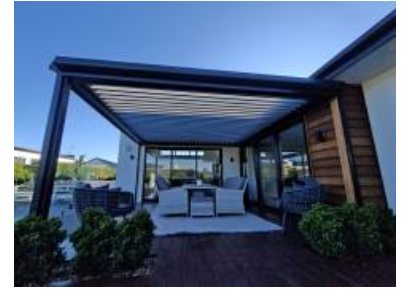
*Pergola:*

Aluminium-framed pergola in good condition.

Electric louvre installed, blinds installed, outdoor speaker installed.

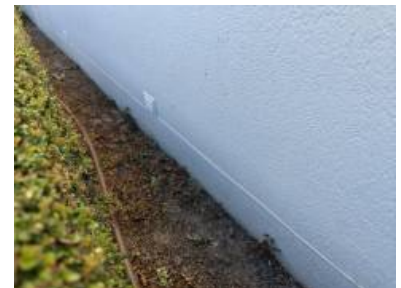
*Foundation:*

Concrete Floor

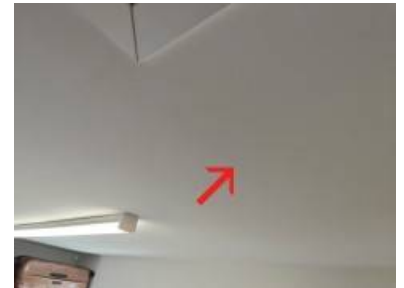
Internal Ceiling & Wall Linings:

Base linings intact, good condition.

Maintenance task: Cracks evident to ceiling lining, suggest to rake out plaster, then paint.

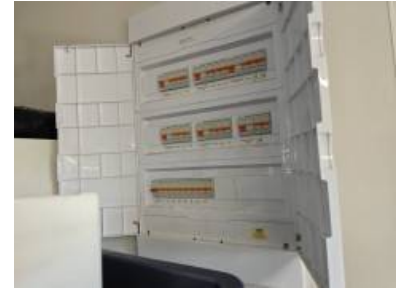
*Fuse Box:*

This is a modern style fuse board with RCD fuses, this suggest that the wiring in this house is modern TPS wiring.

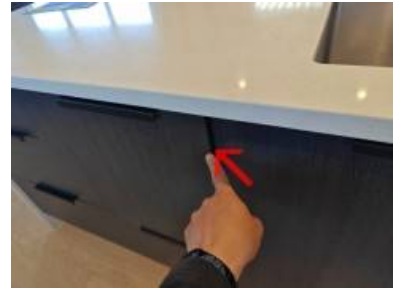
Auto close function on bin drawer does not close all the way in.

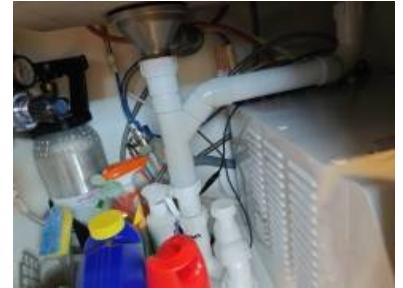
No leaks surrounding the waste trap area.

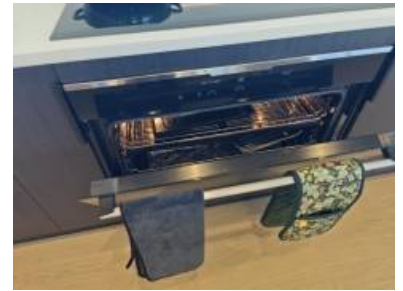
*Oven was turned on and heat function works fine.*

*Be aware thermostats are not checked. This is a specialised inspection which we do not carry out. I suggest if there are any concerns here, an appliance service contractor should be engaged to fully assess any electrical appliances.*

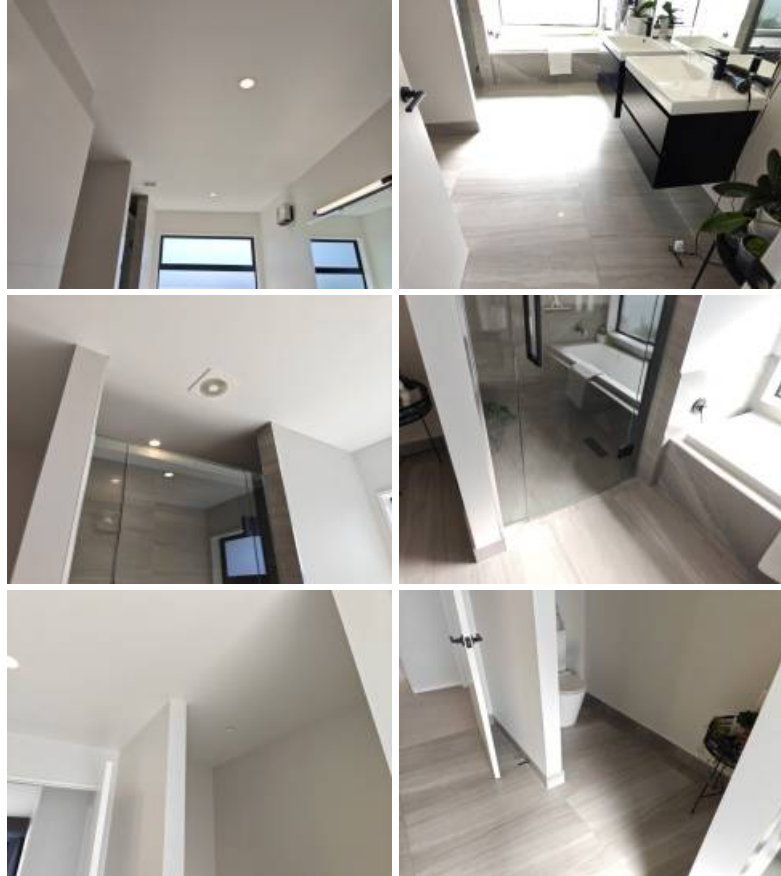
*Internal Ceiling & Wall Linings:* Base linings intact, good condition. Hairline crack to wall lining joint, can gap fill and paint, or leave it alone as it's cosmetic.

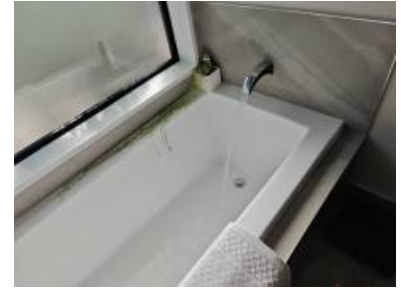
Bath tap has good water pressure.  
Bath surface and surround is in good condition.

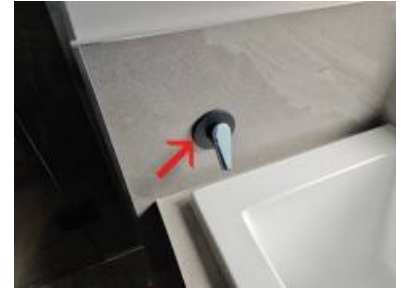
I can hear the plumbing pipe making a ting sound when I turn off the tap, it's not possible to tighten the pipe up anymore with wall tiles installed. Suggest leave alone.

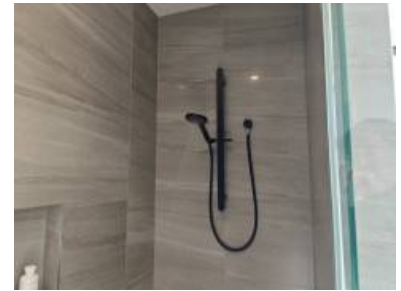
Walk in design shower, with tile surround, and a tiled base, enclosed in a glass door. The shower rose shows good water pressure.

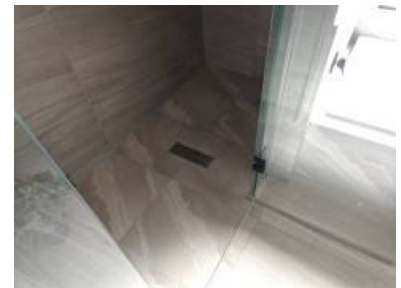
A brief test was undertaken which entailed directing the shower rose at suspected leak areas at the time of inspection. No obvious leaks were detected.

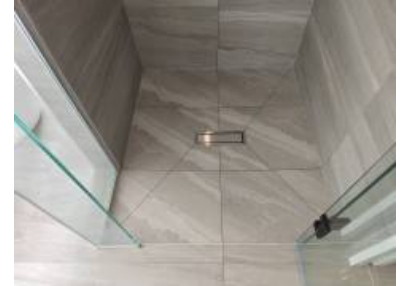
A brief test was undertaken which entailed directing the shower rose at suspected leak areas at the time of inspection. No obvious leaks were detected.

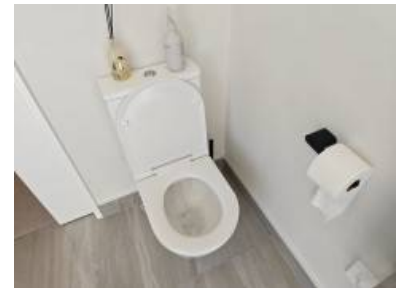
Porcelain cistern, The toilet flushed, and the cistern refilled.

The toilet is consistently running when it's nearly filled up for around 20 seconds, this suggest a faulty flapper that doesn't seal, suggest plumber to repair.

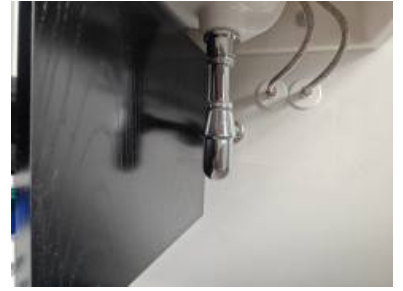
No leaks surrounding the waste trap area.

Maintenance task: Slow draining, suggest cleaning out the s bend pipe.

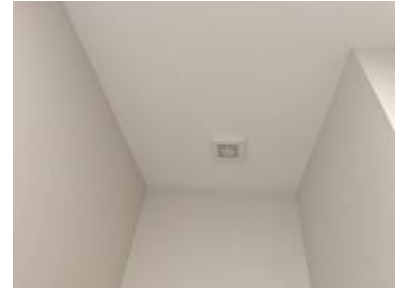
Extraction fan installed, tested working.

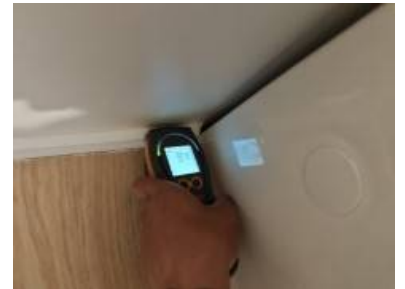
No moisture readings of concern were found in this room on the day of inspection.

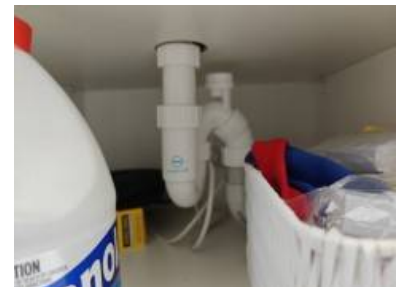
No leaks surrounding the waste trap area.

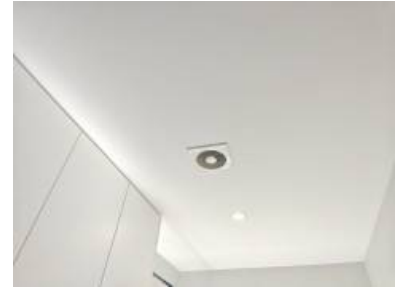
Drying vent fitted, Electric type, Tested, working.

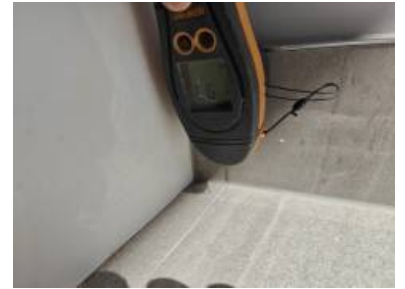
No moisture readings of concern were found in this room on the day of inspection.

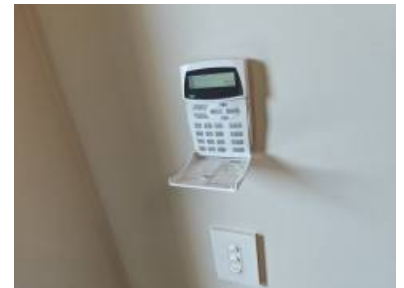
*Service Sockets & Other Accessories:* Alarm keypad installed.

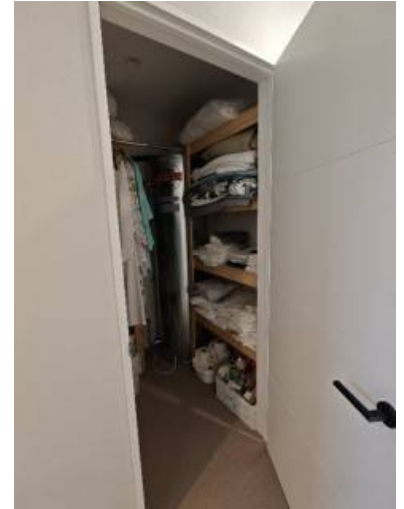
Storage cupboards installed, doors function as designed.

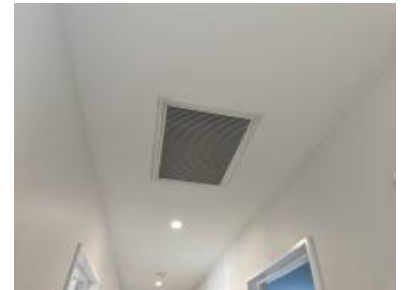
Central heating system installed, Central heating return vent installed, suggest clean filter annually.

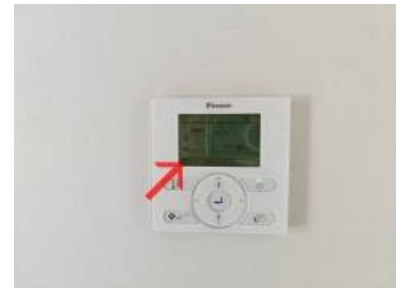
*Service Sockets & Other Accessories:* Central heating controller installed.  
[Clean filter light is on.](#)

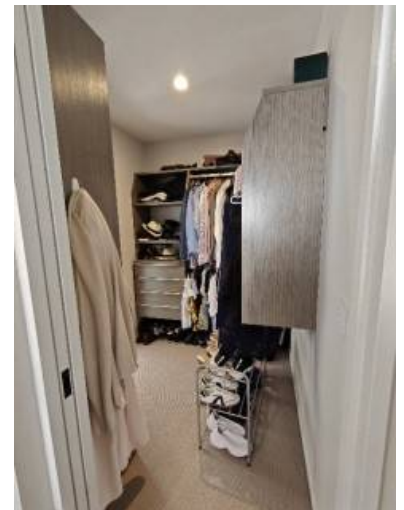
*Wardrobe:* Walk in design, Lighting installed, tested working. Internal storage areas installed.

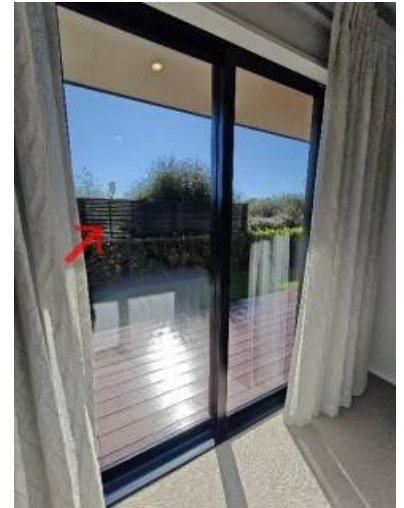
*Windows & Reveals:* Opening window not installed, just a sliding door.

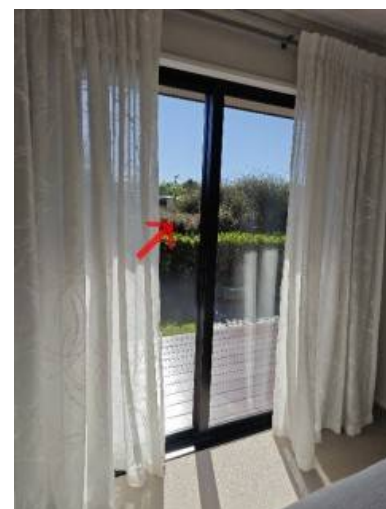
*Windows & Reveals:* Opening window not installed, just a sliding door.

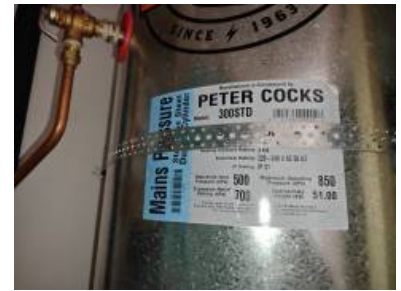
300 Litre, Mains Pressure, Year Manufactured:  
Unknown, strap has covered it up.

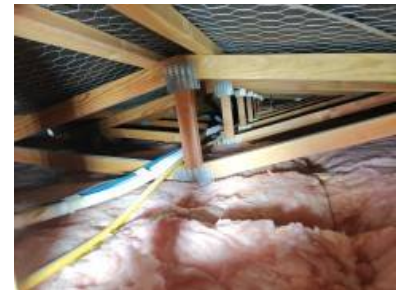
Inspection from man hole only, due to lack of space within the ceiling space. Area inspected only what could be seen by the inspector from this vantage point.

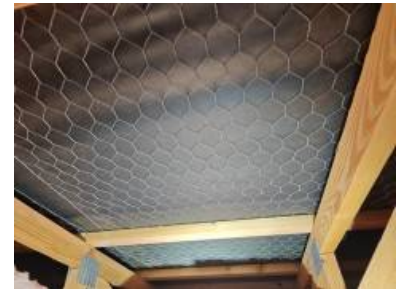
Roof lining Paper installed. Good condition, secure, no deterioration on the roof lining installed. Wire mesh Installed.

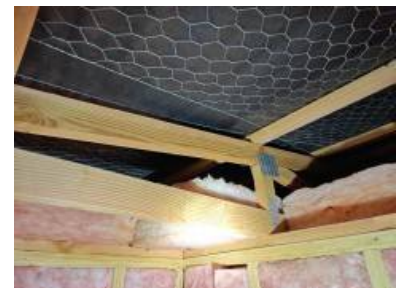
The factory manufactured trusses are secure, and in a good sound condition.

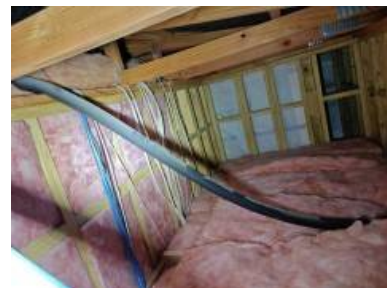
PVC, Lagged or insulated, The plumbing installed in this area is secure, and shows no signs of any moisture leaks, or damage.

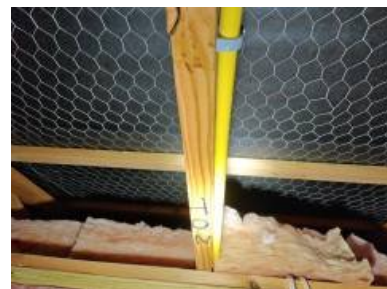
Gas pipe installed here.

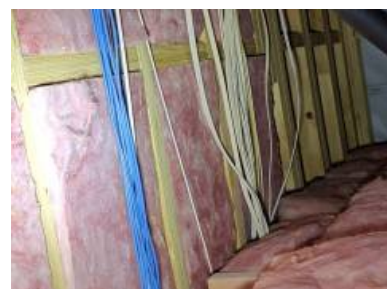
The wiring here is a modern plastic coated design. Well stowed, the wiring appears to be in good condition.

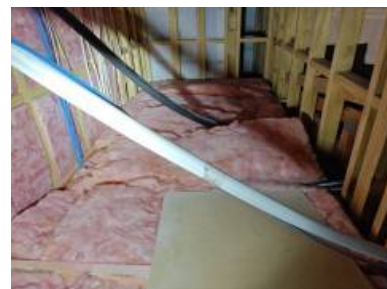
Plenty of room to install plywood or timber planks and use this space as storage.

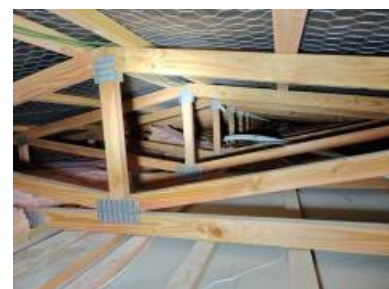
Inspection from man hole only, due to lack of space within the ceiling space. Area inspected only what could be seen by the inspector from this vantage point.

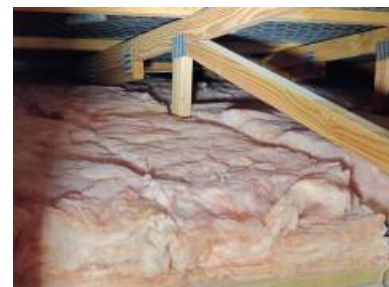
Fibreglass or wool batts. Insulation in reasonable condition and thickness (Over 120mm), has reduced in thickness over time. Still in place, reasonably tidy.

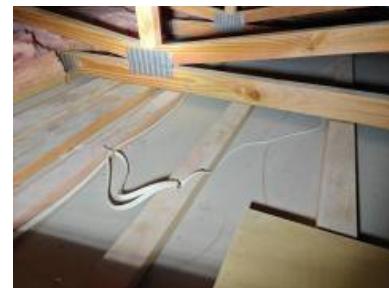
No insulation installed over garage area, this is not a current building code requirement.

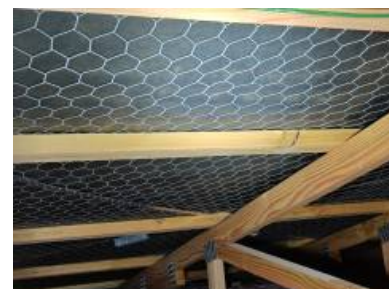
Roof lining Paper installed. Good condition, secure, no deterioration on the roof lining installed. Wire mesh Installed.

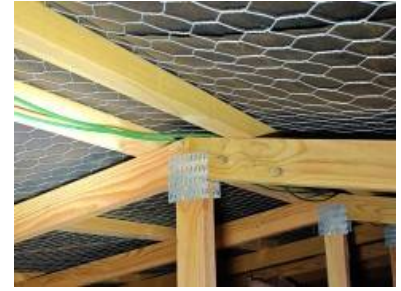
The factory manufactured trusses are secure, and in a good sound condition.

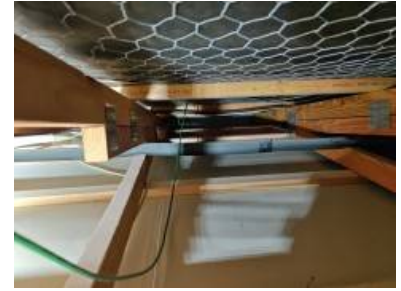
PVC, Lagged or insulated, The plumbing installed in this area is secure, and shows no signs of any moisture leaks, or damage.

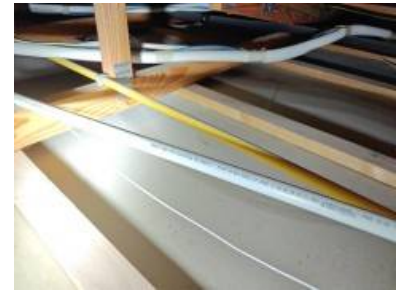
Gas pipe installed here.

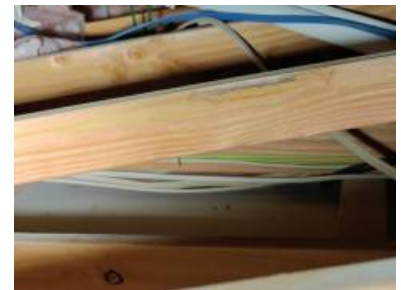
The wiring here is a modern plastic coated design. Well stowed, the wiring appears to be in good condition.

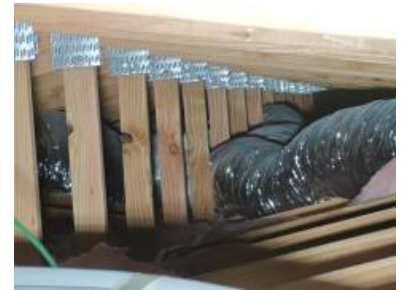
Central heating installed.

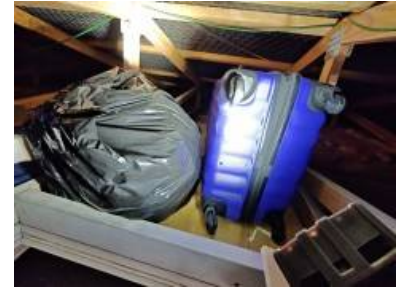
Home owner's belongings stored in the ceiling space.
