# BUILDING INSPECTION REPORT

11 Jun 2026 / 4 Wherstead Rd

## Pre-Purchase/Sale Visual Non-Invasive Property Inspection

Eye Spy Property Inspections  
Pre sale building report  
4 Wherstead Rd, Cashmere

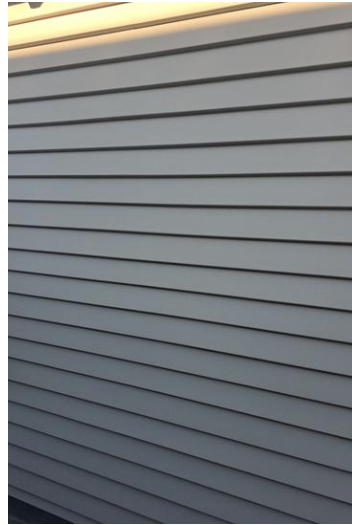
Photo 34

The painted timber weatherboard appears to be in generally sound condition, which is typical for its age.  
1: The pipe penetration requires sealing.  
2: Several borer holes necessitate treatment and filling, in addition to some paint finishing.

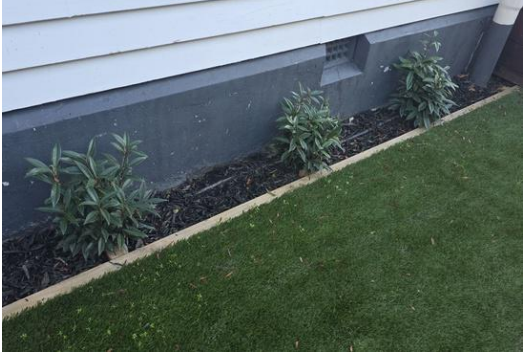
Photo 43

Concrete ring foundation. Visible sections appear generally sound, with no significant visible cracking or movement. Some minor cracking typical for age

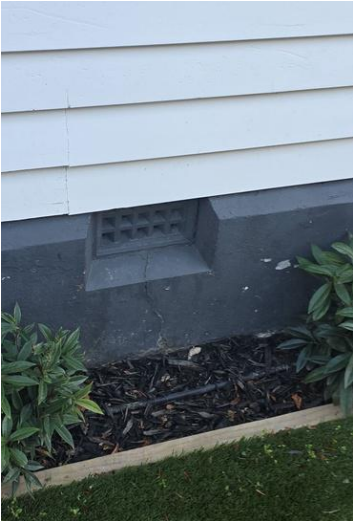
Photo 45

Yes

Typical for age

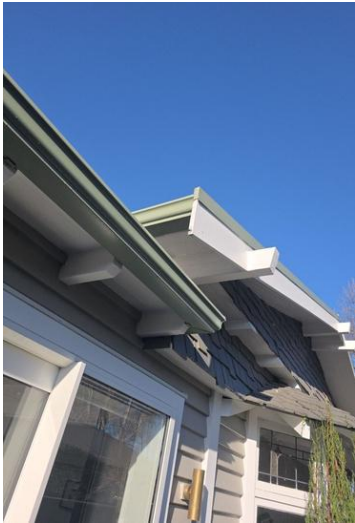
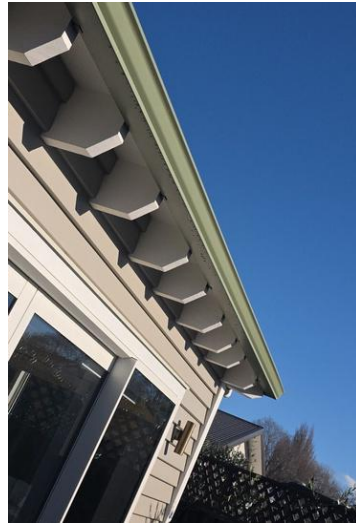
Painted timber fascia with painted board soffit

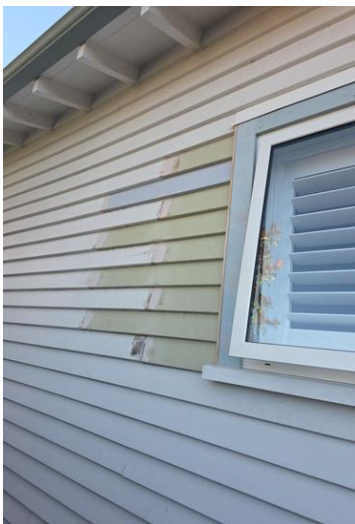
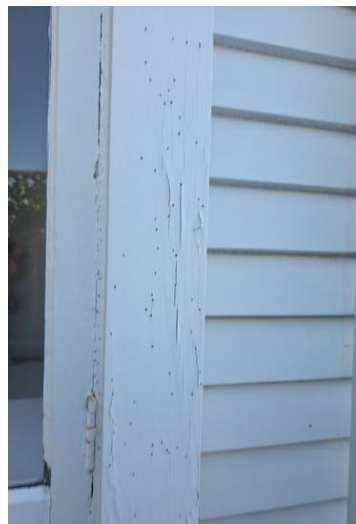
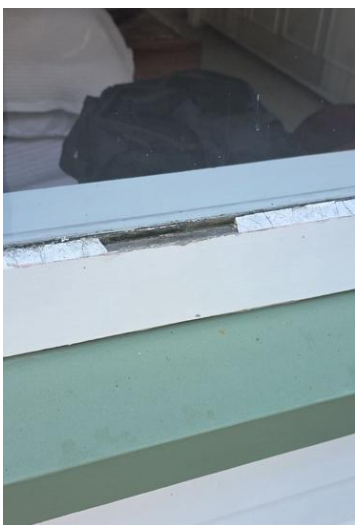
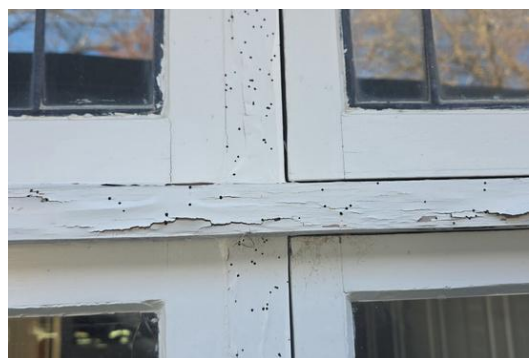
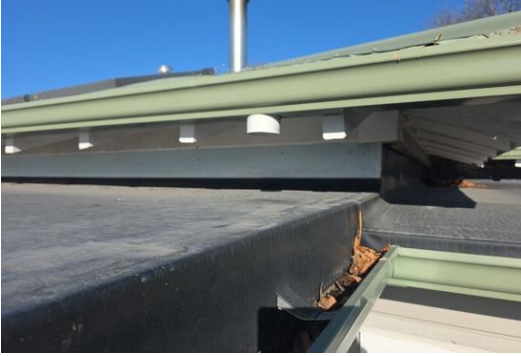
Some finishing still required to south/east walls

General maintenance

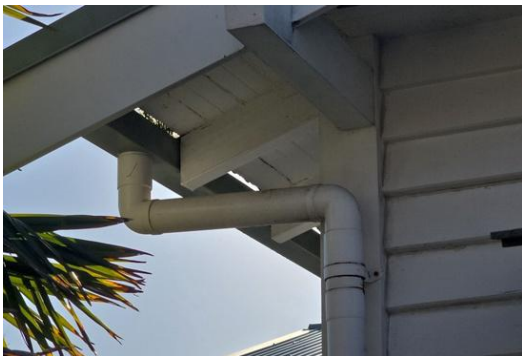
Coil coated steel spouting with pvc downpipes.  
Spouting due for clean out in places

General maintenance

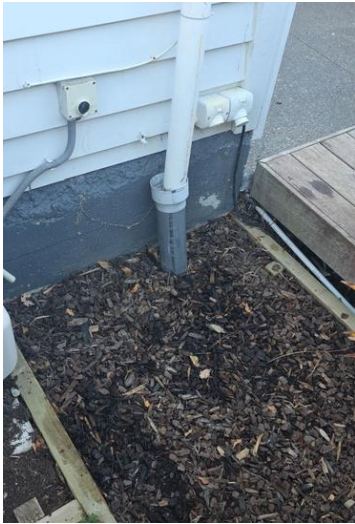
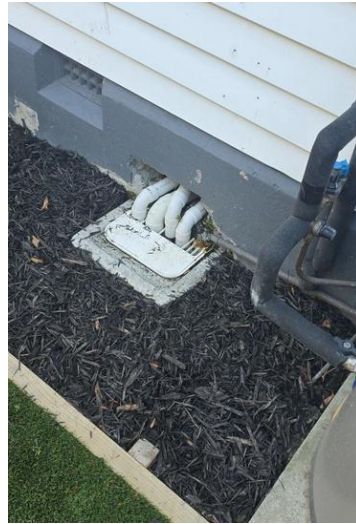
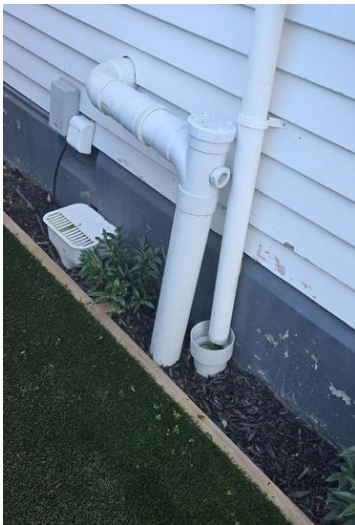
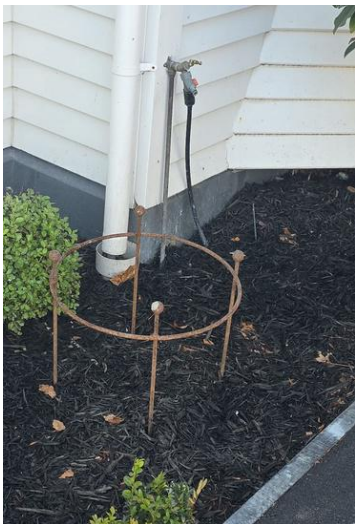
Downpipes fall to pvc stormwater risers. Gully traps clear

No guarantees can be given regarding the integrity of the underground pipes (if any) due to seismic or historical damage and/or blockage.  
Due to the seismic events, it is advisable to have the underground drains CCTV inspected.

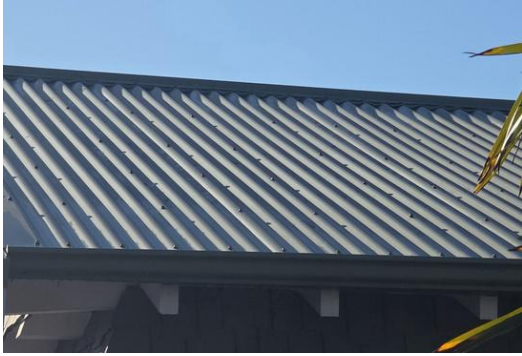
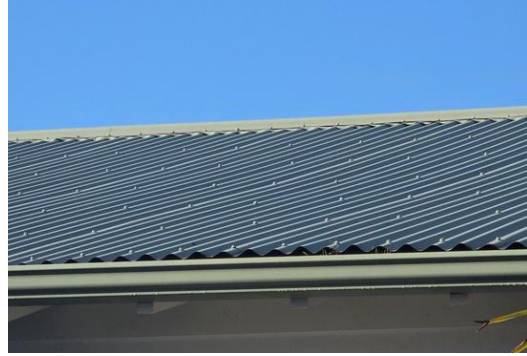
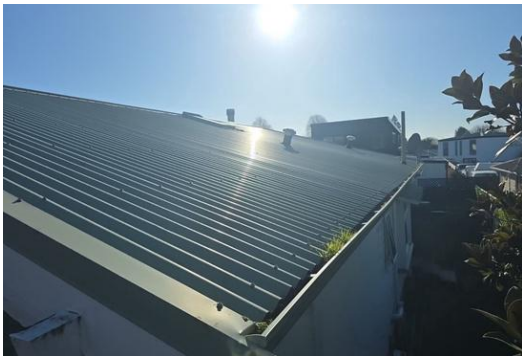
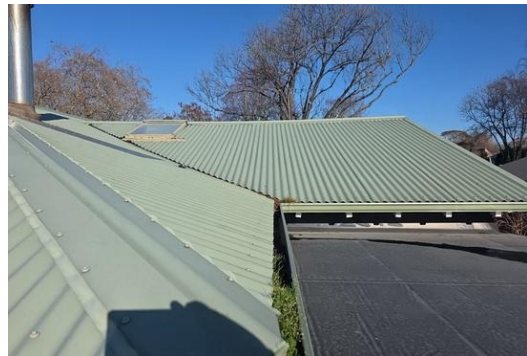
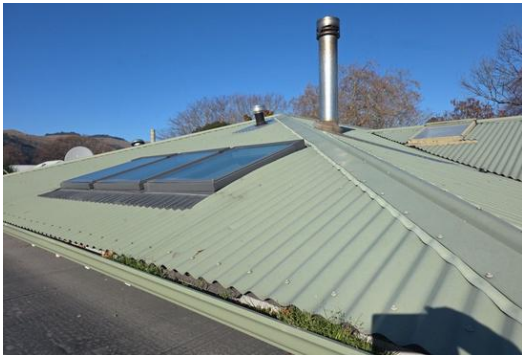
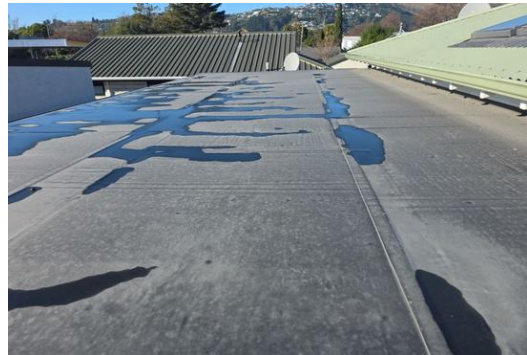
Relatively new coil coated corrugated iron roof fixed with tek screws.  
Rubber membrane to addition

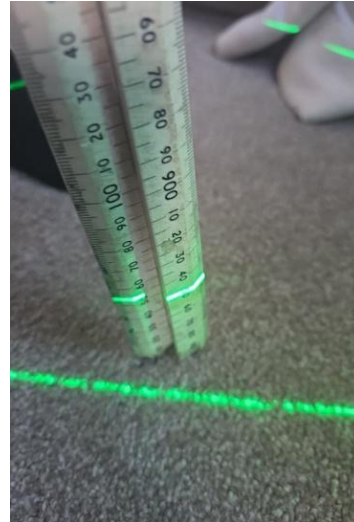
**The floor slope between two points greater than 2m apart is less than 0.5% (1:200) as per MBIE guidelines and/or any slope differential slightly outside mbie guidelines is deemed typical for age and style of house and does not require further investigation**

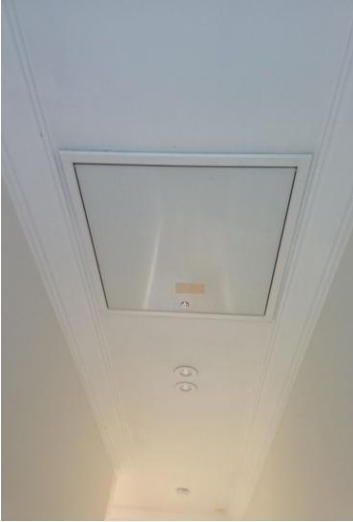
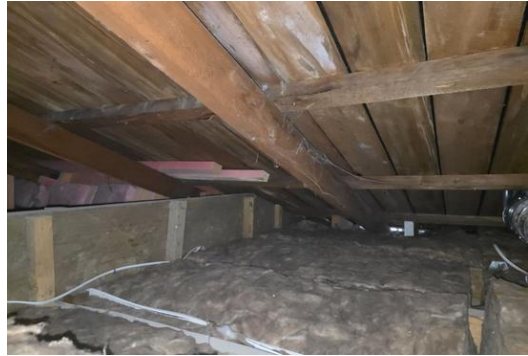
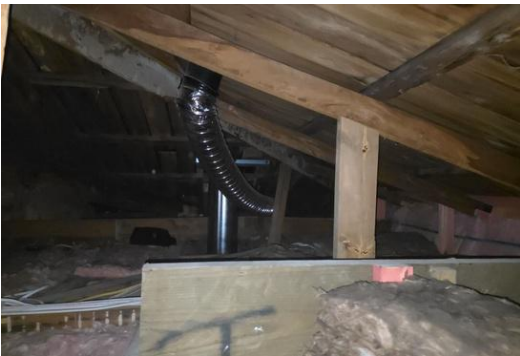
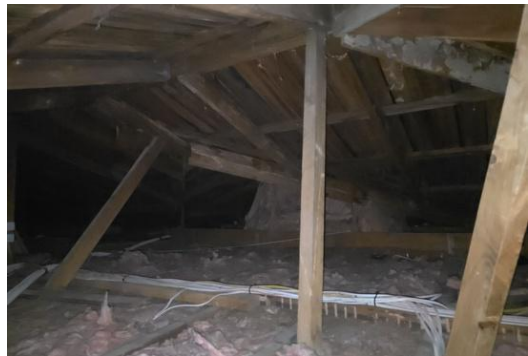
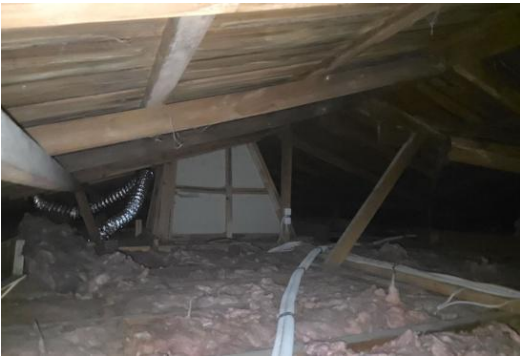
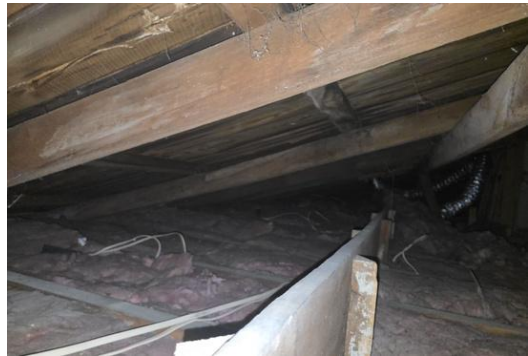
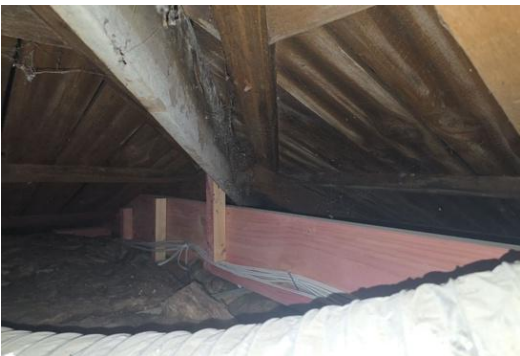
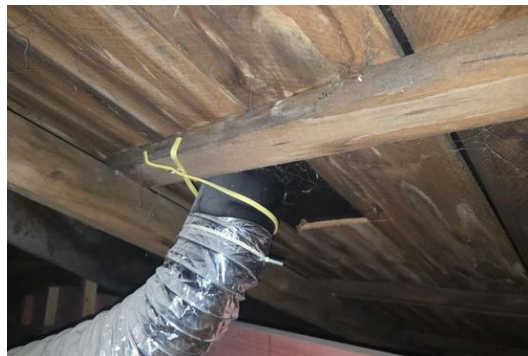
This is a pitched roof with timber rafters and joists

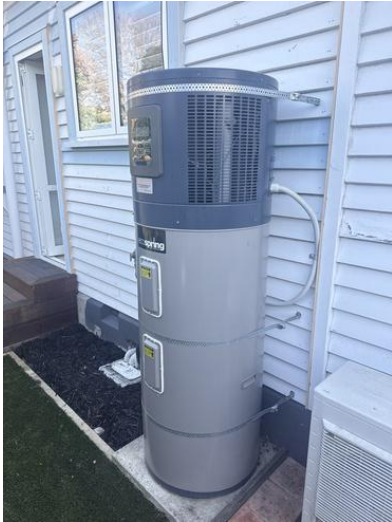
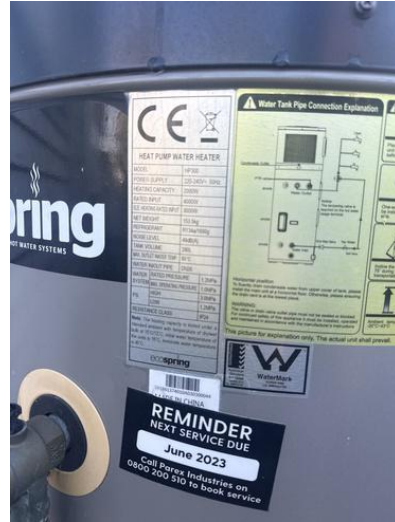
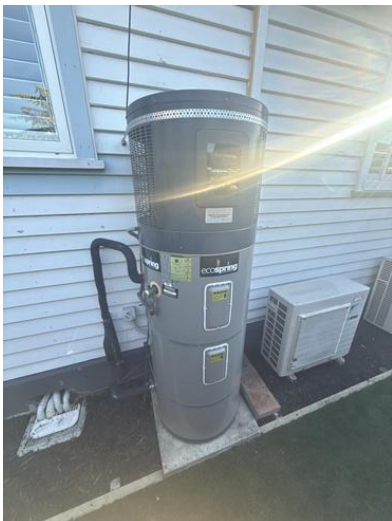
External mains pressure cylinder

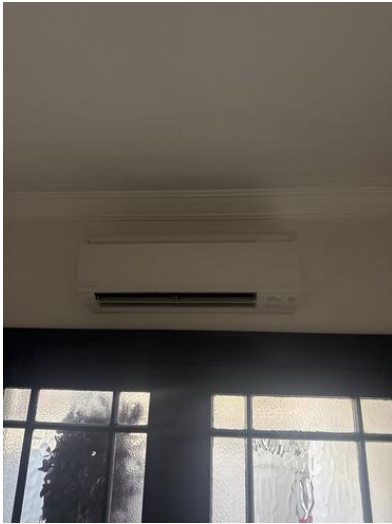
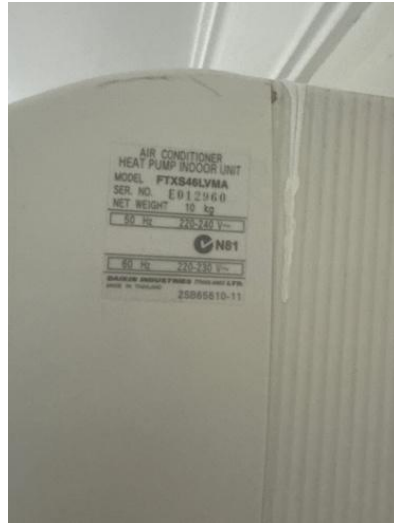
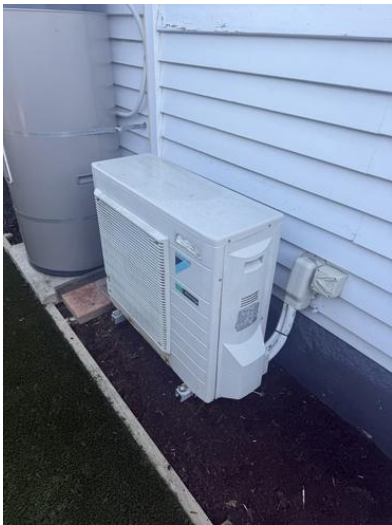
Wall-mounted heat pump appears typical for its age. Untested.

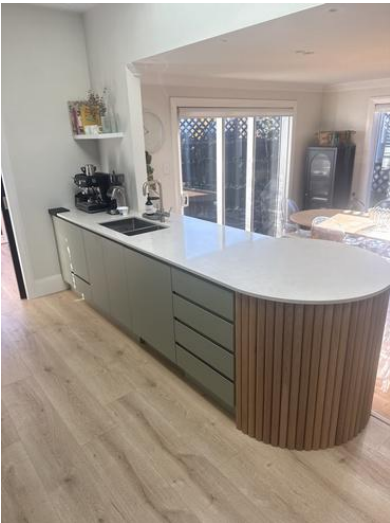
Photo 128

Kitchen joinery appears in sound usable condition

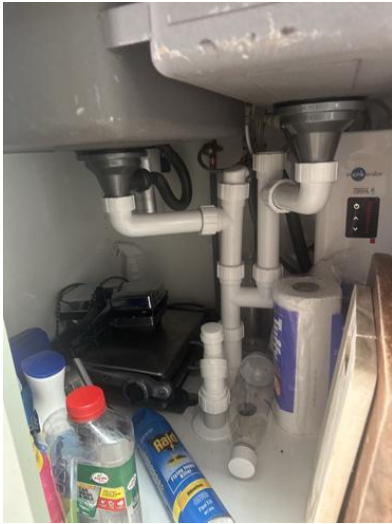
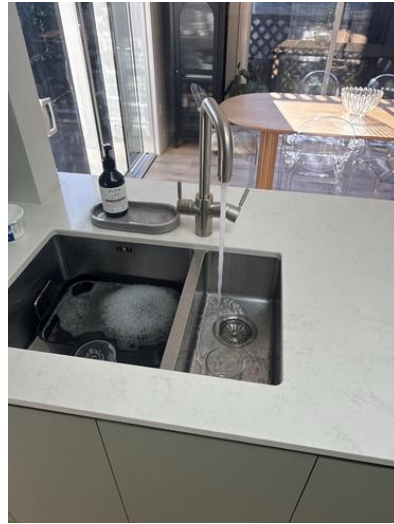
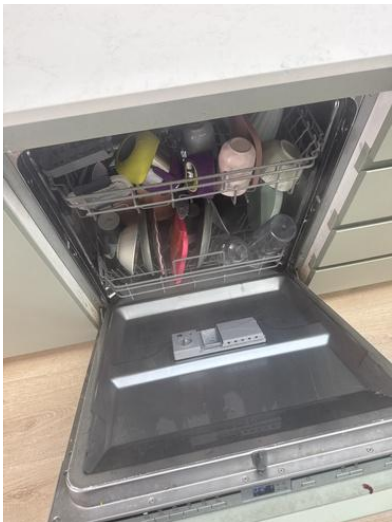
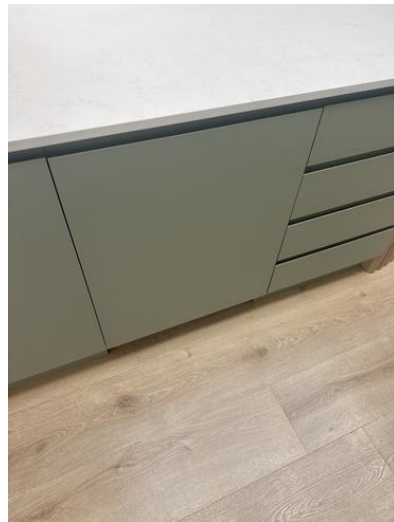
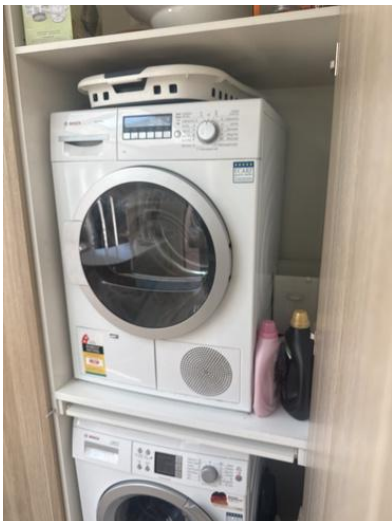
Plumbing fittings appear in sound, usable condition with good hot water pressure, typical for a mains pressure system.

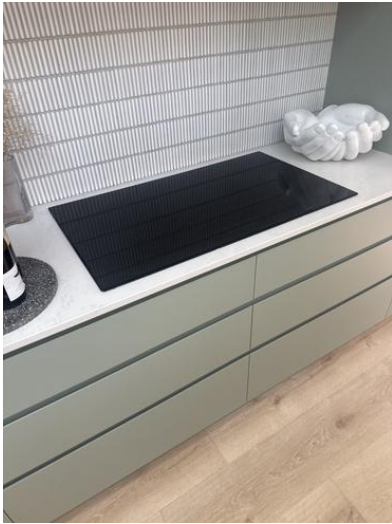
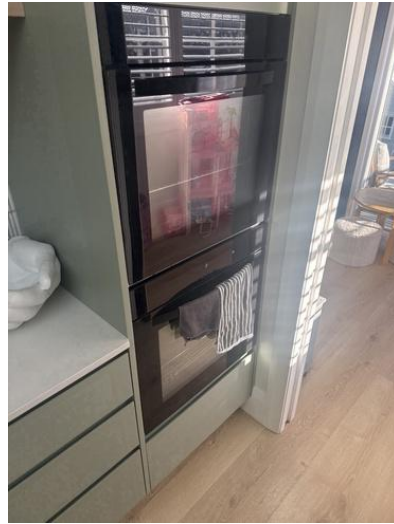
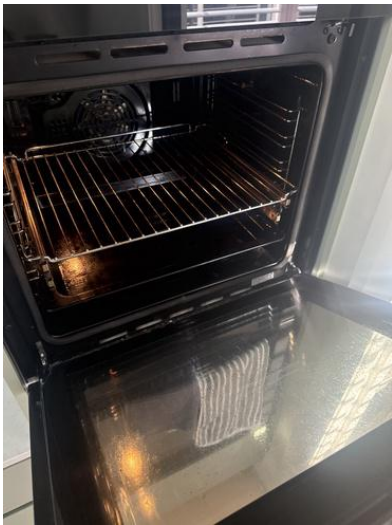
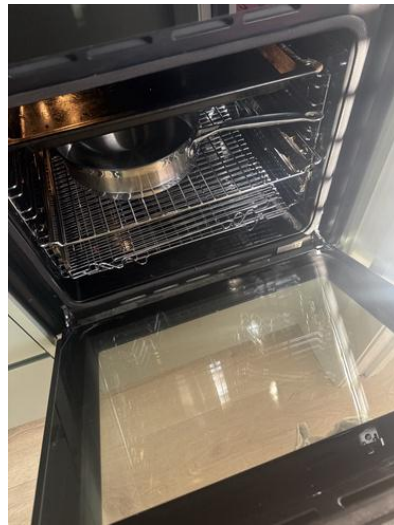
Inbuilt electric oven and hob untested

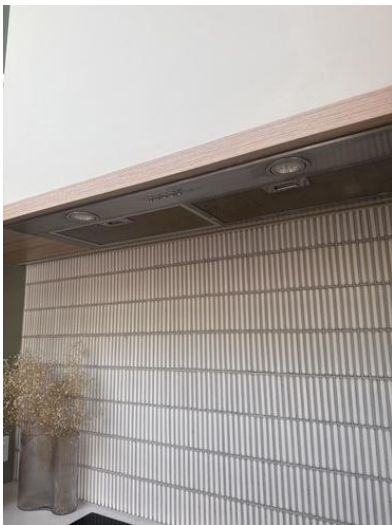
Photo 141

Operational. Externally ducted

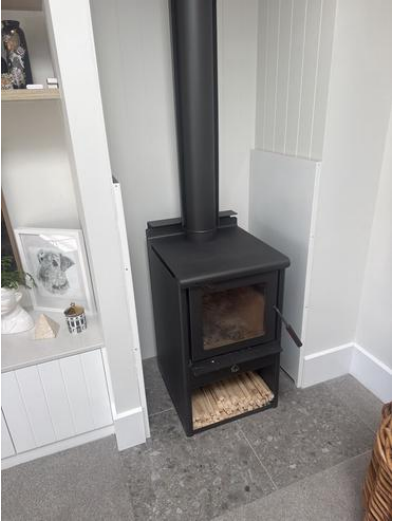
Photo 151

Free standing woodburner untested

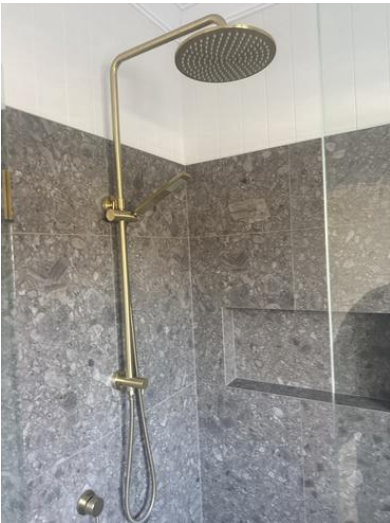
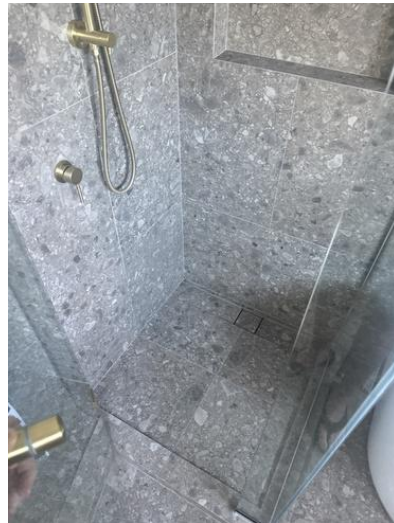
Tiled walls and floors

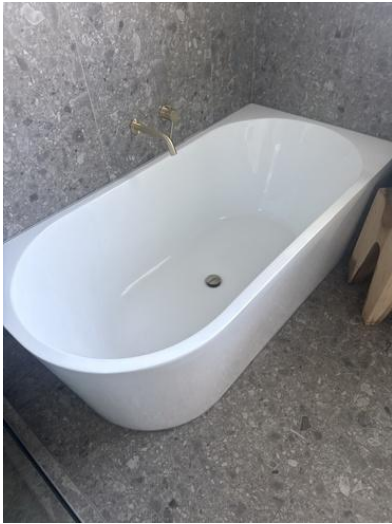
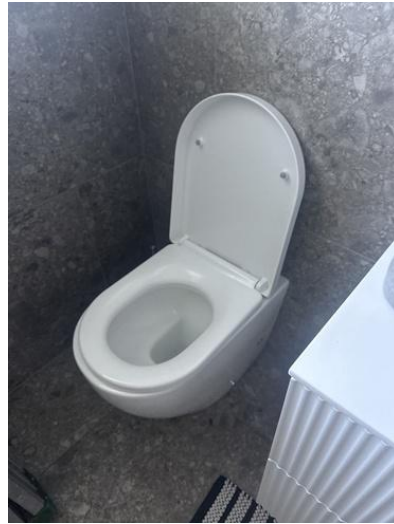
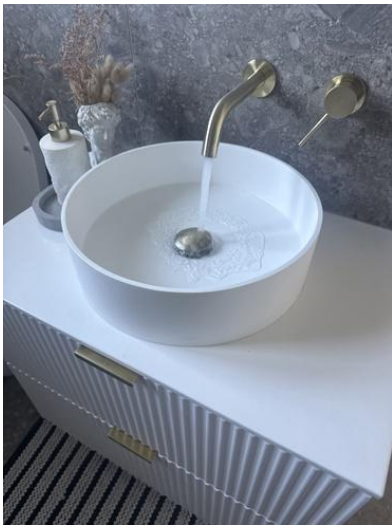
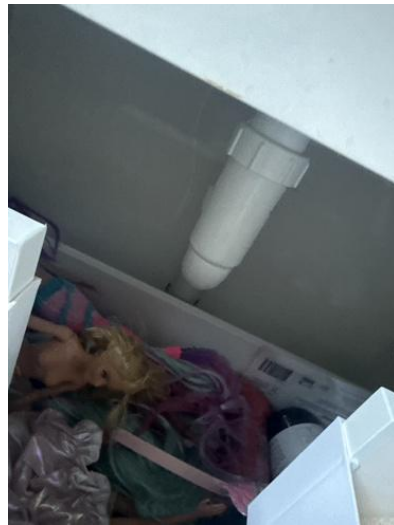
Plumbing fittings appear in sound, usable condition with good hot water pressure, typical for a mains pressure system.

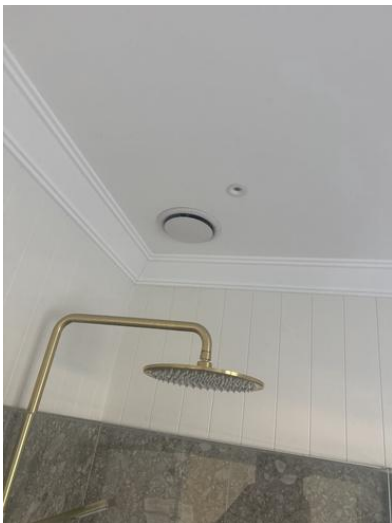
Photo 162

Ceiling fan operational. Externally ducted

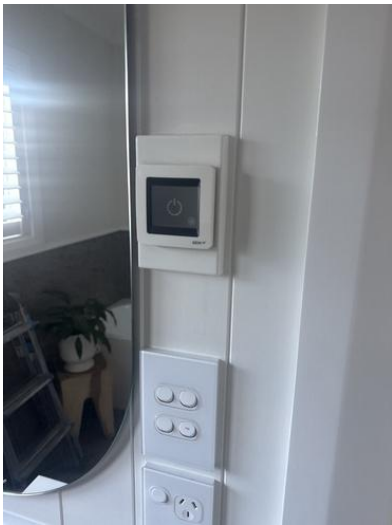
Photo 163

Undertile heating control untested

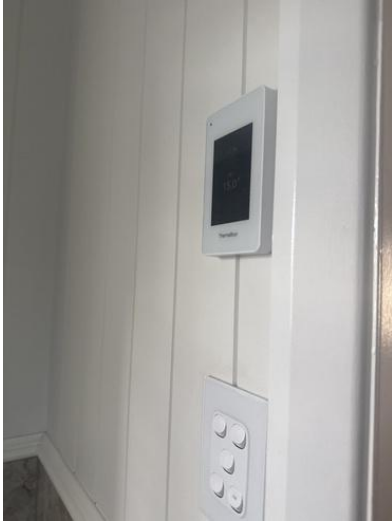
Photo 172

Undertile heating control untested

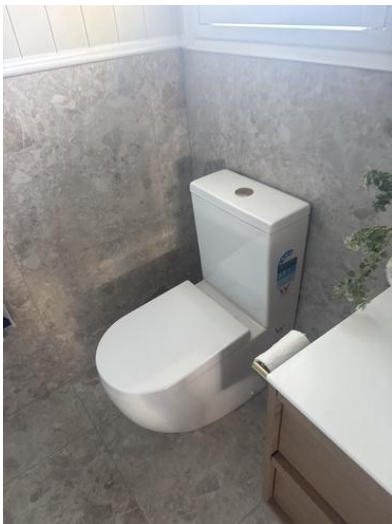
Photo 173

Plumbing fittings appear in sound, usable condition with good hot water pressure, typical for a mains pressure system.
