# Property Inspection Report

**- Habit Christchurch Limited -**

***24 Edward Law Boulevard, Prebbleton***

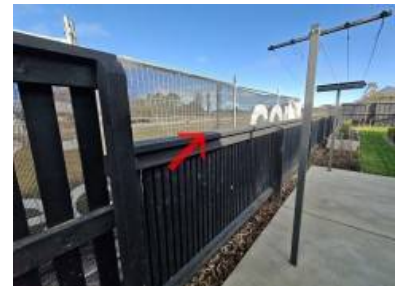
*Fencing General  
(Maintenance):*

Suggest make fence paling 1.8m height by  
clothesline area.

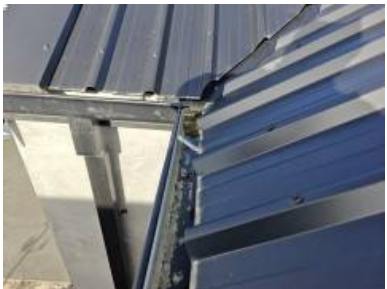
Maintenance task: Gutters have debris build up and will benefit from an internal clean.

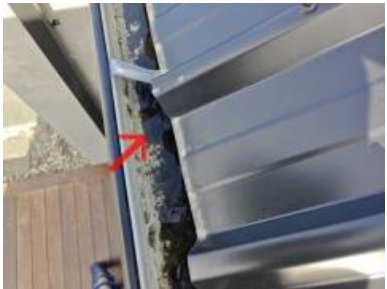
By decking.

Maintenance task: Leaking gutter joint, sealing of main joints suggested.

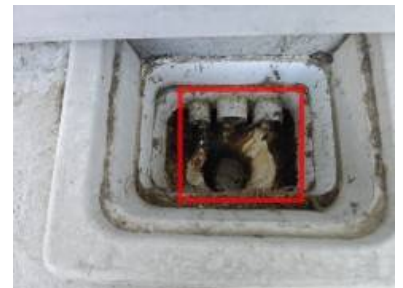
Partially blocked, suggest clear debris.  
Outside laundry.

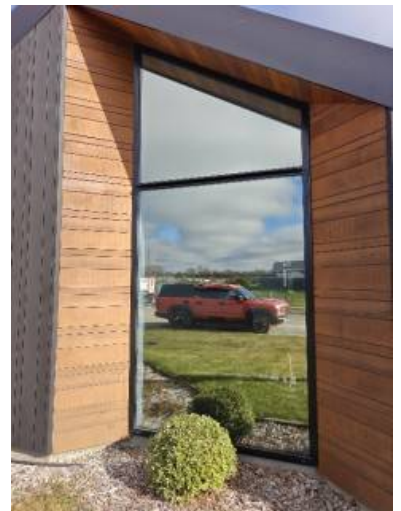
Laundry exterior door not yet sealed with ms silicone, need to do so.

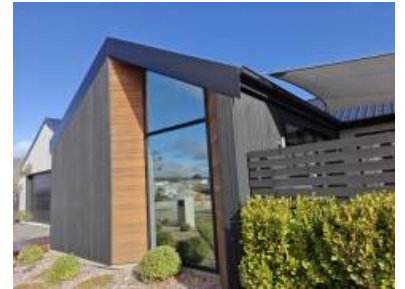
*External Wall Cladding  
(Maintenance):*

Plaster work not yet smoothed out.  
Outside ensuite.

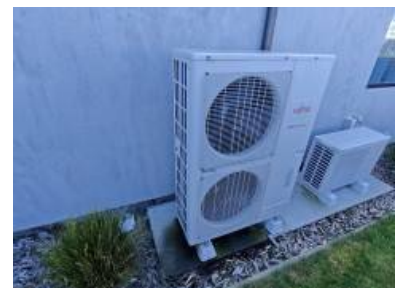
Suggest install a condensation pipe and feed it to the waste trap nearby.

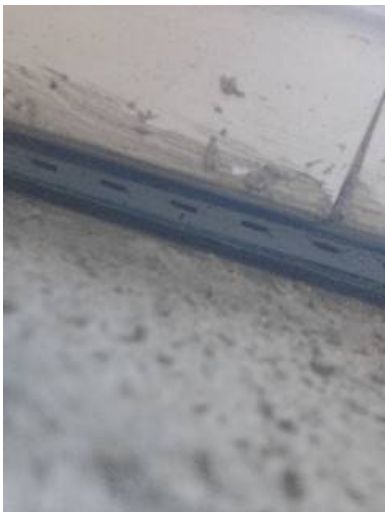
Cladding: Cedar, Vermin and vent strip evident, indicating this is a cavity vented system.

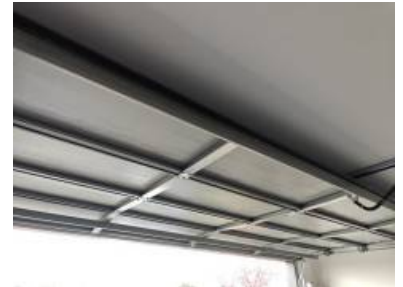
Automatic Sectional, coloursteel panel, function as designed.

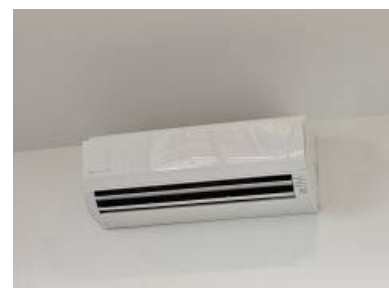
*Heating:* Heatpump securely installed, operational on day of inspection.

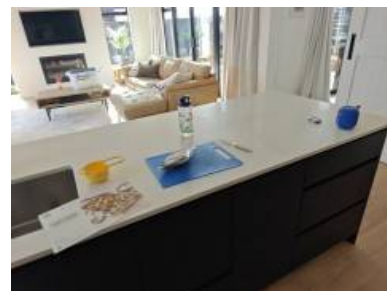
Engineered Stone (Quartz), Good condition.

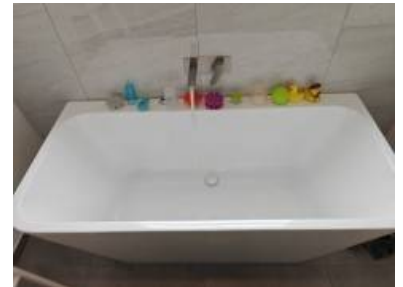
*Bath & Tapware:* Bath tap has good water pressure.  
Bath surface and surround is in good condition.

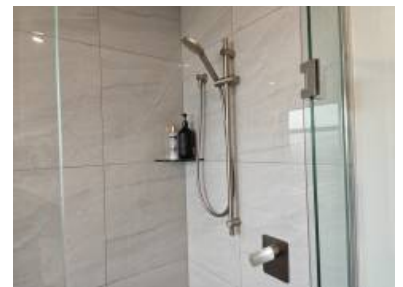
*Shower:* Walk in design shower, with tile surround, and a tiled base, enclosed in a glass door. The shower rose shows good water pressure.

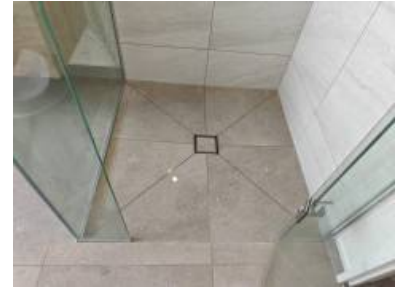
A brief test was undertaken which entailed directing the shower rose at suspected leak areas at the time of inspection. No obvious leaks were detected.

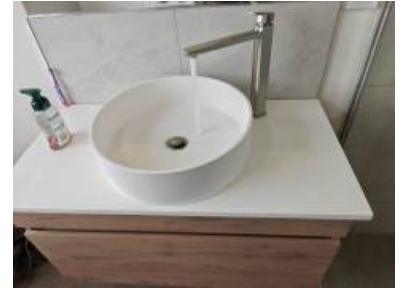
Vanity in good condition, draining well without blockages, The mixer tap has good water pressure.

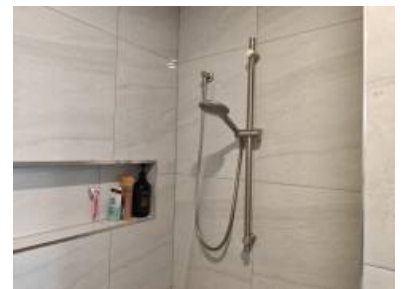
*Shower:* Walk in design shower, with tile surround, and a tiled base, No door installed, as per design. The shower rose shows good water pressure.

Maintenance task: Mould evident, suggest cleaning with a chemical solution.

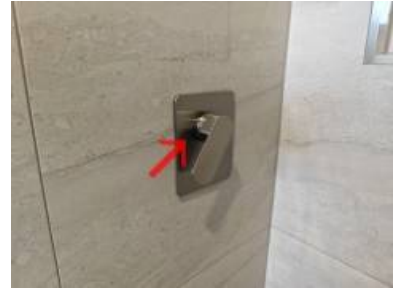
A brief test was undertaken which entailed directing the shower rose at suspected leak areas at the time of inspection. No obvious leaks were detected.

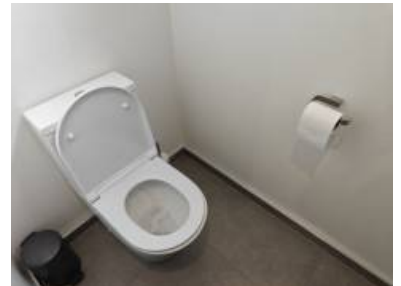
Maintenance task: Loose toilet paper holder, suggest re-fix.

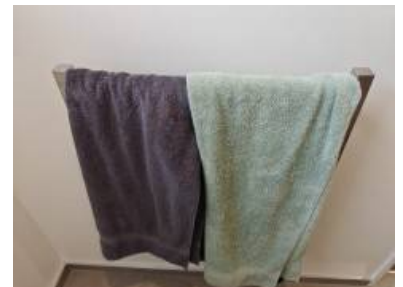
Hardwired heated towel rail installed, heating function not tested.

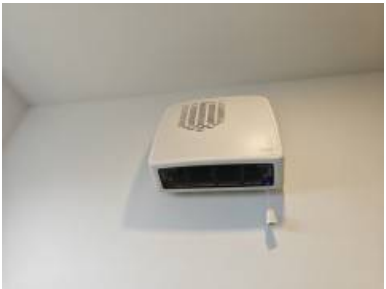
Electric heating installed, tested working.

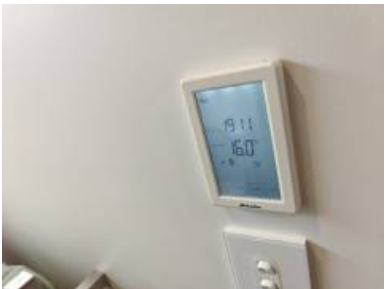
Underfloor heating installed, not tested.

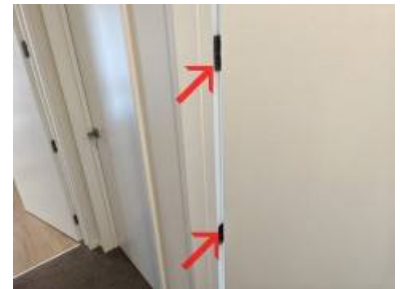
*Interior Door & Surround:* Hinged door, function as designed.  
[Maintenance task: Squeaky hinges, suggest CRC spray.](#)

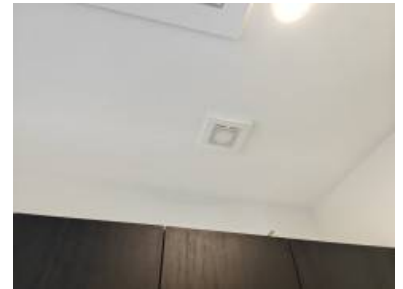
Drying vent fitted, Electric type, Tested, working.

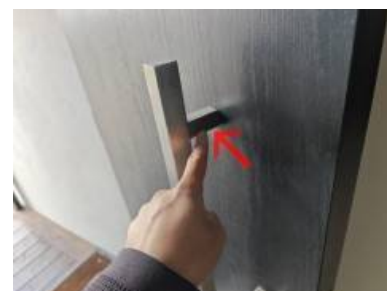
[Suggest tighten door handle screw.](#)

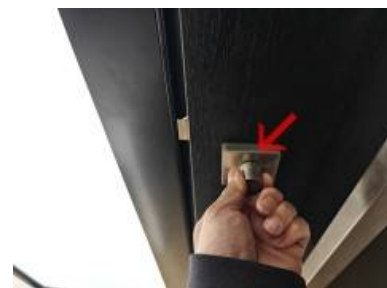
[Latch a little tight, suggest make adjustment to latch.](#)

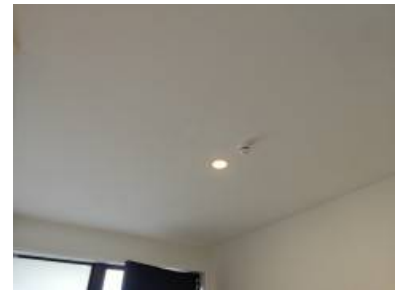
Smoke alarm securely installed. Smoke alarm(s) installed here covers all the bedrooms in this house, which meets the current building regulations.

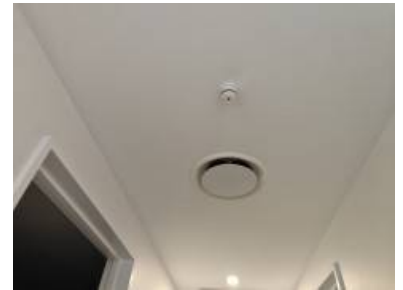
Central heating system installed, operational on the day of inspection.

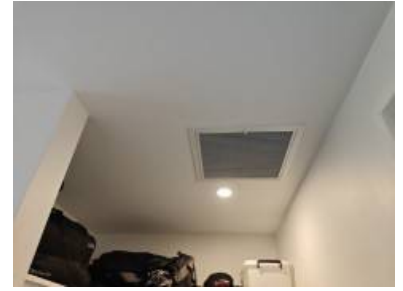
Central heating system installed, Central heating return vent installed, suggest clean filter annually.

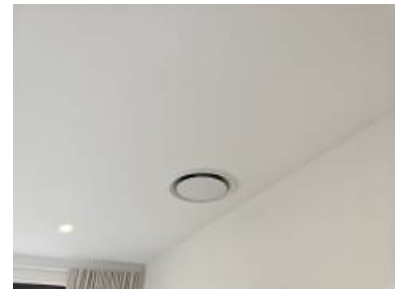
Central heating system installed, operational on the day of inspection.

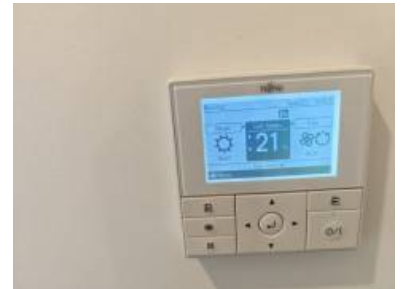
Central heating control panel installed, operational on the day of inspection.

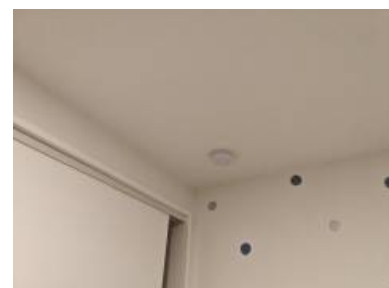
- Internal Ceiling & Wall Linings:* Base linings intact, good condition.
- Windows & Reveals:* Aluminium-framed double-glazed windows, function as designed.
- Interior Door & Surround:* Hinged door, function as designed.
- Lighting & Power Points:* Lighting installed, tested, function as designed. Power points installed, tested, function as designed.
- Smoke Alarms:* Smoke alarm securely installed.

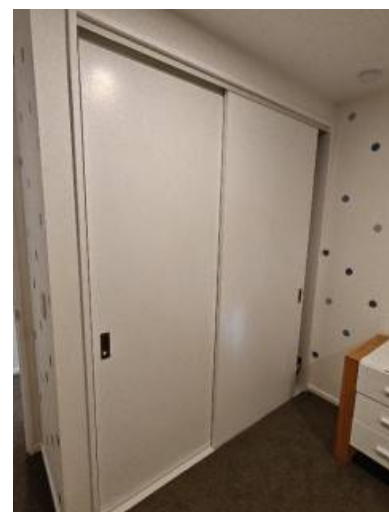
- Wardrobe:* Built in wardrobe, doors function as designed.

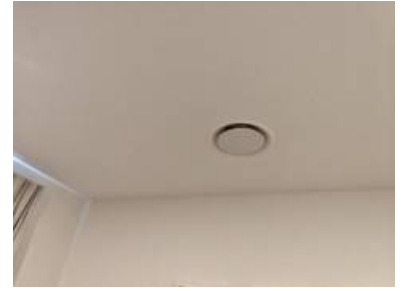
Central heating system installed, operational on the day of inspection.

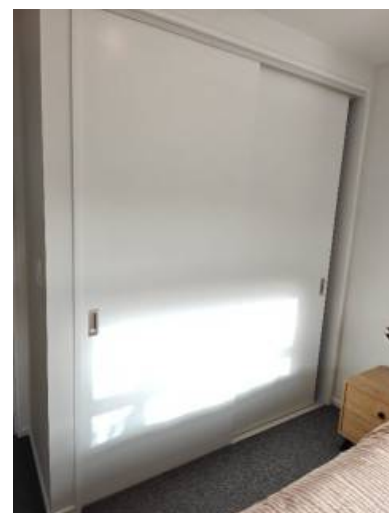
*Wardrobe:* Built in wardrobe, doors function as designed.

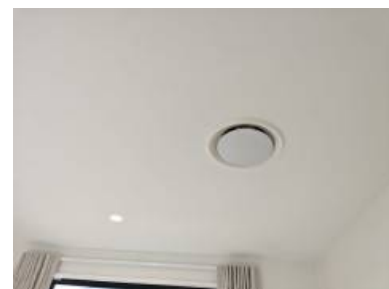
*Heating:* Central heating system installed, operational on the day of inspection.

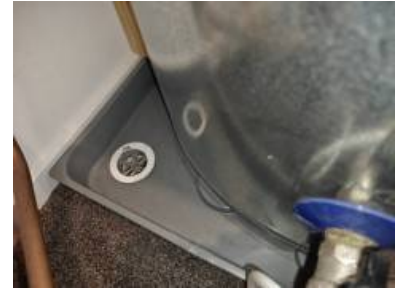
Overflow tray installed, no signs of water leakage.

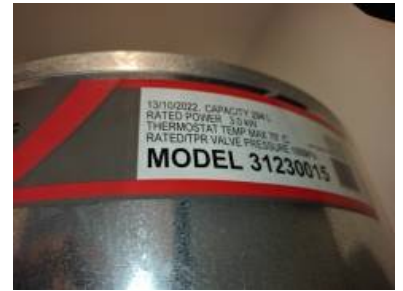
300 Litre, Mains Pressure, Year Manufactured: 2022.

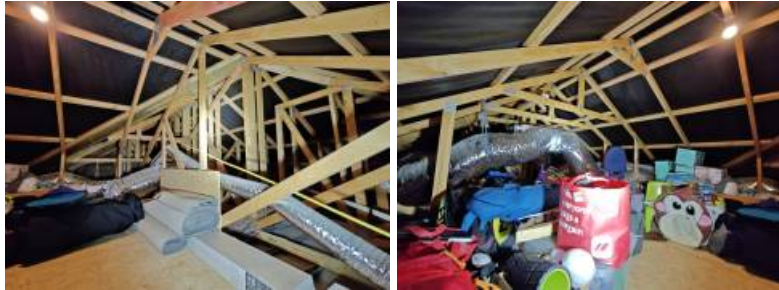
Access into and movement in the internal ceiling space is generally good, most areas able to be inspected.

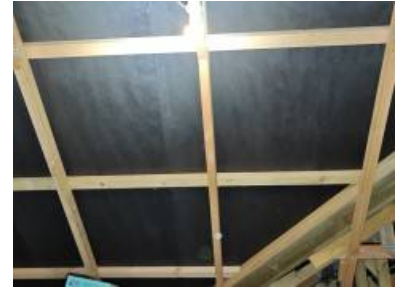
Roof lining Paper installed. Good condition, secure, no deterioration on the roof lining installed.

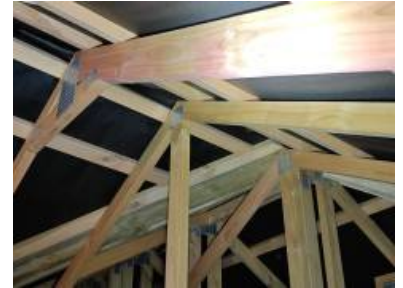
The factory manufactured trusses are secure, and in a good sound condition.

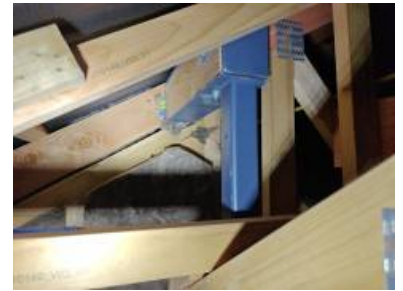
*Support Timber, Batten & Joist:* Steel beams installed, good condition.

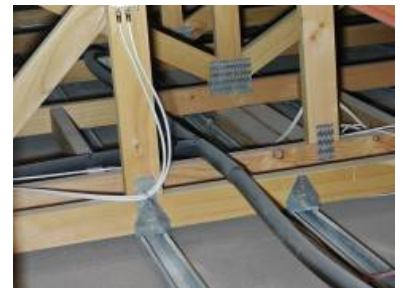
PVC, Lagged or insulated, The plumbing installed in this area is secure, and shows no signs of any moisture leaks, or damage.

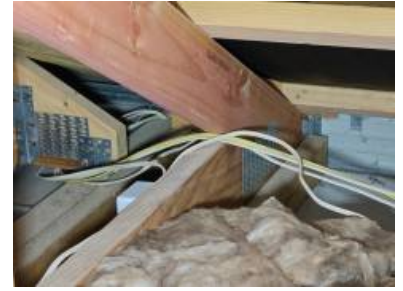
The wiring here is a modern plastic coated design. Well stowed, the wiring appears to be in good condition.

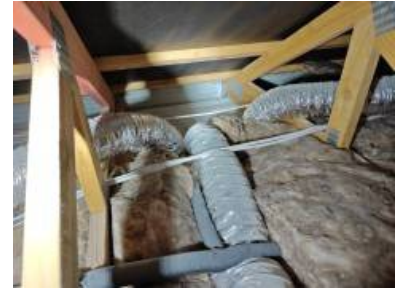
The extraction unit housing is in good condition. Well connected vented to the outside area.

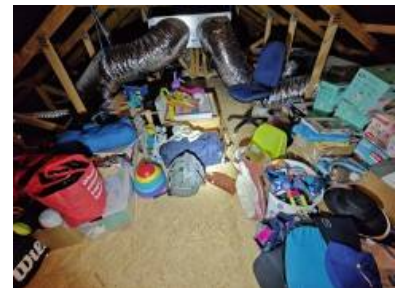
Home owner's belongings stored in the ceiling space.
